STATEMENT OF DECISION OF THE TRIBUNAL UNDER SECTION 24(1) OF THE
HOUSING (SCOTLAND) ACT 2006

Case Reference FTS/HPC/RP/23/3326`

Property at 25 Douglas Crescent, Hamilton ML3 7SQ ("the Property"), being the subjects registered in the Land Register of Scotland under Title Number LAN158629.

Pre-hearing inspection summary and schedule of photographs

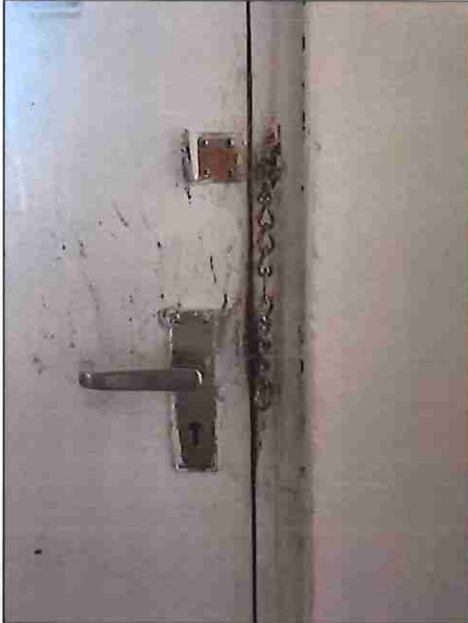
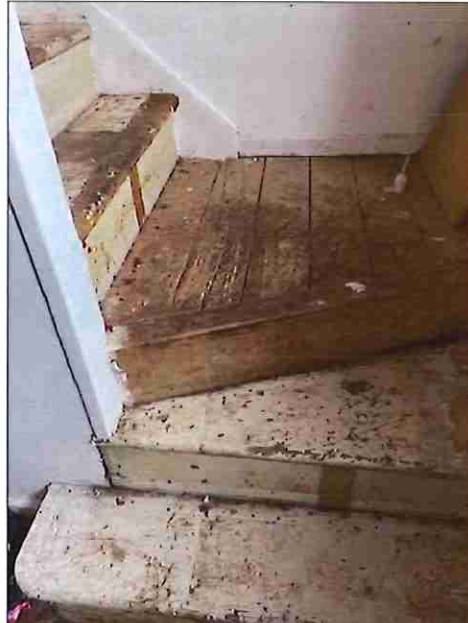
Hall

- f) The Tribunal noted that repairs had been carried out to the flooring and lower stairs within the Property. The flooring in these areas was now in a reasonable state of repair.
- g) The Tribunal noted that there were no significant draughts from around the front door of the Property. Draught excluders had recently been fitted to the door by the Landlords. The locking mechanism of the front door was found to be faulty, but that was not a matter which had been specifically raised by the Tenant in the Application.

Draught from front door, new seal has been fitted no draught noted at time of inspection. Loose floorboards on stairs have been repaired.

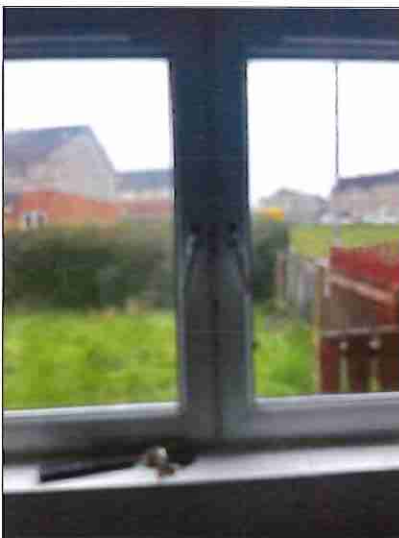
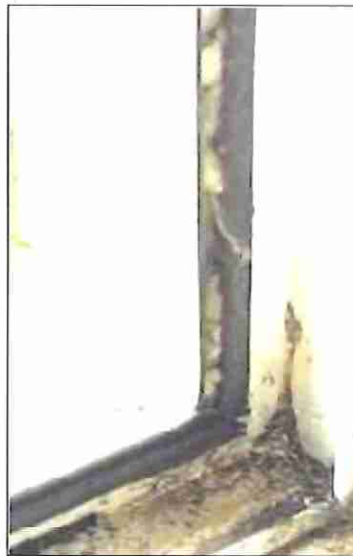
Living Room

- a) The electrical socket in this room had been repaired by the Landlord.
- b) The windows in this room were in a reasonable state of repair and in proper working order. The Tribunal had noted that parts of the window seals were worn and would require attention, but there was no evidence of significant draughts from these windows.

On inspecting the window for draughts, it was noted that a section of the window gasket had perished.

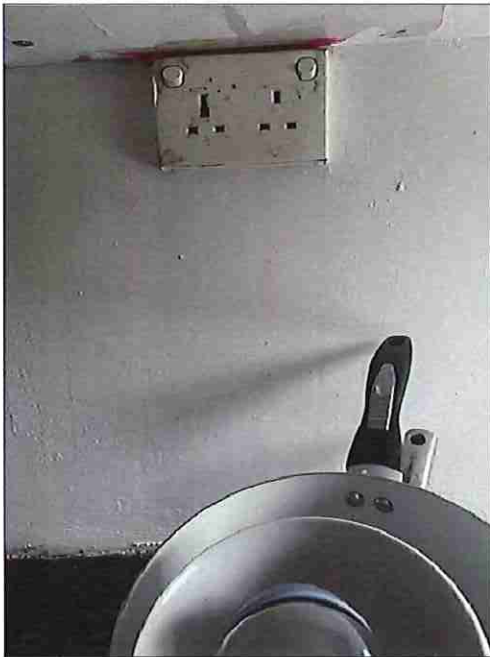
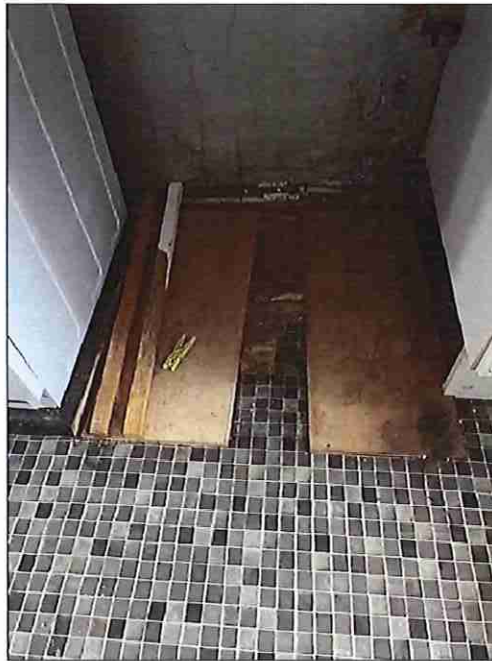
Kitchen

- c) The electrical socket in this room had been repaired by the Landlord.
- d) The flooring in the space provided for a washing machine in the kitchen had been repaired. It was in a reasonable state of repair.
- e) There was no evidence of rodents in the oven in the kitchen.

Broken socket in kitchen replaced. Crumbled flooring temporary repair noted.

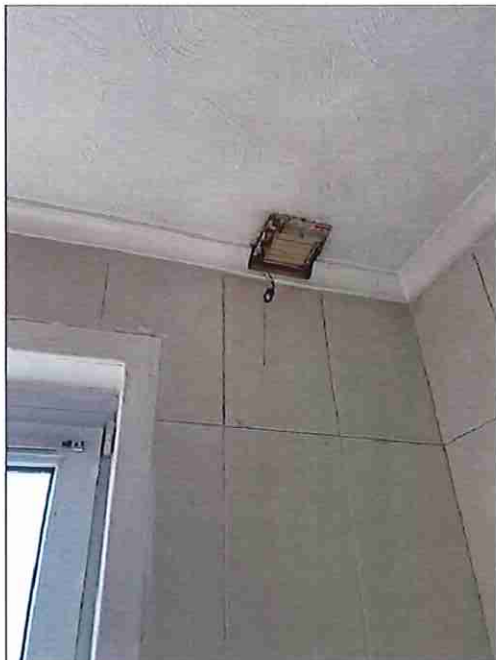
- h)* The Tribunal noted that the extractor fan in the bathroom was broken and not operational. The extractor fan is a fitting provided by the Landlords under the tenancy between the parties and it is not in a reasonable state of repair or in proper working order.
- i)* The Tribunal noted that part of the flooring on the landing immediately outside the bathroom door was loose. As a result, the flooring is uneven and presents a potential tripping hazard. That part of the flooring was not in a reasonable state of repair and requires to be repaired.

- c) The extractor fan in the bathroom of the Property is a fitting provided by the Landlords under the tenancy between the parties and it is not in a reasonable state of repair or in proper working order.

Bathroom - Mechanical extract fan is broken.

- a. Repair or replace the extractor fan in the bathroom of the Property so that it is in a reasonable state of repair and in proper working order.
 - b. Repair or replace the flooring on the landing immediately outside the bathroom door of the Property so that it is in a reasonable state of repair.

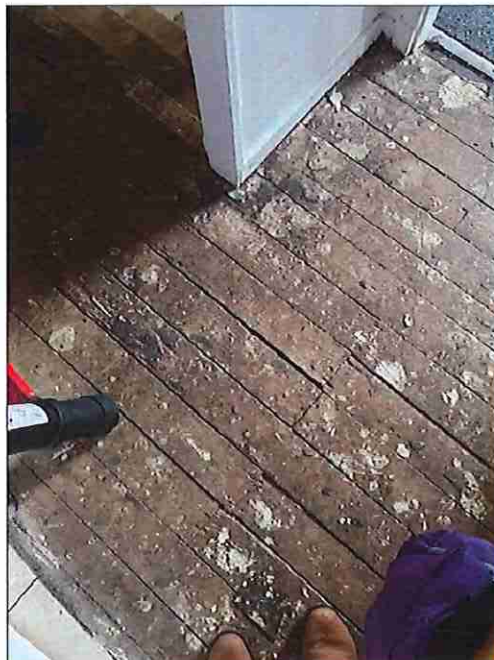
- d) Part of the flooring on the landing immediately outside the bathroom door is loose. That part of the flooring is not in a reasonable state of repair.

Hall- Floorboards loose top landing.

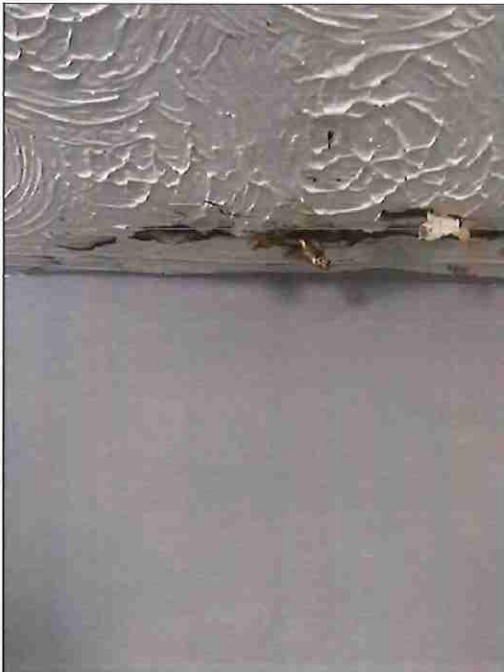
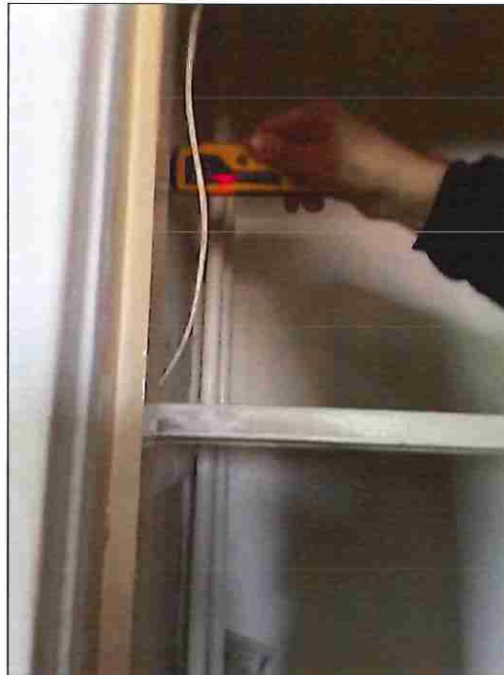
Front bedroom

- j)* The Tribunal noted that there was evidence of historic water ingress into the front bedroom of the Property. The Tribunal tested the walls of the room (and the cupboards within the room) for dampness using a damp meter. There was no evidence of continuing water ingress or dampness within that room of the Property. The Tribunal noted that there was evidence of water staining and small holes in the ceiling of the room which were likely related to previous water ingress into the Property. The Tribunal did not consider these issues to be significant.

Hole in bedroom ceiling noted – Caused by historic water ingress.

A medium moisture reading was noted in one section of the cupboard all other areas are well within the normal range.

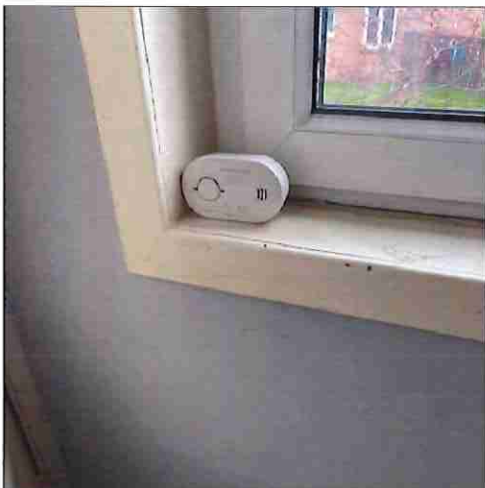
- k)* The gas boiler for the Property is located in a cupboard in the Front Bedroom. The Landlords have supplied a CO2 detector. That detector has not been affixed to the wall of the room in compliance with current regulations. The detector requires to be correctly located and until that work is completed the Property does not have an adequate system for the detection of carbon monoxide.

- e) The CO2 detector in the front bedroom of the Property has not been affixed to the wall of the room in compliance with current regulations
- f) Within the loft of the Property certain section of the roof the timber sarking and roof membrane had been damaged due to water ingress. The roof of the Property is not in a reasonable state of repair.

Carbon monoxide monitor has been replaced but not fitted as per guidance.

Ceiling mounted and positioned at least 300 mm from any wall, or wall mounted and positioned at least 150 mm below the ceiling and higher than any door or window in the room.

Carbon monoxide detectors in the space containing the combustion appliance should be sited between 1 m and 3 m from the appliance. Note: where the combustion appliance is located in a small space it may not be possible to locate the detector within that space. In such circumstances the detector may be located at the appropriate distance out with the space.

- c. Locate the CO2 detector in the front bedroom of the Property so that it is fully functioning and meets current regulatory standards
 - d. Repair those sections of the roof timber sarking and roof membrane within the loft of the Property which have been damaged due to water ingress, so that the roof of the Property is in a reasonable state of repair.

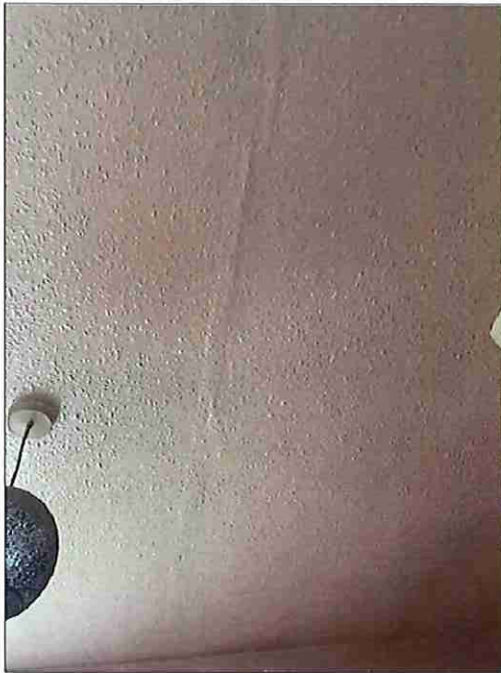
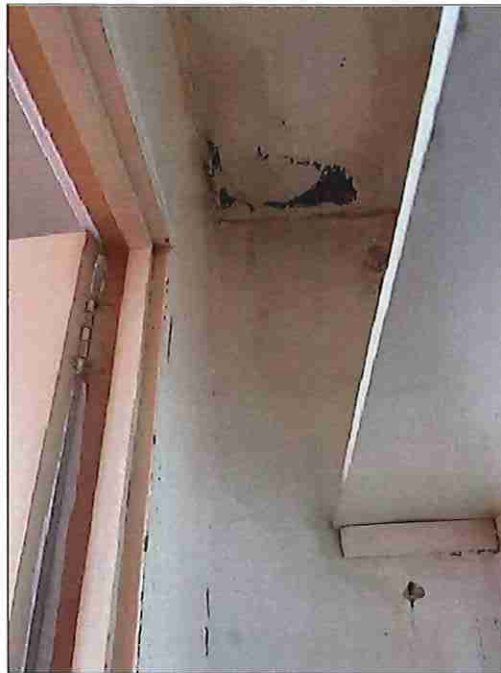
Back bedroom

- l) The Tribunal noted that there was evidence of historic water ingress and dampness in the rear bedroom of the Property. The Tribunal tested the walls of the room for dampness using a damp meter. There was no evidence of continuing water ingress or dampness within that room of the Property.

Evidence of historic water ingress visible. No high moisture readings noted on ceiling, walls or in fitted wardrobe.

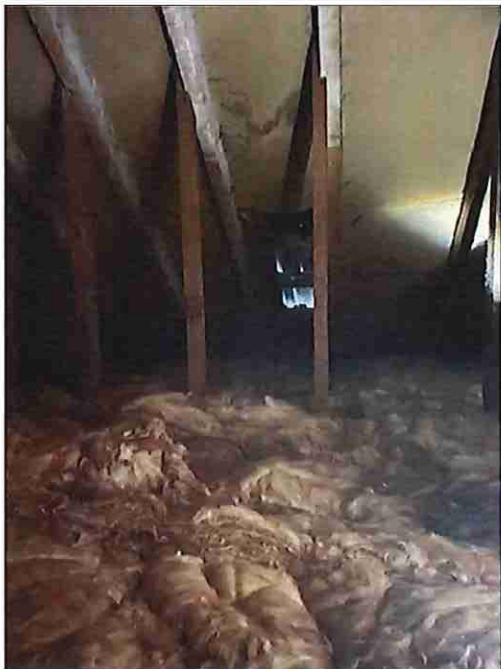
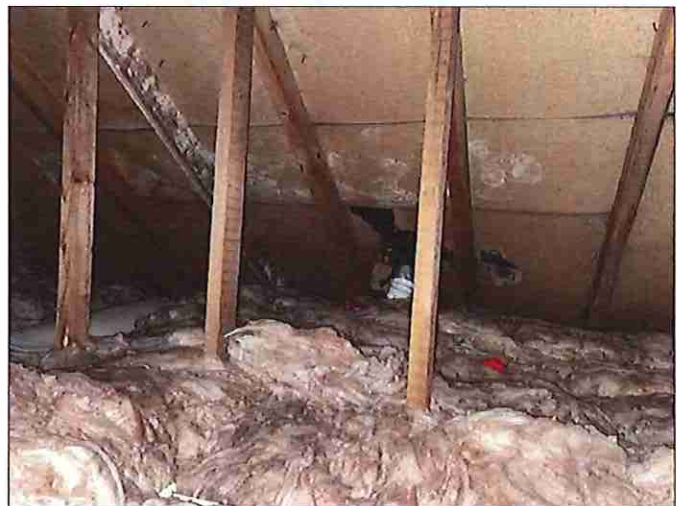
Loft

- m) The Tribunal carried out a limited inspection of the loft/roof space of the Property. It was observed that in certain sections of the roof the timber sarking and roof membrane had been damaged due to water ingress. This disrepair was likely to allow water ingress into the Property. The Tribunal did not consider that the roof of the Property was in a reasonable state of repair for this reason.
- n) The Tribunal was not satisfied that there was any evidence of woodwork on the beams in the loft of the Property.

Water ingress both historic and more recently is visible.

Two areas of sarking and sections of the roof membrane appear to be missing and day light is visible.

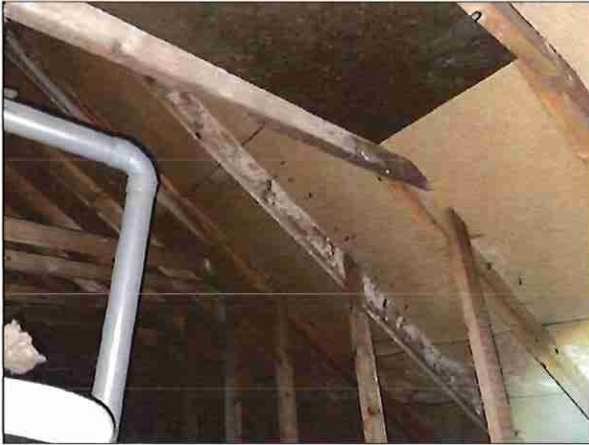
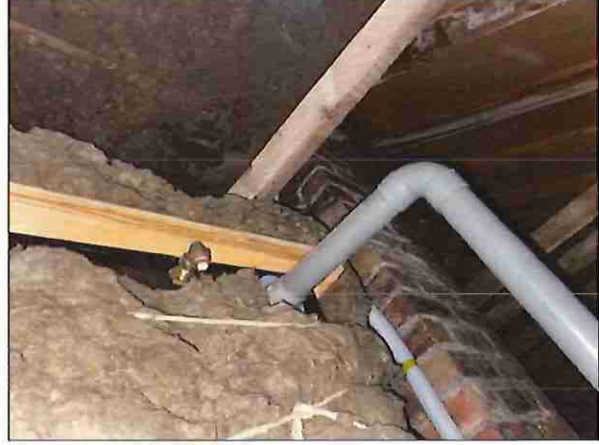
Access to the loft space was limited due to loft insulation covering the loft joists. Unable to identify any woodworm, landlord has advised woodworm has been recently treated by a contractor.

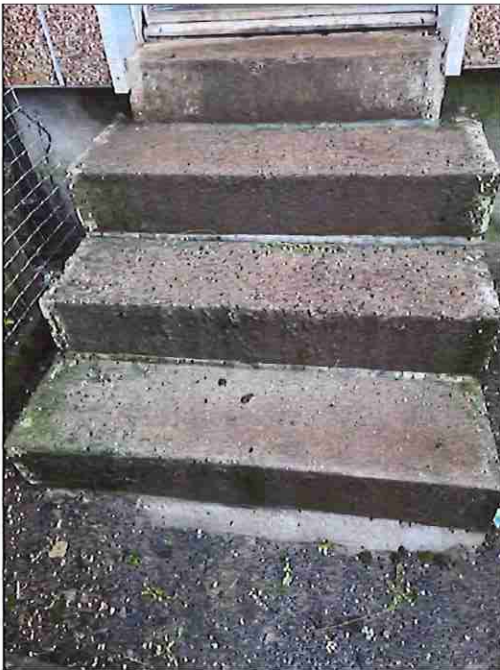
External stair to garden

- o) The Tribunal noted that repairs had been carried out to the external stone steps leading to the back door of the Property. The steps were now in a reasonable state of repair.
9. The Landlords and the Tenant's representative accepted the Tribunal's observations and did not seek to challenge their views following the inspection. Whilst the Landlords have carried out certain works to the Property since the date of the Application, they confirmed that they recognised that some minor works were required to repair the issues identified by the Tribunal and to bring the property up to the Repairing Standard.

Stairs have been repaired and no holes noted.
