STATEMENT OF DECISION: Housing (Scotland) Act 2006 Section 24 (1)

Reference number: FTS/HPC/RP/23/2895

Re: Property at 7 Old Schoolhouse Lane, Houston, PA6 7JB (“the Property”)

Inspection - Photograph Schedule
7 Old Schoolhouse Lane, Houston,
PA6 7JB

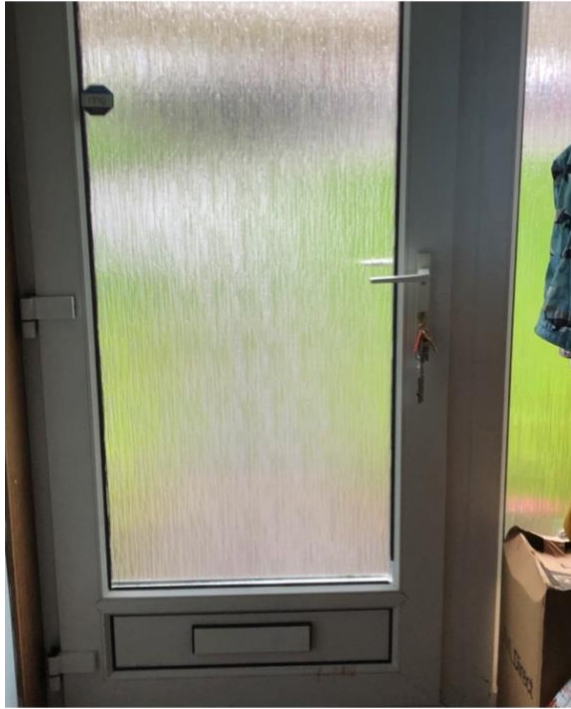
(k) Parties agree that satisfactory trickle vents have been fitted to each of the window units in the property. Parties agree that the perceived defect in the front door has been remedied, and the problem the appellant originally complained about with the shower has been remedied.

Photo 2 – Correctly functioning front door and lock

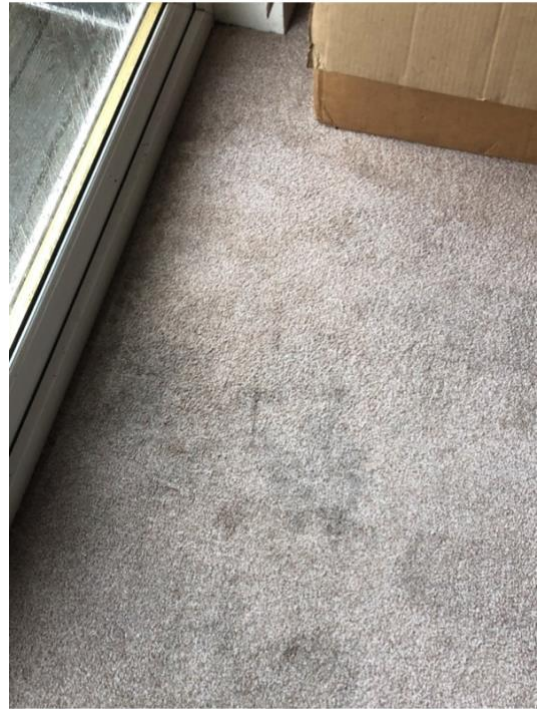
(f) The carpet adjacent to the patio door in the living room was wet.

(f) There is embedded dampness on the floor adjacent to the patio doors (to the rear of the living room).

Photo 3 – Saturated carpet at patio door

1. (i) Instruct a suitably qualified damp specialist to prepare a survey report detailing the cause and full extent of the damp affecting the property together with a proposed specification outlining all necessary remedial action.

- (ii) Submit that report to the Tribunal for further consideration and thereafter carry out all works then required by the Tribunal as are necessary to eradicate the damp and mould from the property to ensure that the property meets the Repairing Standard.

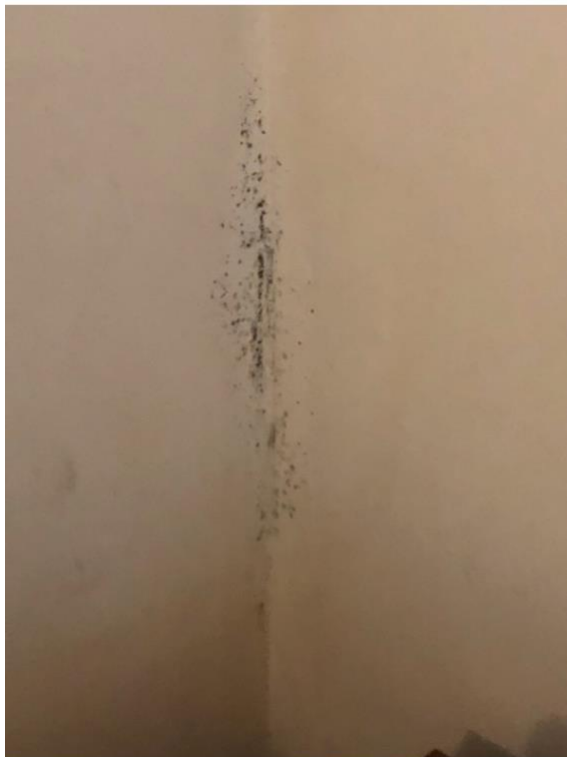
(c) Tribunal members could see mould staining in the corners of interior walls in the living room and three bedrooms. The surveyor member of the tribunal took damp meter readings in the areas of mould staining. He took damp meter readings around the window surrounds and the patio doors to the rear of the living.

Photo 4 – Surface mould on living room wall

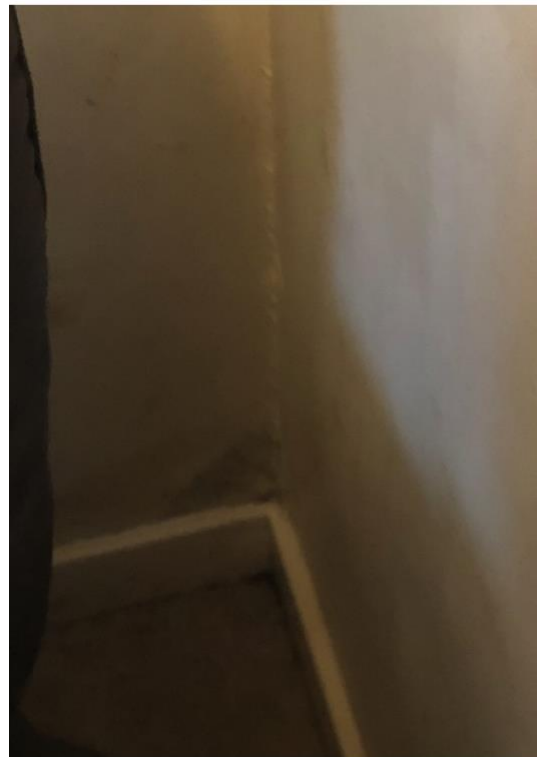
Photo 5 – Surface mould on Living room wall

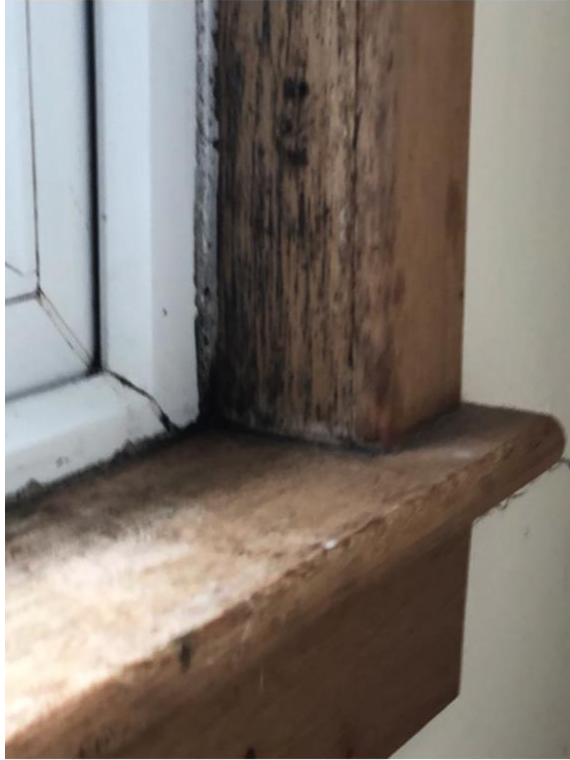
(g) The wooden windowsills throughout the property are compromised. Higher than average damp meter readings were taken from each windowsill. Each of the wooden windowsills shows signs of water ingress/condensation issues.

(e) The surveyor members observations and the damp meter readings disclose embedded dampness in the ground-floor bedroom, and in the living room. One upstairs bedroom has badly stained windowsills - indicative of water ingress from the rear pitch of the roof. Only surface readings of dampness were obtained from either side of the patio doors in the living room, but the floor adjacent to those patio doors is so wet that when the surveyor member rose after kneeling to take damp proof readings, he found that his knees were wet.

Photo 6 – Water damage to upper-right bedroom sill

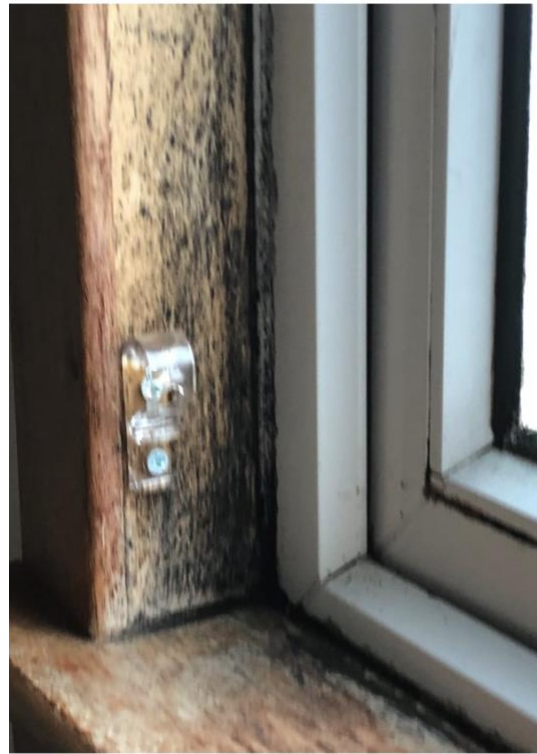
Photo 7 – As per photo 6

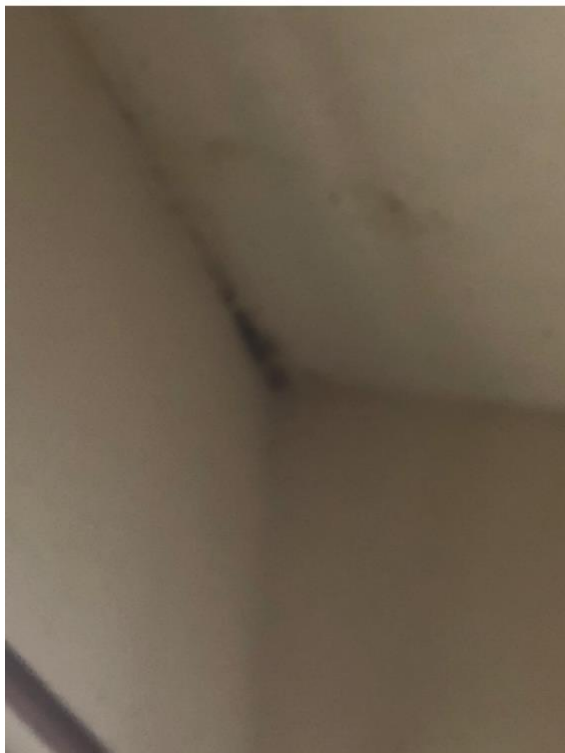
Photo 8 – Mould on upper-right bedroom ceiling

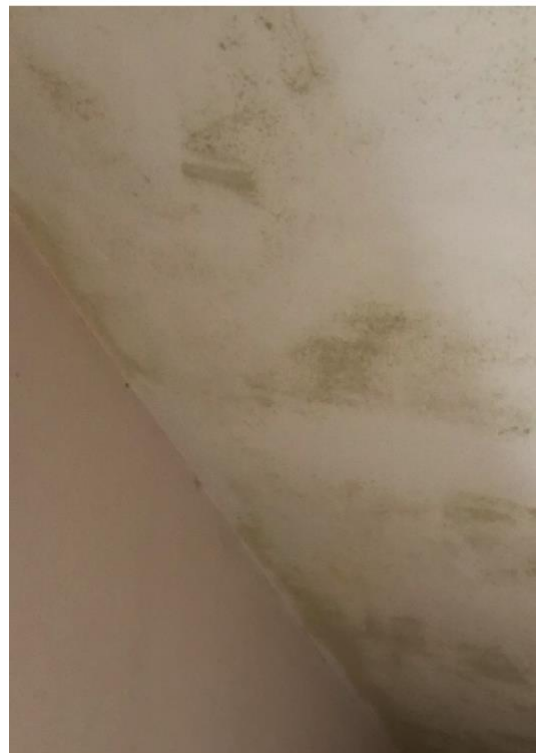
Photo 9 – Mould on upper-left bedroom ceiling

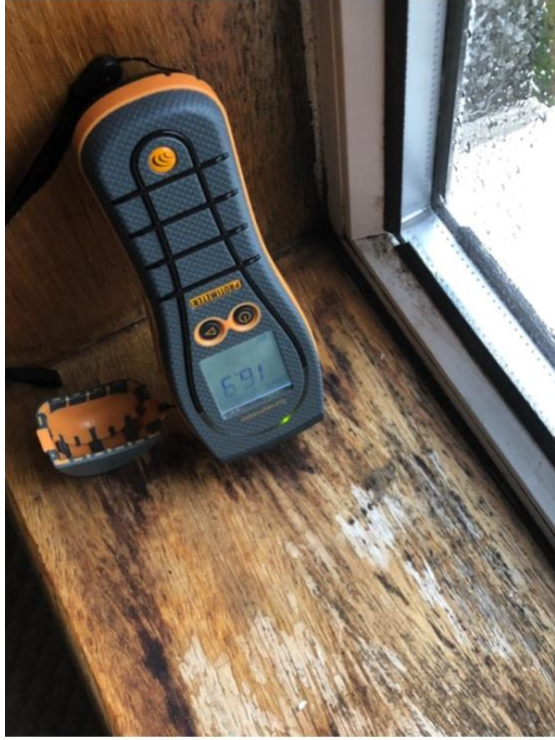
Photo 10 – Water staining/damp reading in bedroom

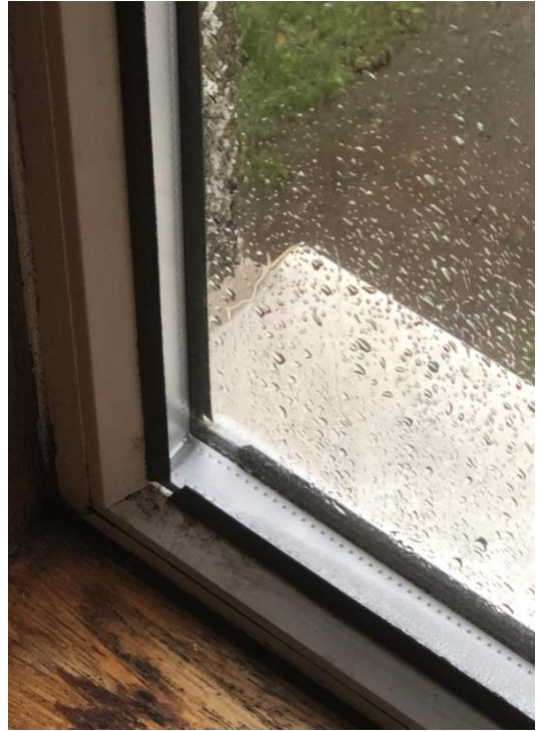
(h) The landlord replaced at least two windows in May 2023. Even the newly replaced windows have defective seals on the glazed units.

(h) All of the windows, including the new window units, are compromised. The UPVC frames have no apparent defect. The defect is in each of the double glazed units because the seals are incomplete.

Photo 11 – Window seals incomplete/damaged

2. Repair or replace all and any defective window seals throughout the property.

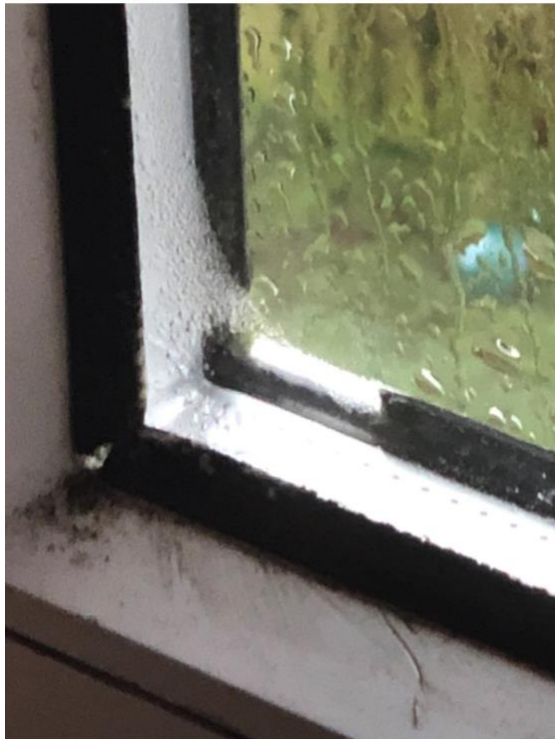
Photo 12 – Window seals incomplete/damaged

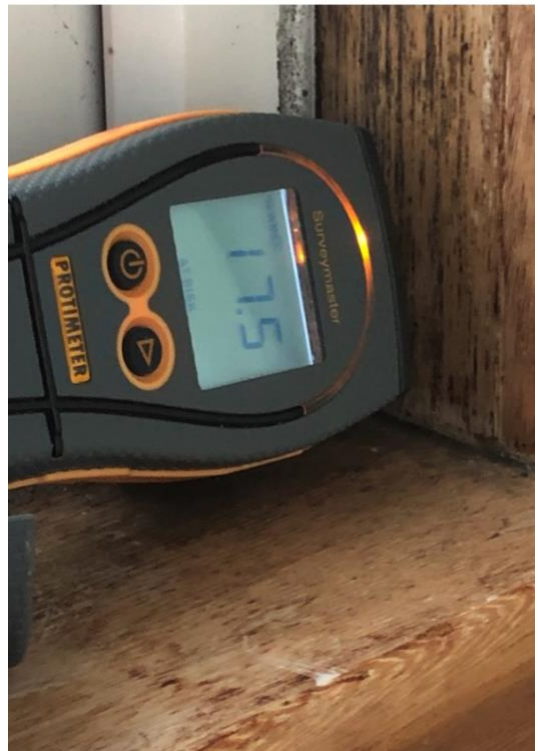
Photo 13 – Damp reading in upper-left bed. Sill

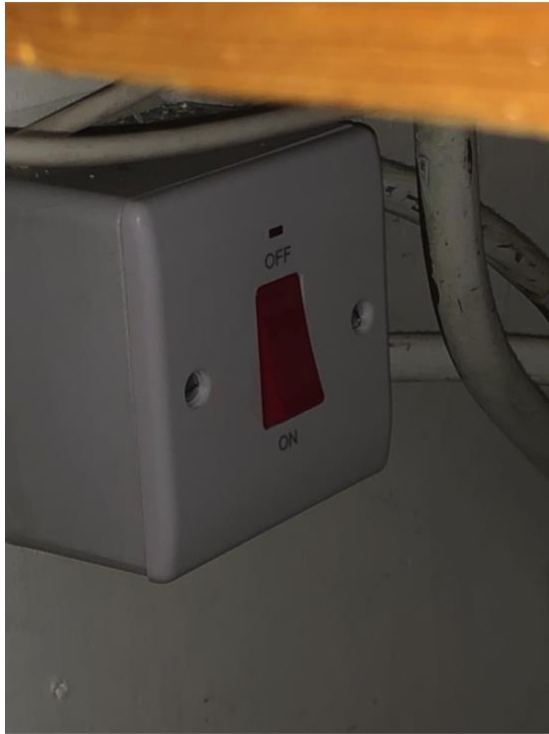
Photo 14 – Replacement shower switch near boiler

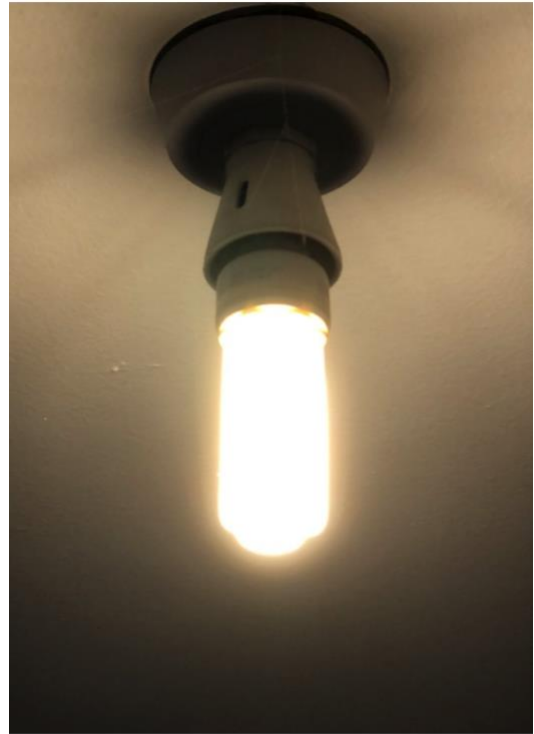
Photo 15 – Inappropriate bathroom light fitting

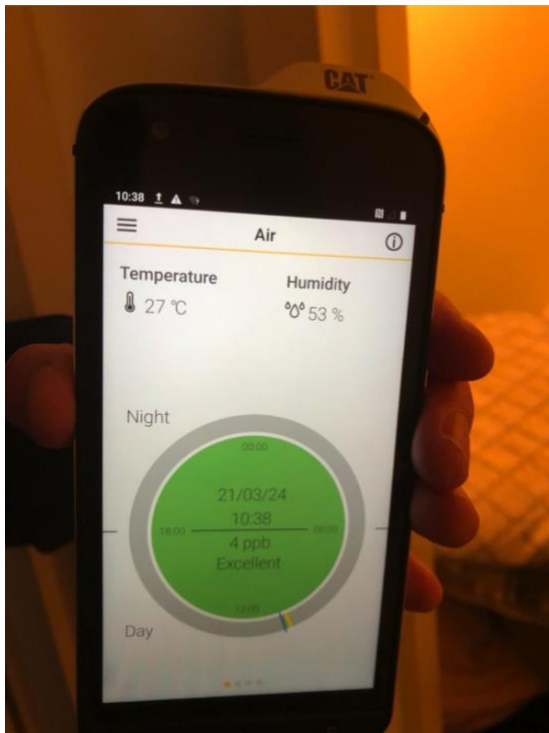
Photo 16 – Air quality reading in walk-in cupboard

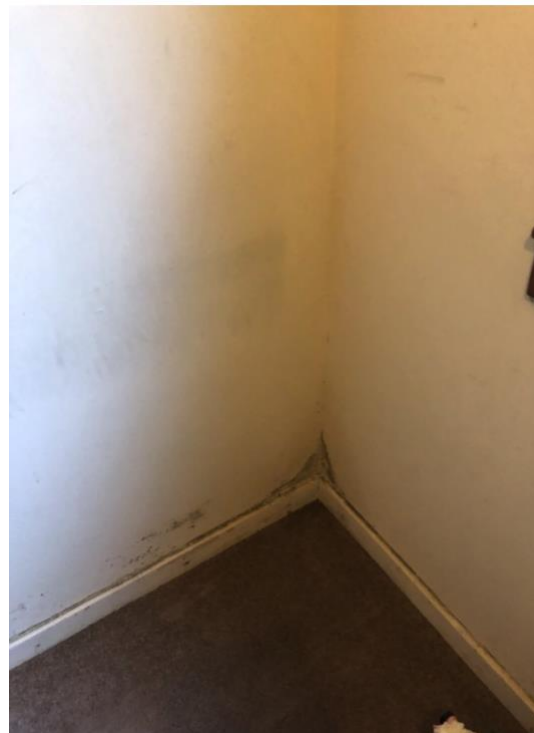
Photo 17 – Dampness and mould in G/F bed.

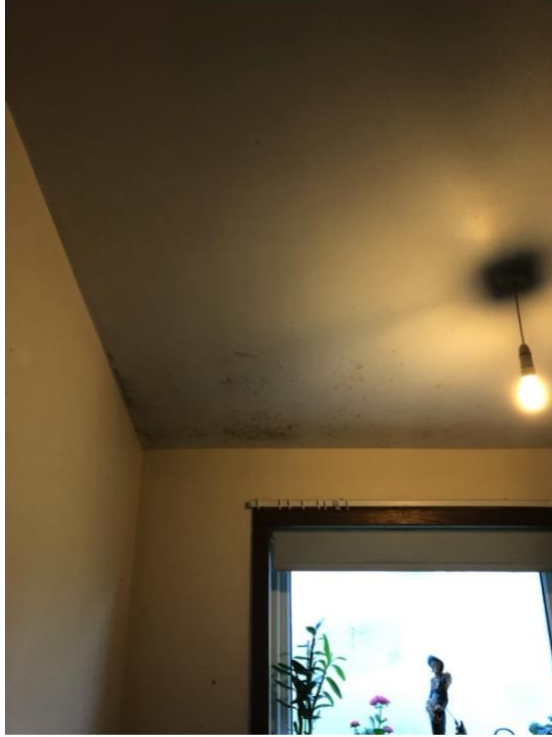
Photo 18 – Mould on G/F Bedroom ceiling

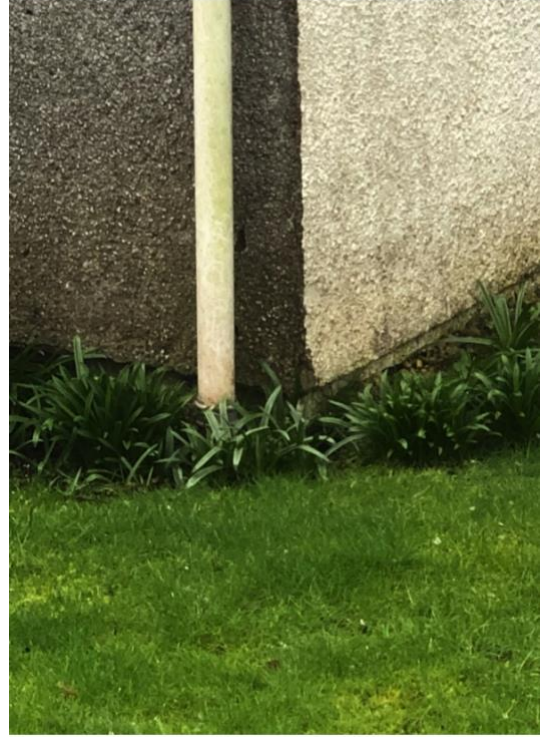
Photo 19 – Roughcast issues front elevation

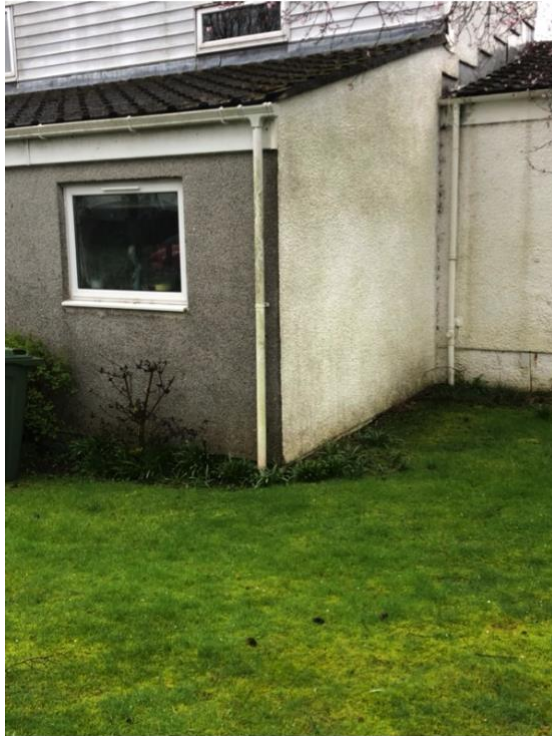
Photo 20 – Re-rendered section of wall

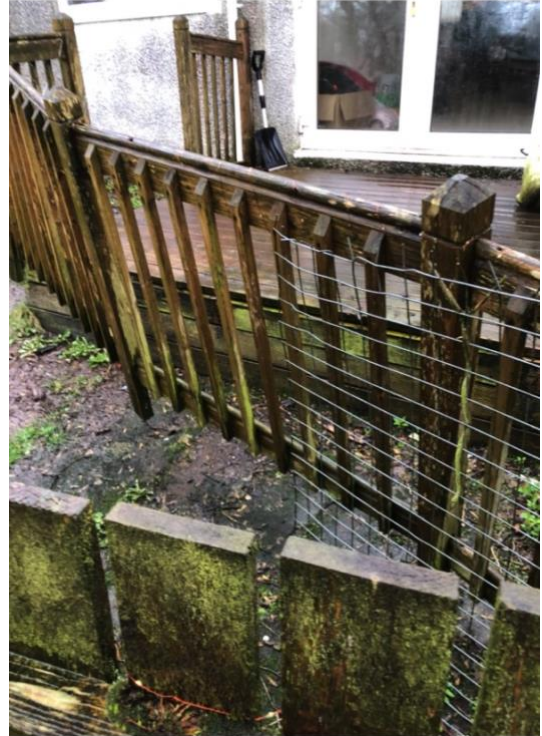
(k) The patio doors to the rear of the property open on to an area of wooden decking. The decking once had a balustrade attached. That balustrade has separated from the decking, and is hanging loosely to the rear of the decking,

(j) To the rear of the property, the decking is damaged. The balustrade has come loose. It is separated from the wooden decking and needs to be repaired or replaced. The decking itself is showing signs of age. Reinstatement of the balustrade is necessary, but the landlord might consider overhauling the entire decking area.

Photo 21 – Broken balustrade

3. Repair or replace the broken balustrade surrounding the decking in the rear garden.
