# Housing and Property Chamber

### Statement of Decision of the Housing and Property Chamber of the First-tier Tribunal for Scotland under Section 26 (1) of the Housing (Scotland) Act 2006

**Property:** 7 Prior Avenue, Canonbie, Dumfries and Galloway DG14 0UT  
("the Property"/ "the house")

**Chamber Reference:** FTS/HPC/RT/19/3345 and FTS/HPC/RP/2577

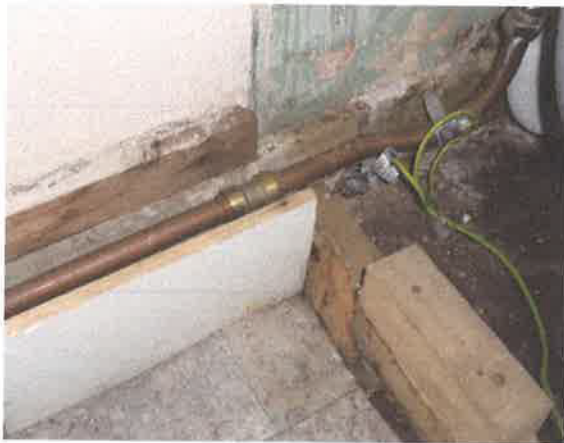
- Internally, there are areas of mould affecting plasterwork specifically at the bathroom, hallway, entrance porch and kitchen particularly the area around the kitchen sink unit. In recent months a significant leak was identified in a water supply pipe in the bathroom. Remedial action was completed and the pipe now appears in good working order (Photograph 2).

**(2) Repaired pipe bathroom**

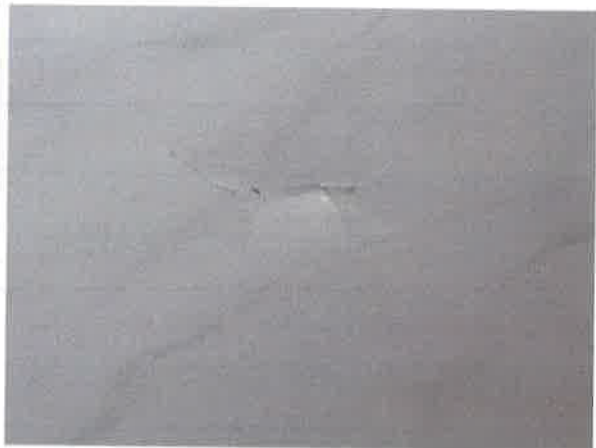
- Within the bathroom, the "PVC wet wall lining" on the mutual wall with the hall has been damaged and there is a visible tear in the material (Photograph 3). The lining is therefore no longer protecting the surrounding wall plaster from water damage at this area.

**(3) Split in shower "wet wall" lining**

14. It was clear to the Tribunal and accepted by the Landlord that works were required to repair or renew the damaged wet wall lining in the bathroom, in order to prevent recurring water damage. The mould on various internal walls required to be removed and work was required to the work top surrounding the kitchen sink. Adaptations were required to the smoke detection system to make it comply with current Scottish Government guidelines. In particular, a smoke detector should be fitted in the living room and interconnected with the existing smoke detector in the hall and the heat detector in the kitchen. The issue regarding the gap adjacent to the wall mounted electrical power socket in the kitchen had to be resolved and, as there was a possibility that the high levels of historic damp may have affected the electrical installation, the Order should require the landlord to provide the Tribunal with an Electrical Installation Condition Report which, in the view of the Tribunal, was satisfactory. The defective joints around the base of the patio doors should be repaired as should the defective rendering and coping at the chimney, to ensure the Property is wind and watertight. Repairs should also be carried out to the paving slabs in the rear garden and to the garden gate.

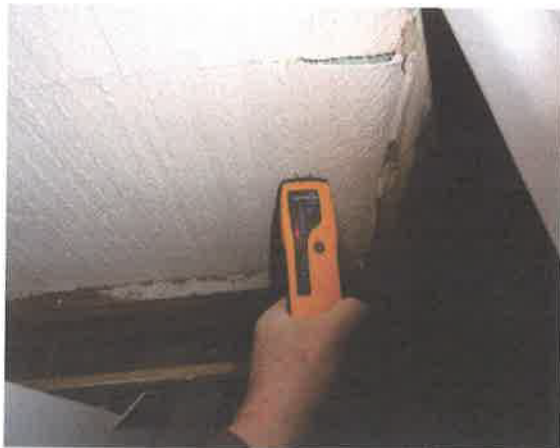
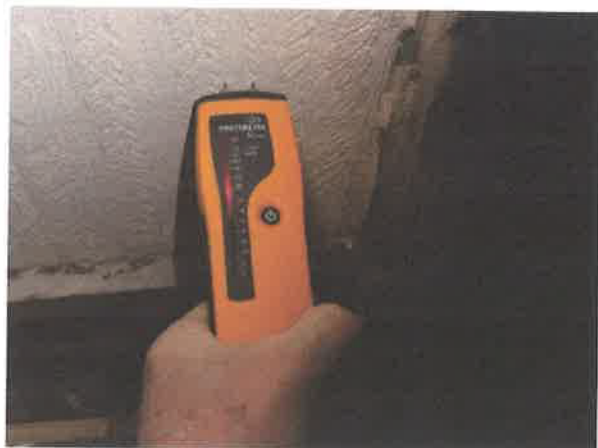
- Moisture readings taken throughout the property specifically at those areas where mould was evident ranged from a negligible level of 11% to a maximum level of 23% (Photographs 4-9). Historically there have been two major sources of damp within the property. The defective plumbing in the bathroom, since repaired, and the defective wet wall lining within the bathroom. The shower is understood to have been in operation since the repair to the plumbing was completed and the defective wall lining continued, therefore, to be a source of damp until the property became vacant. Mould was also evident at the entrance porch adjacent to the entry door (Photographs 12 – 13). Readings taken at these areas identified no significant damp and there was no evidence of water ingress around the door.

**(4 & 5) Positive moisture readings (23%) in wall adjacent to bath.**

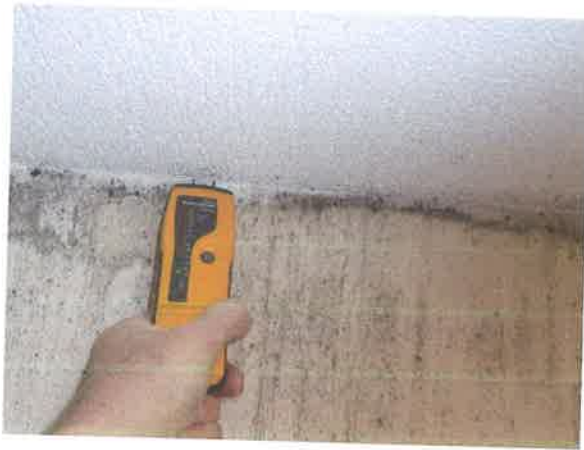
**(6) Low reading (11%) bathroom**

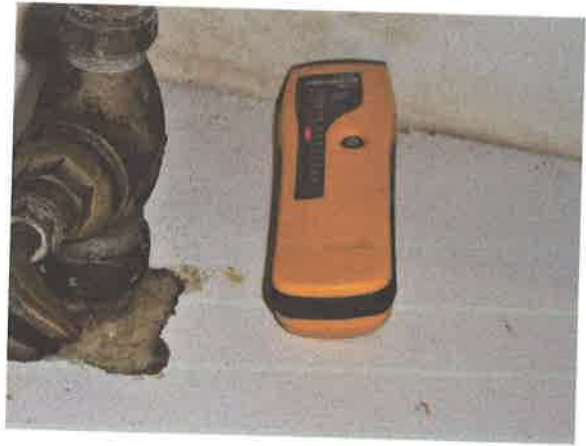
**(7) Damp 19% reading below sink unit**

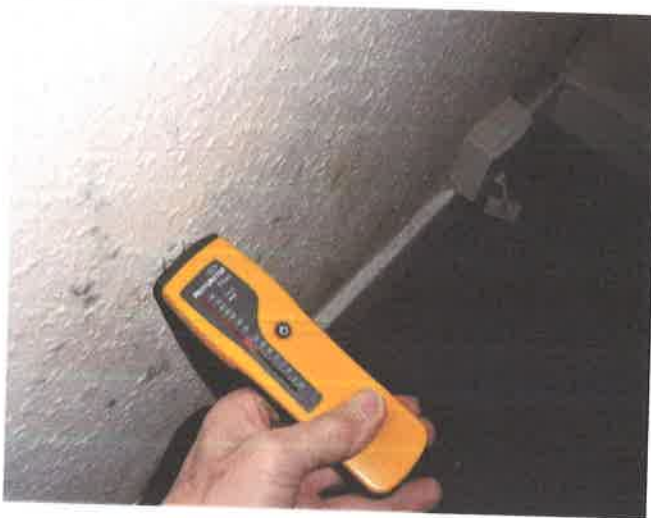
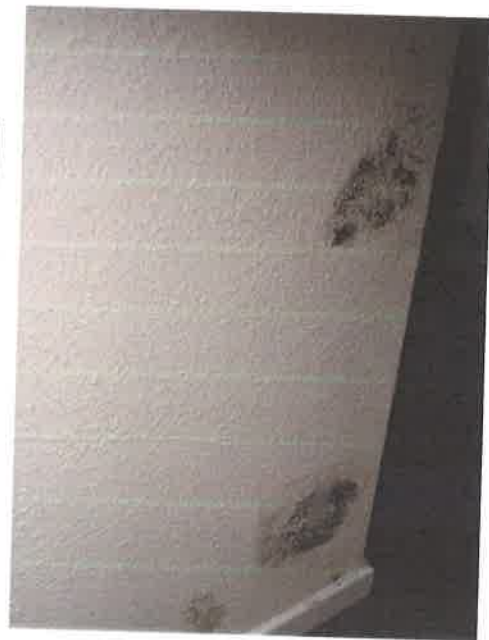
**(8 & 9) Damp staining and mould on hall wall**

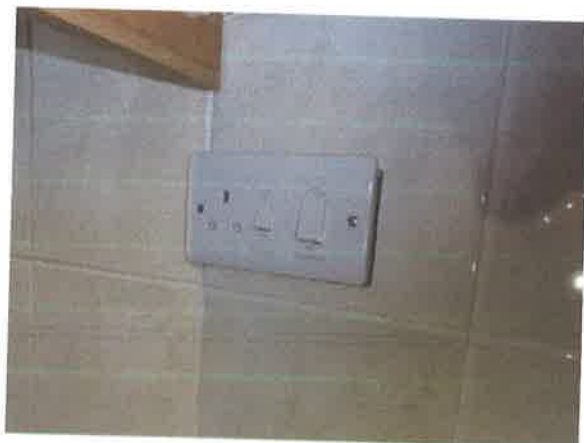
- Within the kitchen there is a gap next to an electrical wall socket which is surrounded by ceramic tiles (Photograph 10) and wiring is clearly visible through the gap behind the facing of the socket. The high levels of historic damp within the property, notably in the hall, may also have come into contact with and had an effect on the electrical wiring.

**(10) Kitchen electrical socket**

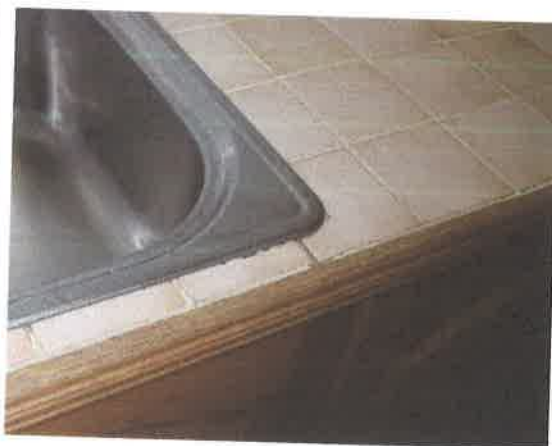
- Around the worktop area at the sink unit there are localised areas of defective grouting at the ceramic tile finish (Photograph 11)
- There are hard wired interlinked smoke and heat detectors within the hall and kitchen although, in contravention of current Scottish Government guidelines, there is no smoke detector within the living room.

**(11) Grouting at kitchen sink**

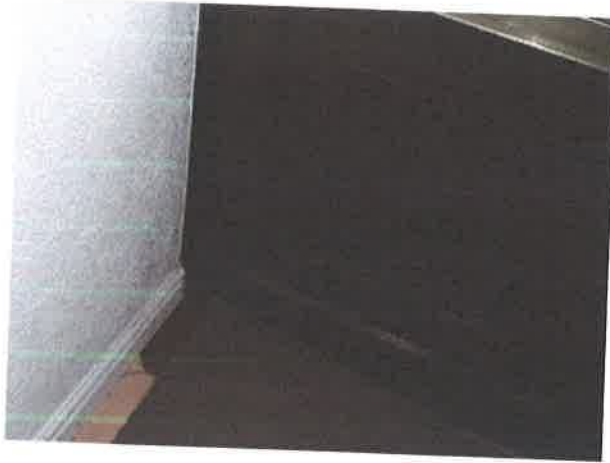
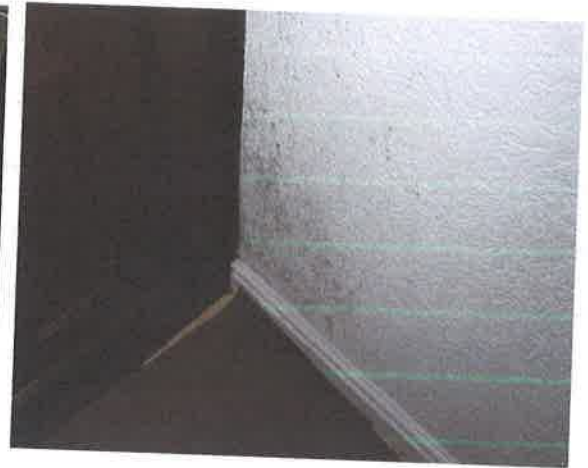
**(12 & 13) Damp staining at internal walls of entry porch**

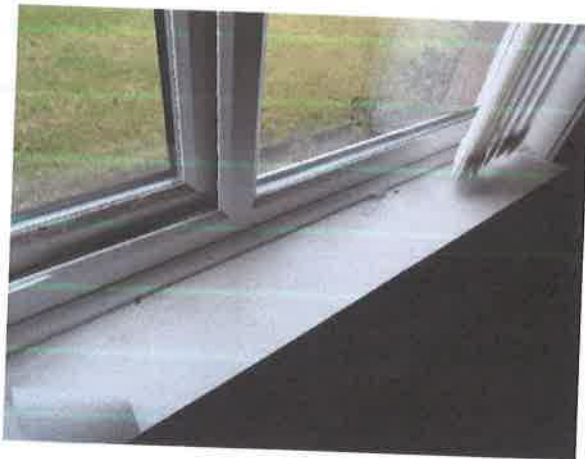
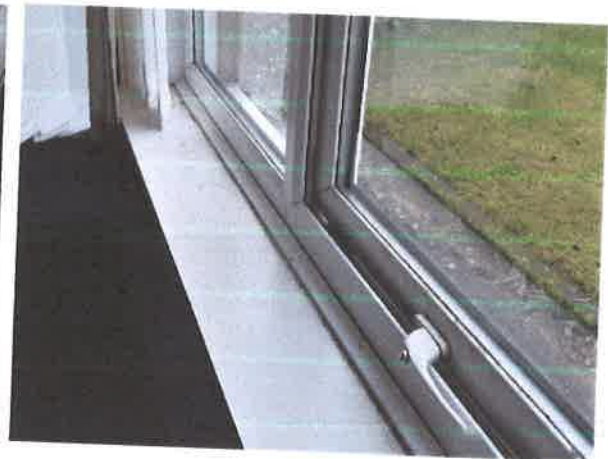
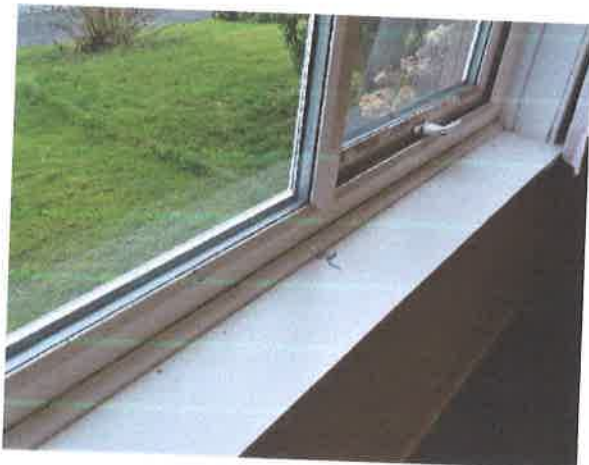
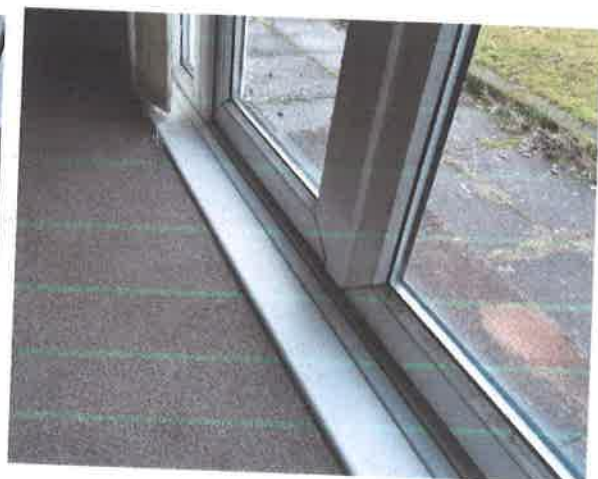
from a previous defect in the plumbing combined with a defect in the wet wall lining. Residual staining resulting from previous condensation, currently dry, was evident affecting a number of sills, windows and door frames (Photographs 14-17).

**(14-17) Residual condensation staining at windows and patio door frames**

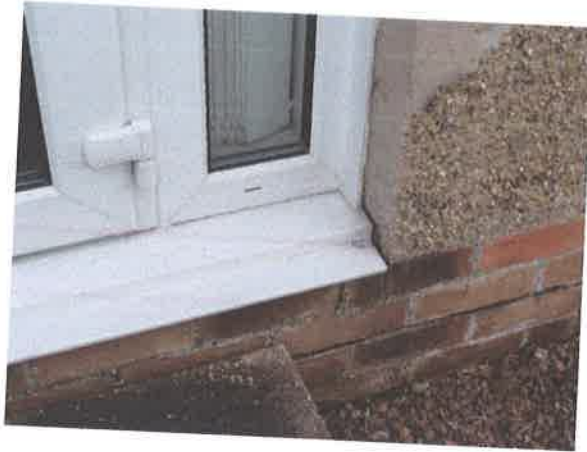
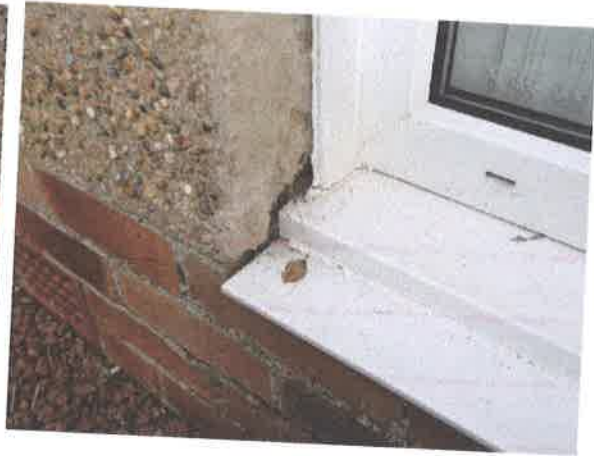
- Externally, around the base of the patio doors and projecting sills there are significant areas of defective and missing pointing (Photographs 18 – 19). Although there is no corresponding evidence of damp internally at these areas, they do represent a defect in the building and a latent source of future damp penetration.

**(18 -19) Defective and missing pointing at patio doors**

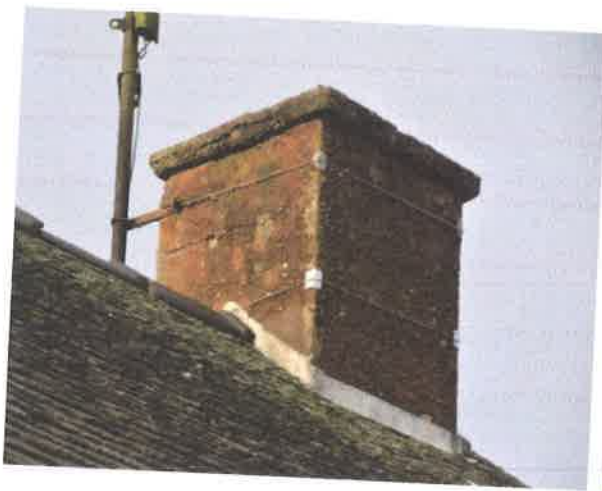
- There are cracked and broken paving slabs at the footpath in the rear garden which represent a health and safety issue (Photograph 21). At the chimney head the rendering and concrete coping is badly cracked and in need of repair (Photograph 20).

**(20) Cracked render at chimney**

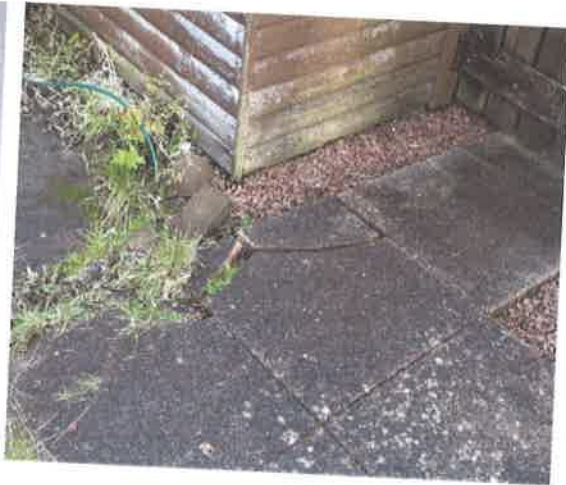
**(21) Cracked paving slab**

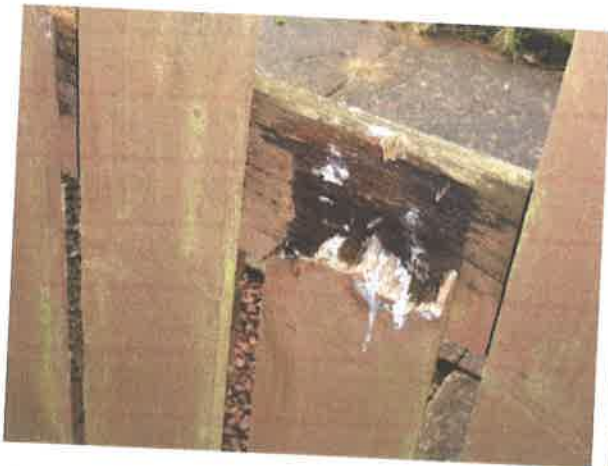
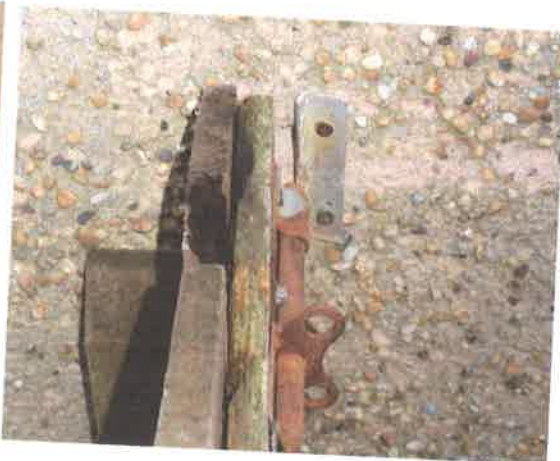
- The timber gate leading to the rear garden is damaged and in need of repair. Due to a missing section of timber on the gate there are several exposed and projecting nails. The closing mechanism is also defective (Photographs 22 & 23).

**(22 & 23) Projecting nails, broken spar and defective closing mechanism at garden gate.**

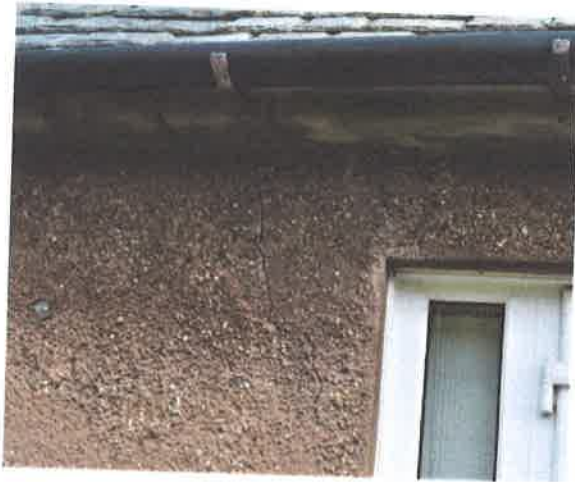
- There is, on the rear wall in particular, clear evidence of cracking above the windows and specifically around the concealed lintels (Photograph 24). This is almost certainly as a direct result of old localised movement within the property and is relatively common in properties of this age and design. There is no evidence of corresponding water ingress when viewed or tested internally. The rendering on the external walls, and, in particular, on the rear elevation, displays evidence of significant wear although this appears to be commensurate with a building of this age and design and not of a serious nature (Photograph 25).

**(24) Cracking around window lintel**

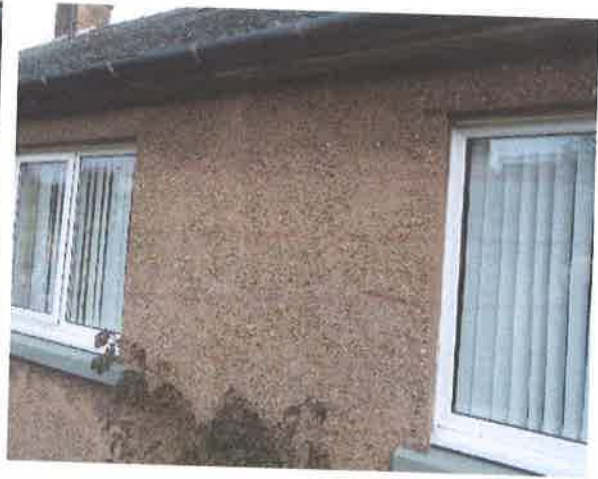
**(25) Worn render at rear wall**

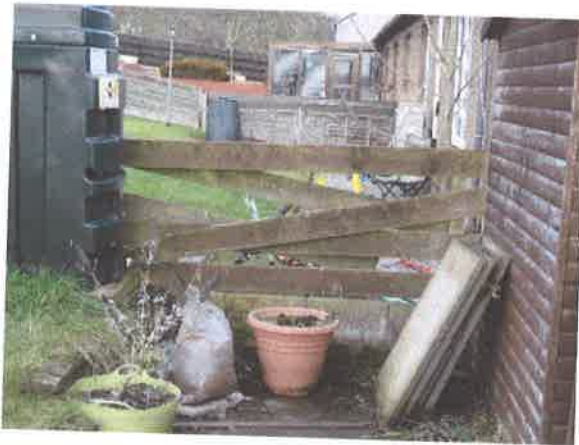
- The first application to the Tribunal submitted by the Tenant, who has since vacated the property and is no longer an interested party, included most of the items raised in the subsequent Third Party application. Specifically, it also included reference to a broken fence at the garden and missing wall tiles behind the cooker. The garden fence is broken and in need of repair (Photograph 26). There are no wall-

**(26) Broken fence**

15. The Tribunal was unable to make an Order in respect of the timber fence in the rear garden, as it was not included in the Third Party application, but the Tribunal recommends that the Landlord restores it to a reasonable state of repair.

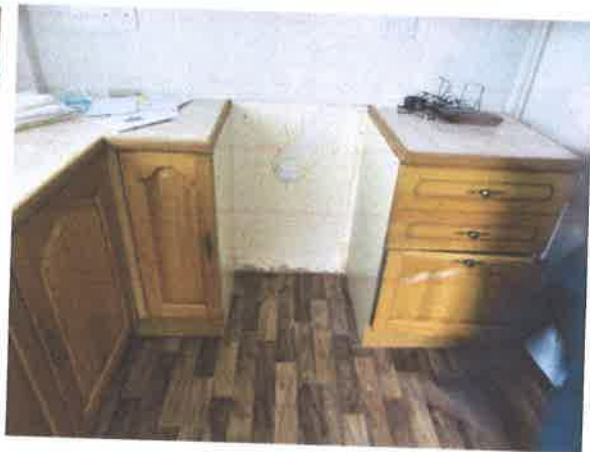
tiles at the location where the cooker would be positioned although this is not unusual (Photograph 27).

**(27) "Missing" tiles at "cooker space"**
