Statement of Decision of the Housing and Property Chamber of the First-tier Tribunal for Scotland under Section 26 (1) of the Housing (Scotland) Act 2006

Chamber Reference number: FTS/HPC/RP/23/3367

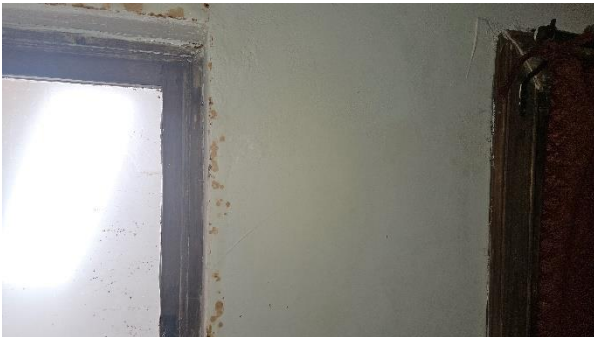
5 View of visual staining around Kitchen window.

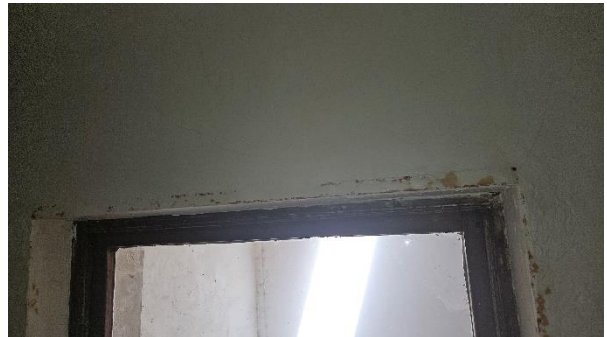
6 View of visual staining around Kitchen window.

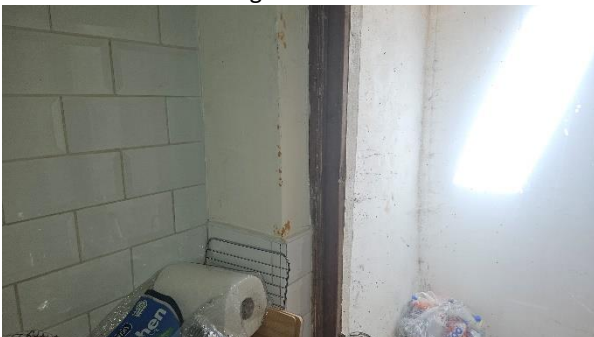
7 View of visual staining around Kitchen window.

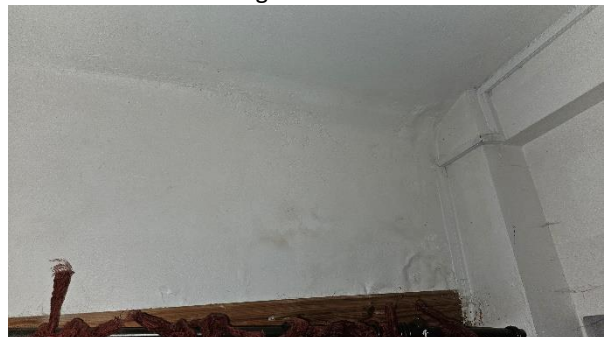
8 Wall area above "coal bunker" door.

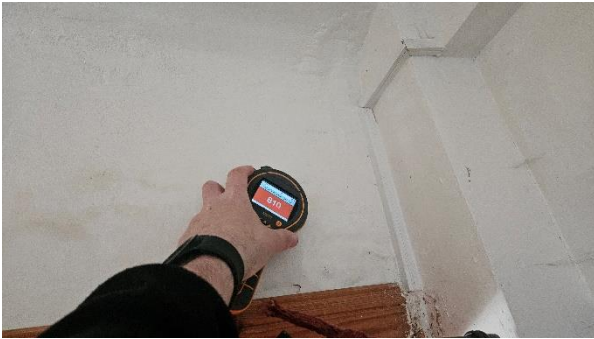
9 Elevated qualitative moisture meter readings above "coal bunker" door.

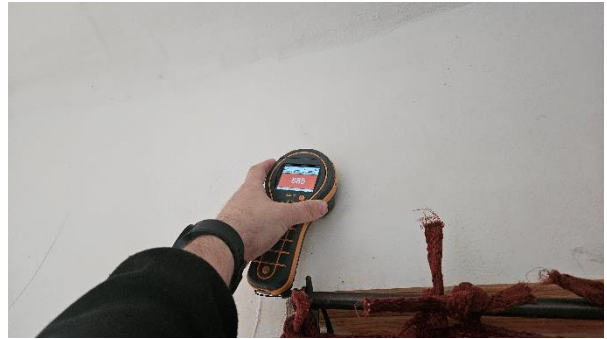
10 Elevated qualitative moisture meter readings above "coal bunker" door.

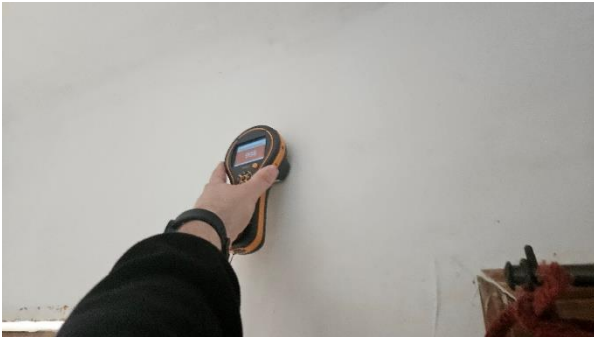
11 Elevated qualitative moisture meter readings above "coal bunker" door.

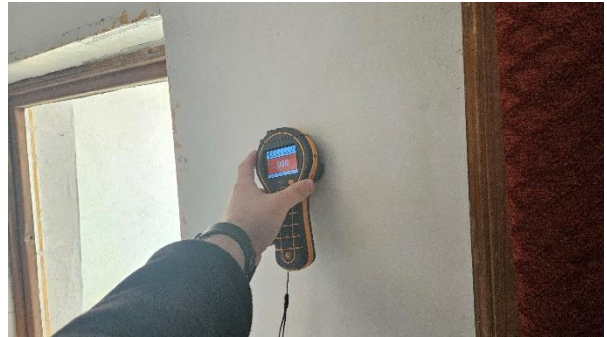
12 Elevated qualitative moisture meter readings above "coal bunker" door.

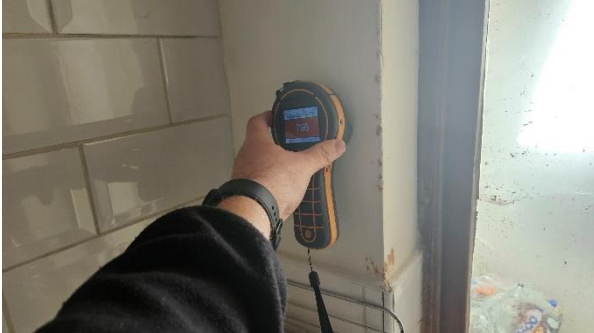
13 Elevated qualitative moisture meter readings adjacent to kitchen window.

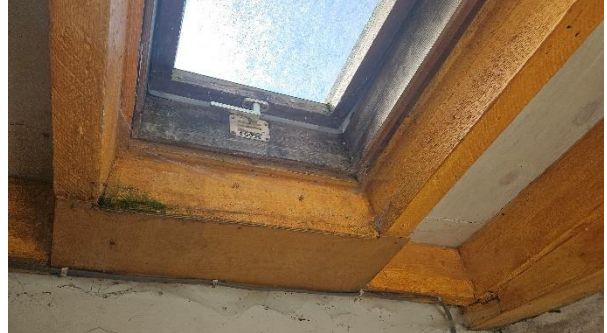
14 "Coal bunker" skylight.

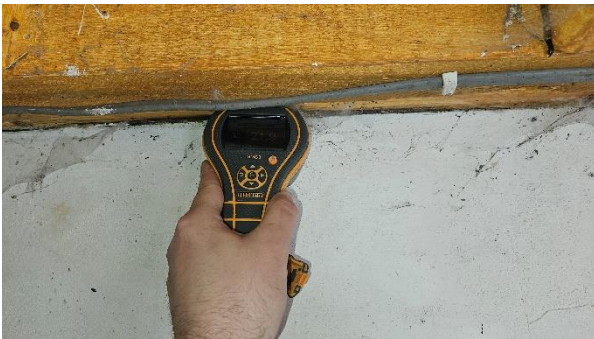
19 High (21.9%) quantitative moisture readings to timber abutting separating wall to kitchen.

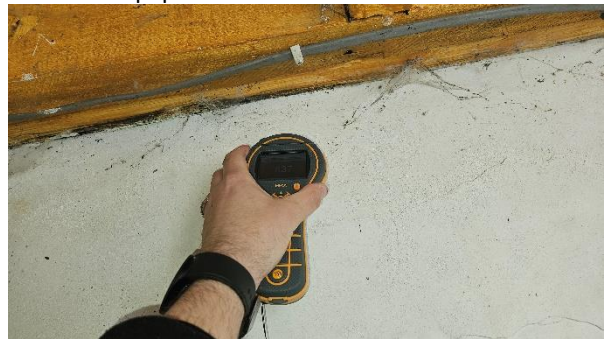
20 High qualitative moisture readings to separating wall between "coal bunker" and kitchen.

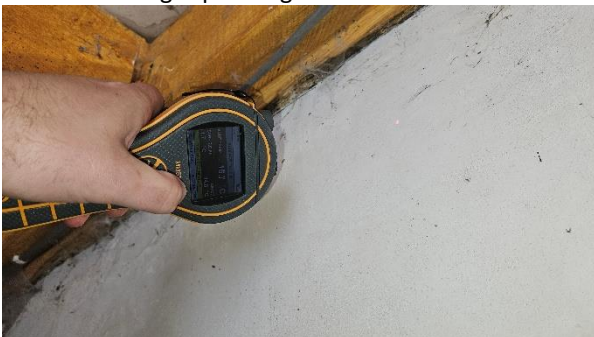
21 Condensation assessment – "coal bunker" walls 1.7°C above dewpoint at time of inspection.

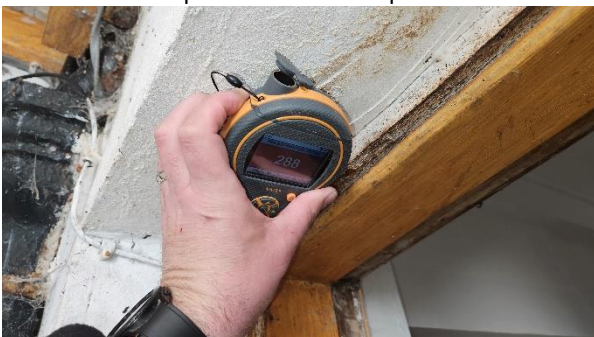
23 Elevated qualitative moisture readings over kitchen door at lintel soffit.

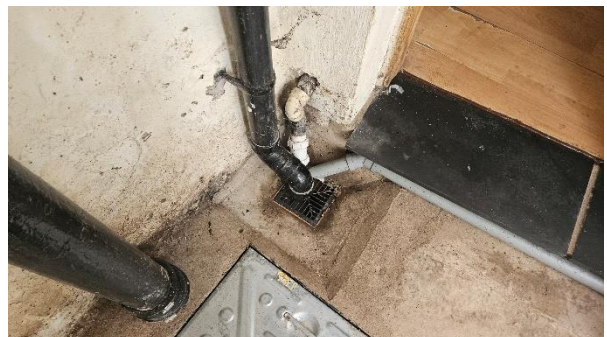
24 Drainage gulley and branch pipework.

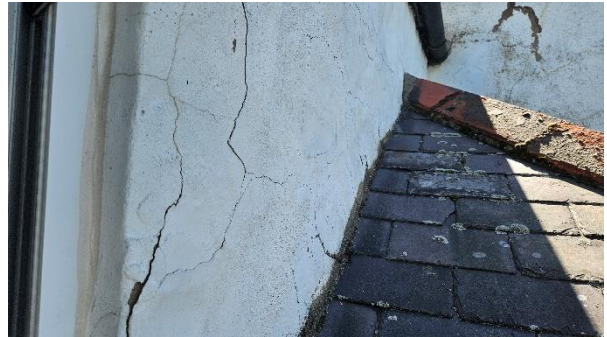
26 Poor condition of render to rear elevation at first floor level and poor skew detail to junction with slatework.

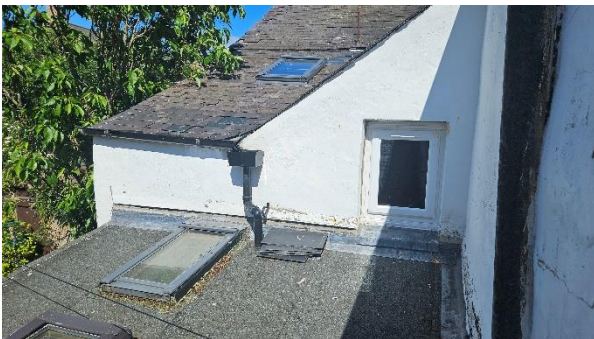
27 View towards gable of adjoining property.

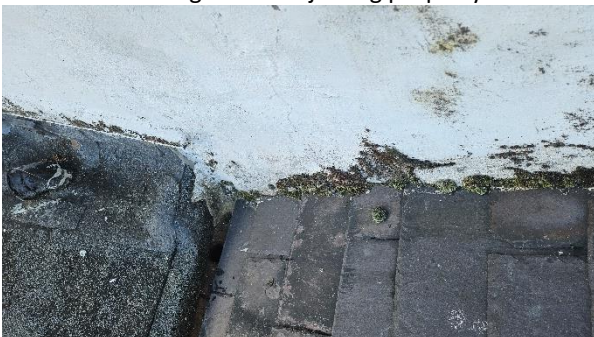
29 Poor skew detailing extending into gutter and over stop end, presence of moss growth at cracks indicating moisture retention.

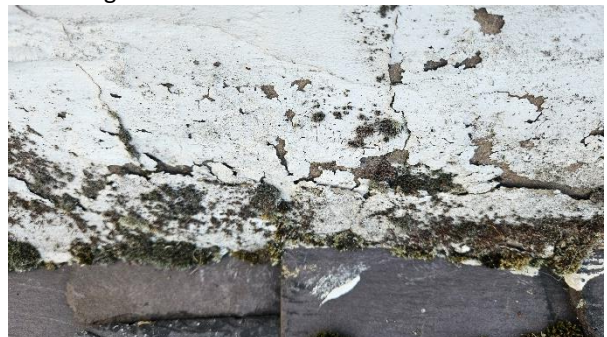
30 Poor skew detailing, presence of moss growth at cracks indicating moisture retention.

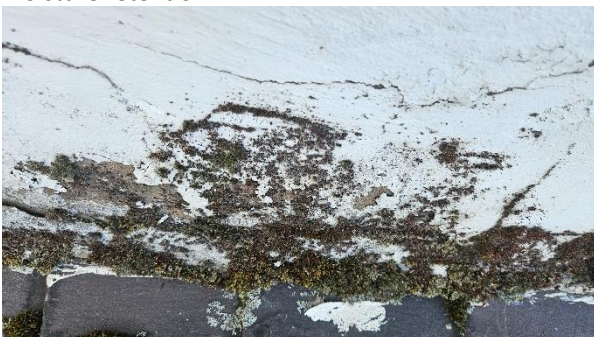
31 Poor skew detailing, presence of moss growth at cracks indicating moisture retention.

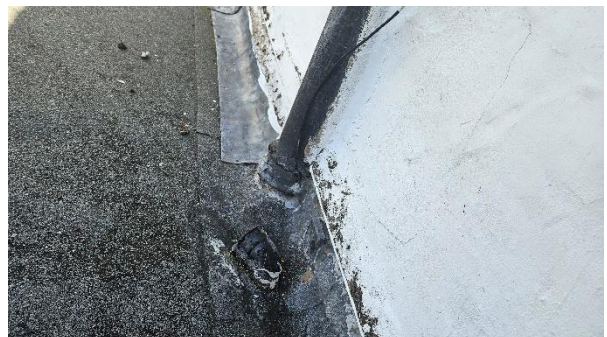
32 Pipework penetration detail and lead cover flashings not installed in accordance with good practice.
