**First-tier Tribunal for Scotland (Housing and Property Chamber) (“the tribunal”)**

**STATEMENT OF DECISION: Housing (Scotland) Act 2006, Section 24(1)**

**Chamber Ref: FTS/HPC/RP/24/0102**

**8/1 Grove Street, Edinburgh, EH3 8BB (Title number MID236791) (“the Property”)**

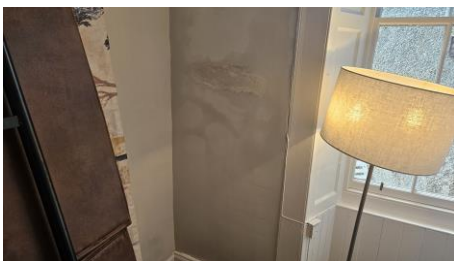
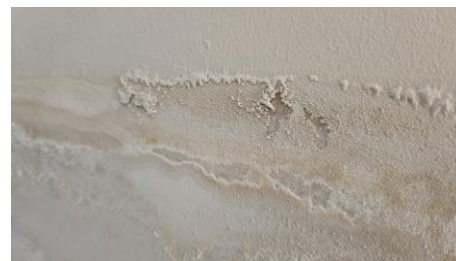
A visual assessment was undertaken and there was considered to be visual indicators of dampness present within both Bedrooms with evidence of staining patterns noticeable. Bedroom 2 was considered to be more heavily affected and there was evidence of eruption of finishes (plaster and paint) in addition to dampness staining present within that bedroom.

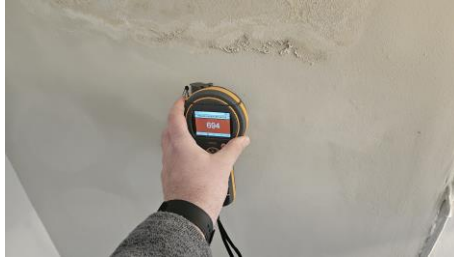
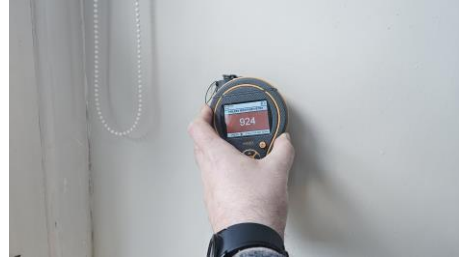
A “qualitative assessment” utilizing a Moisture Profiling technique which provides a sub-surface/at depth moisture reading was undertaken to the areas of concern within both bedrooms. The use of qualitative assessment is a non-disruptive technique and does not provide the true moisture content, rather the relative measurement compared to the other readings. Adverse readings were obtained to suggest that there was dampness affecting i) the

rear elevation wall within Bedroom 2 and ii) the separating wall between Bedroom 1 and Bedroom 2 adjacent to the external pedestrian door.

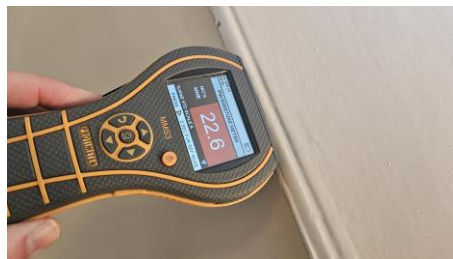
A more limited “quantitative assessment” utilizing a Moisture Profiling technique with the pin-mode of a moisture meter was undertaken at the architrave of the Bedroom 2 window. Such meters are calibrated to timber and provide the true moisture content of any timbers tested with the meter providing a colour coded backscreen on a traffic light warning system. This method of moisture assessment is to be preferred over “qualitative” assessment given that it provides the true moisture content. The readings obtained confirmed that there were elevated moisture present to the timbers.

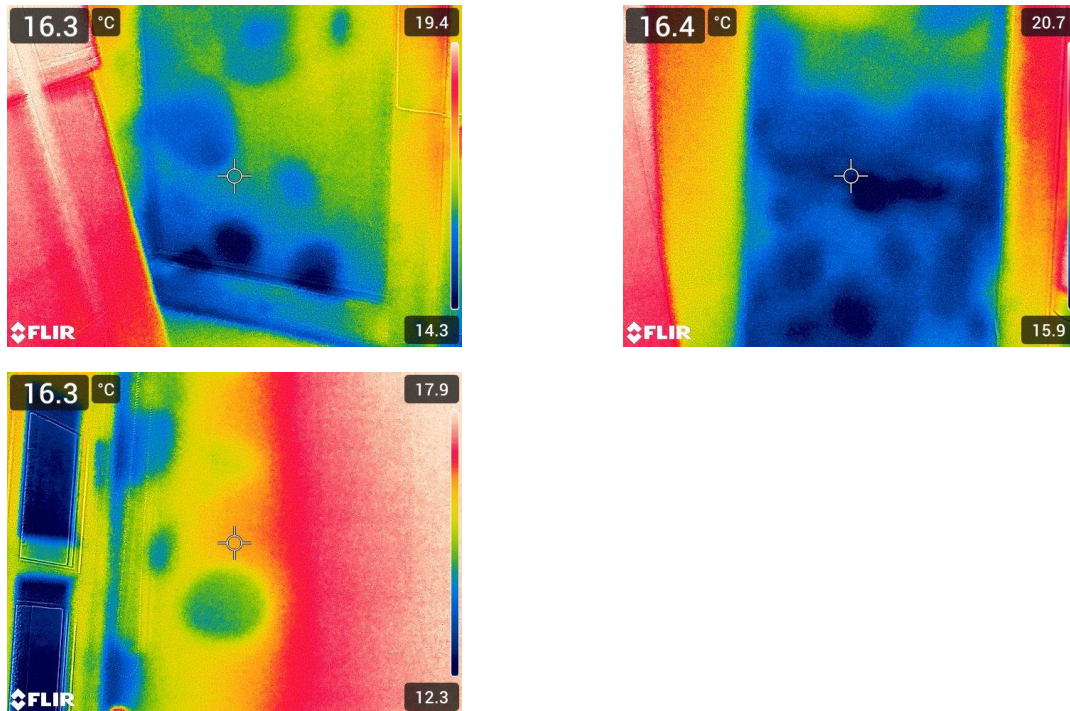
Various anomalies were evidenced from this thermal imaging exercise undertaken which was considered to be consistent with a penetrating dampness issue:

In summary, there was considered to be elevated moisture present within both Bedrooms as a result of penetrating dampness.

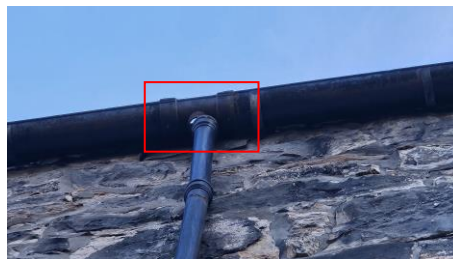
A ground level brief inspection was undertaken and it was noted that the downpipe was dislodged at the gutter outlet connection with a breach in watertightness noted at this point.

The external disrepair pertaining to the rainwater goods was considered to be the most likely source of the penetrating dampness issues recorded.

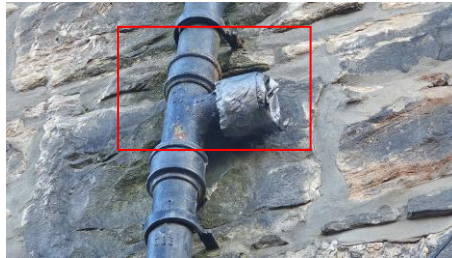
In addition, it was noted that a branch pipe has at sometime been removed from the upper residential neighbouring property with the single socket branch connector section provided with a "flashband" (self-adhesive flexible bitumen

strip) overlay capping. Such a tape repair relies upon adhesion however, ensuring long-term adhesion to a gloss painted cast iron downpipe is difficult especially given the contours and mouldings being overclad. It was also noted that the edges of the tape at the socket were noted to be uplifting and loose. It is unknown whether there is any blanking end cap provided below the tape.
