STATEMENT OF DECISION: Housing (Scotland) Act 2006 Section 24 (1)

Chamber Ref: FTS/HPC/RP/24/2401

32/6 Morningside Road, Edinburgh EH10 4DA ("The Property")

Inspection Report

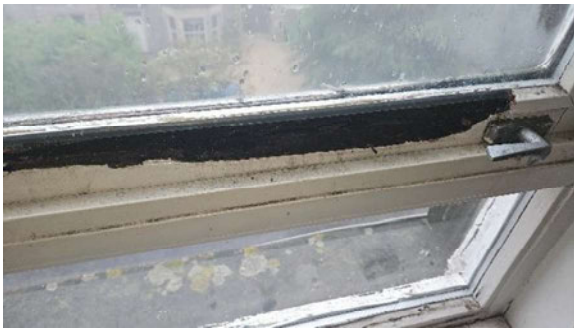
The left hand (north) window was noted to be extensively timber decayed and in very poor condition to such extent that affects the integrity of the window and represents an immediate safety concern. This window was not attempted to be opened such was the extent of concern.

3 Living Room – north window (timber decay evident).

11. There is no doubt based upon the Tribunal's findings that the serious state of disrepair of the windows in the property mean that the property does not currently meet the repairing standard. The property is not wind and watertight. Mr Thomson did not dispute this. The repair issues with the windows have been ongoing for around two years now. Given the length of time which the issue of replacement of the windows had been ongoing, it is reasonable, necessary and proportionate, for a formal legal order to be made by the Tribunal requiring the Landlord to take steps as soon as possible to replace the windows.

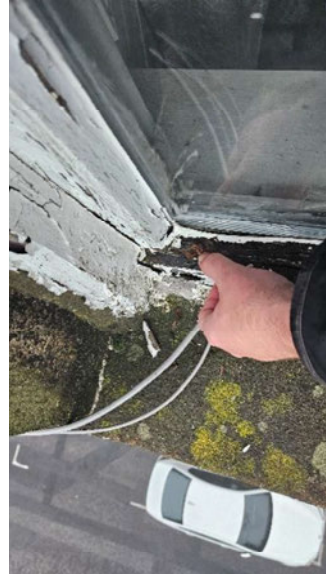
The right hand (south) window was opened to allow review of the external timberwork. There was obvious significant timber decay affecting the lower sections of the window and by applying simple finger pressure, timber was found to be soft and breaking away affecting the integrity of the window.

4 Living Room – south window (timber decay evident).

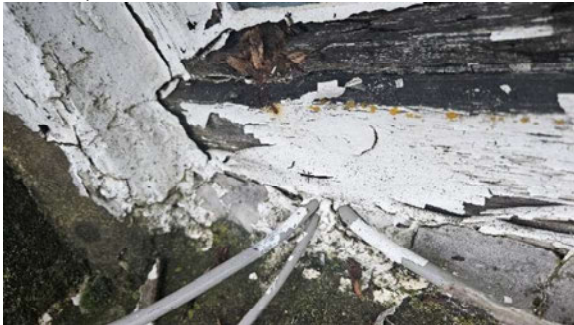
5 Living Room – south window (timber decay evident).

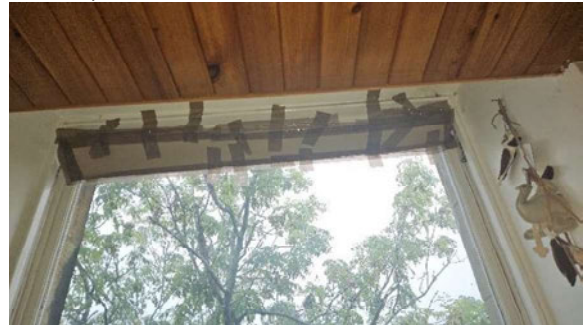
There was noted to be obvious misalignment at the central rail position between the top and bottom sashes due to the top sash slipping vertically and not being secured in its fully closed position resulting in an open gap at the head of the top sash, A makeshift internal protective lining has been provided to attempt to limit debris, rain and wind infiltration whilst timber blocks have been affixed to the sash frame to attempt to limit any further vertical slippage of the top sash. Perimeter seals were also noted to be cracked and defective.

6 Kitchen window – temporary protection to gap above top sash unable to be closed.

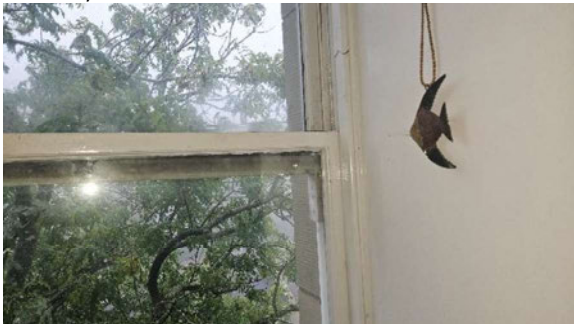
7 Kitchen window – misalignment of central rail due to top sash slippage.

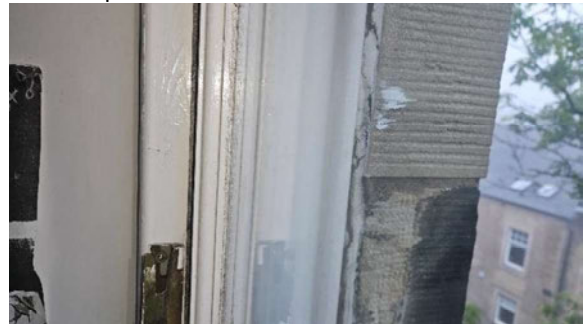
8 Defective perimeter sealant at Kitchen window.

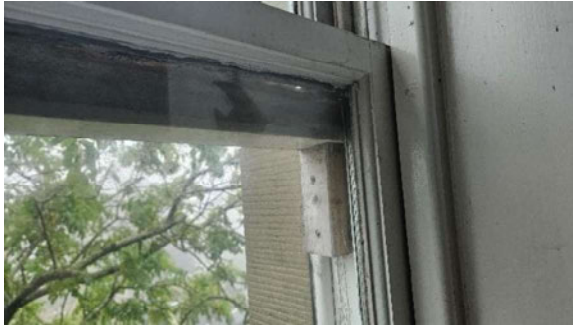
9 Timber blocks fitted to sash frame below top sash to prevent further slippage.

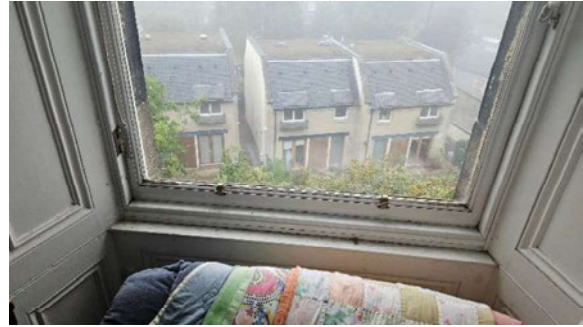
10 Rear Bedroom window.

The rear bedroom sash and casement window sash cords were noted to be snapped and defective resulting in impairment of the sashes and a lack of counterbalance to allow such parts to be safely operated. Perimeter seals were also noted to be cracked and defective.

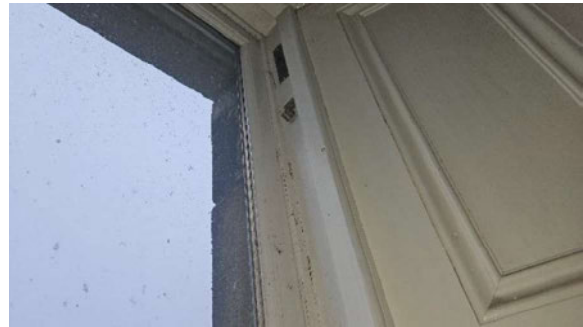
12 Rear Bedroom window – defective sash cords.

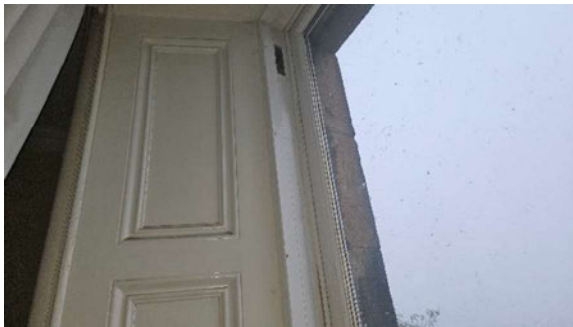
13 Rear Bedroom window – defective sash cords.

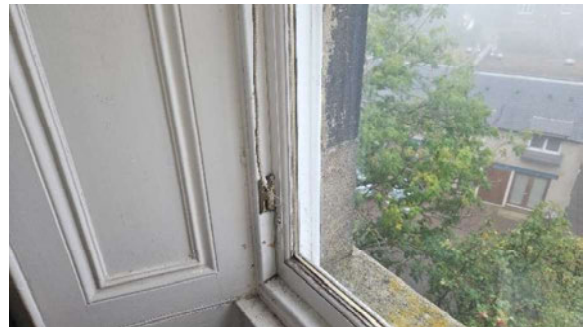
14 Rear Bedroom window – defective sash cords.

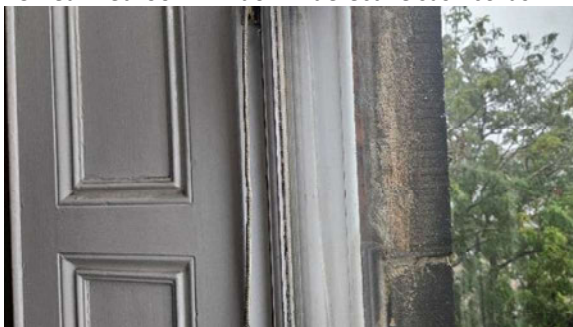
15 Rear Bedroom window – defective perimeter seals.
