**First-tier Tribunal for Scotland (Housing and Property Chamber)**

**Statement of Decision of the First-tier Tribunal for Scotland  
(Housing and Property Chamber) under section 60(5) of the  
Housing (Scotland) Act 2006**

**Chamber Ref: FTS/HPC/RP/24/1409**

**45D New Street, Stevenston, KA20 3HD being the subjects registered in  
the Land Register of Scotland under Title number AYR59515 (“the  
Property”)**

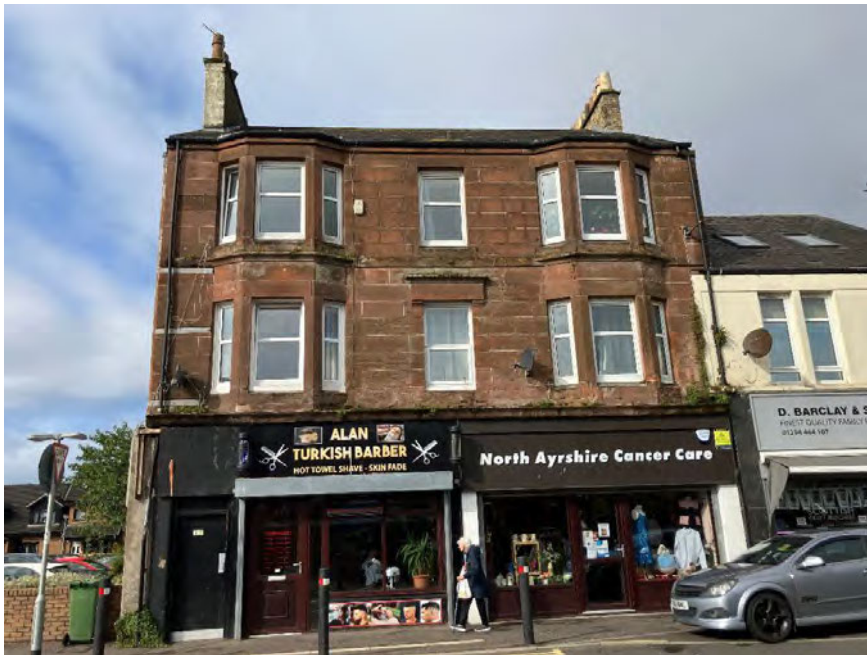
**1. Front elevation as viewed from road.**

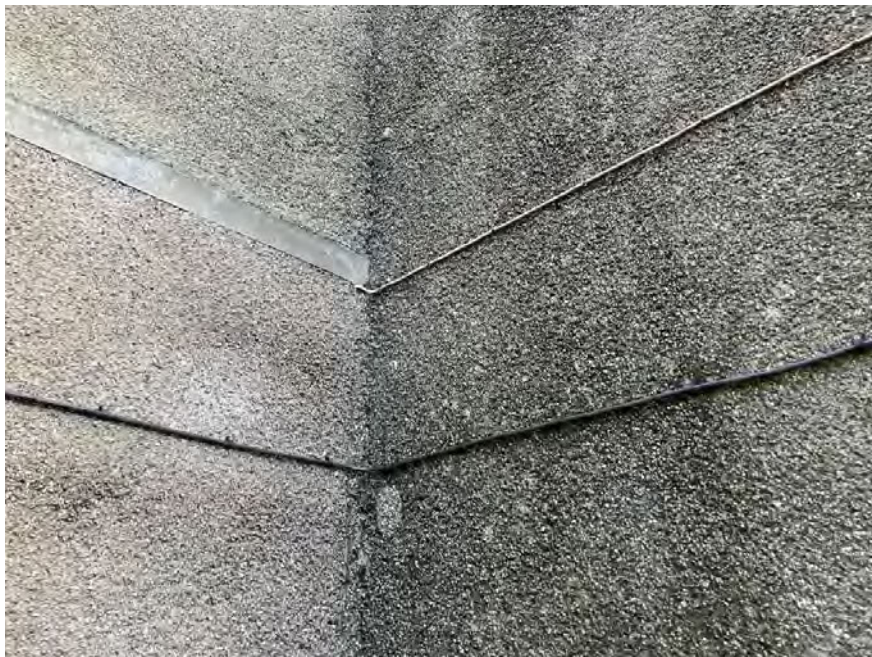
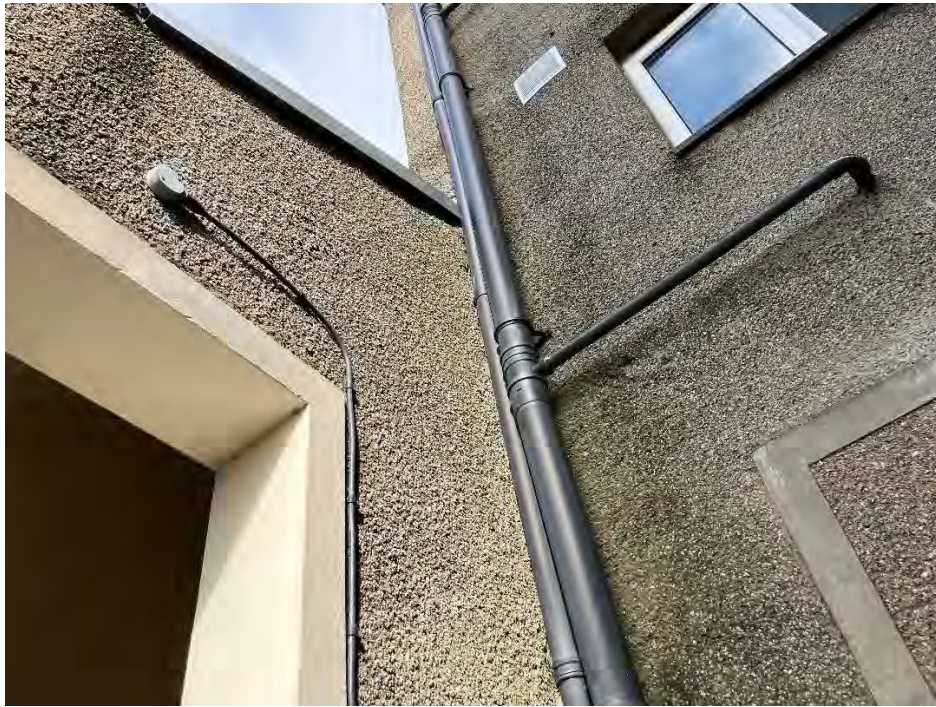
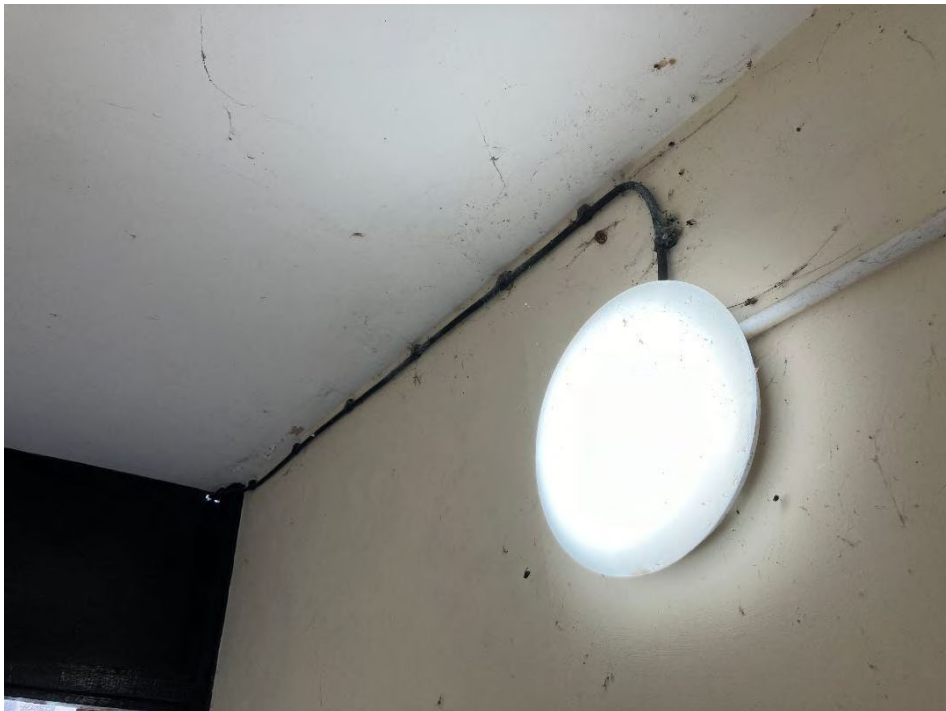
The external wiring appears to be adequately secured to the outer wall before entering the common close/stairwell. Thereafter it is encased in various coverings and well secured to the internal wall face. As a result of a defect in the external fabric of the stairwell, there is evidence of considerable water ingress affecting both the wall and ceiling plaster around and in close proximity to the wiring.

**Photographs 2-4:-** Illustrate generally well secured and protected exposed wiring at the rear external wall and within the shared stairwell entrance

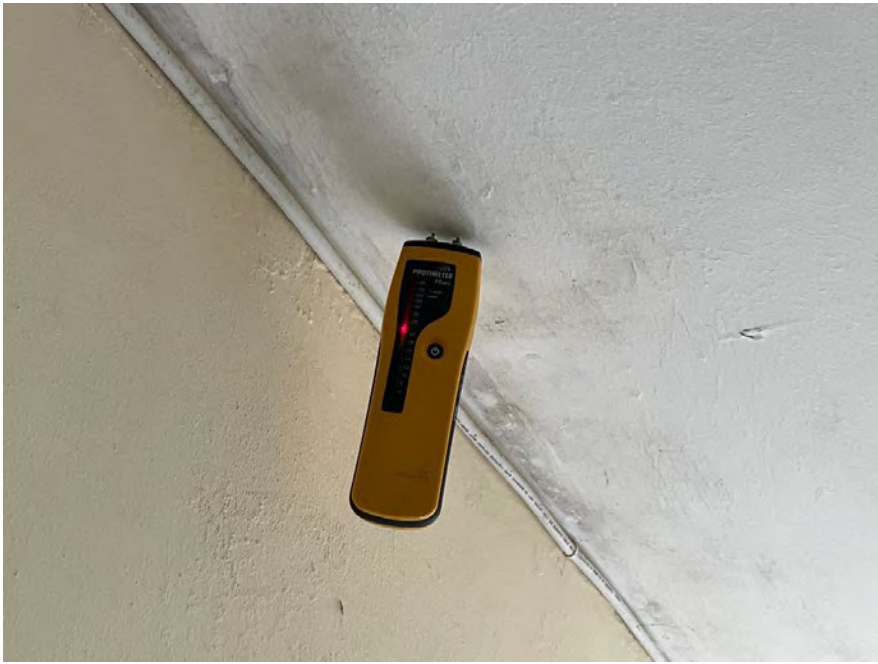
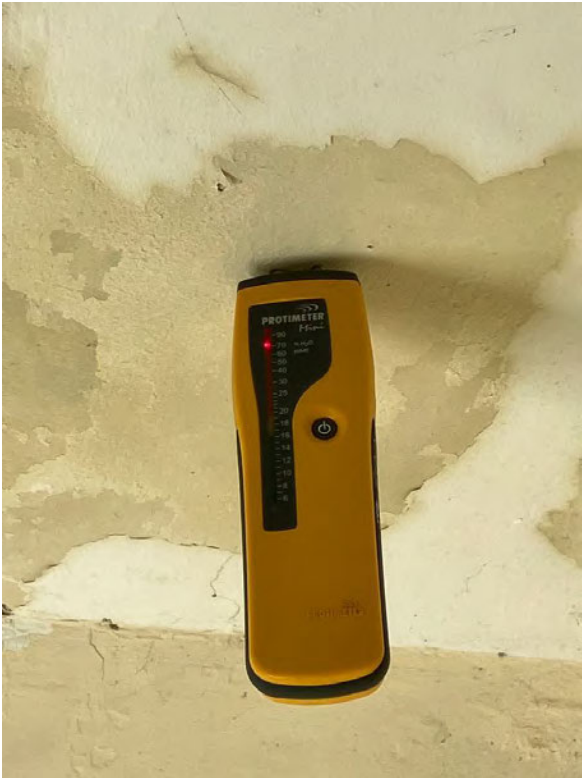
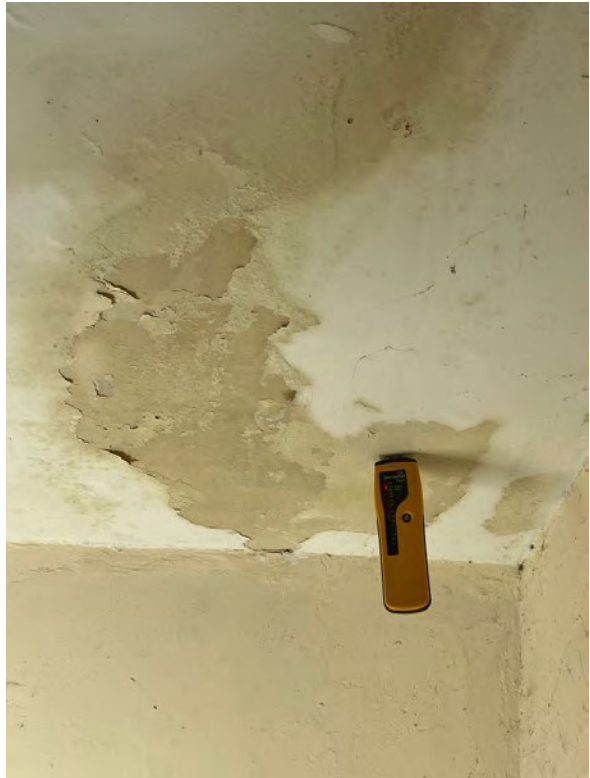
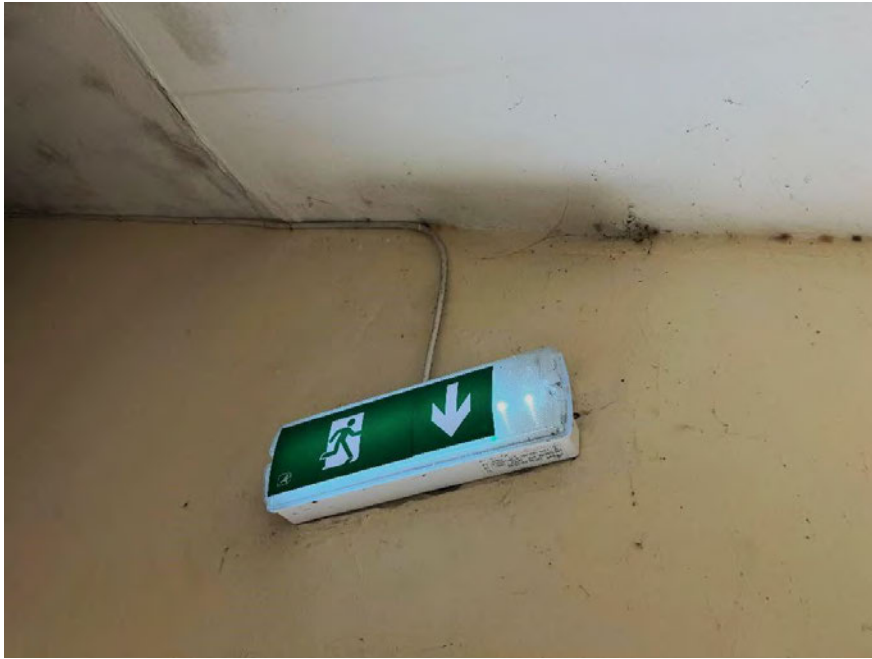
8.4.1 There is visible damp in the location of the external wiring.

The presence of dampness in the location of the external electrical wiring renders the wiring potentially in an unsafe condition.

**Photographs 5-8:-** Illustrate high levels of damp in and around the vicinity of the surface mounted wiring in the shared stairwell area.

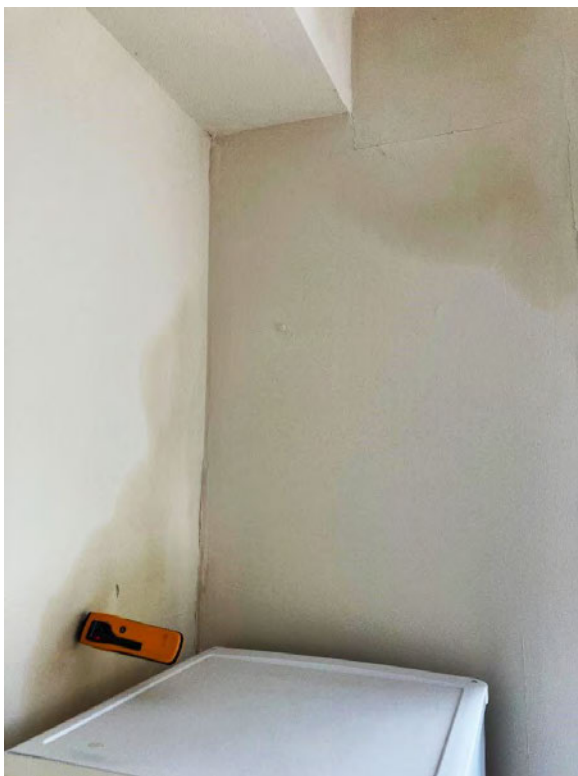
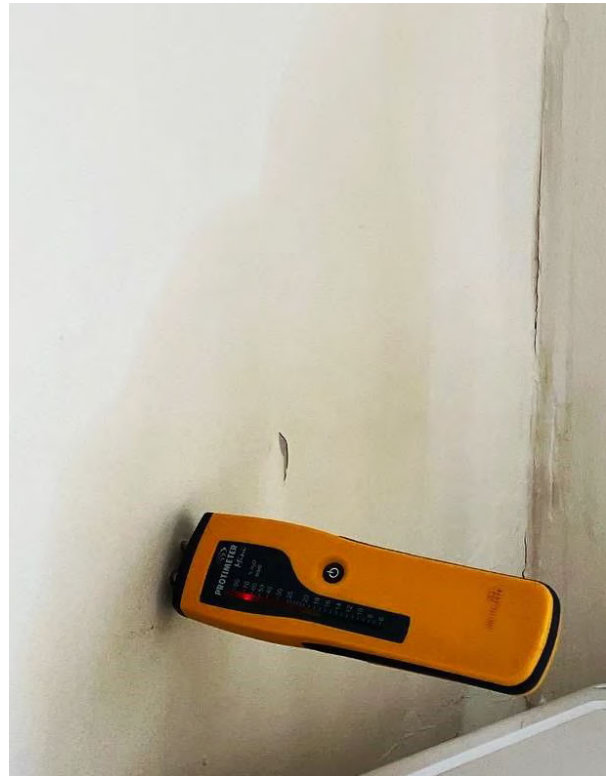
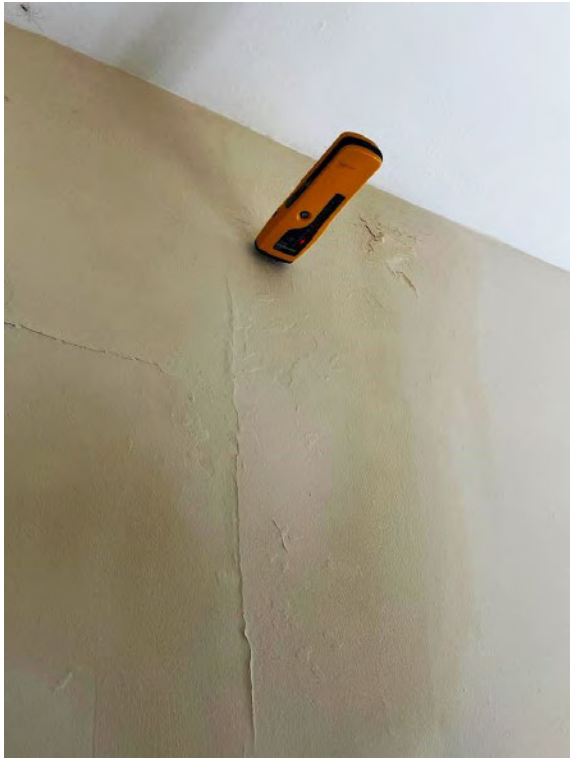
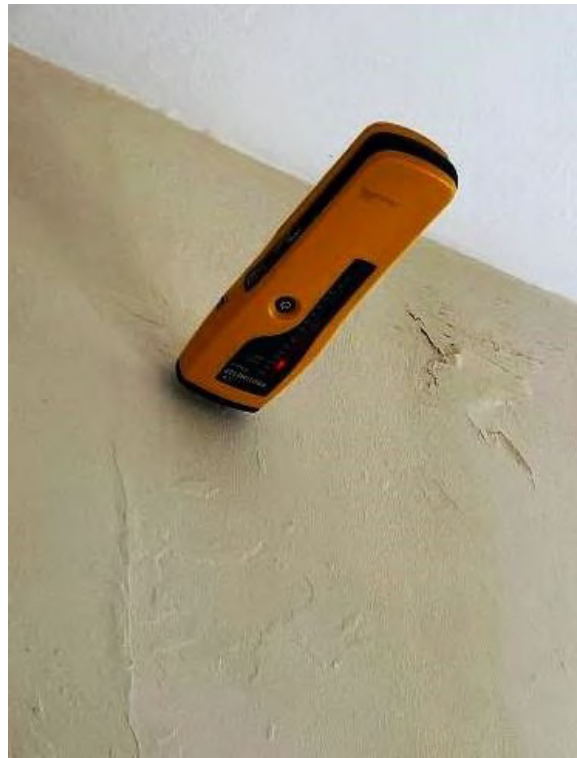
Significant damp staining is evident affecting the ceiling and wall plaster to the left, as viewed from within, and around the kitchen window. Moisture readings of between 65% and 85% were obtained at the affected areas. The plaster shows signs of localised deterioration and when dry will require redecoration.

8.4.2 The kitchen walls are damp.

The residual damp to the kitchen walls render them not wind and watertight. The roof may not yet be in a wind and watertight condition.

**Photographs 9-12:-** Illustrate high levels of damp (65-85%) and some localised deterioration of the wall plaster in the kitchen, affecting both the external and adjoining internal walls.

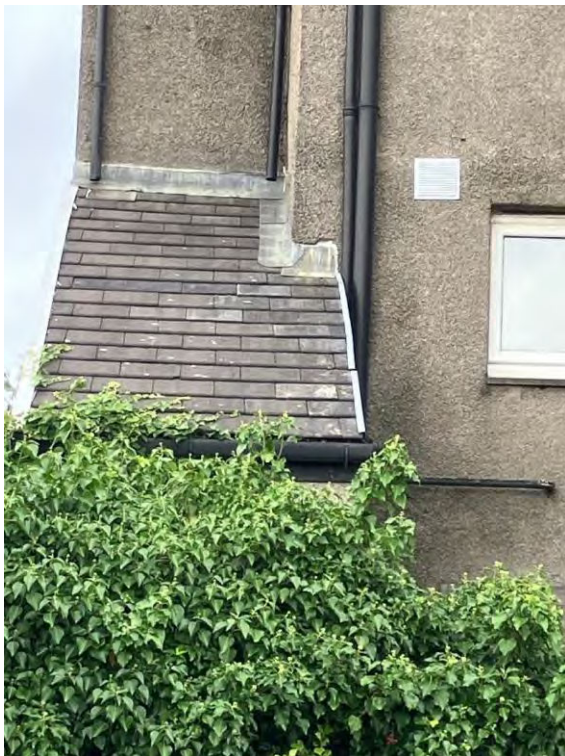
13

**Photograph 13:-** Mono pitch roof covering above stairwell

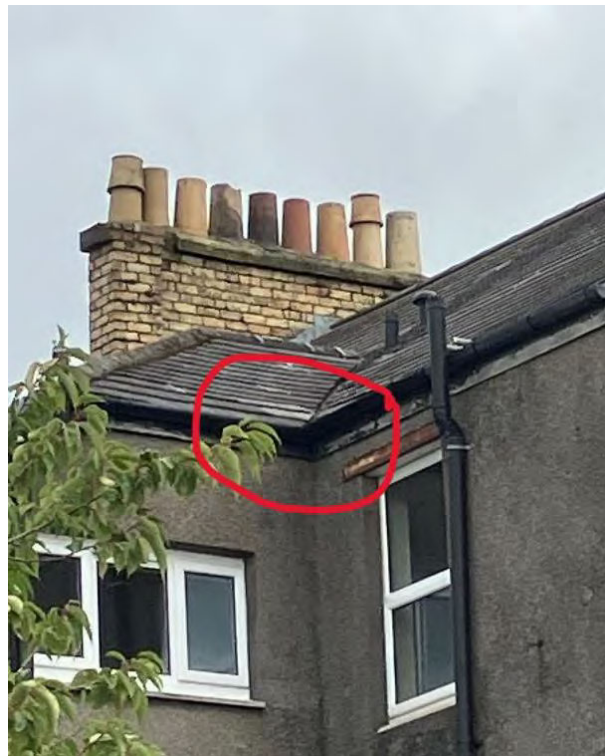
14

The penetrating damp within the kitchen coincides with an area immediately below a valley gutter. Viewed externally there is evidence of a recent repair or renewal of several roof tiles at and around the base of the valley gutter. It is understood that this repair was completed to address the issue of penetrating damp in the kitchen although until the plaster dries out it will not be clear if this action has been entirely satisfactory.

8.4.3 A recent roof repair has been carried out but it is too soon to determine if the repair has been effective.

**Photograph 14:-** The area circled in red highlights the the base of the rear valley gutter coinciding with a recent repair to several tiles above the kitchen roof.

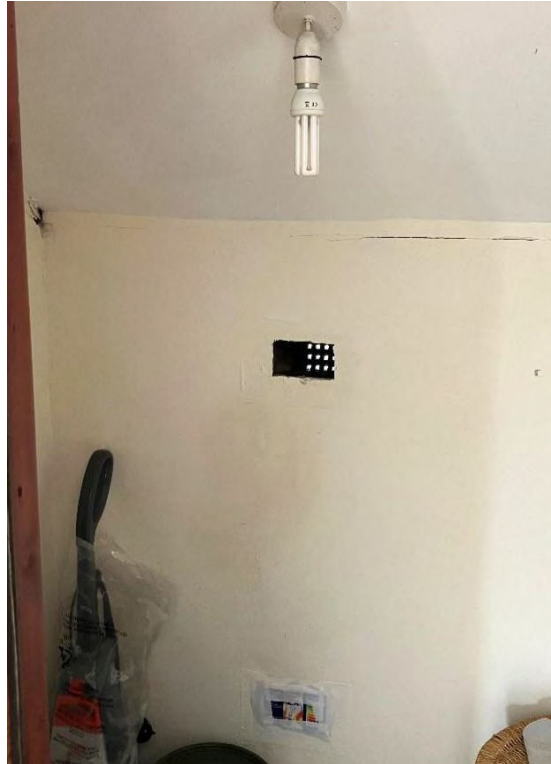
**15**

Within the kitchen, there is a walk in “cold storage cupboard. It is ventilated through the external wall, plastered internally and extends below the external roof pitch. The vent is protected externally by an air brick although there is no corresponding vent cover within the storage area.

8.3 The Tribunal determined that the complaint of the missing vent cover in the kitchen cold store is a de minimis matter.

**Photograph 15:-** Illustrates a missing internal “vent cover” on the inner face of the external wall of the kitchen “cold storage” cupboard.

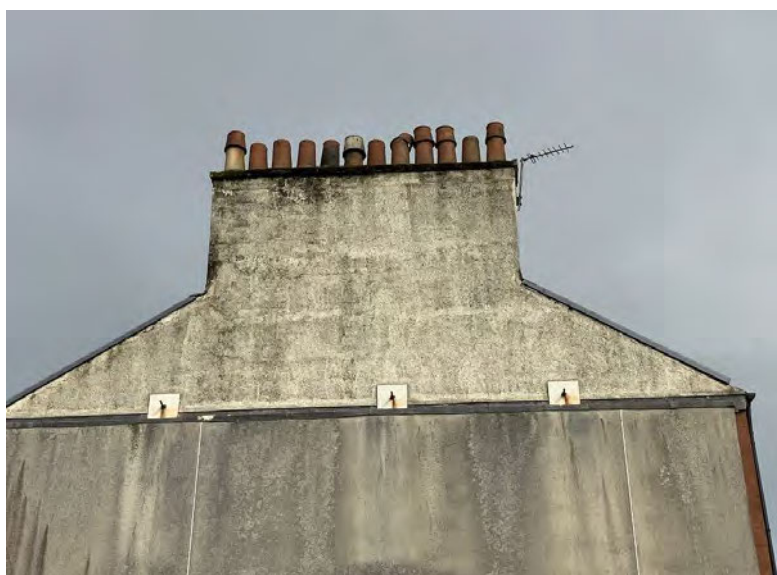
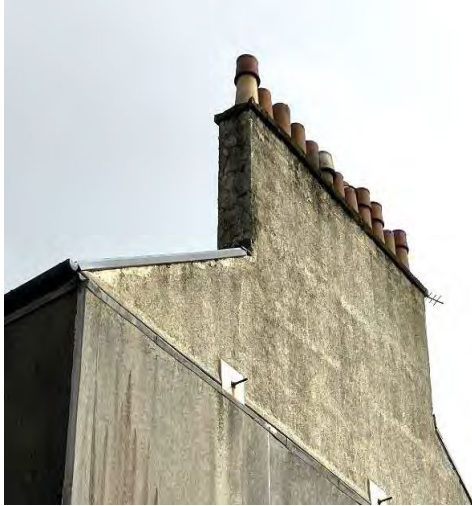
Viewed externally from ground level the gable chimney stack appears vertical with no noticeable outward or inward lean. There is some evidence of localised cracked and possibly bossed rendering which is common in property of this age and design. One chimney cowl/pot has become dislodged, is poorly secured and if left unrepaired this may fall to ground.

**Photographs 16 & 17:-** Illustrate that the gable chimney, as viewed from ground level, is vertical with no significant evidence of any lean

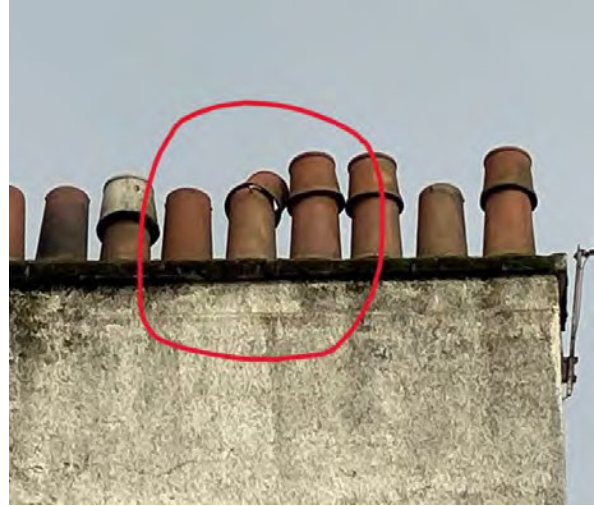
18

8.4.4 The chimney cowl is loose and not in a reasonable state of repair.

The loose chimney cowl is not in a reasonable state of repair.

**Photograph 18:-** Illustrates that the chimney cowl/pot (5<sup>th</sup> from the right) is poorly secured and in an unstable condition.
