First-tier Tribunal for Scotland (Housing and Property Chamber) (“the tribunal”)

Re-Inspection Report

Chamber Ref: FTS/HPC/RP/24/0102

Property: 8/1 GROVE STREET, EDINBURGH, EH3 8BB (“The Property/The House”)

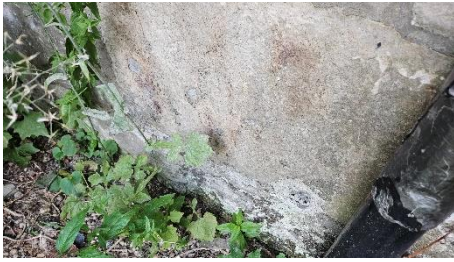
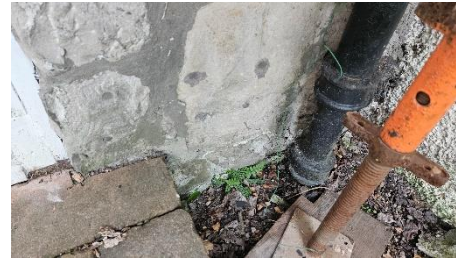
At the external rear elevation, there was noted to be evidence of various historic damp control works including chemically injected damp proof courses (appears to be more than one) and also an apparent knapen siphon tube system. Such dampness remedial works are typically designed to assist in the control of “rising dampness”.

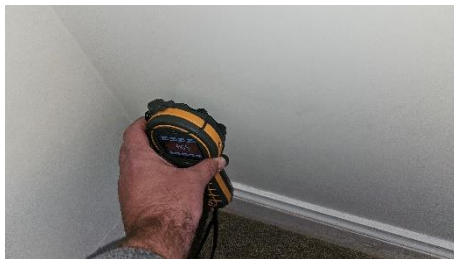
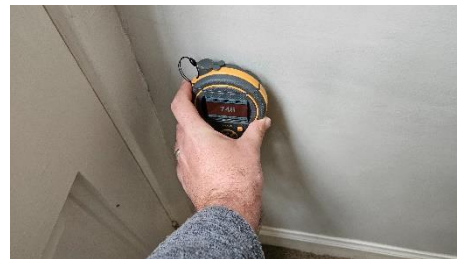
A “qualitative assessment” utilizing a Moisture Profiling technique which provides a sub-surface/at depth moisture reading was undertaken to the areas of concern within both bedrooms. The use of qualitative assessment is a non-disruptive technique and does not provide the true moisture content, rather the relative measurement compared to the other readings. At low level to walls in the previous areas of concern, there were elevated moisture readings recorded.

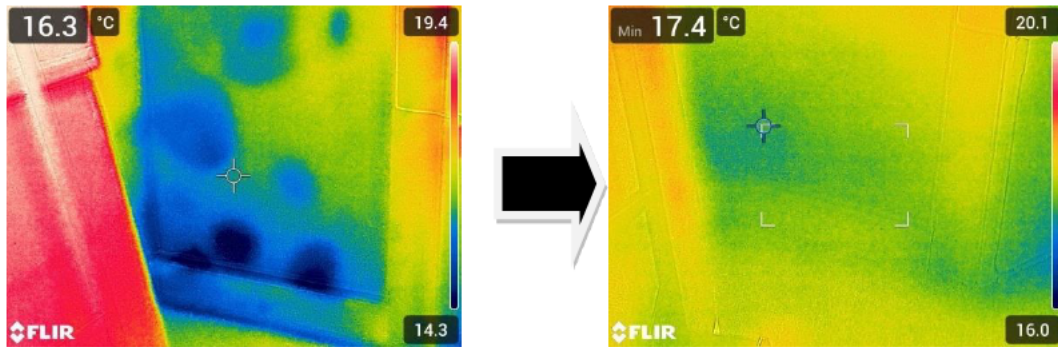
The below left image records the dampness issue at the time of our previous inspection compared to the bottom right image that records the area during the reinspection. It is clear that significant drying to the areas has taken place with thermal gradient remaining to be expected (due to thermal bridging at the floor junction).

In summary, it is clear that there has been a significant improvement within both Bedrooms and such parts have dried significantly since our last inspection whilst there were no longer any visual indicators of dampness noted. The masonry walls will continue to naturally dry until they reach equilibrium and the remaining elevated readings are not considered to represent a present concern against the backdrop that such moisture meters are extremely sensitive and that elevated readings at low level to walls that have been subject to historic rising dampness treatments would be reasonably expected (as such measures are control rather than eradication measures, designed to control dampness to such a level that internal finishes are not unduly affected).

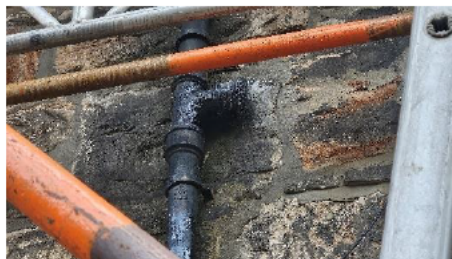
It was evident that further remedial works had been progressed at the former branch connection into the cast iron downpipe with flashband removed and repairs undertaken to the capping. There was a scaffold in place (not accessed) and due to the top lift remaining in place we were not able to view the gutter adequately however, there was not any obvious signs of leakage to the elevation whilst drying works have managed to be progressed internally. Various debris from external maintenance works was noted to be remaining within the garden area including the scaffold access ladder.
