**STATEMENT OF DECISION: Sections 26 and 27 of the Housing (Scotland) Act 2006, as amended**

**Chamber Ref: FTS/HPC/RT/23/3949**

**49 Meadowside, Dundee DD1 1EQ (“The Property”)**

### First-Tier Tribunal for Scotland (Housing and Property Chamber) Re-inspection report

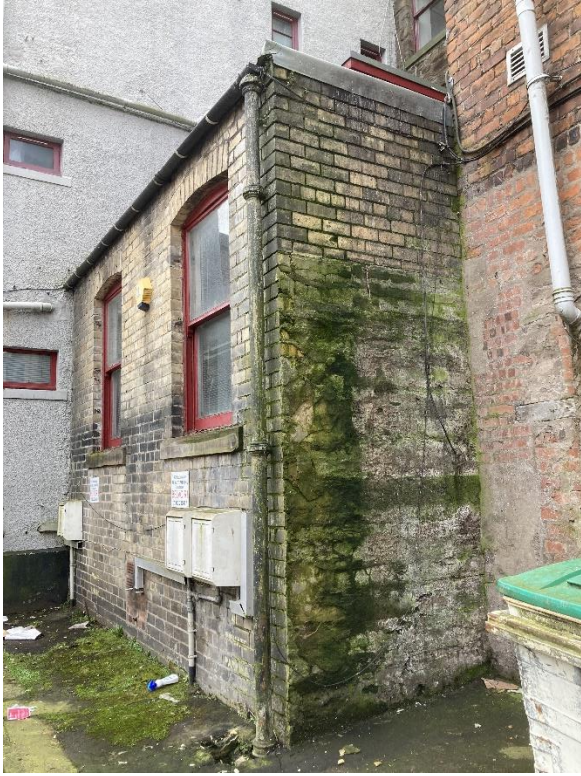
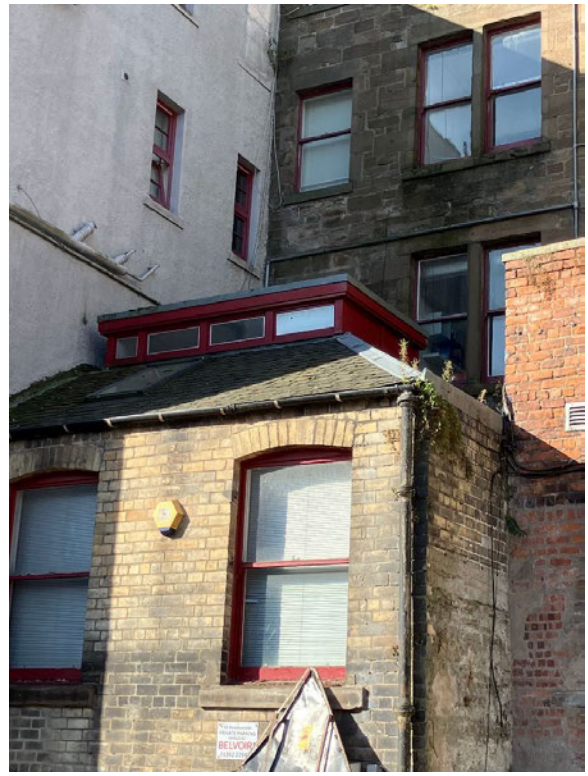
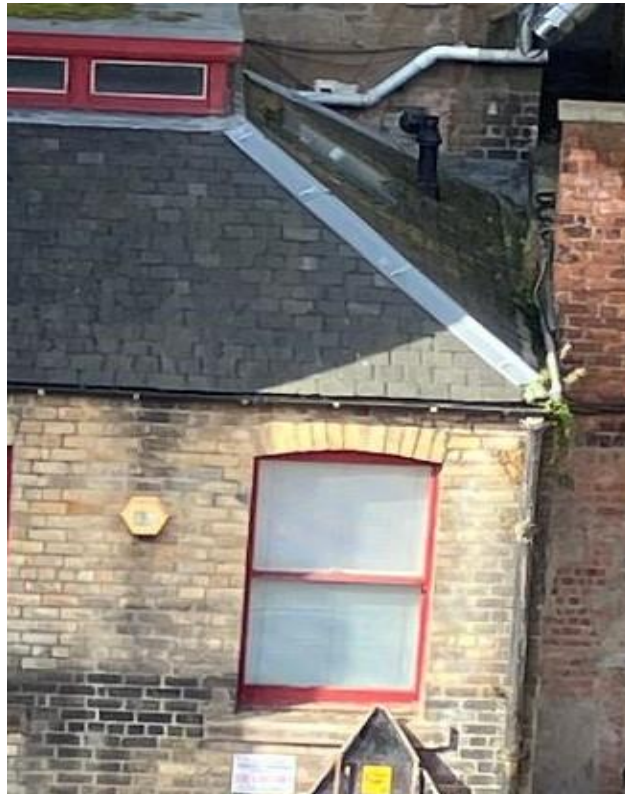
The vegetation previously noted at the eaves and valley areas remains and appears to have increased.

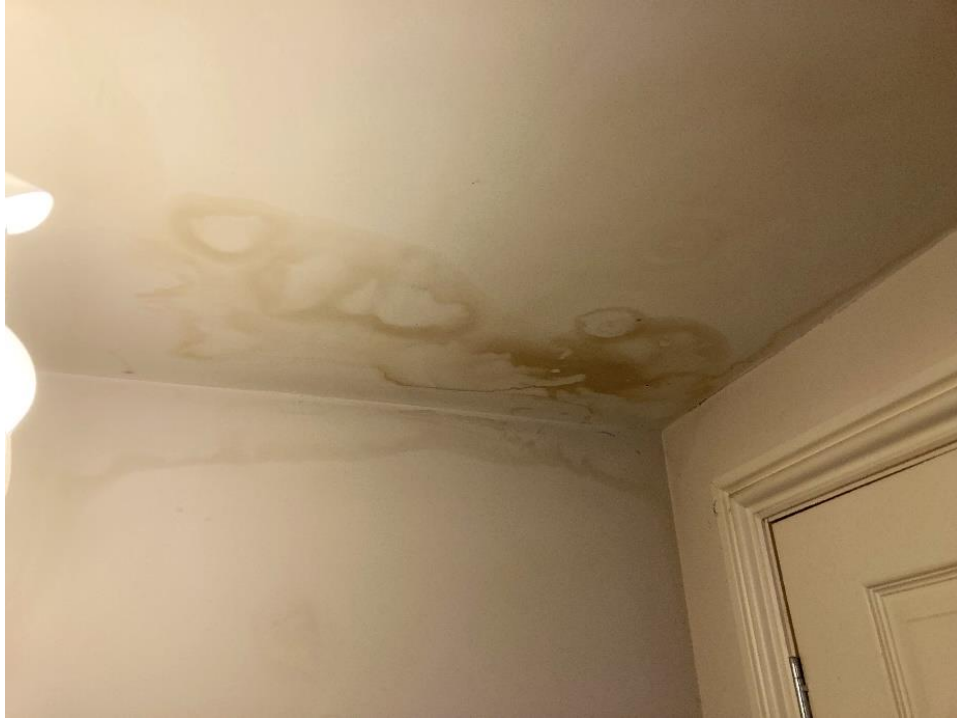
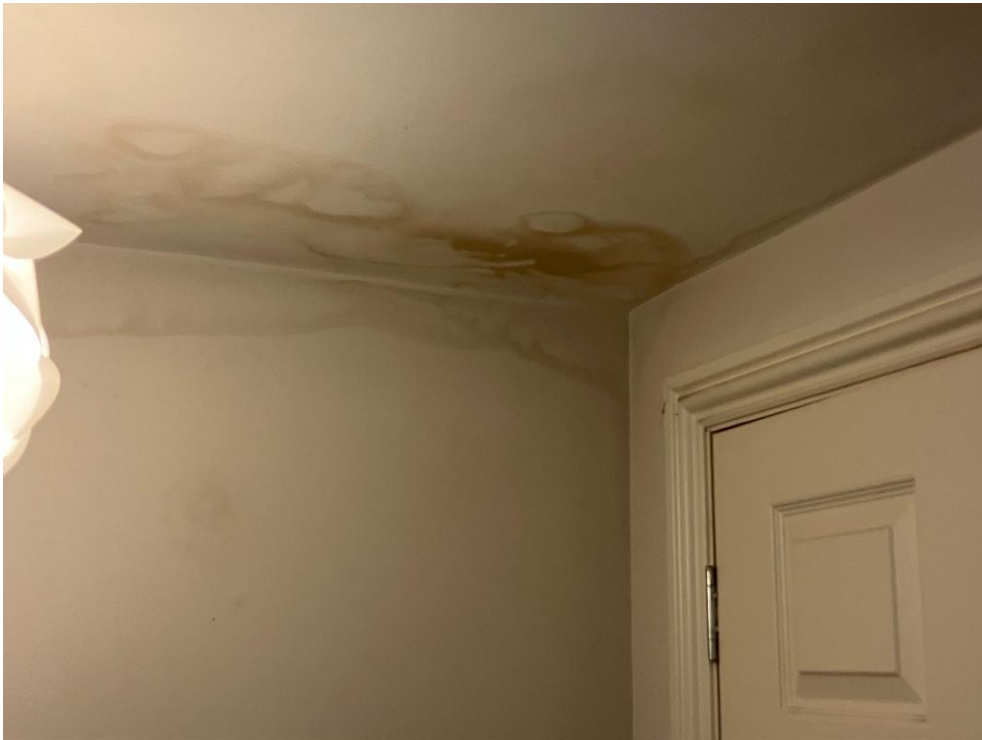
The damp staining clearly visible at the entrance to the living room remains. Dry at the time of inspection there has been no redecoration or repair completed to the plasterwork.

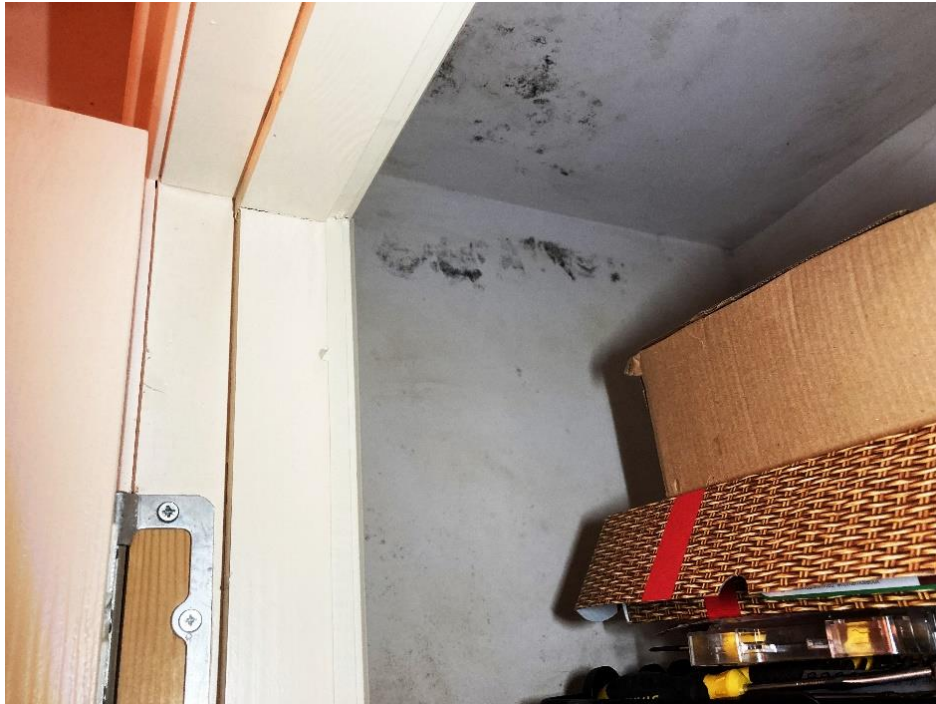
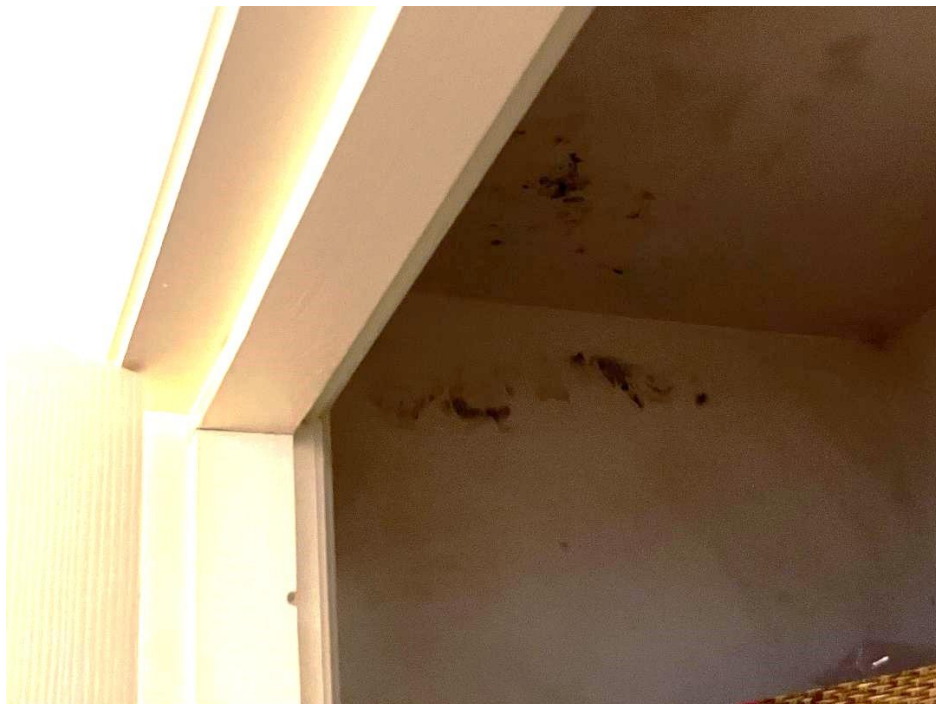
The damp staining and mould, visible in the cupboard next to the entrance to the living room remains. Dry at the time of inspection, there has been no redecoration, mould removal or repair completed to the plasterwork.

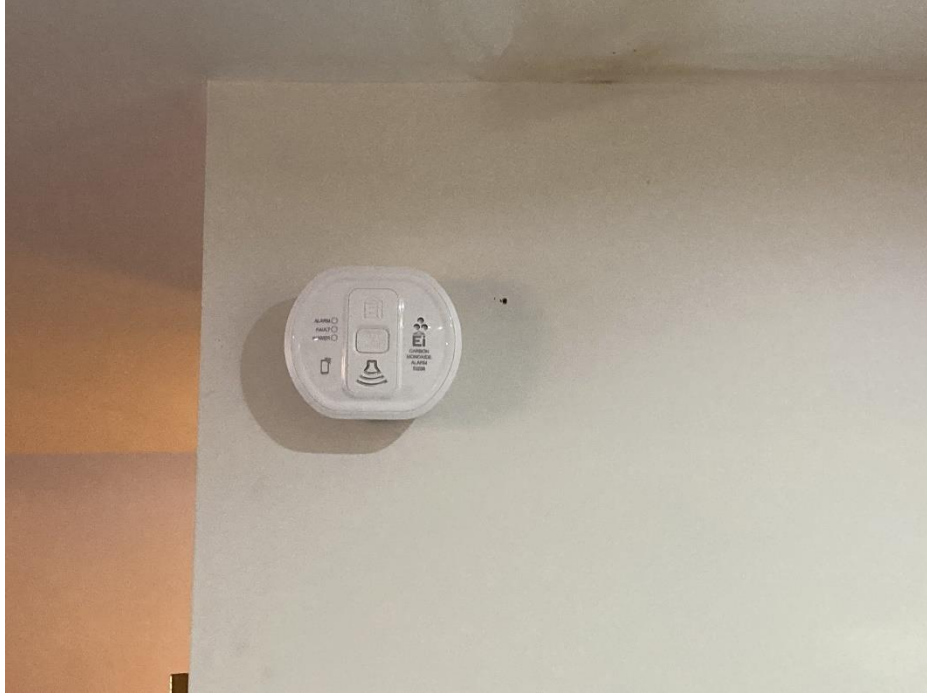
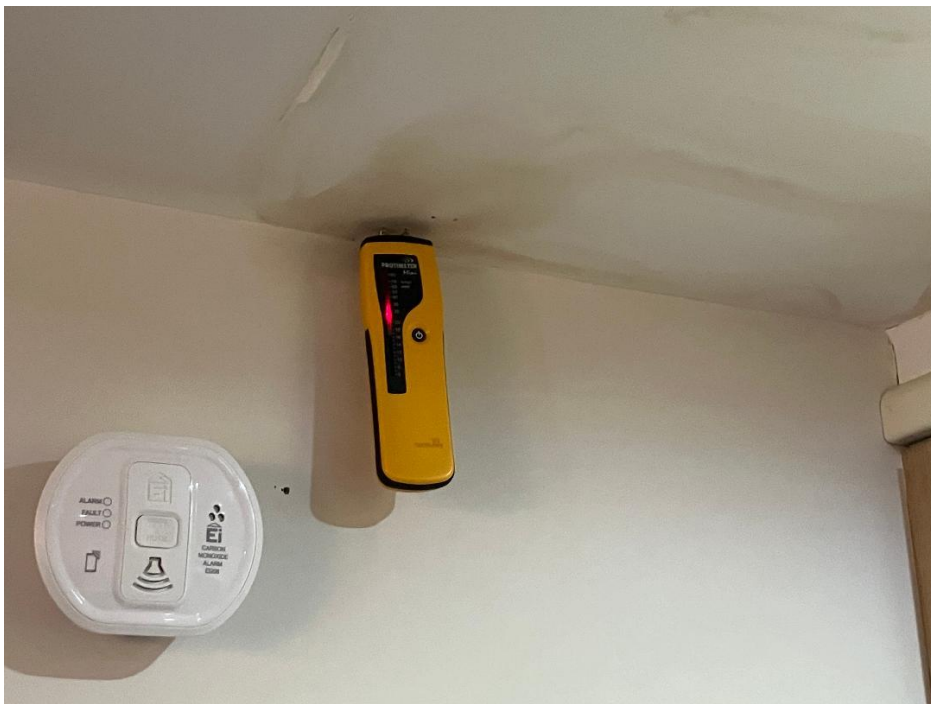
The damp staining clearly visible on the kitchen ceiling remains. Damp readings at a level likely to cause further deterioration were obtained and there has been no redecoration or repair completed to the plasterwork.

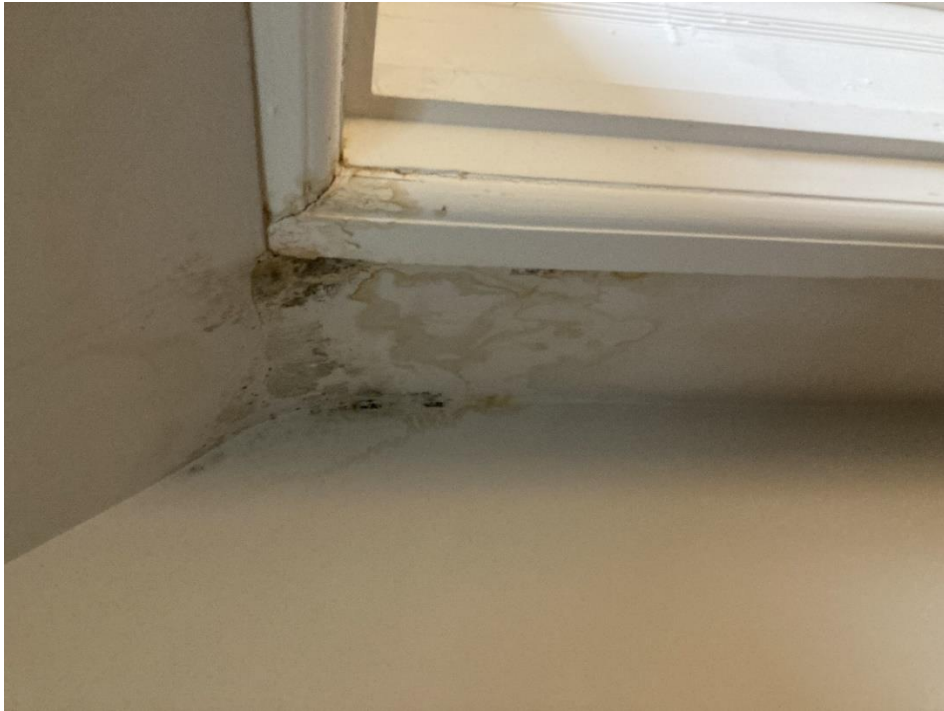
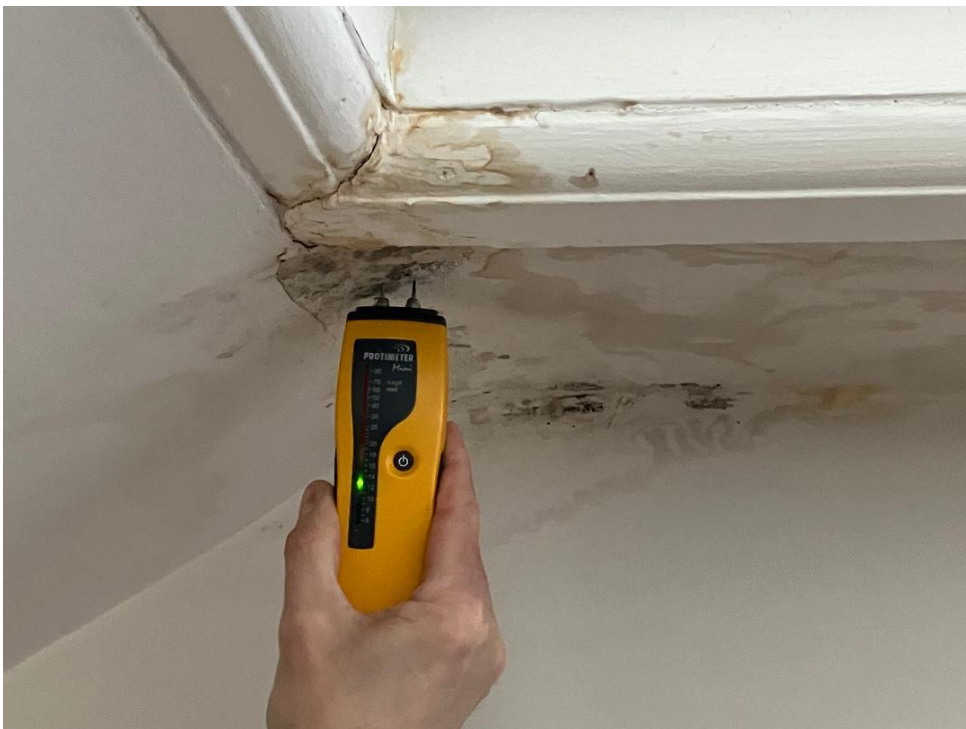
The damp staining clearly visible below the mezzanine cupola remains. Dry at the time of inspection there has been no removal of the mould, redecoration or repair completed to the plasterwork.

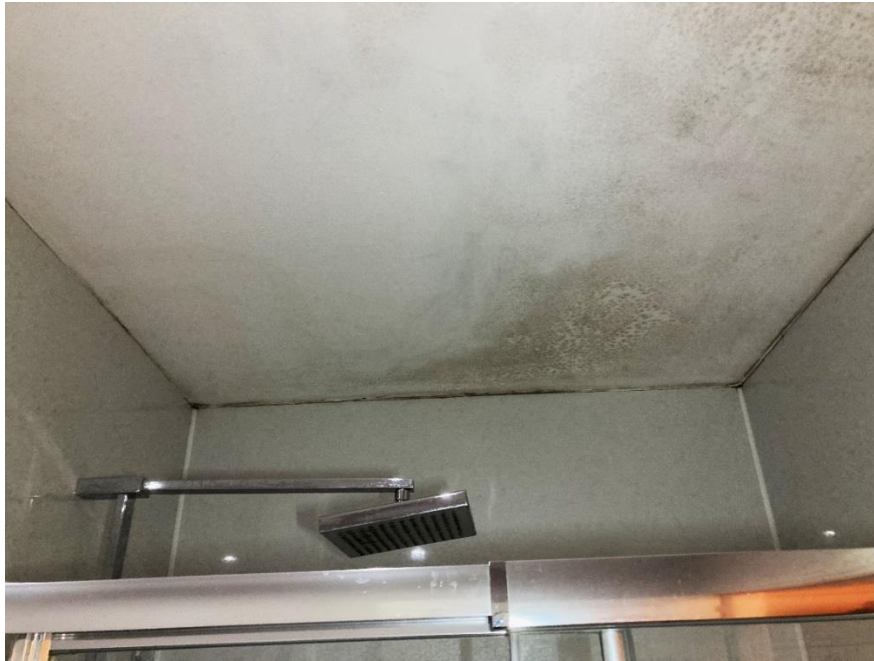
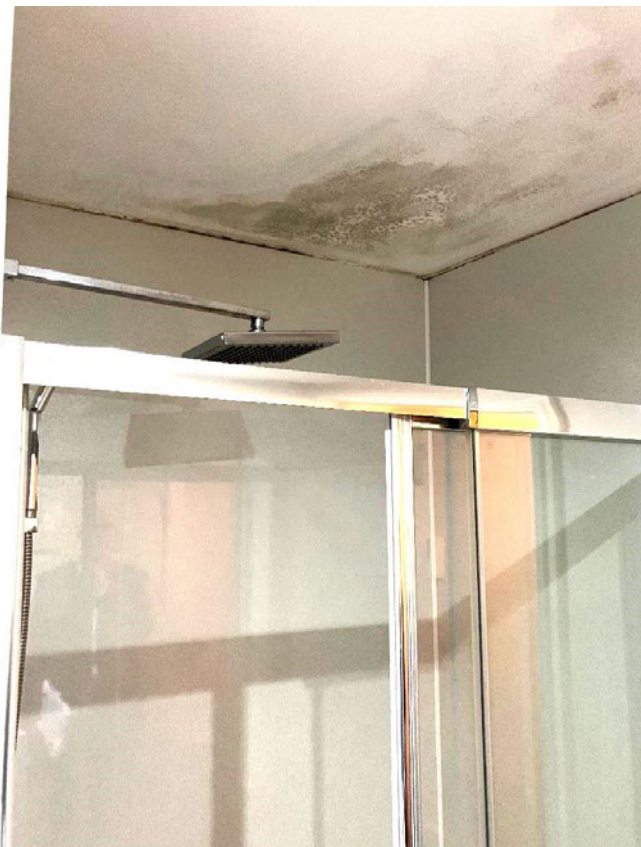
The damp staining above the shower area remains. Dry at the re-inspection there has been no removal of the mould, redecoration or repair to the plasterwork.

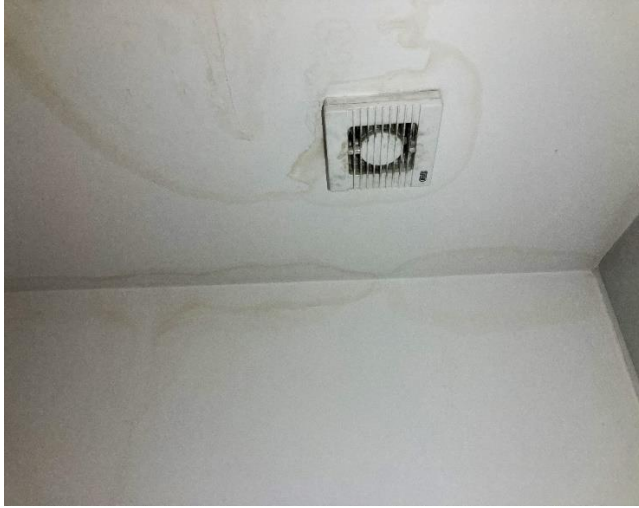
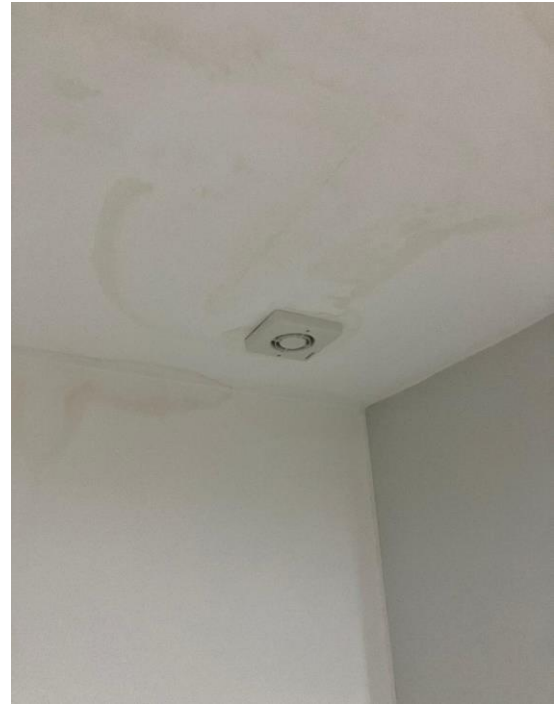
**27 February 2024 - Bathroom vent**

The ceiling mounted electrical ventilator in the bathroom has been repaired and was functioning satisfactorily during the re-inspection. The surrounding damp staining on the ceiling remains, there are isolated areas of damp and the ceiling has not been redecorated.

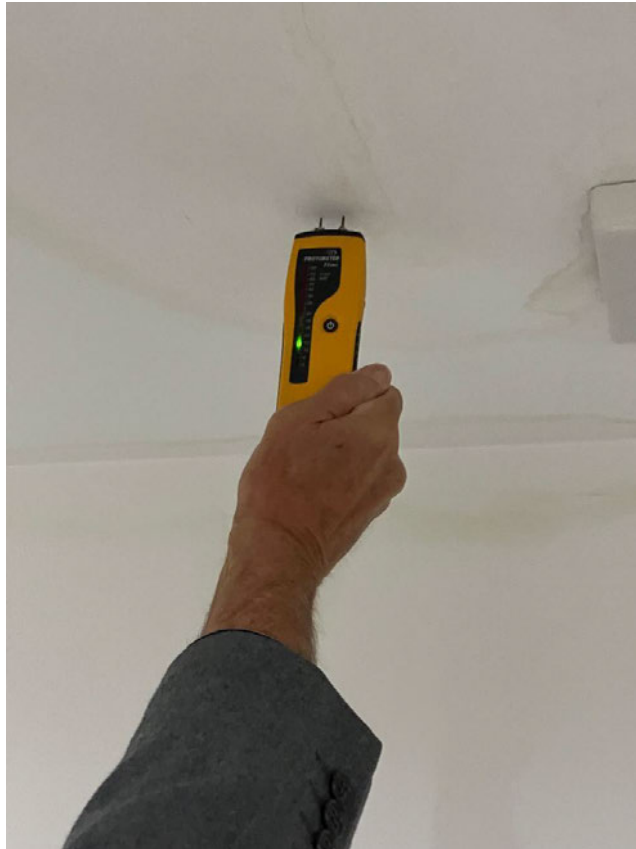
**30 August 2024**

The damp readings on the bathroom ceiling were localised and no significant levels were noted at several areas close to the ventilator despite highly visible staining.

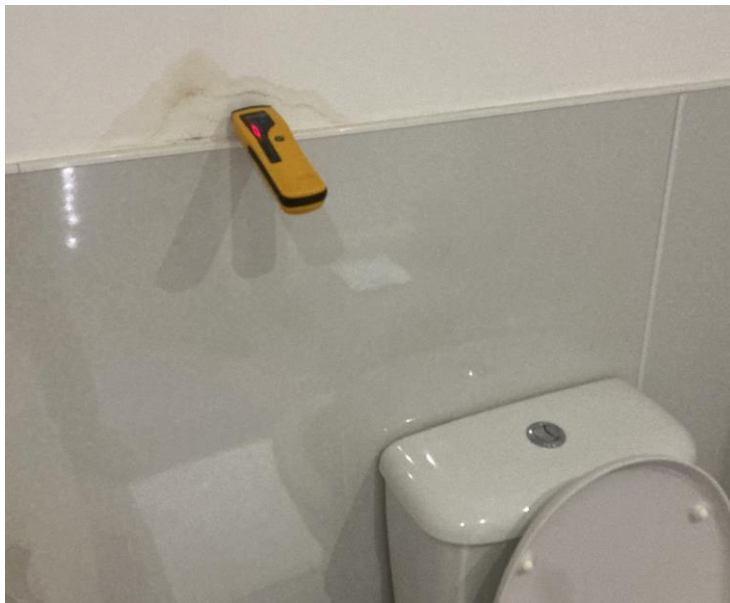
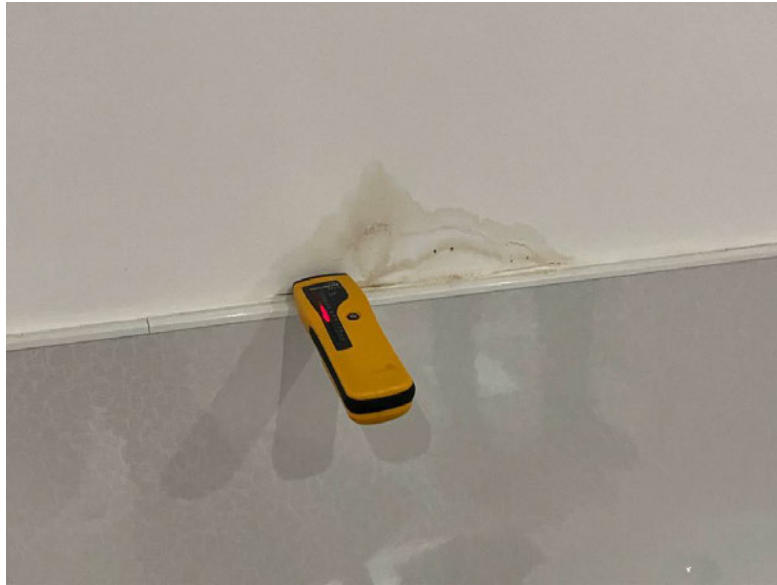
**27 February 2024 – Mutual wall bathroom/living room**

Moisture readings taken in the bathroom at the mutual wall with the living room/kitchen area remain positive at an area immediately above the lower wall cladding.
