**First-tier Tribunal for Scotland (Housing and Property Chamber)**

**Statement of Decision: Housing (Scotland) Act 2006 Section 24(1)**

**Chamber Ref: FTS/HPC/RP/24/1856**

**Re: 32 Westermains Avenue, Kirkintilloch, Glasgow G66 1EH  
("the House")**

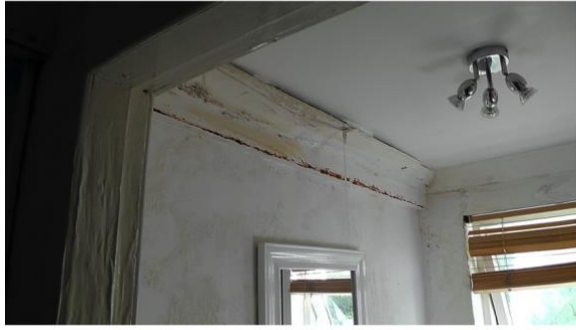
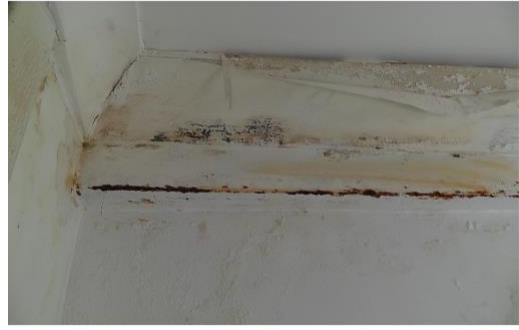
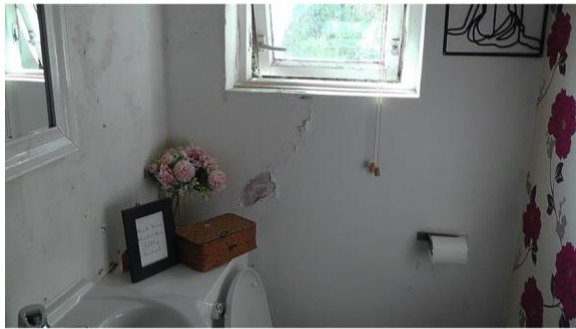
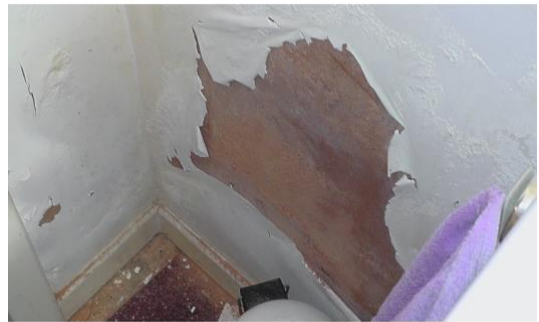
It was clear that there is evidence of persistent water damage in those areas. Surface and below surface readings were taken in the utility room and WC using a specialist damp meter. The readings recorded indicate that several sections of the wall and ceiling are saturated. This is embedded dampness and does not correlate with potential condensation issues. Staining and bubbling to various surfaces was evident. There were holes in the pipe chase in the utility room. The party wall with the Kitchen had

evidence of staining and surface damage indicative of sustained water penetration.

32. Areas of plasterwork in the downstairs toilet and utility room are damaged due to water ingress.
33. There were holes in the pipe chase in the utility room.

Photo 2 – Water damage in WC

Photo 3 – Water damage in WC

Photo 4 – Water damage in WC

Photo 5 – Water damage in WC

- (8) Carry out finishing works to dry out, repair and restore the interior walls and ceiling of the downstairs toilet and utility room; to include restoring any finishes.

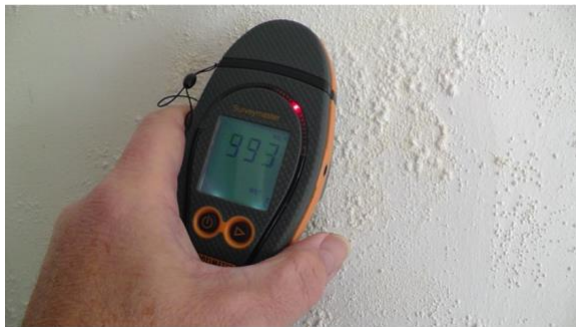
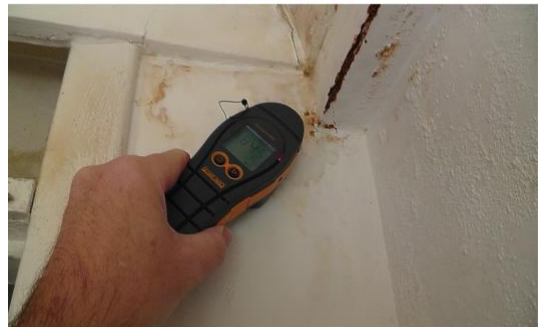
34. The walls in the downstairs toilet and utility room have the highest moisture readings possible.
35. The cause of the high moisture readings is not condensation.

Photo 6 – Embedded dampness reading in WC

Photo 7 – Embedded dampness reading in WC

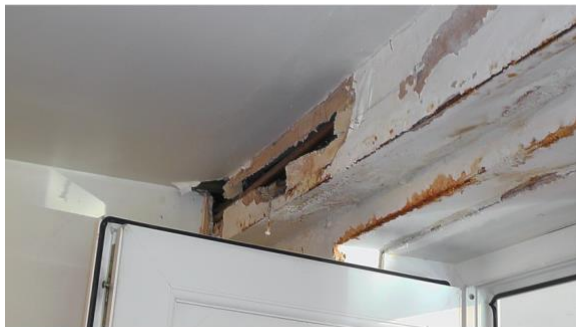
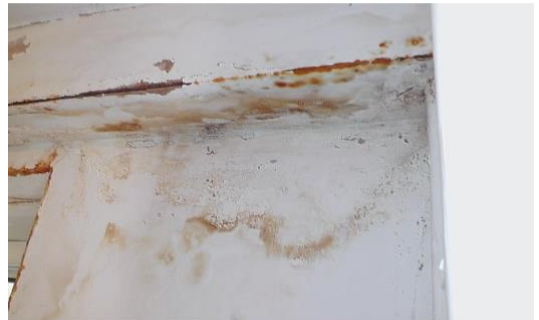
Photo 8 – Water damage in Utility room

Photo 9 – Water damage in Utility room

- (6) Repair the covering to the pipe chase in the utility room of the House.
  - (7) Clean the surface of the decking area outside the House to remove any potential source of slipping hazards. This work should be done once the gutter above same has been repaired.

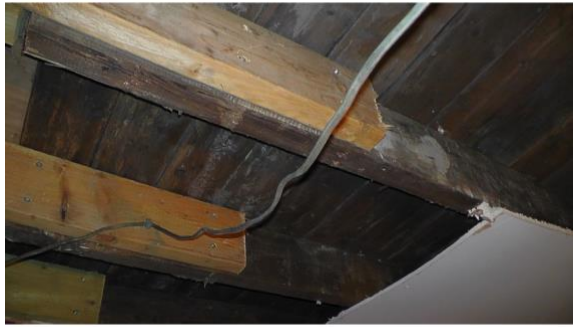
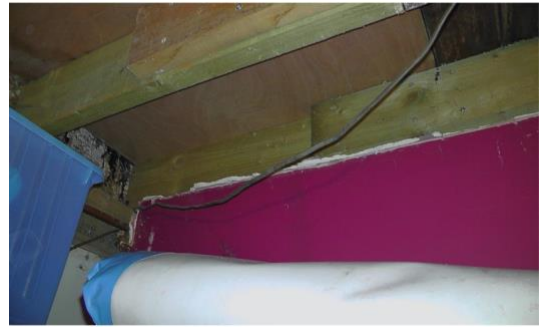
The garage area did not appear to have any water damage issues, but an electrical cable was hanging loose from the ceiling. It appeared to pose no risk.

38. The electric cable in the garage does not pose a safety risk but should be secured to the ceiling joists.

Photo 10 – Loose electrical cable in garage

Photo 11 – Continuation of loose cable

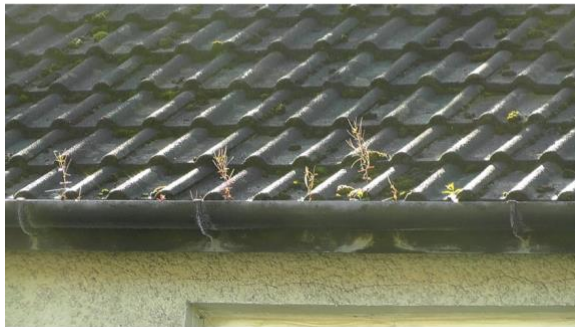
The front guttering was choked with vegetation. The rear guttering had two areas where it was out of alignment/pitch and could be a potential source of pooling of water with overspill. There was evidence of a repaired section above the decking area which potentially could be the source of water dripping onto the decking.

Photo 12 – Choked gutter on front elevation

- (2) Carry out such repairs to the rear gutter to align the run and pitch on it.
  - (3) To clean out the front guttering and remove any obstructions and repair it as necessary.

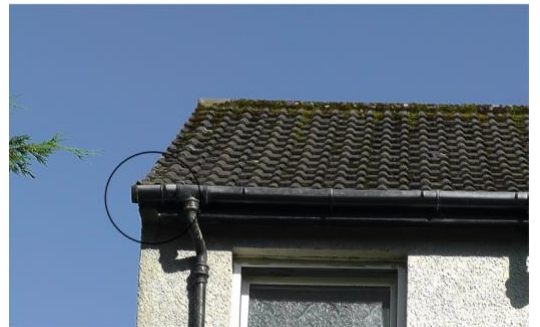
Photo 13 – Pitch/run issue with rear gutter

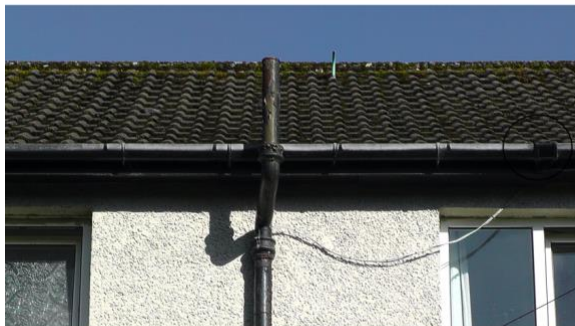
Photo 14 – Potential issue with gutter section to right

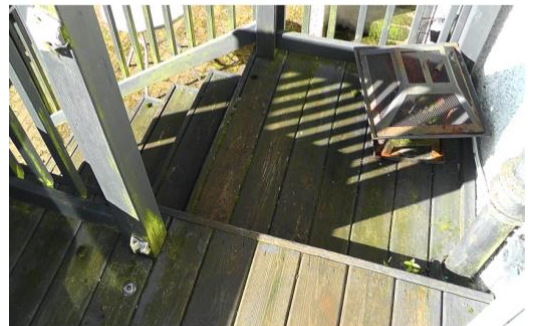
The flooring comprised timber slats. It was slippery despite the weather being dry and had some surface algae.

36. The guttering at the front of the House is choked with vegetation. The rear guttering is out of alignment/pitch in two sections.
37. The decked timber area is wet and slippery. It is below an area of guttering that is out of alignment.

Photo 15 – Moss covered deck and garden steps

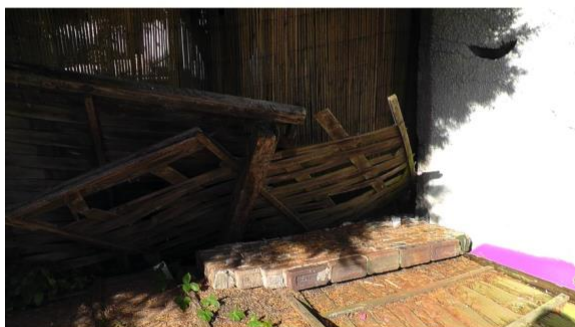
Adjacent to the rear stone steps, two wooden fence panels had come down. A section of single brick wall at the same location had also collapsed. It had no identified purpose and it did not appear to form part of the boundary. Neither Party appeared to have any interest in it other than that the debris should be removed when the boundary fence is being re-instated.

Photo 16 – Collapsed fence panels and wall section

- (4) To reinstate the boundary by replacing the two wooden panels at the rear boundary fence and remove any surrounding debris.
  - (5) Remove any loose roughcast to the exterior of the House and carry out such repairs as necessary to reinstate same.

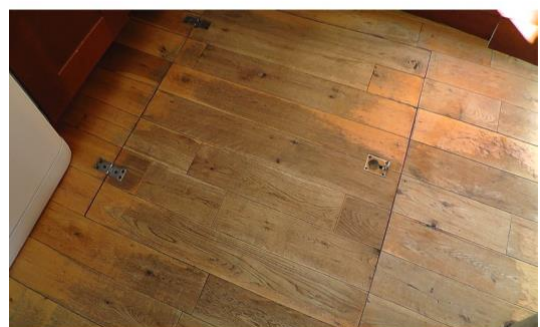
The central heating boiler was in an underfloor area in the kitchen and the access hatch was jammed. The tribunal was unable to inspect the boiler despite efforts by the Parties to release the hatch. The central heating system was operated by a wireless thermostat and the Tenant turned on the heating for the purposes of inspection. After a short time, the radiators were inspected. There were two in the living room that were hot at the top and cool at the bottom. The upstairs three-bedroom radiators and the towel rail in the bathroom were hot at the bottom and cool at the top. However, the system was generally working sufficiently.

Photo 17- Floor hatch

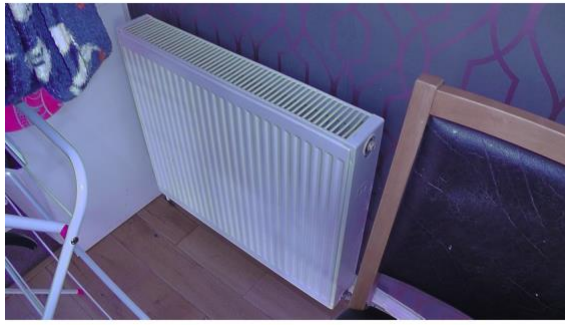
Photo 18 – Living room/Dining area radiator

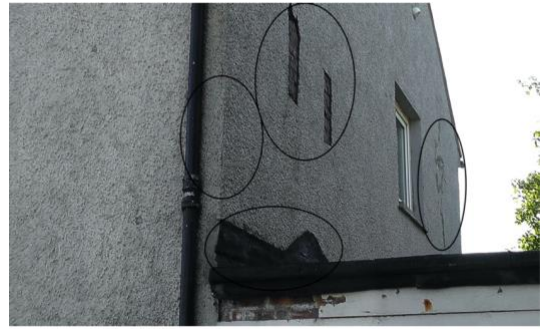
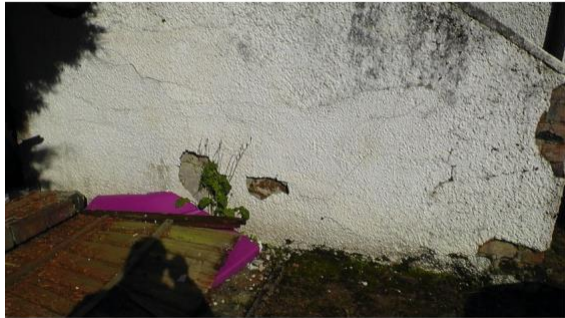
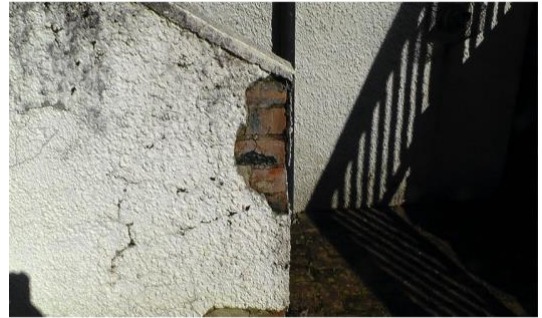
There were two rectangles of roughcast that had been removed from the gable wall to allow for inspection, and evidence of other attempts to resolve the water ingress problems. There were also signs of cracking and the roughcast had blown at sections and been patched at others.

Photo 19 – Bossed roughcast/exposed brickwork

Photo 20 – Roughcast issues

Photo 21 – Roughcast issues/exposed brickwork

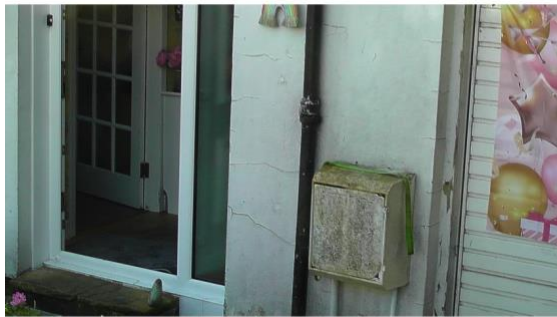
Photo 22 – Cracking on render

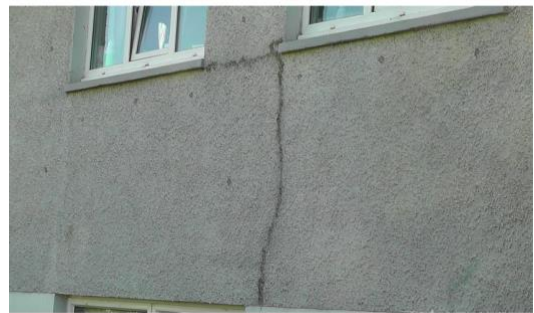
Photo 23 – Roughcast issues on front elevation

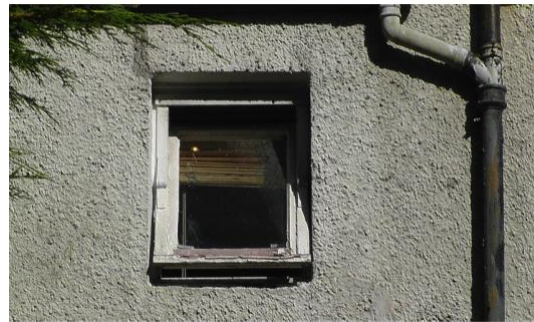
Photo 25 – WC window issues

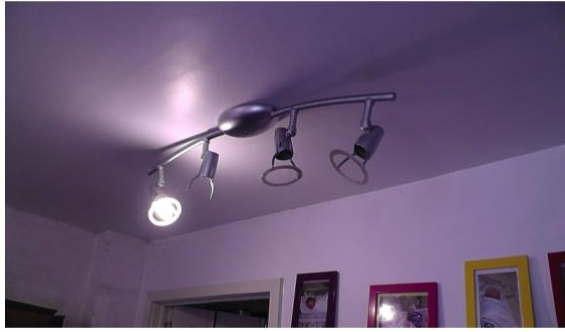
Photo 26 – Broken light fitting in Utility room
