Decision with Statement of Reasons of the First-tier Tribunal for Scotland (Housing and Property Chamber) in terms of Section 24(1) of the Housing (Scotland) Act 2006

Reference number: FTS/HPC/RP/24/1669

Re: 9 Warrix Avenue, Irvine, North Ayrshire KA12 ODP (registered under title number AYR5568) (“Property”)

Schedule of Photographs taken at the inspection on 26 September 2024

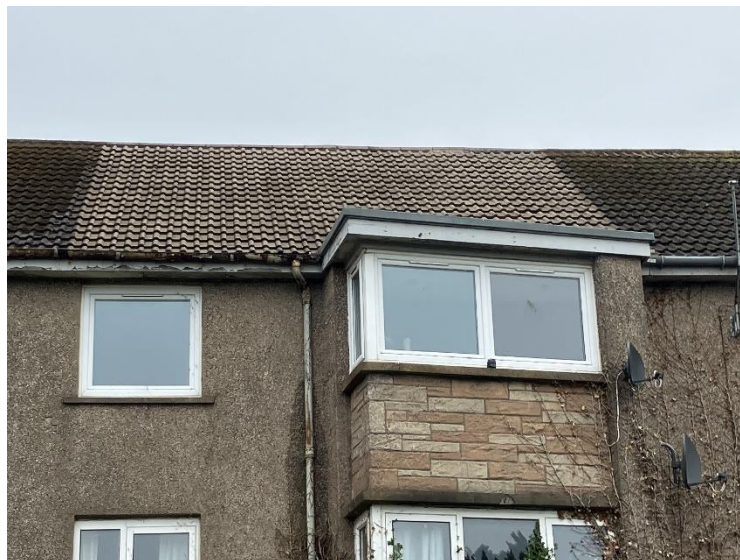
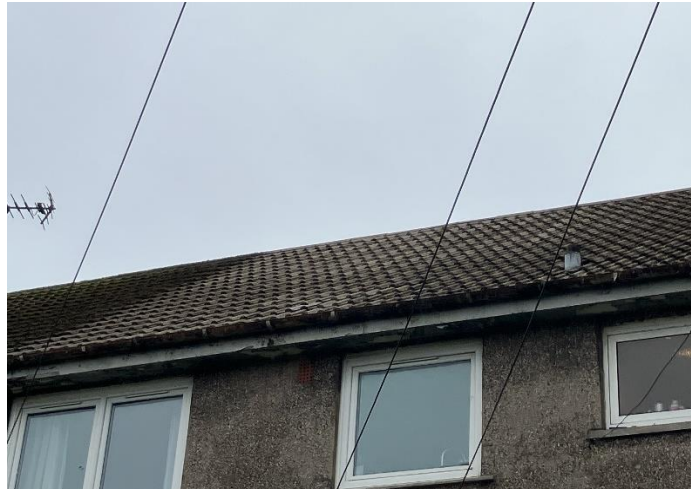
10. As regards the roof, the Tribunal noted that there was no evidence of holes in the roof tiles. The Landlord told the Tribunal that works had been carried out to the roof which had been completed on 25 September 2024. He said that the roof tiles had been power washed and that may have contributed to dampness evident at the inspection. The Landlord said that the gutters were being cleared every 4/6 months. He hoped the removal of moss from the roof would help with the dampness.

Photographs 2 and 3:- The roof tiles have been “cleaned” and that there are no significant holes in the roof covering

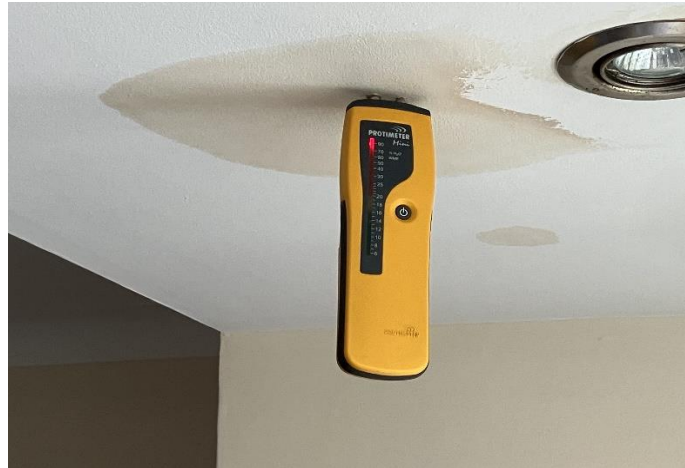
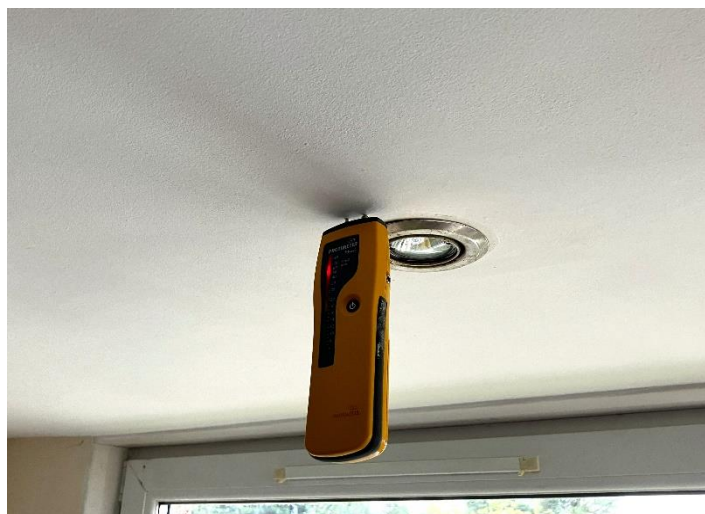
11. As regards the living room, the Tribunal noted that there was large damp stain around the lights in the bay window and that damp meter readings taken in this area were very high. The Landlord said that may be because the roof had recently been power washed. The Tenant said that water pours in at this area when it rains. The Landlord told the Tribunal that the lights in the bay window area had been disconnected because of the water ingress. He said they would be reconnected once it was clear that the water ingress had been resolved.

- 19. As regards the dampness, the Landlord has undertaken works including the removal of the ivy and redressing and extending the flashing between the flat and pitched roof sections on the front of the building in an attempt to address the issue. The latest works were completed the day before the Tribunal inspected the Property. It is too early to determine whether the works carried out have fully addressed the issue. At the time of the inspection there was evidence of damp which was at a significant level in the ceiling below the flat roof.

Photographs 4 & 5:- Evidence of water ingress below the flat roof projection above the living room and moisture readings in the vicinity of recessed ceiling light fittings at levels likely to cause further damage, if not repaired.

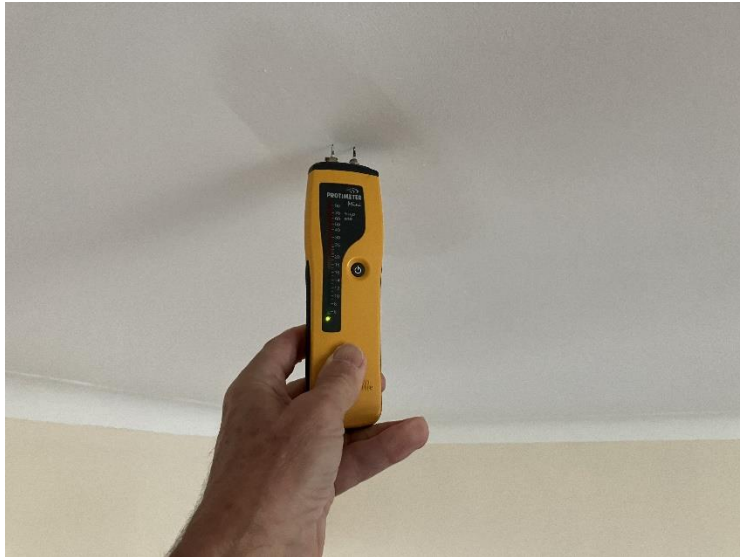
6.

Photograph 6:- Confirms that the damp staining towards the centre of the living room ceiling is dry.

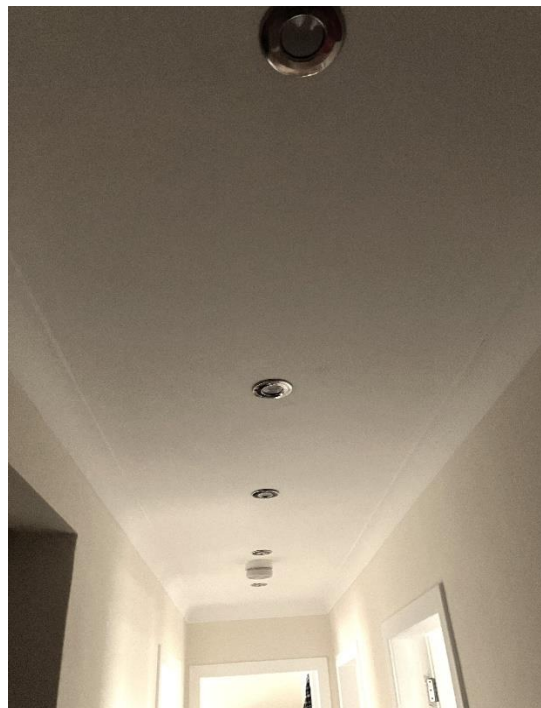
7.

12. As regards the light fittings, the Tribunal noted that the lights in the hall were in a reasonable state of repair. The tribunal noted that the EICR lodged by the Landlord was dated 14 December 2021 and noted C2 issues. The Tribunal noted that electrical works had been carried out since the EICR had been prepared and asked if a more up to date EICR was available. The Landlord said he did not think so but would require to check.

Photograph 7:- Recessed ceiling lights in the entrance hall all of which appear to be properly secured. No poorly secured ceiling mounted light fittings were identified within the property or brought to the attention of the Tribunal by the applicant.

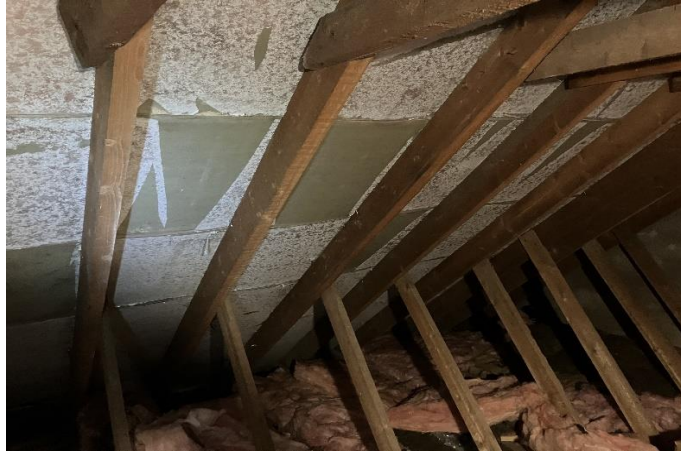
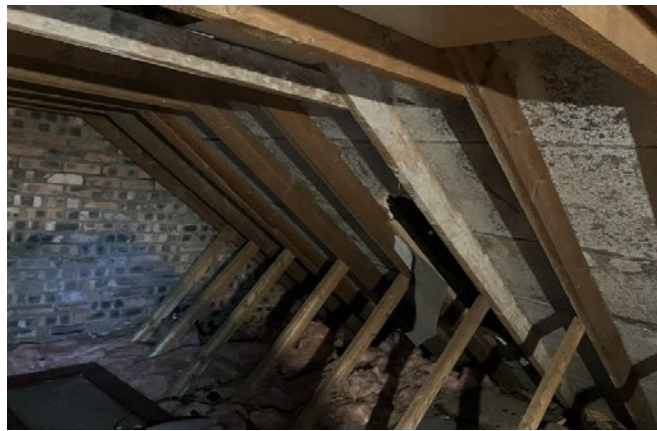
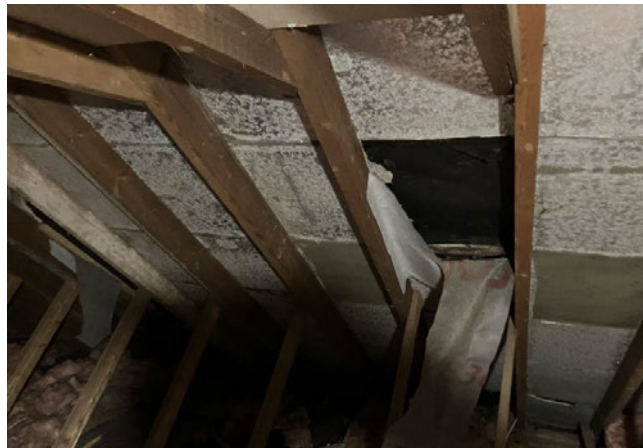
Photographs 8 - 10:- Historic condensation staining on the foil backed plasterboard sarking in roof space and a damaged sarking panel which was disturbed during a recent repair to the roof tiles on the front roof pitch. Such staining and condensation within roofs of this style of construction is very common, most notably during winter. There was no evidence of any recent penetrating damp within the roof space.

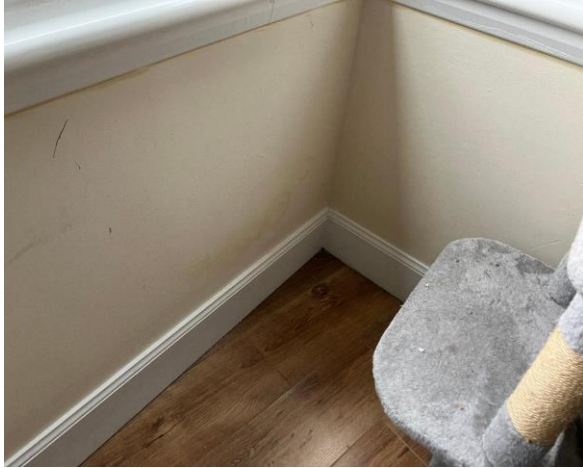
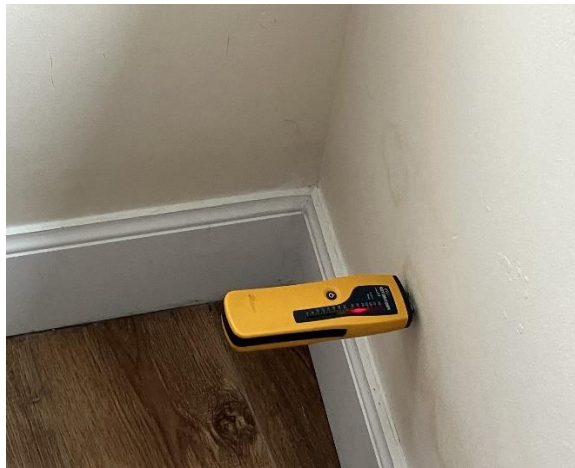
Photographs 11 & 12:- Damp staining at front and return walls of living room. This coincides with an area of the external wall where, as a result of a recommendation from “Peter Cox”, a timber and damp preservation company, ivy which was previously growing on the external face of the wall was removed in order to address the likely cause of penetrating damp. Damp levels, still in the region of 30% remain, although it is very possible this is residual damp which will reduce as the wall dries out.

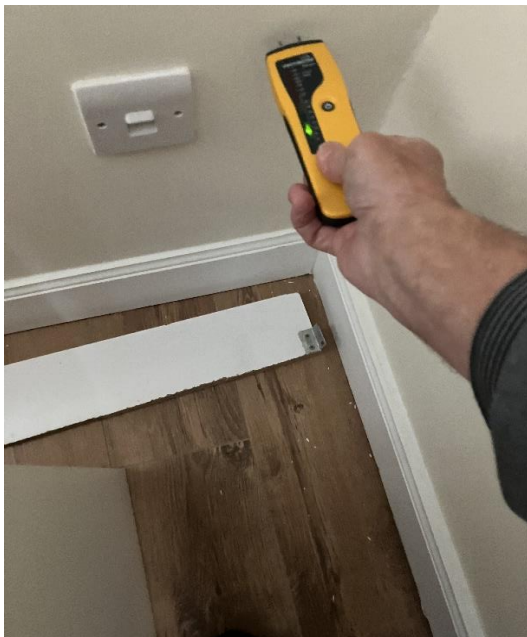
13.

Photograph 13:- Readings taken in the front bedroom, where the tenant considered there to have previously been damp, identified no evidence of damp.

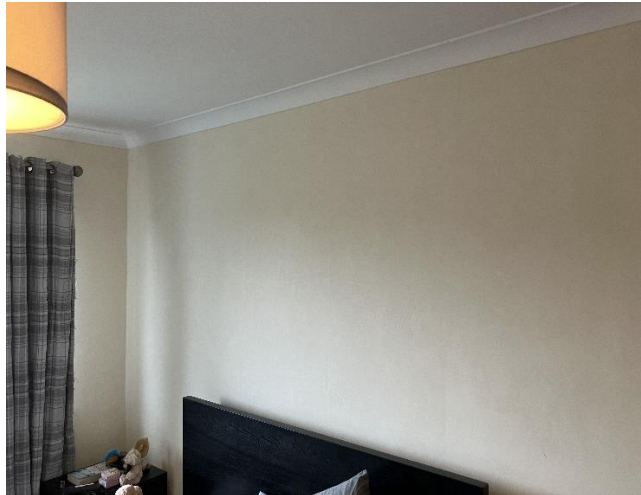
14.

Photograph 14:- Readings taken in the rear bedroom, where the tenant considered there to have previously been damp, identified no damp. There is evidence of variable “shading” on the wall although it was completely dry at time of inspection.

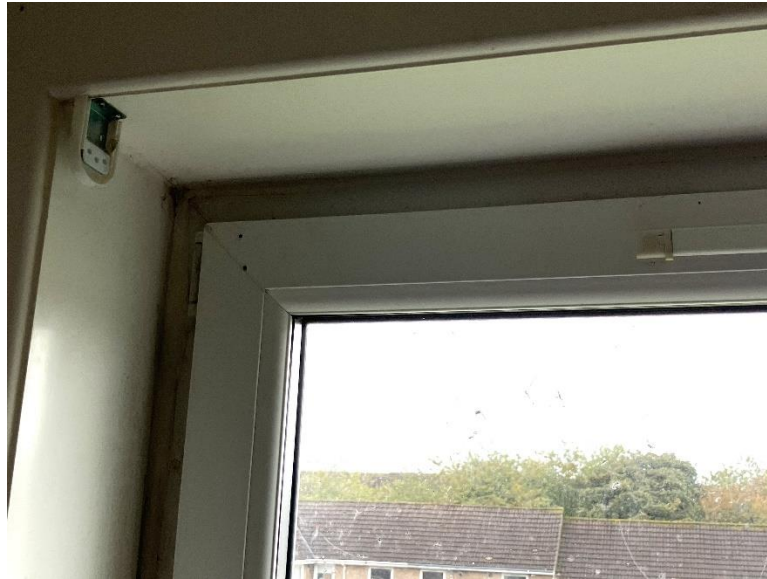
15.

13. As regards the kitchen window, the Tribunal noted that it did not close properly and therefore was not wind and watertight. The Landlord said that a glazier was coming to look at it on Saturday 28 September 2024. If it could be repaired, he would arrange a repair otherwise he would arrange for it to be replaced.

Photograph 15:- Top left hand corner of PVC double glazed kitchen window. Operating mechanism of window is not fully functional and there is a noticeable draught at this area when in the closed position.
