First-tier Tribunal for Scotland (Housing and Property Chamber)

Statement of Decision: Housing (Scotland) Act 2006 Section 24(1)

Chamber Ref: FTS/HPC/RT/24/1772

**Re: 37 Main Road, Collin, Dumfries, DG1 4JL
("the House")**

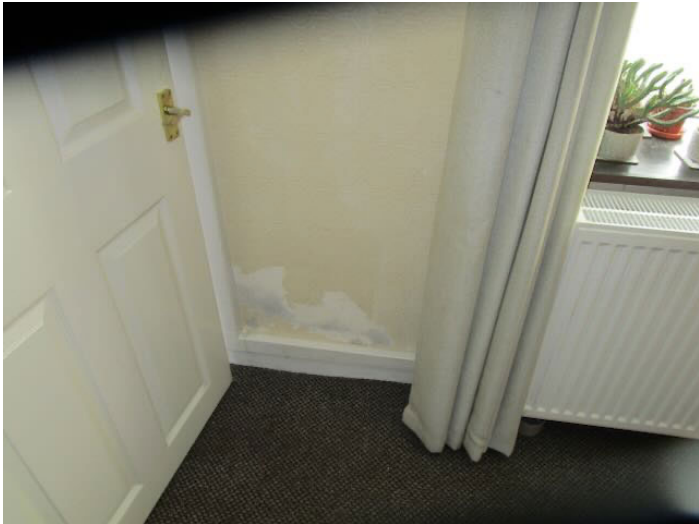
8. The lounge area
To the lower wall to the left hand side of the window, a damp meter reading was taken from an area identified by those present. The moisture reading taken was 6% and was much lower than the reading of 26.4% submitted in the application. A second wall area was examined which was on the living room, where the living room met the kitchen entrance. The moisture reading taken was 6%.
Within the fireplace was a multi stove. The area was clean, and the tribunal was unable to see any debris said to have been dropping from the chimney at the time of inspection.

23. The House is one to which the repairing standard applies.
24. The damp meter readings taken in the living room were low and did not evidence damp issues on either wall at the date of the inspection.

1. Damp patch in Living Room.

- 1) Engage a suitably qualified damp specialist to investigate the causes of dampness at two patches on the walls in the Living Room and at the concrete slab adjacent the front door. Undertake all works recommended; make good all plaster, decoration and flooring.

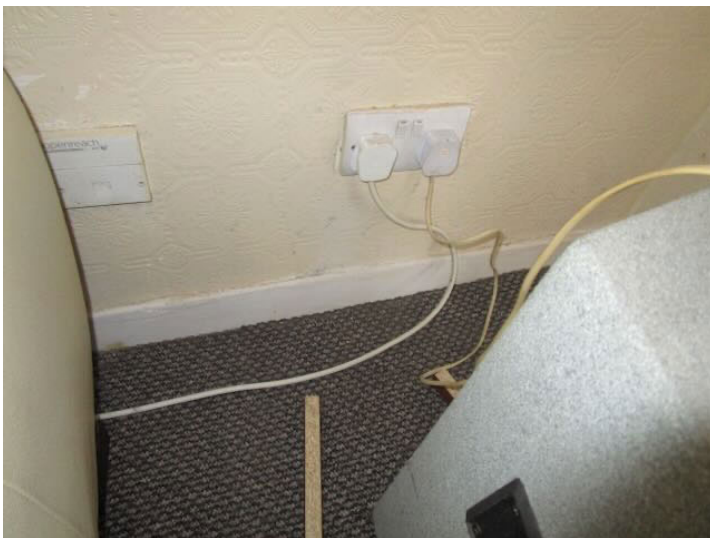
2. Damp patch in living room.

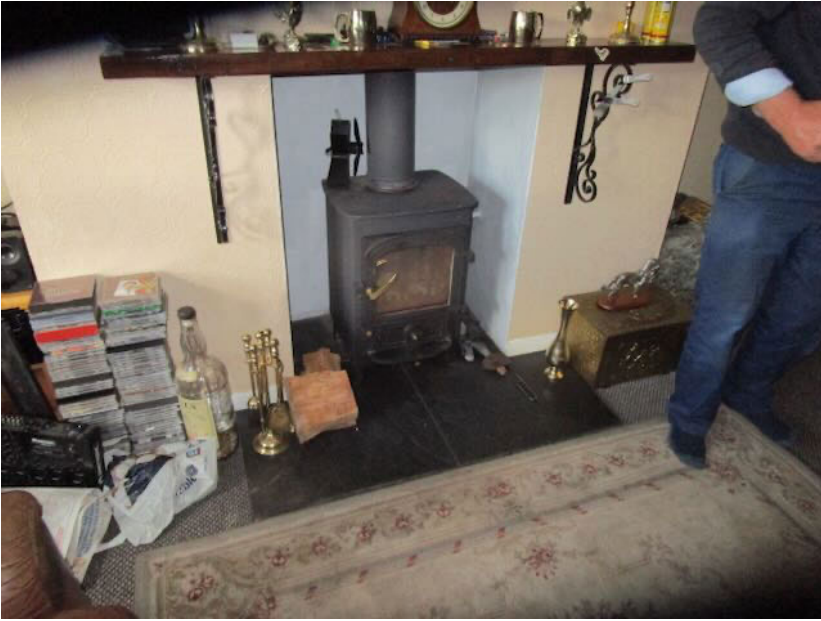
25. The chimney in the living room requires to be swept periodically notwithstanding the installation of a multi fuel stove. There was no debris noted at the date of the inspection and the area was generally clean.

3. Multi fuel burner and flue.

- 2) Engage a HETAS qualified chimneysweep to sweep the flue to the multi-fuel burner and provide the Tenant with the appropriate certificate.
- 3) Repair or replace the front door to the property including all draught excluders and weather bars so that the door is secure, wind and watertight, and capable of being easily opened and closed.

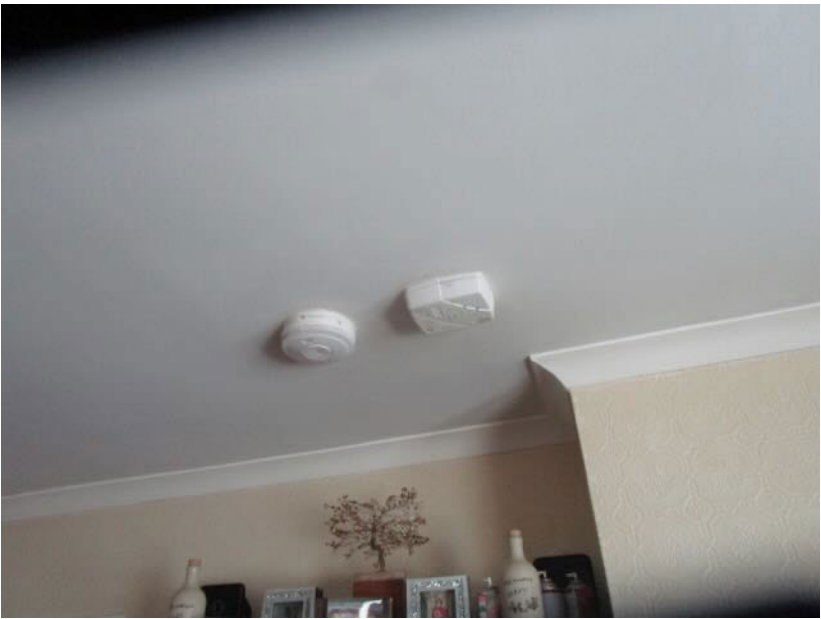
14. There was a working interlinked wireless fire alarm system in the main areas, a heat detector in the kitchen and Carbon Monoxide detector in the House.

4. Smoke and Carbon Monoxide Detector.

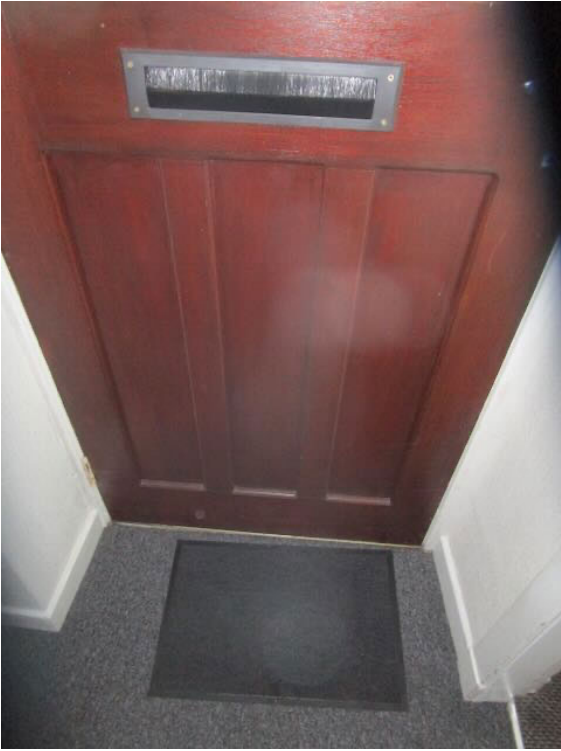
The tribunal found that the timber front door of the house was difficult to open and close, and the door is binding on the rubber draught excluder fitted to the threshold. The concrete floor at the door was inspected by the tribunal after the Tenant had lifted part of the floorcovering. It was visibly wet at the concrete slab.

26. The timber front door of the house was difficult to open and close, and the door is binding on the rubber draught excluder fitted to the threshold.

40. The windows highlighted in the inspection are in need of repair, as was the front door that was taking in water and the rubber draught excluder was no longer sound.

5. Front Door.

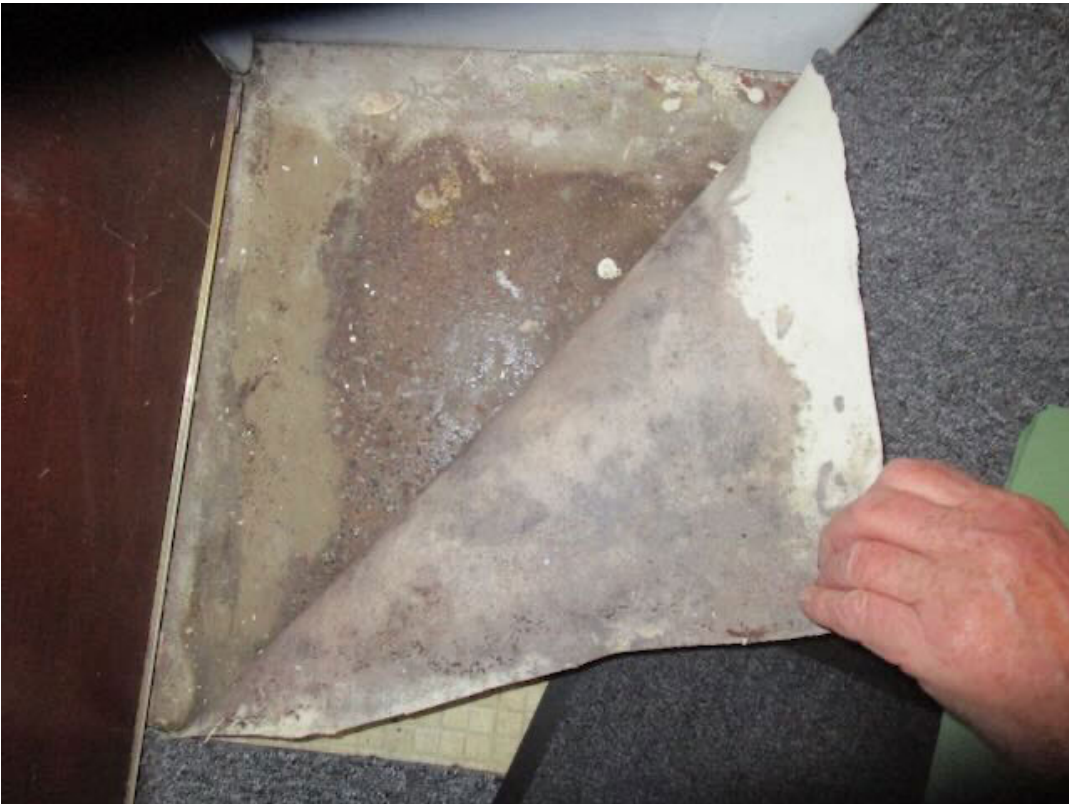
27. The concrete floor at the front door was visibly wet at the concrete slab despite the dry weather.
28. The window seals are rotted in areas of the left hand side window in the bathroom and have separated from the window frame.

41. The concrete floor adjacent to the front door had an obvious water ingress issue and needed to be investigated.
42. The gutters needed repaired or replaced. The downpipes appeared sound.

6. Damp concrete floor adjacent front door.

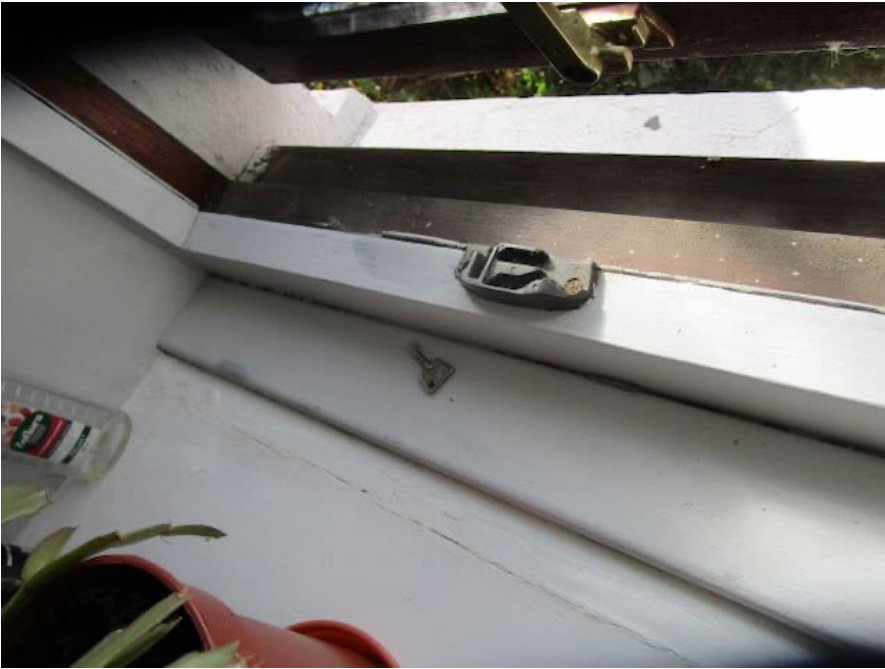
The window seals are rotted in areas of the left hand side window and have separated from the window frame.

7. Damaged seals at bathroom window

- 4) Replace the seals to the bathroom window so that the window is secure, wind and watertight, and capable of being easily opened and closed.
- 5) Investigate and repair the cause of the leak affecting the ceiling to bedroom 1.

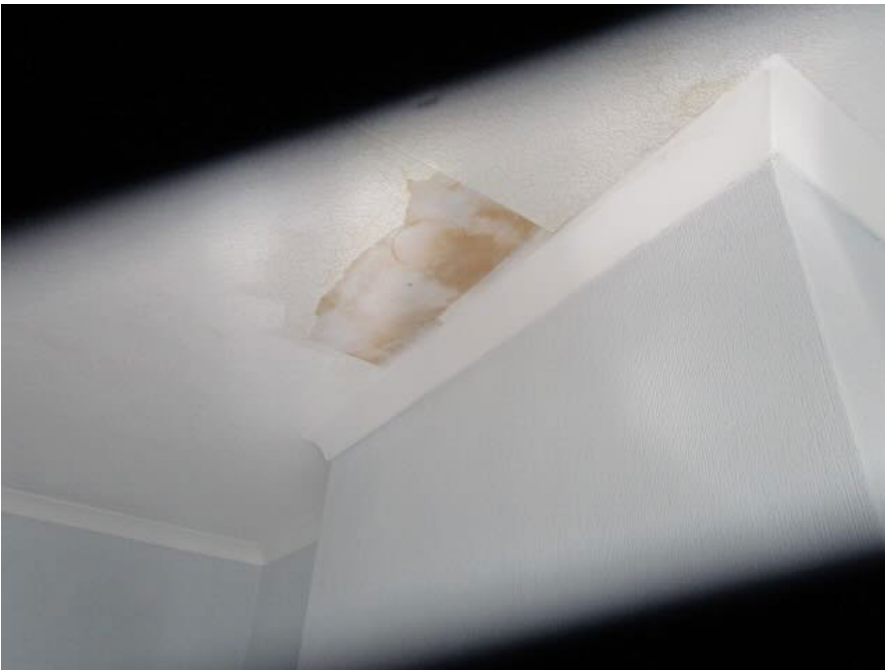
The ceiling area above the chimney breast has a visible patch of water damaged and wallpaper had peeled there. A bucket was present but was empty on inspection. Plastic sheeting had been placed over the bed in this room.

29. The ceiling area above the chimney breast is water damaged.
30. A section of flooring in the kitchen running parallel to the sink and units is spongy underfoot and has sunk in places. This poses a danger to the Tenant or anyone else using the kitchen.

39. The tribunal was primarily concerned with the health and safety aspects arising from the kitchen floor, which needed immediate attention as it posed a risk to the Tenant. The damp patch on the bedroom ceiling also required early attention and may be linked to a roof issue or a chimney breach.

8. Damp patch at ceiling adjacent chimney breast in bedroom.

- 6) Make good plaster and decoration.
- 7) Investigate the subsiding floorboards in the kitchen. Replace floorboards and joists as necessary and carry out any rot works required. Include all making good and replacement of kitchen flooring.

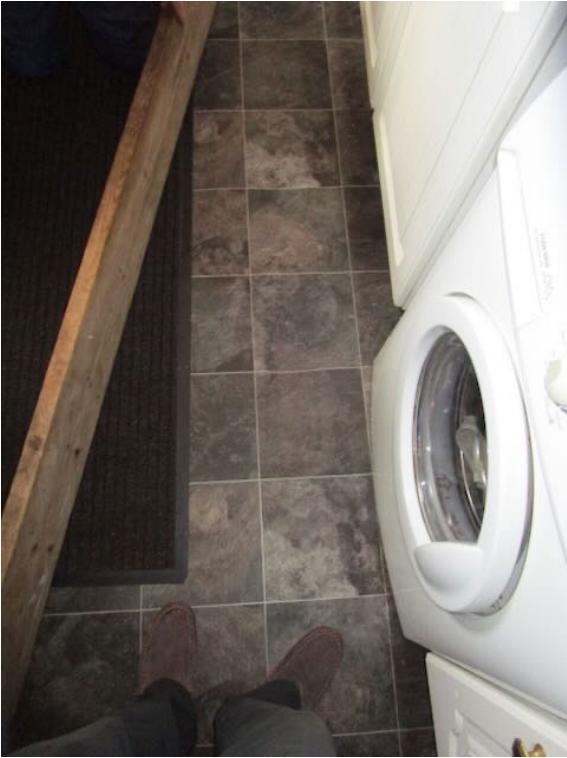
The tribunal was directed to a strip of flooring running parallel to the sink and units. This is spongy underfoot and is sunken. The Tenant had placed a thick wooden board over its length to stand on.

9. Hazardous floor in kitchen

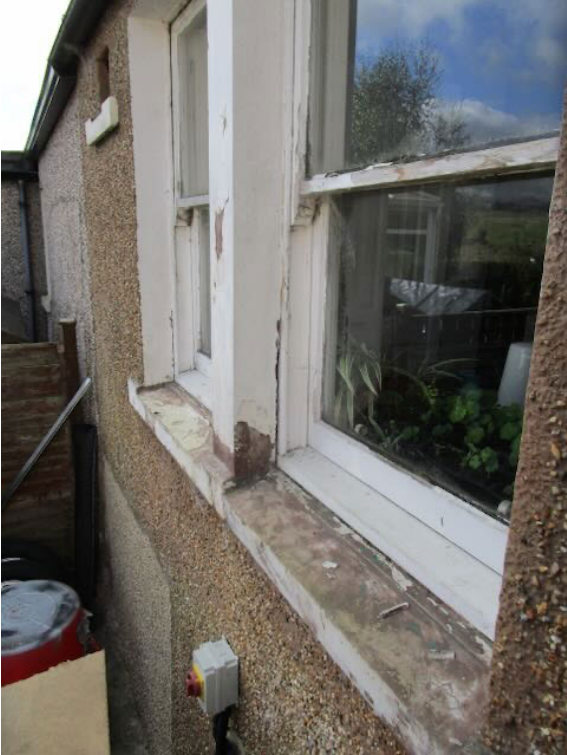
The window frame at the kitchen window mullion has come away and there is a gap. The paint has worn from the exterior of the window.

31. The window frame at the kitchen window mullion has come away and there is a gap. The paint has worn from the exterior of the window.
32. The front and rear gutters showed sign of deterioration and there are gaps with the line not running true.

10. Window and mullion

- 8) Carry out maintenance to double window at rear kitchen so that the window is secure, wind and watertight. Include render repair to mullion, pointing and decoration.

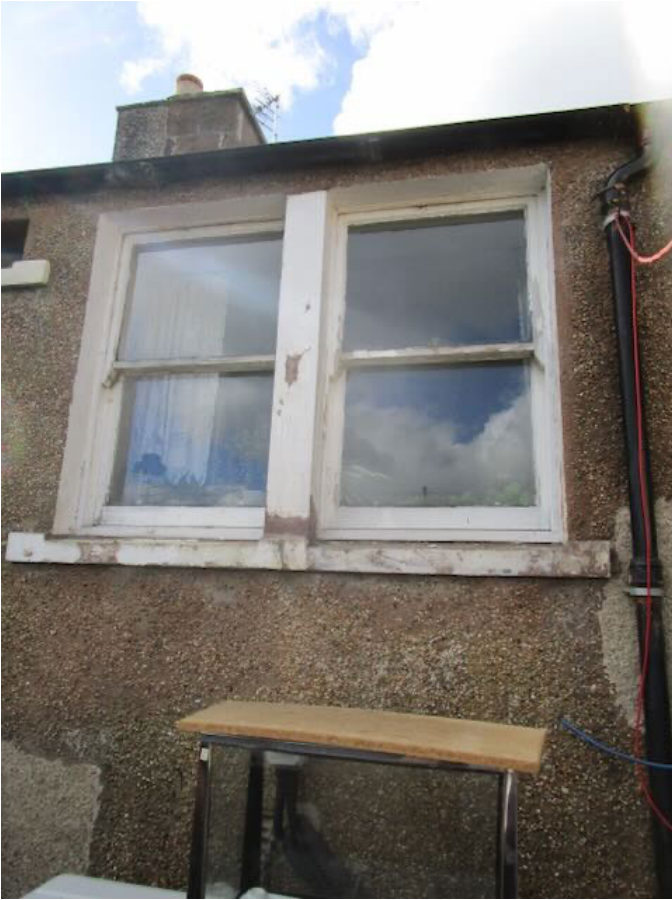
The front and rear gutters showed sign of deterioration and there are gaps with the line not running true.

11. Window and gutters to rear

- 9) Repair or replace gutters throughout the property so that they are watertight and operate efficiently.
- 10) Complete render repairs to all elevations of property and make good.

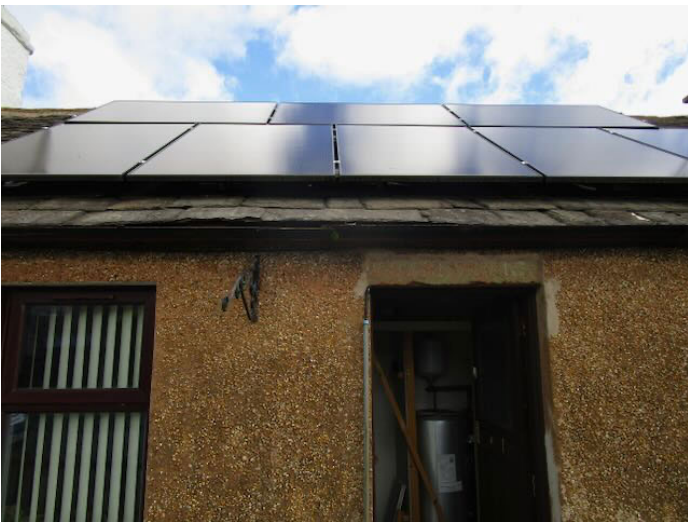
12. Gutters front elevation

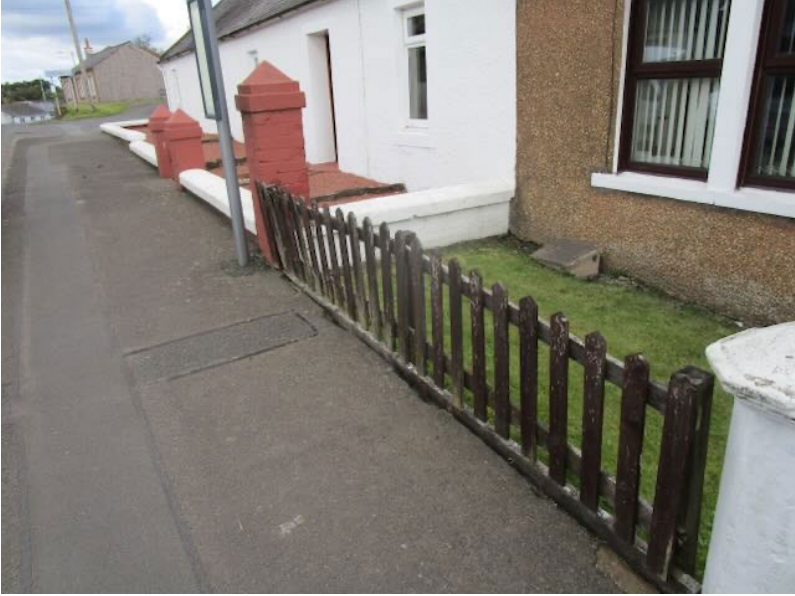
The fence at the front of the House complained of had been re-secured to its post, but generally was showing signs of age.

43. The tribunal had no immediate repair concerns over the front fence albeit it was showing signs of age and will require to be checked from time to time and repaired and secured as needed.

13. Fencing to front garden.

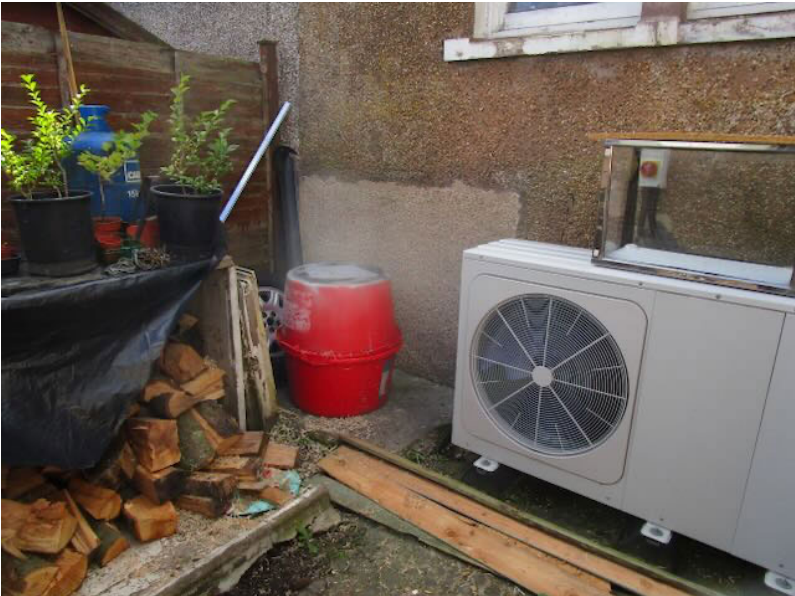
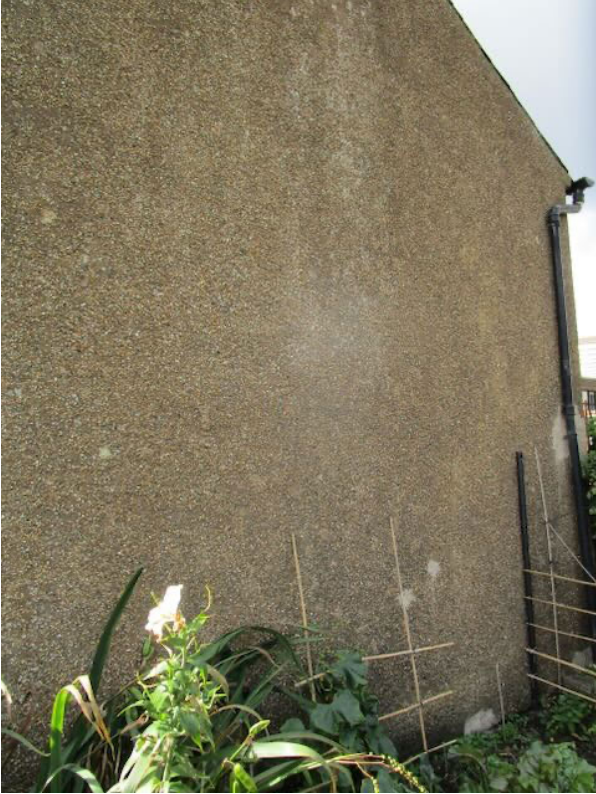
The render at the rear of the House had been patch repaired.

44. The exterior render at the back of the House had been patch repaired and there were no obvious signs that the render was causing any repair issues, but this may be checked and further repairs carried out as necessary. The front of the House needed to be inspected and render repairs completed as appropriate.

14. Render repairs.

15. Render repairs.
