**Statement of Decision of the First-tier Tribunal for Scotland
(Housing and Property Chamber) under section 60(5) of the
Housing (Scotland) Act 2006**

Chamber Ref: FTS/HPC/RP/24/0441

**43, Springfield Square, Bishopbriggs, G64 1PU being the subjects
registered in the Land Register of Scotland under Title Number
GLA180631("the Property")**

Schedule of photographs taken during the inspection of 43 Springfield Square,
Bishopbriggs G64 1PU by the First-tier Tribunal for Scotland (Housing and Property
Chamber) on Monday 18 November 2024

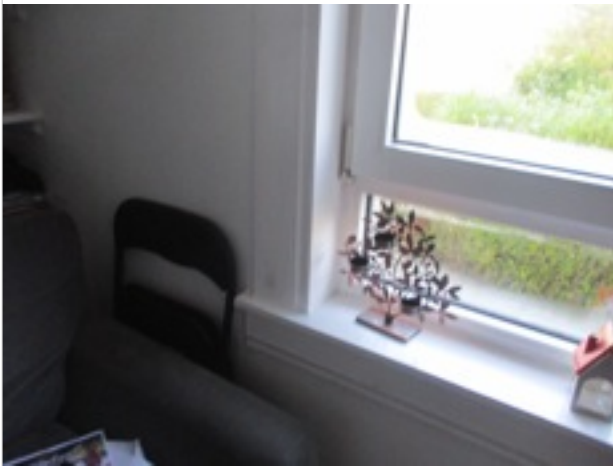
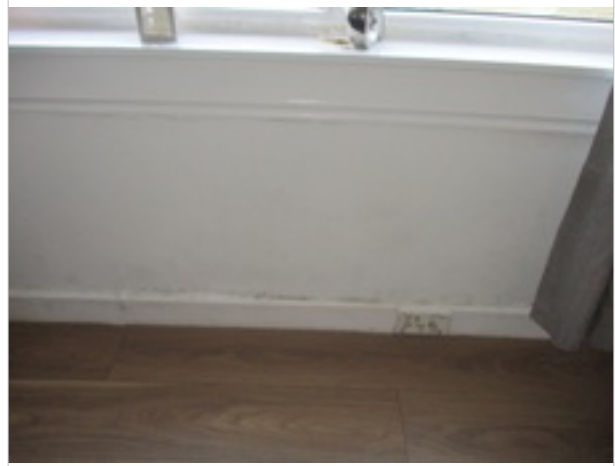
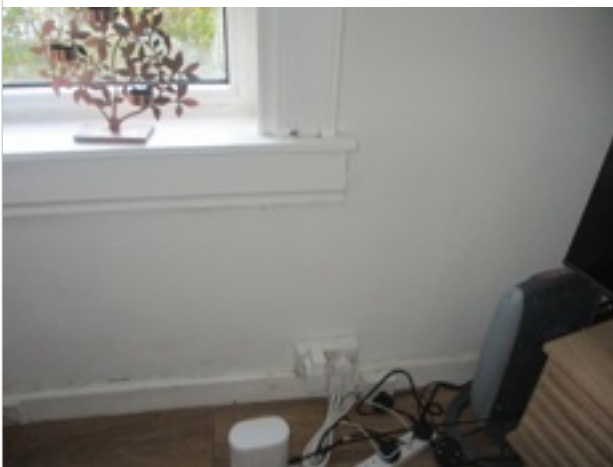
Damp Meter readings were taken on the front external wall and the internal wall adjoining the front bedroom. The readings at the lower part of the front external wall (up to approximately one metre) ranged from amber to red, which was indicative of moderate to high moisture levels on the surface and within the wall. The readings on the internal wall also showed moderate moisture levels but reducing to a low level towards the entrance door to the room.

Living Room - front external wall to left of window

Living Room - front external wall below window

Living Room - front external wall to right of window

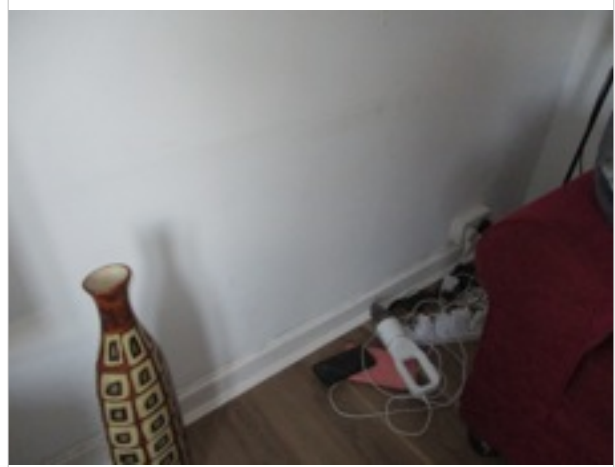
Living Room - base of internal wall adjoining front bedroom

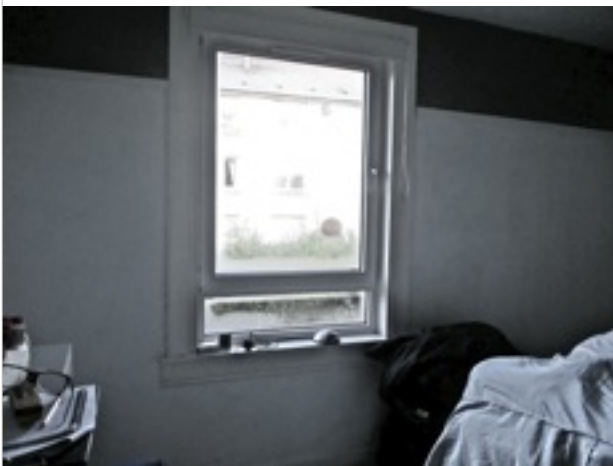
Damp Meter readings were taken on the two external walls. The readings at the lower part of the external walls (up to approximately one metre) ranged from amber to red, which was indicative of moderate to high levels of moisture on the surface and within the walls. There was visible moisture on the external walls and evidence of streaks of water running down the walls. At the far corner of the main bedroom a section of carpet had been pulled back revealing the floor boards. The floor boards were also tested using the damp meter and the reading was red. The floor boards were wet to the touch and the tribunal observed mould growth.

Front Bedroom - front external wall - excessive moisture build up on wall surface

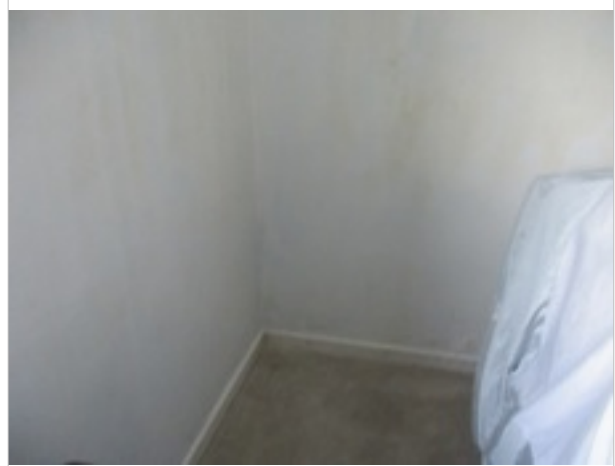
Front Bedroom - corner of front external and hip end walls - excessive moisture build up on wall surfaces

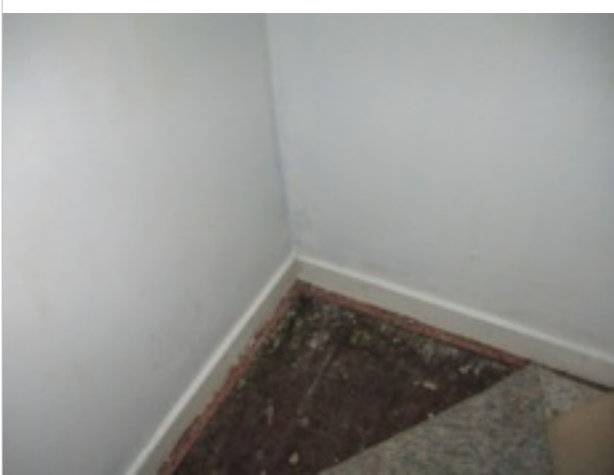
9.1.5 The floor boards in the corner of the main bedroom are damp.

Front Bedroom - corner of front external and hip end walls/carpet lifted to expose floorboards which are damp/showing signs of mould growth

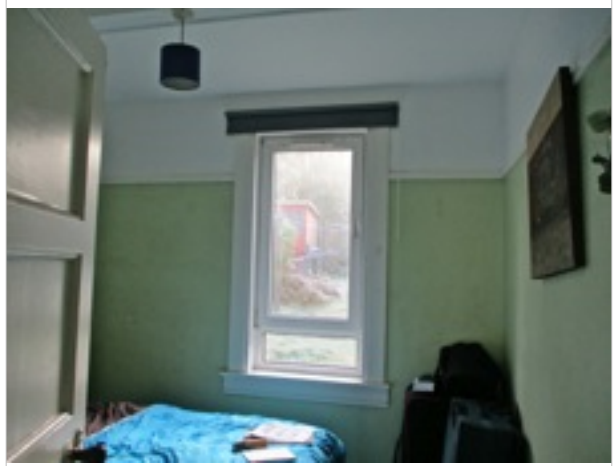
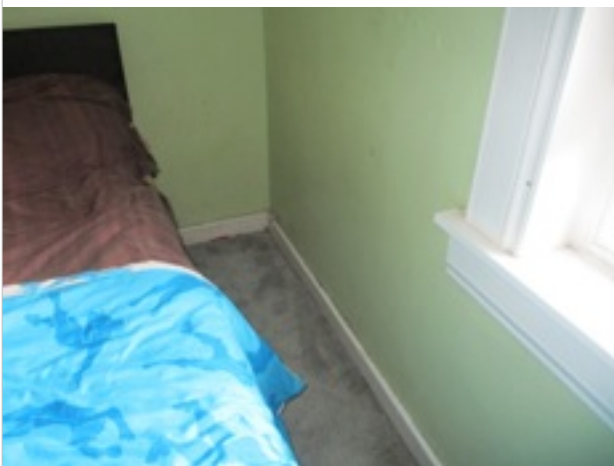
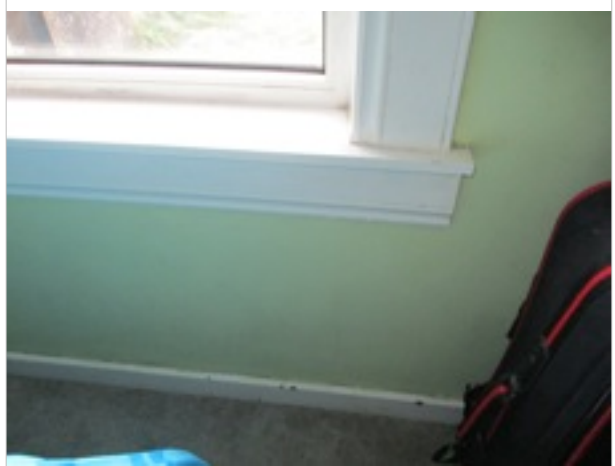
Damp Meter readings were taken on the two external walls. The readings at the lower part of the external walls (up to approximately one metre) ranged from amber to red, which was indicative of moderate to high moisture levels on the surface and within the walls.

Rear Bedroom - rear external wall

Rear Bedroom - corner rear external and hip end walls

Rear Bedroom - base of rear external wall below and to right of window

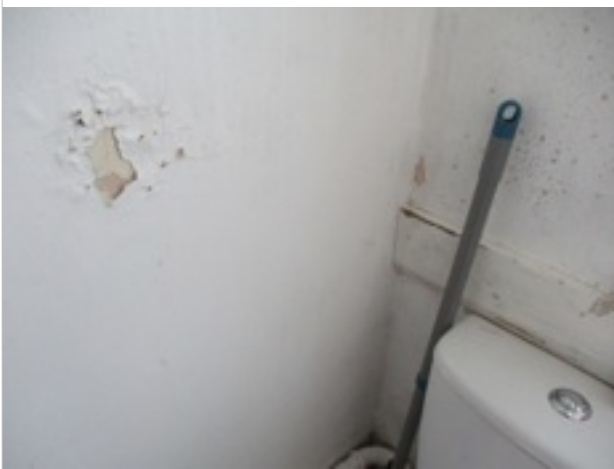
The external wall was very wet. Damp Meter readings were taken on the external wall and the internal wall adjoining the rear bedroom. The readings at the lower part of the walls (up to approximately one metre) ranged from amber to red, which was indicative of moderate to high moisture levels in the walls. There is a wall mounted extractor fan to the left of the window.

Bathroom - internal wall adjoining rear bedroom - moisture build up on wall surface

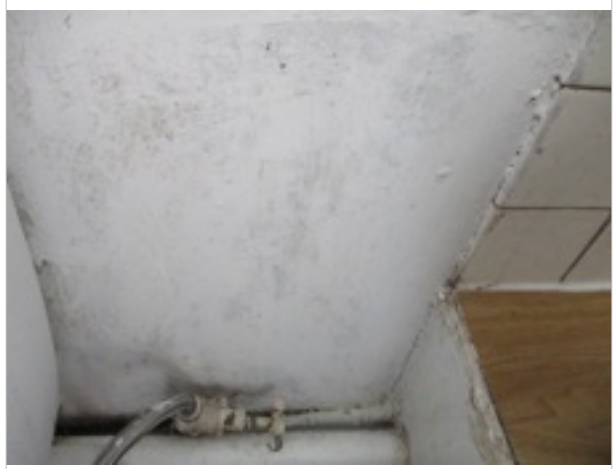
Bathroom - rear external wall - moisture build up on wall surface

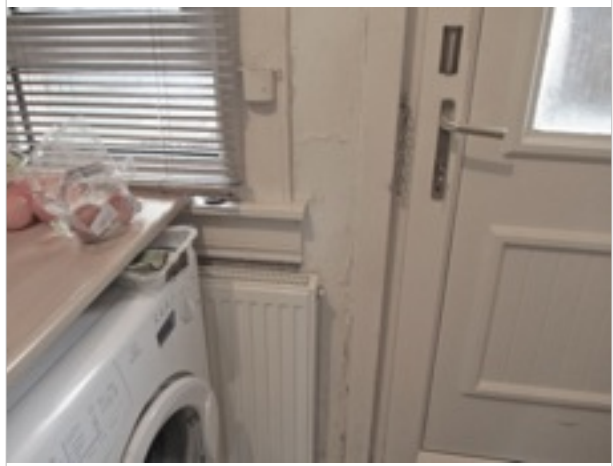
Damp Meter readings were taken on the rear external wall to the left side of the back door. The readings at the lower part of the external wall (up to approximately one metre) were red, which was indicative of high moisture levels on the surface and within the wall. There is a wall mounted extractor fan above the back door.

Kitchen - rear external wall

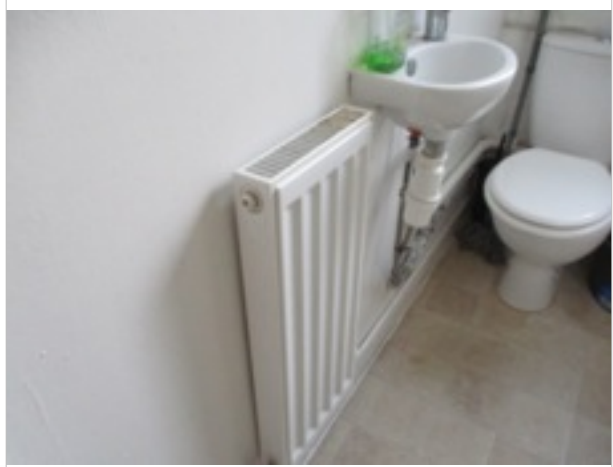
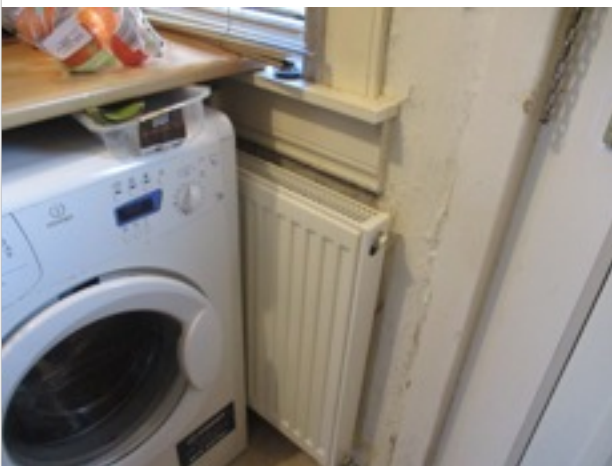
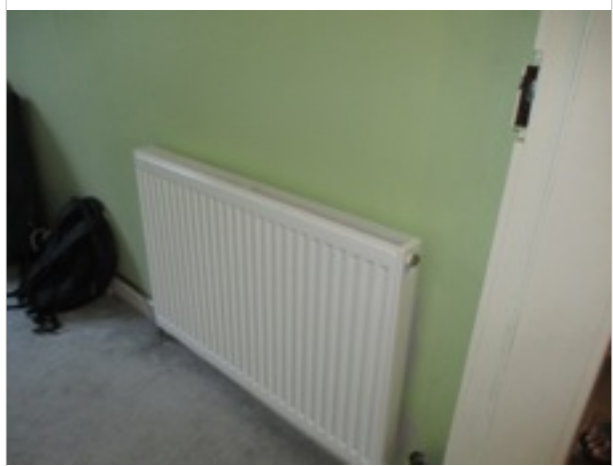
Bathroom - new radiator

Kitchen - new radiator

Rear Bedroom - new radiator

The heating system had been serviced and repaired in February 2024. The Landlord had replaced two defective radiators in the kitchen and rear bedroom of the Property and fitted a new radiator in bathroom where there had previously been none.

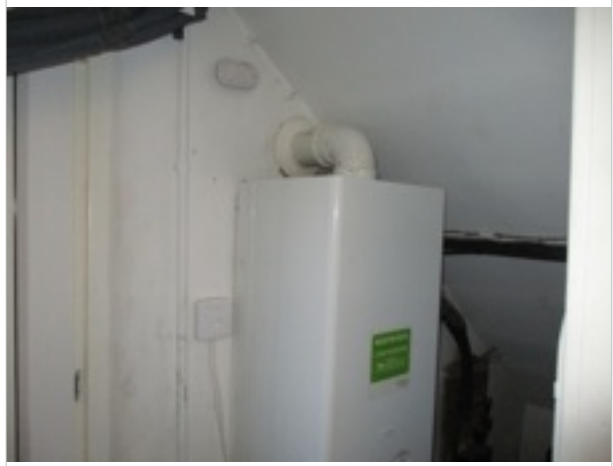
While not forming part of the application the Tribunal observed that that carbon monoxide alarm is not located in accordance with the Scottish Government Guidance for the Provision of Carbon Monoxide Alarms in Private Rented Housing as it is not sited between 1 and 3 metres from the boiler.

Hall - boiler and carbon monoxide detector

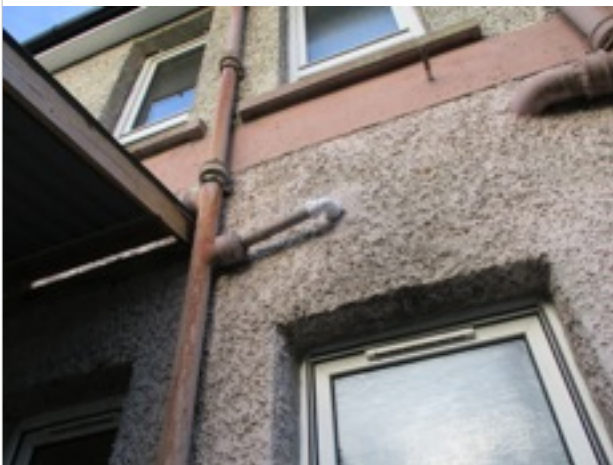
The roof had been relatively recently retiled and new pvc gutters fitted. The downpipes, soil pipes and water pipes were mostly original cast iron pipes. There were signs of corrosion but not obvious signs of water leaks. A section of waste pipe from the upper flat had been repaired/replaced to the rear elevation. The bossed and cracked sections of the external roughcasting had recently been repaired. The cover to one of the rear sub floor vents that had been missing at the inspection on 10th June 2024 had been replaced. The other two sub floor vents to rear are still part blocked by the ground level. The blocked sub floor vents to the front elevation had been cleared.

Rear Elevation - cast iron downpipe and repaired waste pipe from UF flat

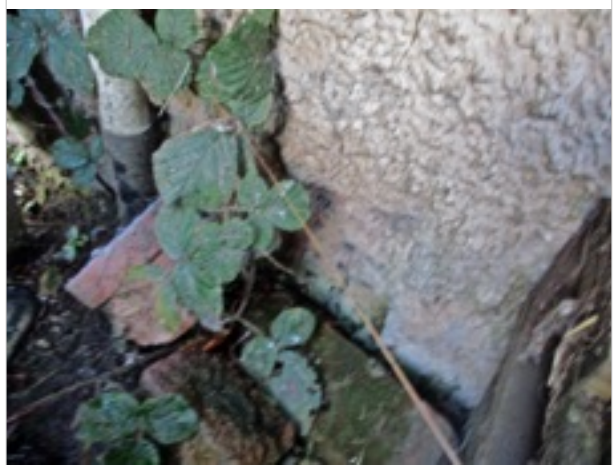
Rear Elevation - underfloor vent to left of back door - part obscured by ground level

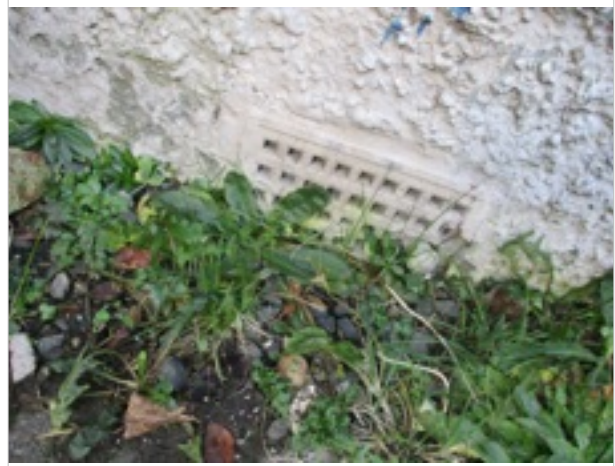
Rear Elevation - underfloor vent part obscured by path/flower bed

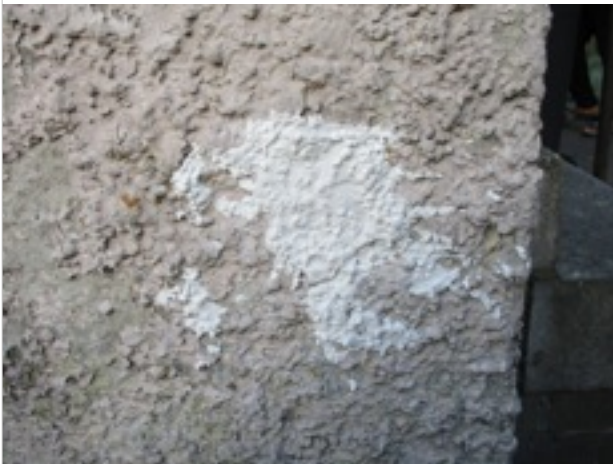
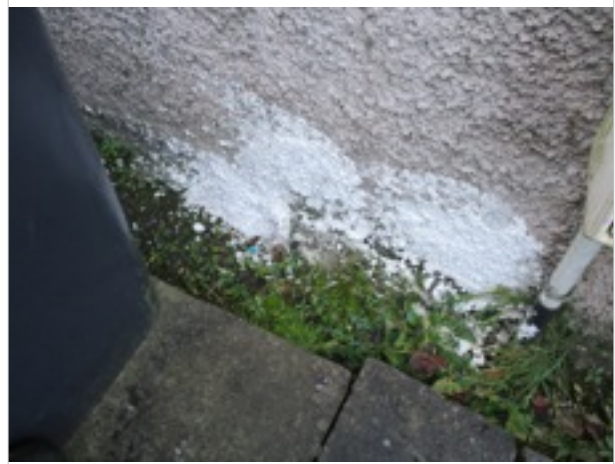
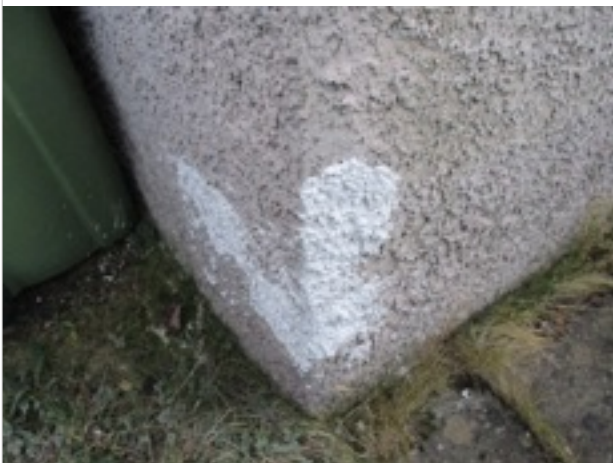
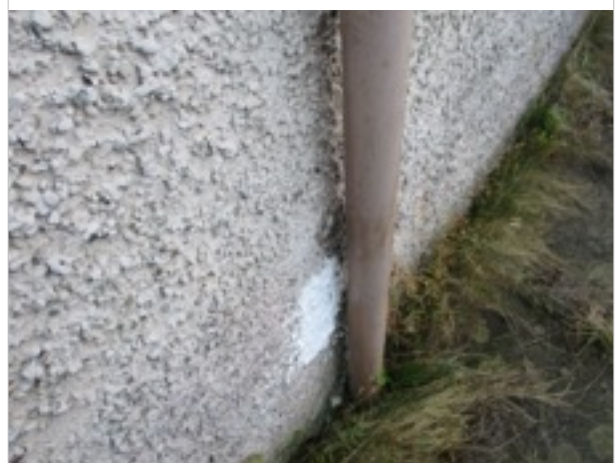
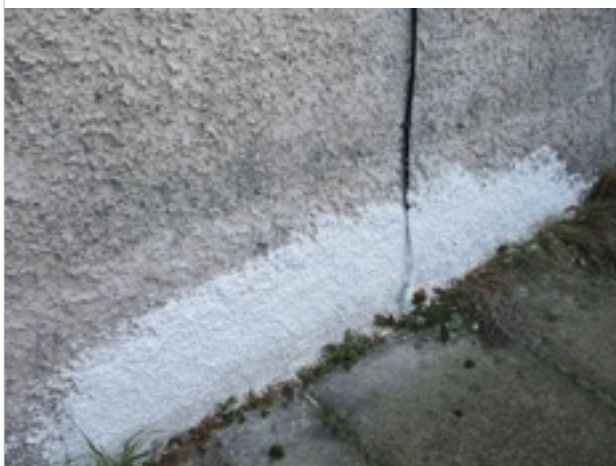
Rear Elevation - roughcast patched

Hip End - roughcast patched

Corner of Hip End and Front Elevation - roughcast patched

Front Elevation - roughcast patched

Visible mould was treated with a topical solution, air vents were unblocked, defective rendering was repaired.

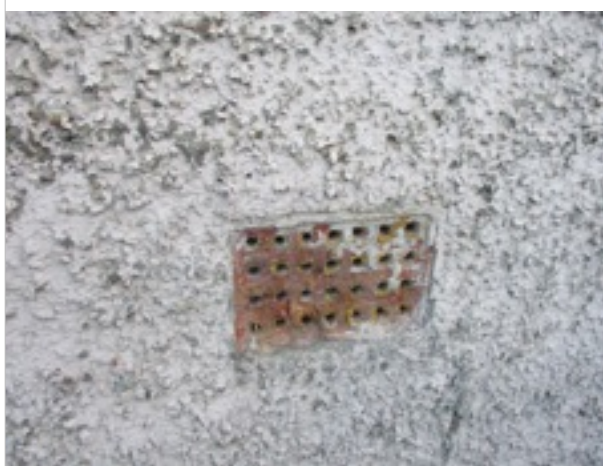
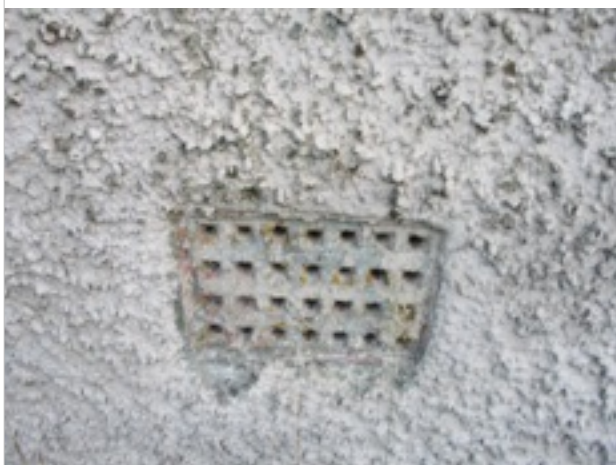
Front Elevation - underfloor vent - cleared and situated well above ground level

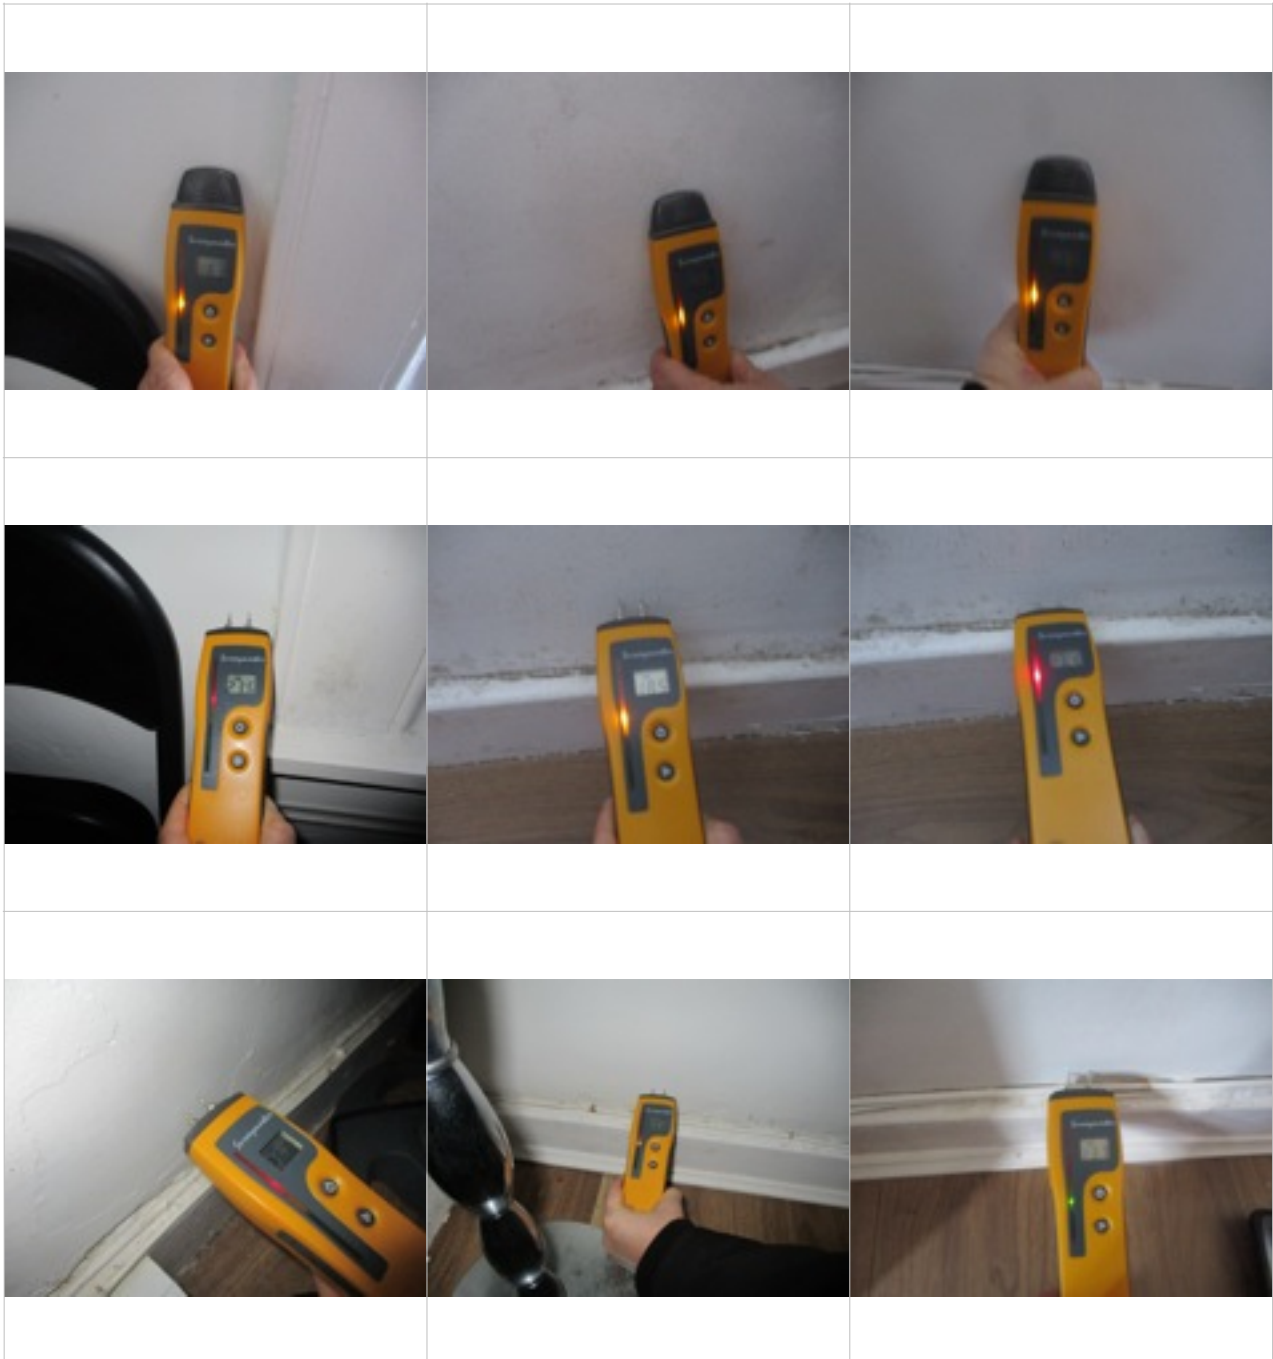
Living Room

Damp Meter Readings in search mode and using probes along the base and up to 1 metre above floor level of the front external wall and internal wall adjoining front bedroom. Showing moderate and high moisture levels, reducing to low moisture levels towards entrance door on internal wall.

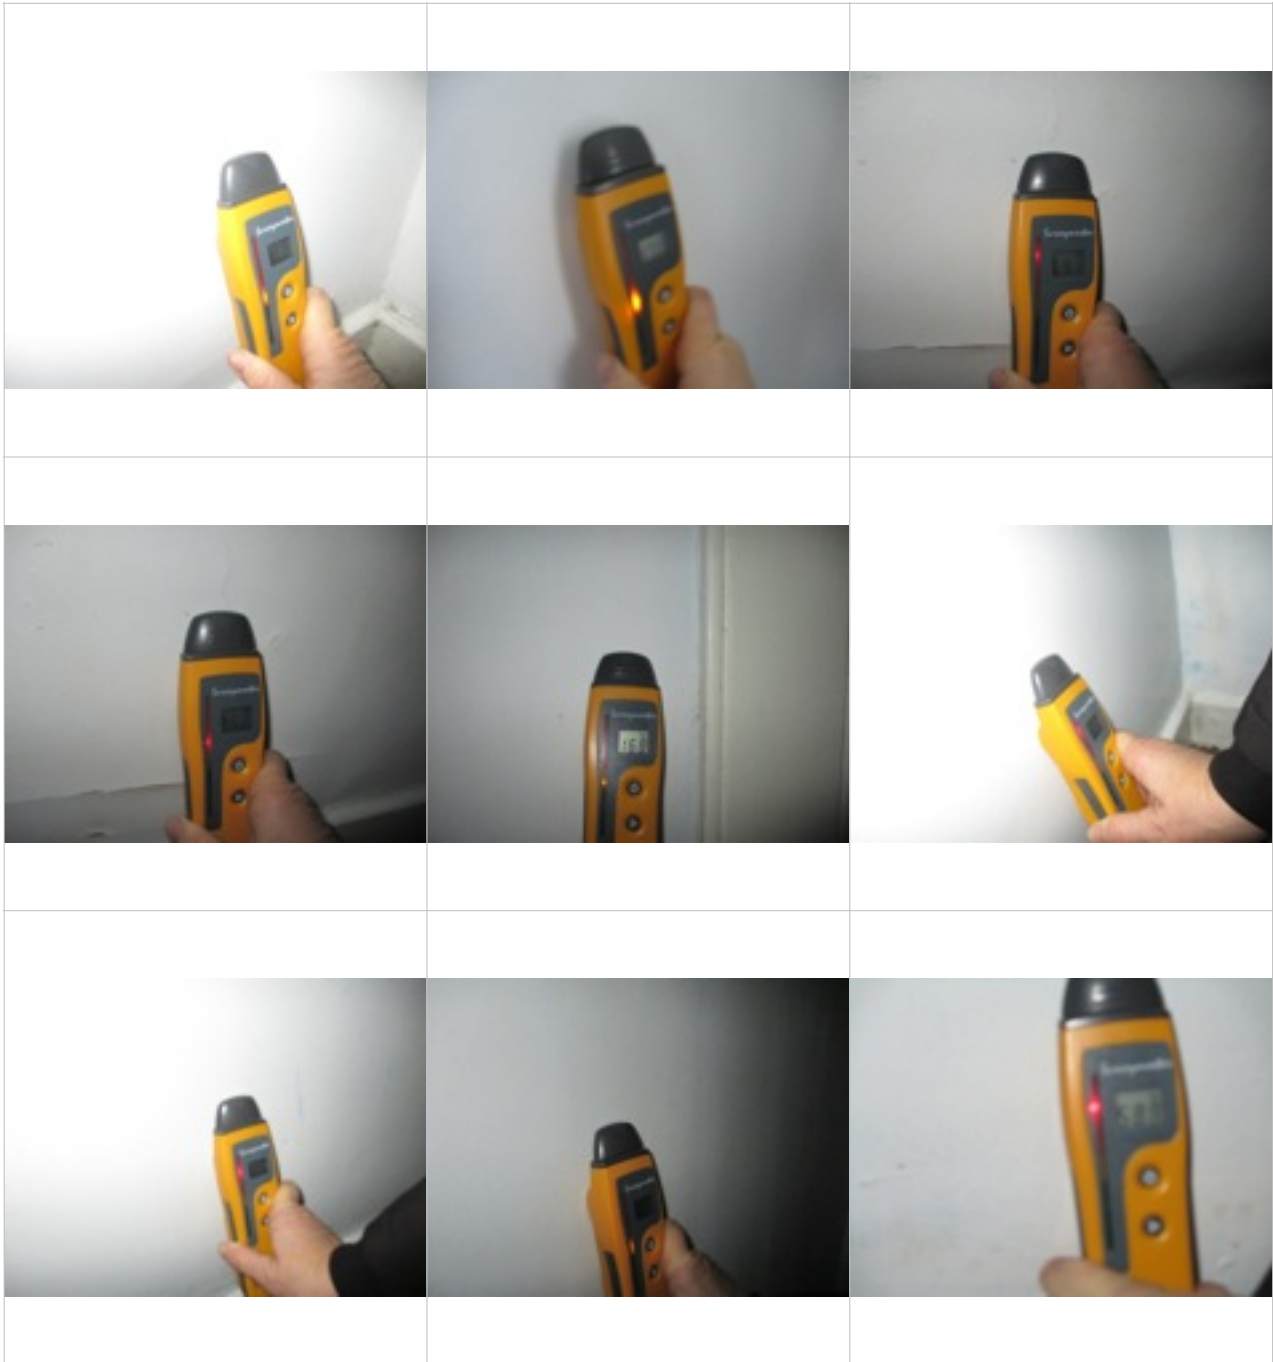
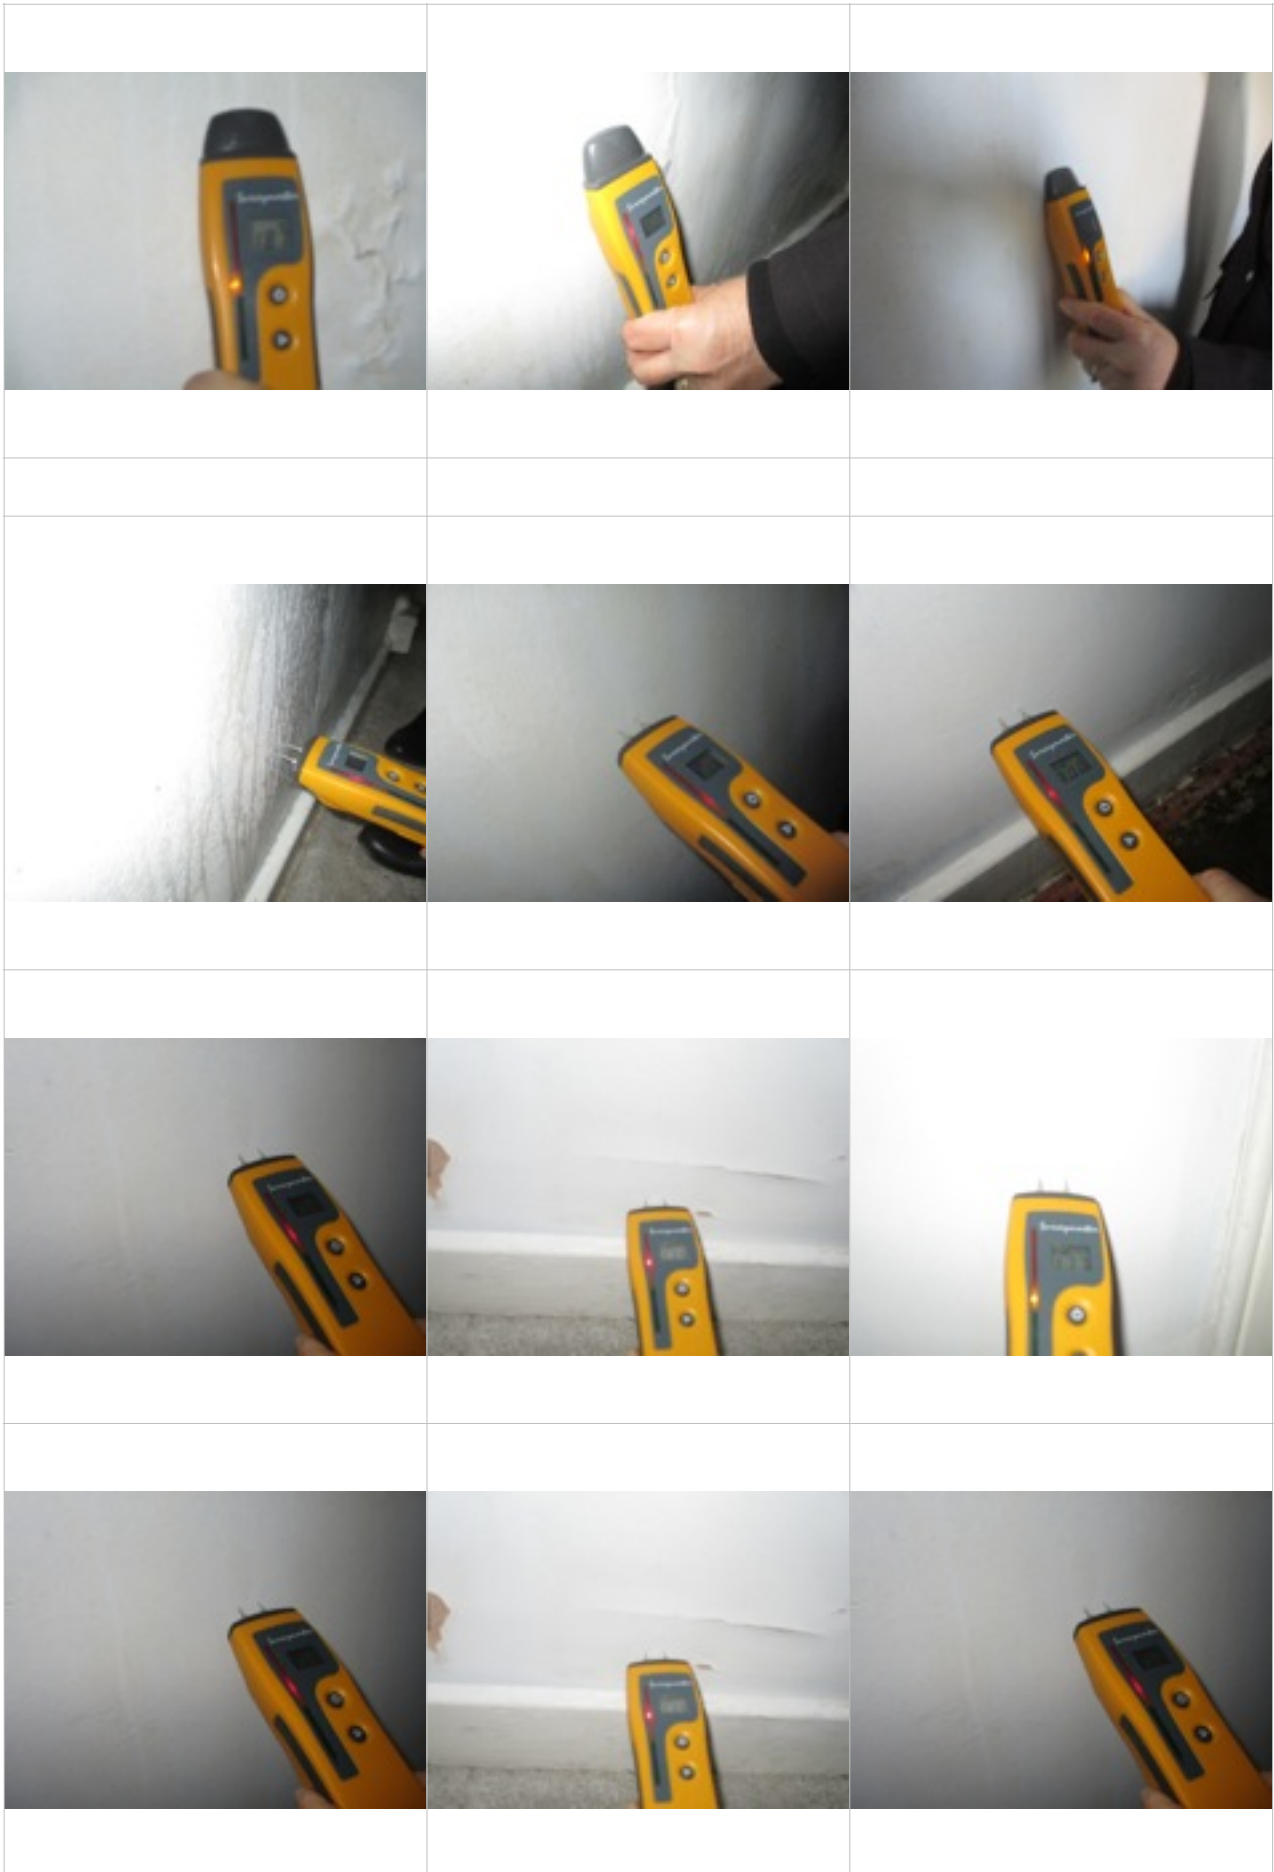
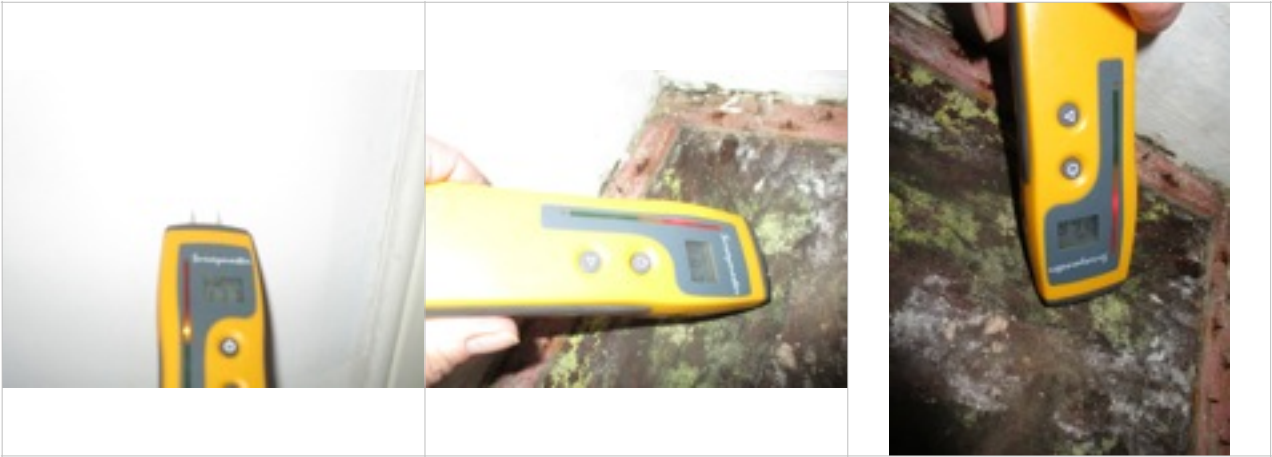
Main Front Bedroom

Damp meter readings in search mode and using probes along base and up to 1 metre above floor level of front and hip end external walls showing moderate and high moisture levels. Damp meter readings also taken to area of exposed floorboards in corner showing high readings and excessive moisture observed on surface of both walls. Moisture running down the hip end wall.

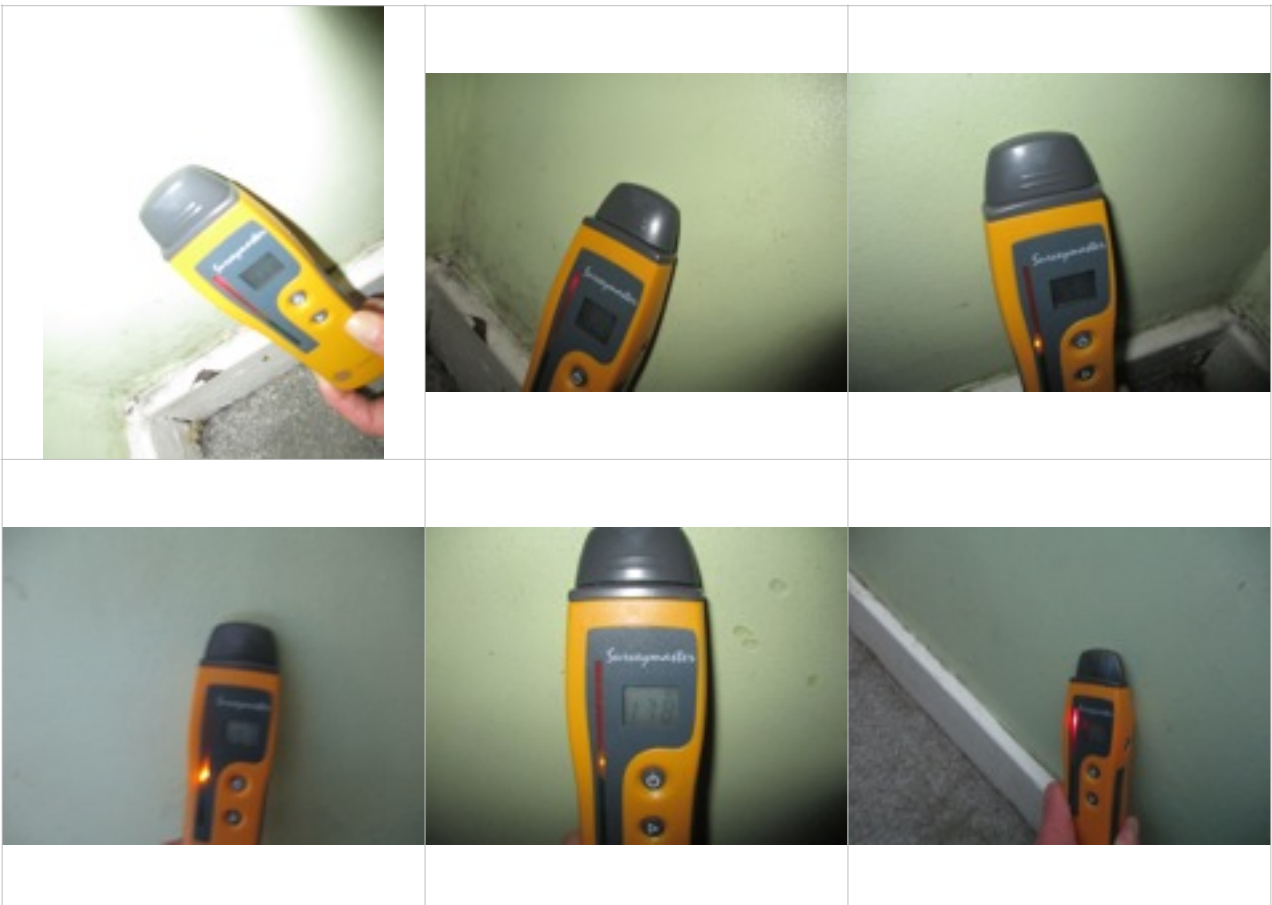
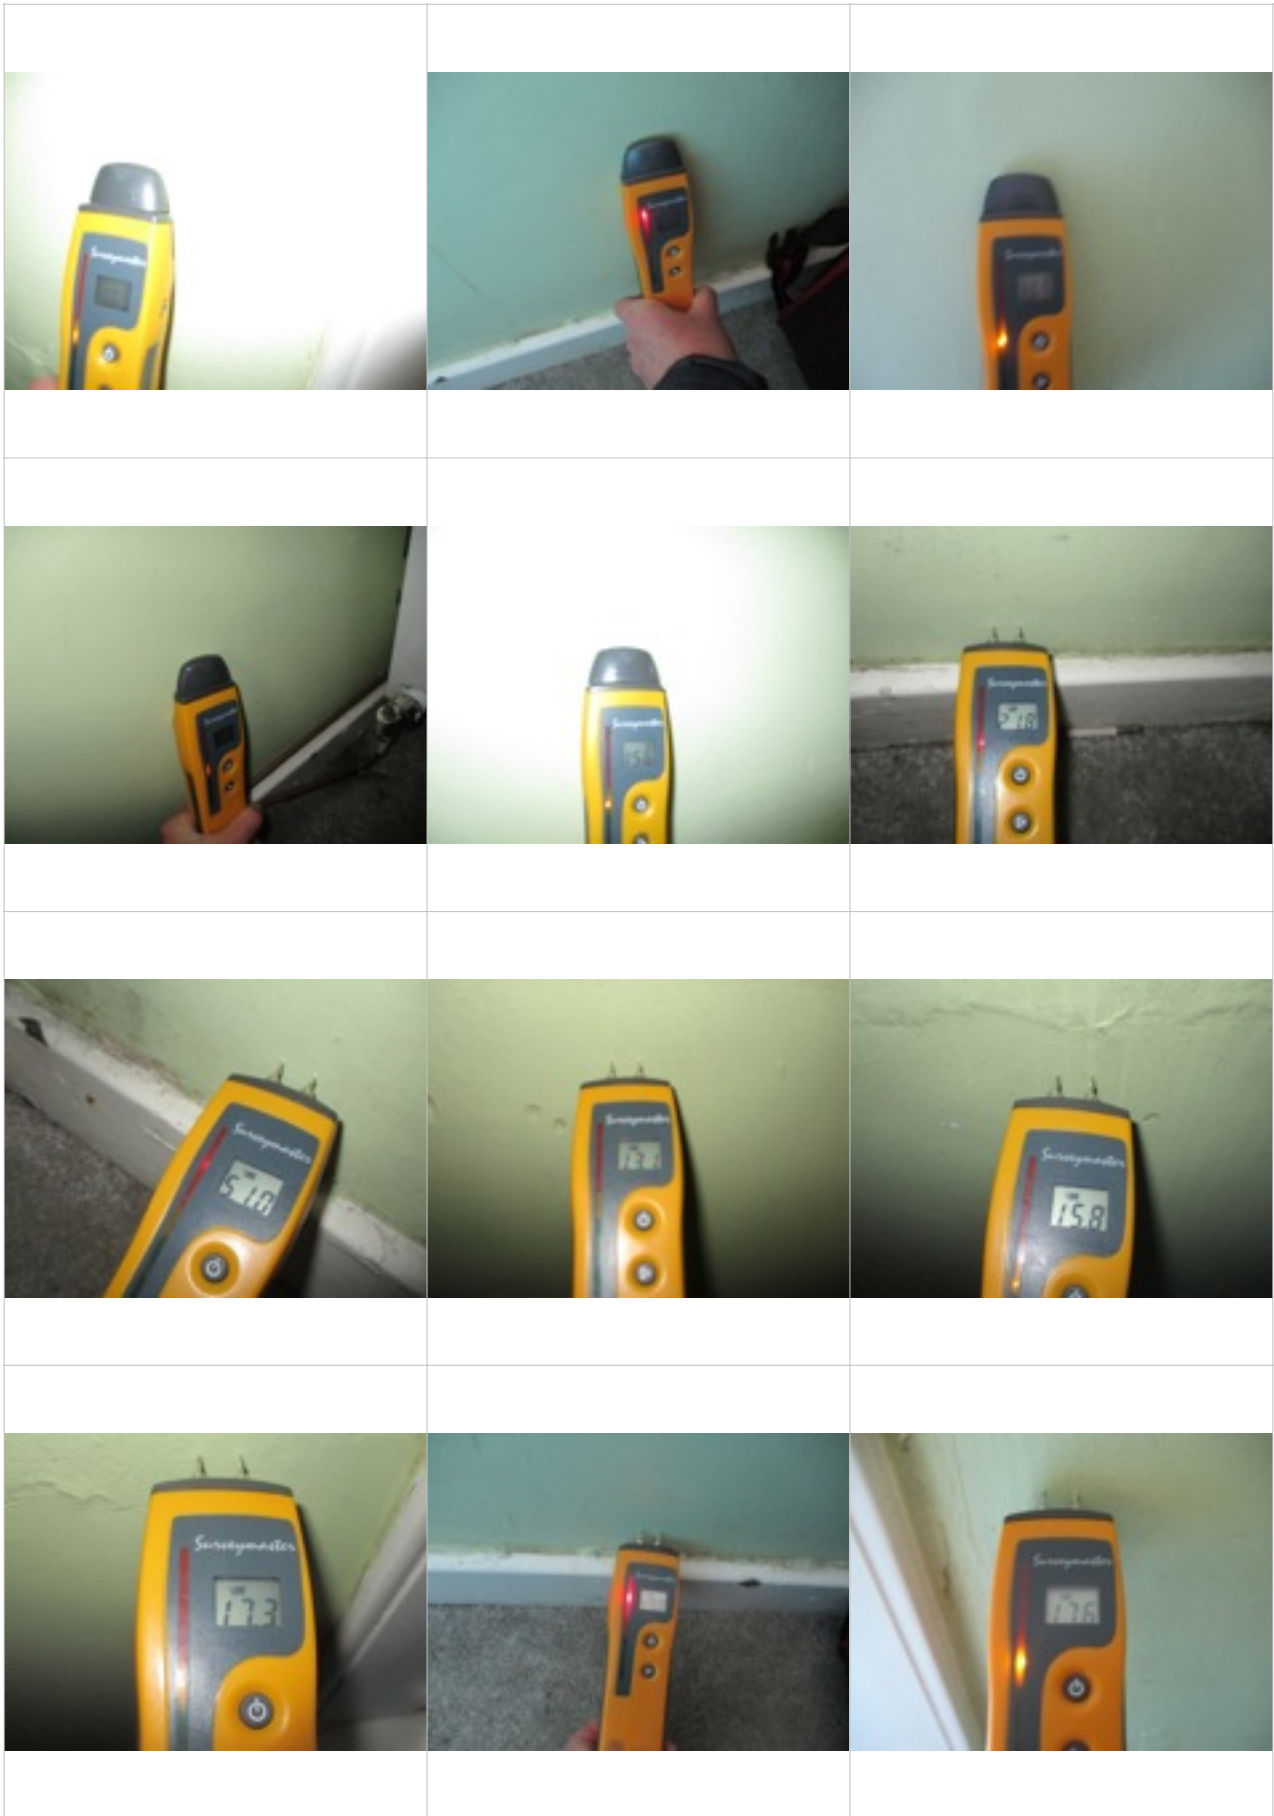
Rear Bedroom

Damp meter readings in search mode and using probes along the base and up to 1 metre above floor level on hip end and rear external walls showing moderate to high moisture levels

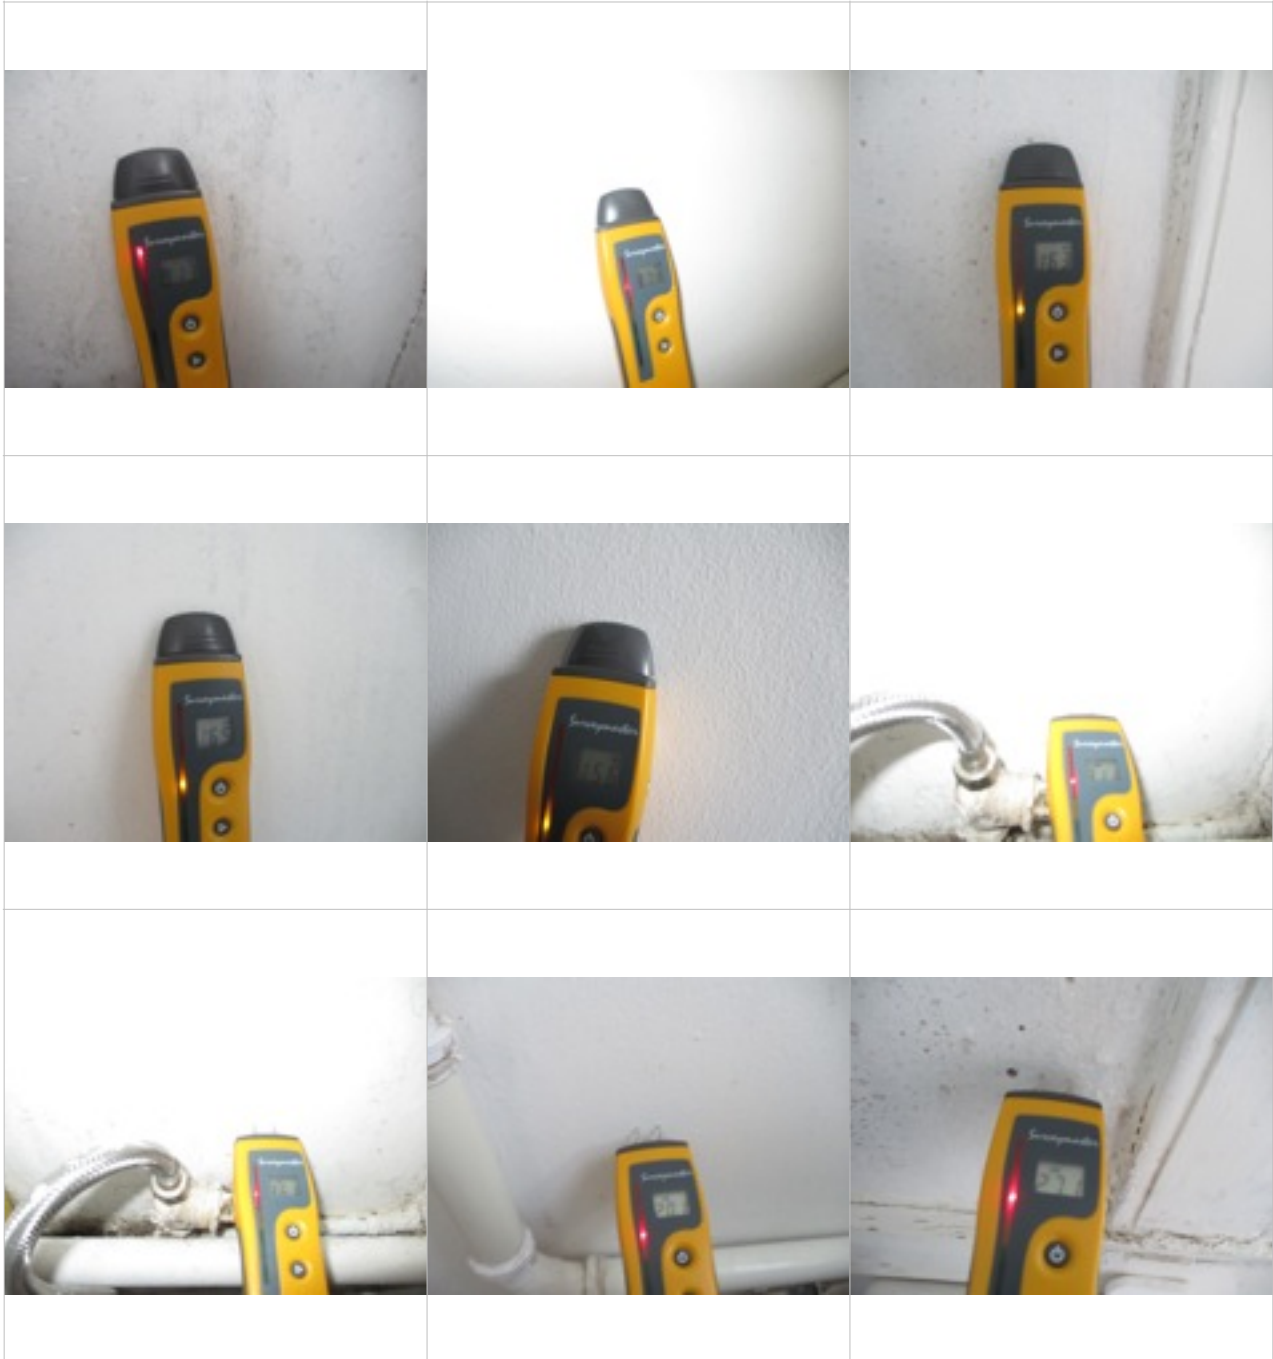
Bathroom

Damp meter readings in search mode and using probes to internal wall adjoining rear bedroom and external rear wall showing moderate to high moisture levels.

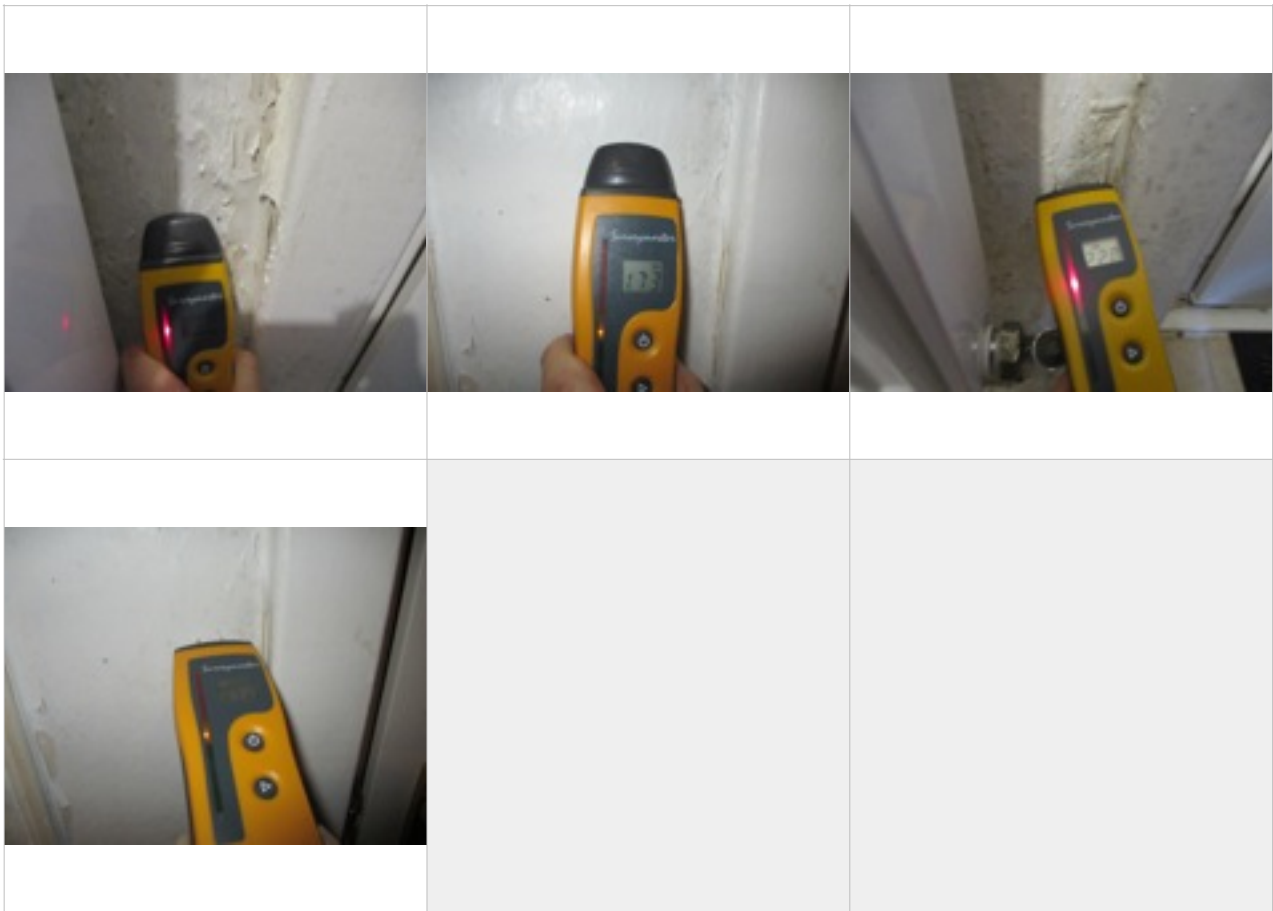
Kitchen

Damp meter readings in search mode and using probes to base and up to 1 metre above floor level on external rear wall to left of back door showing moderate to high moisture levels
