Statement of Decision of the Housing and Property Chamber of the First-tier Tribunal for Scotland under Section 26 (1) of the Housing (Scotland) Act 2006

Chamber Reference number: FTS/HPC/RT/24/4125

Re: Property at 11 Manse Place, Falkirk FK1 1JN (“the Property”)

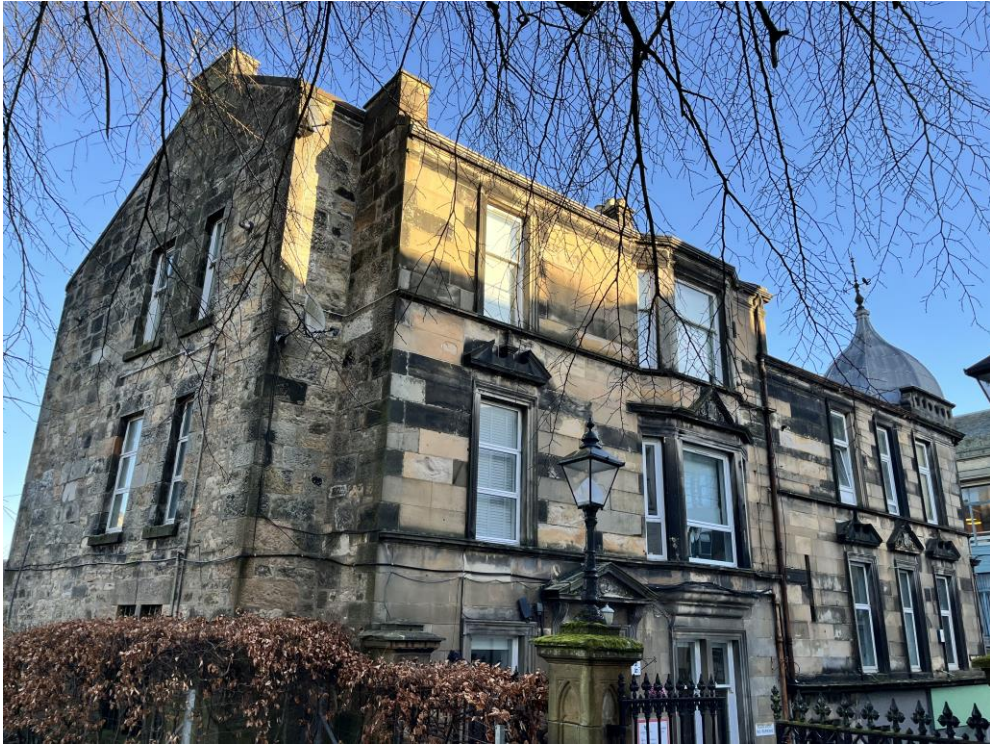
Front – top floor

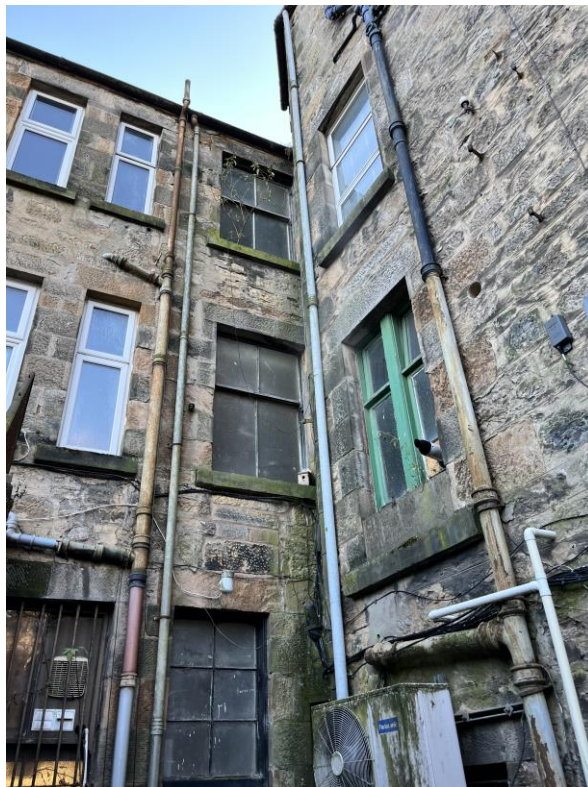
Rear of the building

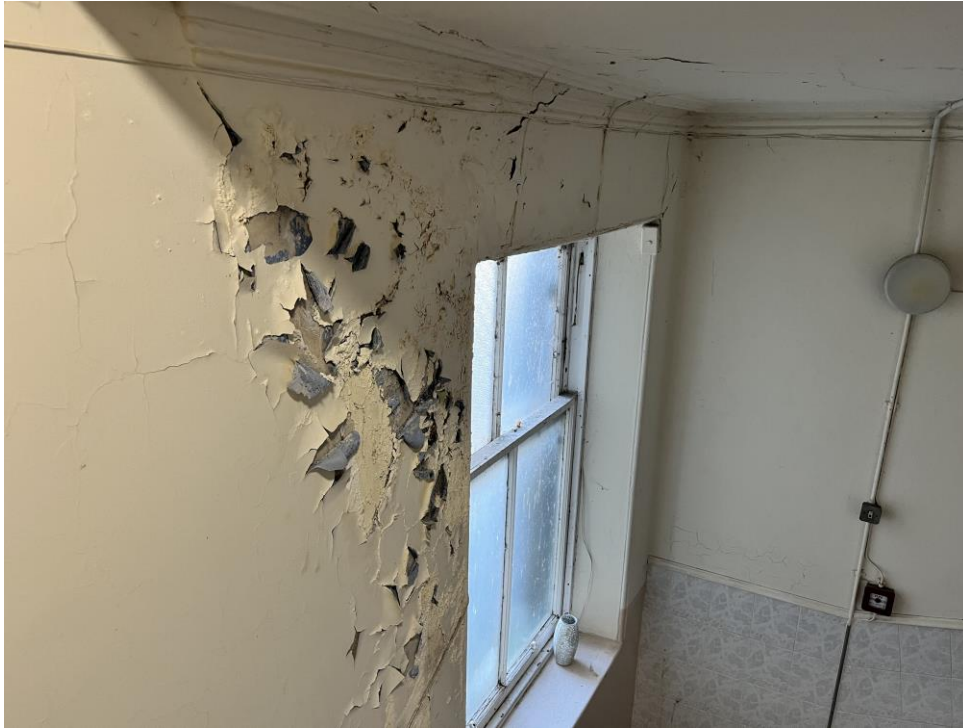
4. Following the Inspection, a Hearing was held by way of a telephone conference call on the afternoon of 8 January 2025. The Third-Party Applicants were again represented by Mr Craig Beatt and the Tenant was present. The Landlord was not present or represented. The Tribunal Members advised the Parties of the findings of their Inspection. The Tenant advised that he had removed the batteries from a carbon monoxide monitor adjacent to the hob, as it started beeping when the batteries ran down. He had reported this to the Landlord, but the Landlord had not replaced the batteries. The evidence of water penetration to the common stair had been there when he moved in, in January 2019, but had worsened over time.

Historic damp penetration on the common stair

10. The Property fails to meet the repairing standard in relation to the matters described in the five preceding paragraphs.
11. The Tribunal's view is that repairs are required to the ceiling and walls of the common stair, but this does not impact on the Tenant's use of the Property, so does not require to be included in a RSEO. They are common repairs and the Tribunal understands that there is a factor for the tenement of which the Property forms part and that repairs cannot be instructed by them until they are put in funds by the owners of the various flats in the tenement.

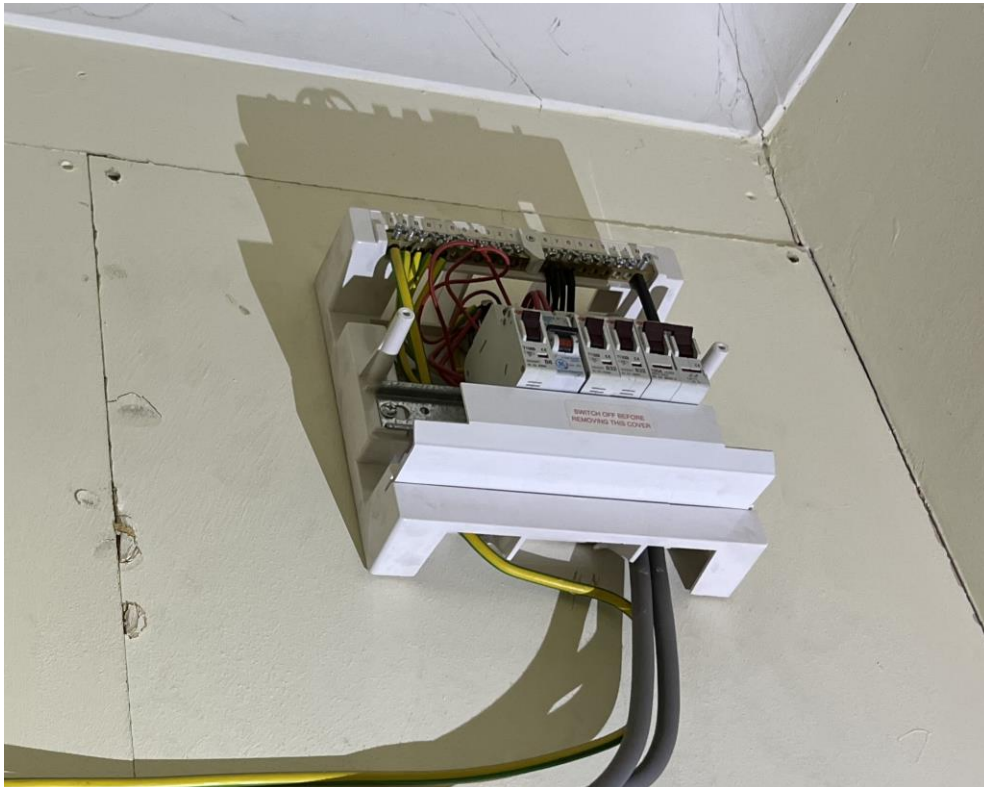
Missing cover on the electricity consumer unit

5. The Tribunal was of the view that the window in the sleeping area is not in a reasonable state of repair.
6. The Tribunal requires to see a satisfactory up to date EICR. This will cover the safety of the consumer unit.

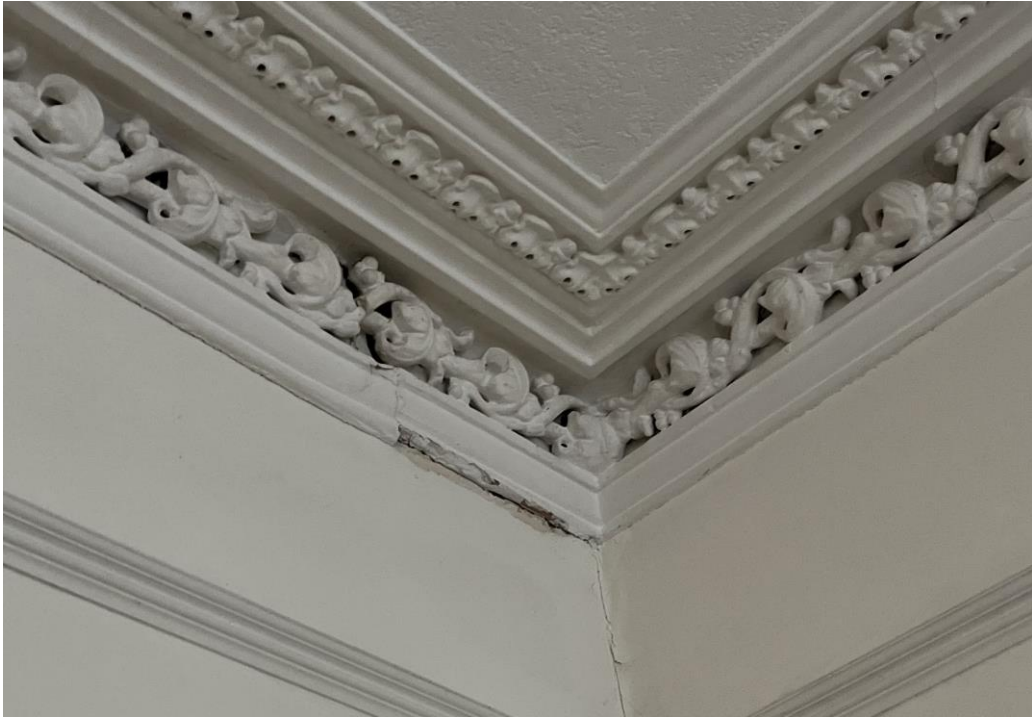
- There is a damp stain on the ceiling of the sleeping area, adjacent to the battery-operated smoke alarm.
- The coving/cornicing on the ceiling of the living area is in typical condition for a property of this age and character and appears to be secure.

Cracked cornice

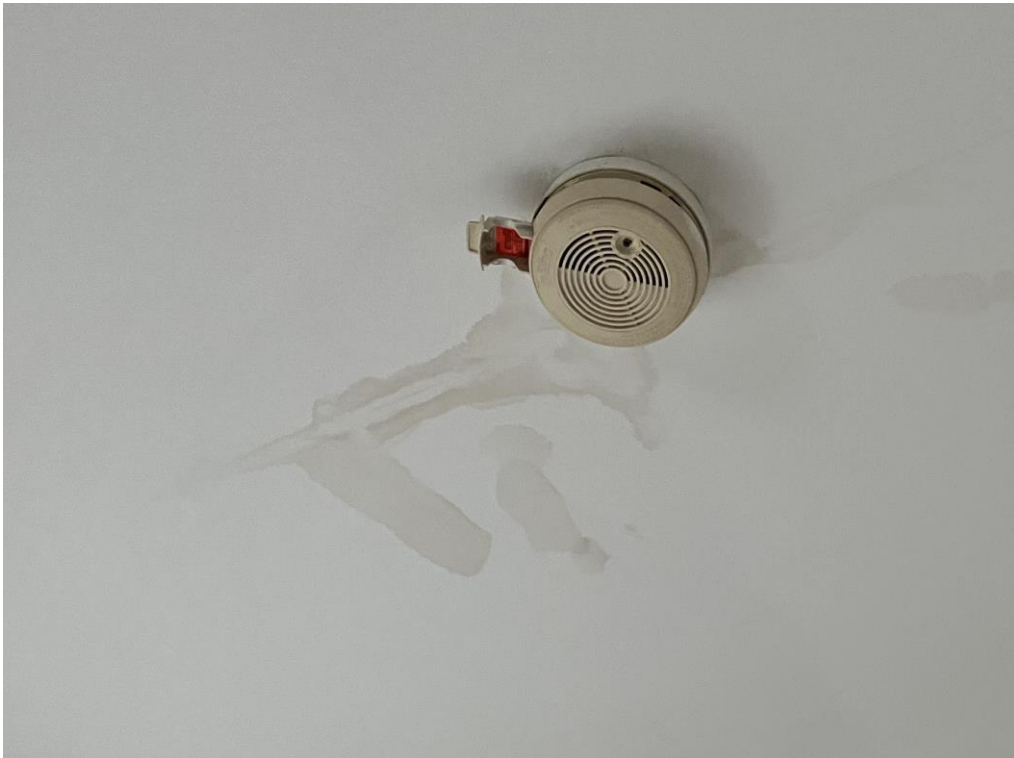
Stain marks on the ceiling and battery powered smoke detector

8. The Property does not have interlinked smoke and heat detectors, or a carbon monoxide monitor adjacent to the central heating boiler.
9. The Tribunal considers that an inspection by a roofing contractor is necessary, to determine the cause of the water ingress which has resulted in the staining on the ceiling of the living area.

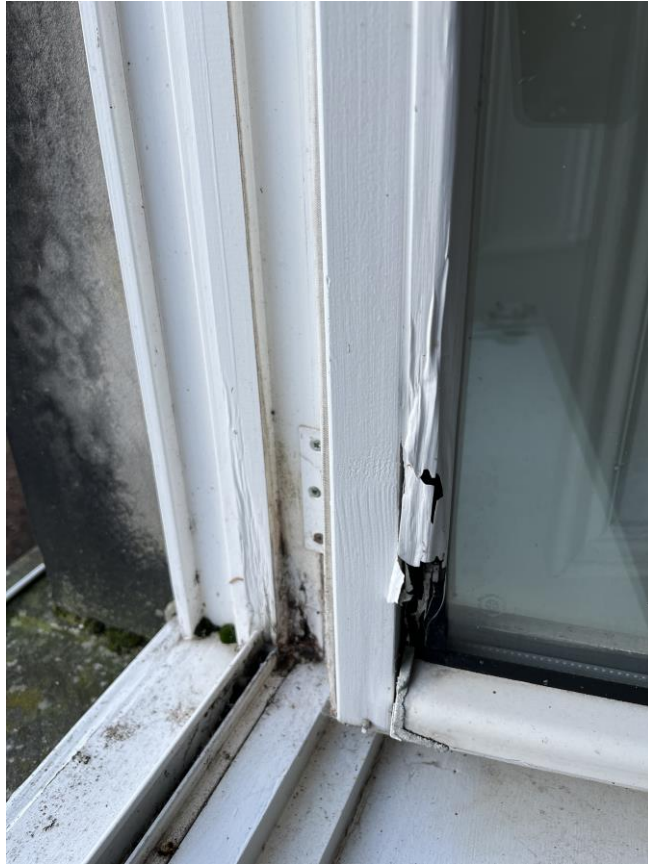
- The frame and windowsill of the window in the sleeping area are rotten. There is evidence of minor rot in some of the other windows, but they appear to be wind and watertight and open and close properly.

Rotten window frame

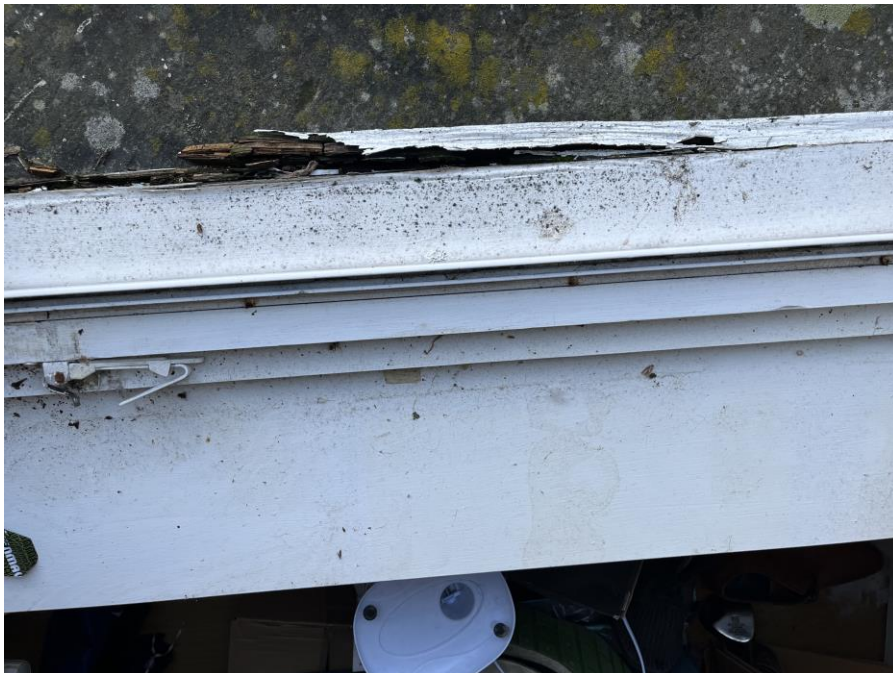
Rotten window sill

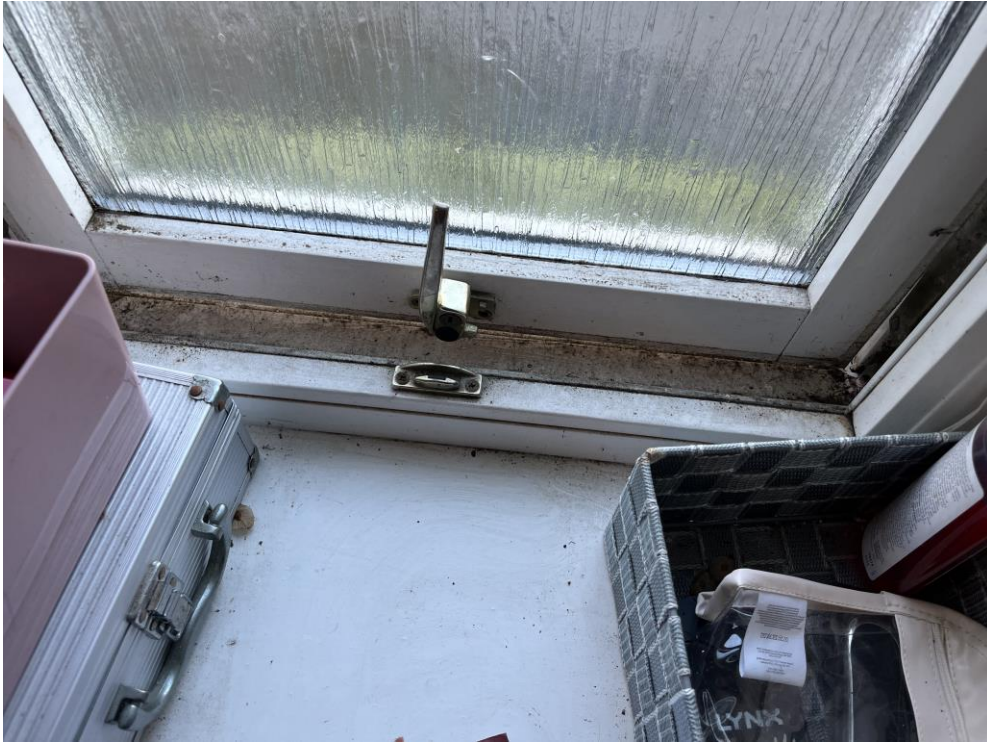
Draughtproofing strip evident

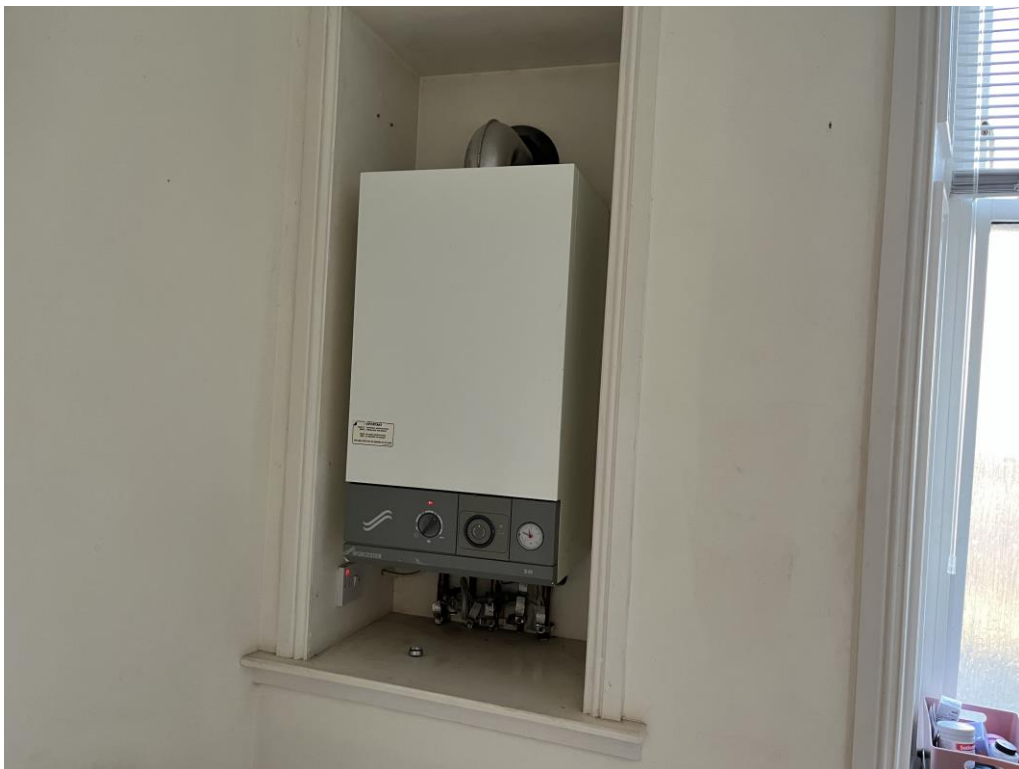
- The Landlord provided the Tribunal with a Gas Safety Record dated 13 August 2024 in relation to the gas hob. It does not cover the gas central heating boiler.
- There are two battery-operated smoke detectors, one in the living area and the other in the sleeping area. The batteries have been removed, but they are not in any event interlinked and there is no carbon monoxide monitor in the shower room.
- There is no cover on the electricity consumer unit and exposed wires are visible in and adjacent to the unit, which is located high up on the wall of the entrance vestibule.
- There is evidence of previous water ingress to the ceiling and wall of the common stair. Where testing with a moisture meter could be carried out, the moisture on the surface of the wall was found to be within acceptable limits, although the plaster is badly flaked and in need of repair.

Gas fired boiler in the bathroom

7. The Tribunal requires to see an up-to-date Gas Safety Certificate, covering the hob, gas central heating boiler and the gas installation addressing the working order of the gas installation.
