STATEMENT OF DECISION of the First-tier Tribunal for Scotland (Housing and Property Chamber) under section 24 (1) of the Housing (Scotland) Act 2006

Reference number: FTS/HPC/RP/24/4076

Re: Property at Flat 0/2, 10 Netherhill Crescent, Paisley PA3 4RU (“the Property”)

Schedule of photographs

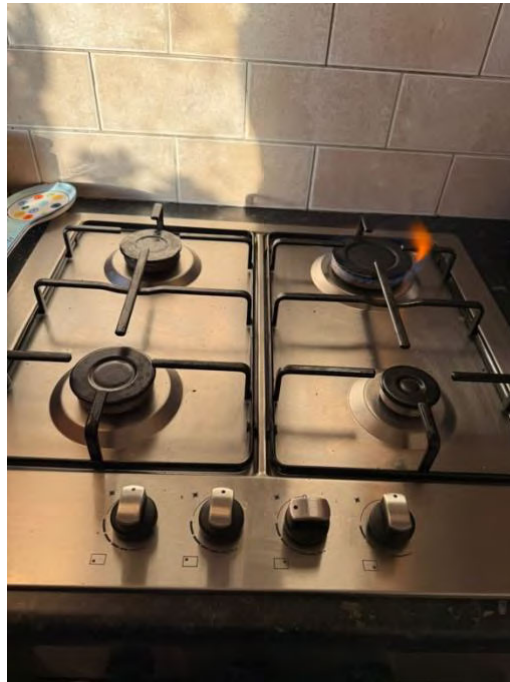
Photograph 2: Kitchen: Gas hob (working)

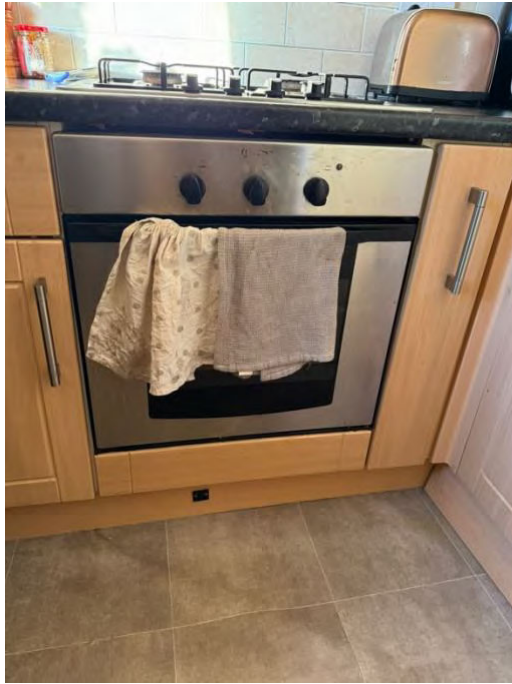
24. The property requires to comply with the repairing standard as set out in the Housing (Scotland) Act 2006 as amended
25. The oven within the kitchen is not in a reasonable state of repair and is not in proper working order.

Photograph 4: Kitchen: Oven

- Repair (or replace) the oven within the kitchen to ensure that it is in a reasonable state of repair and in proper working order.
32. The appropriate repairing standard enforcement order is attached to this decision.

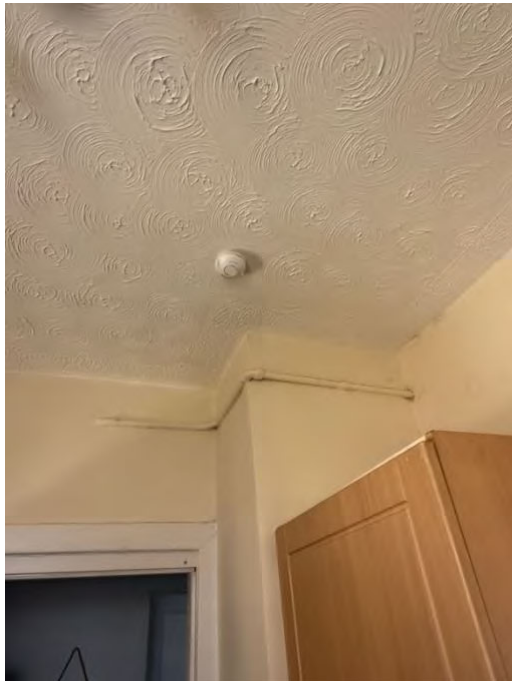
26. The heat detector/alarm in the kitchen is not working and is not interlinked to the existing smoke detectors within the property
27. The Electrical Installation Condition Report which has been produced does not appear to have been prepared by a contractor who is a SELECT, NICEIC or NAPIT registered electrician

Photograph 7: Kitchen: Heat detector (not working)

- Repair (or replace) the heat detector in the kitchen, ensuring that it meets the requirements contained in the with the Housing (Scotland) Acts 1987 and 2006 and in particular that it is interlinked to the existing smoke detectors within the property

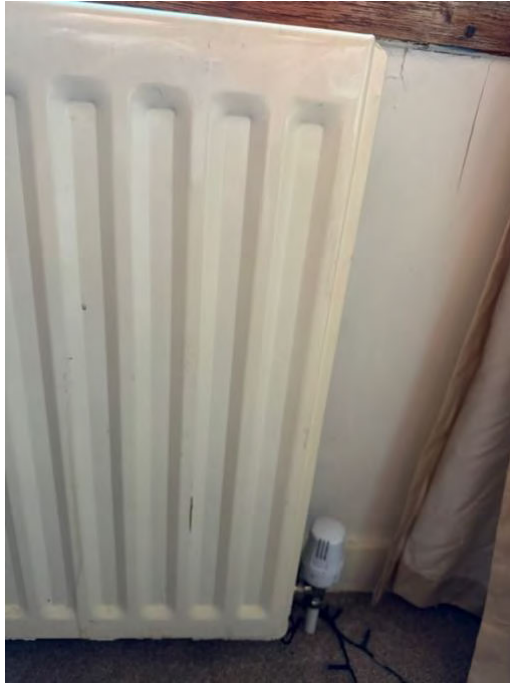
Photograph 10: Main bedroom 1: Radiator valve (replaced)
