Statement of Decision under Section 60 of the Housing (Scotland) Act 2006

Chamber Ref: FTS/HPC/RP/24/0919

4 Henderston Cottages, Newtyle, Angus PH12 8UT (“The Property”)

Reinspection report and schedule of photographs

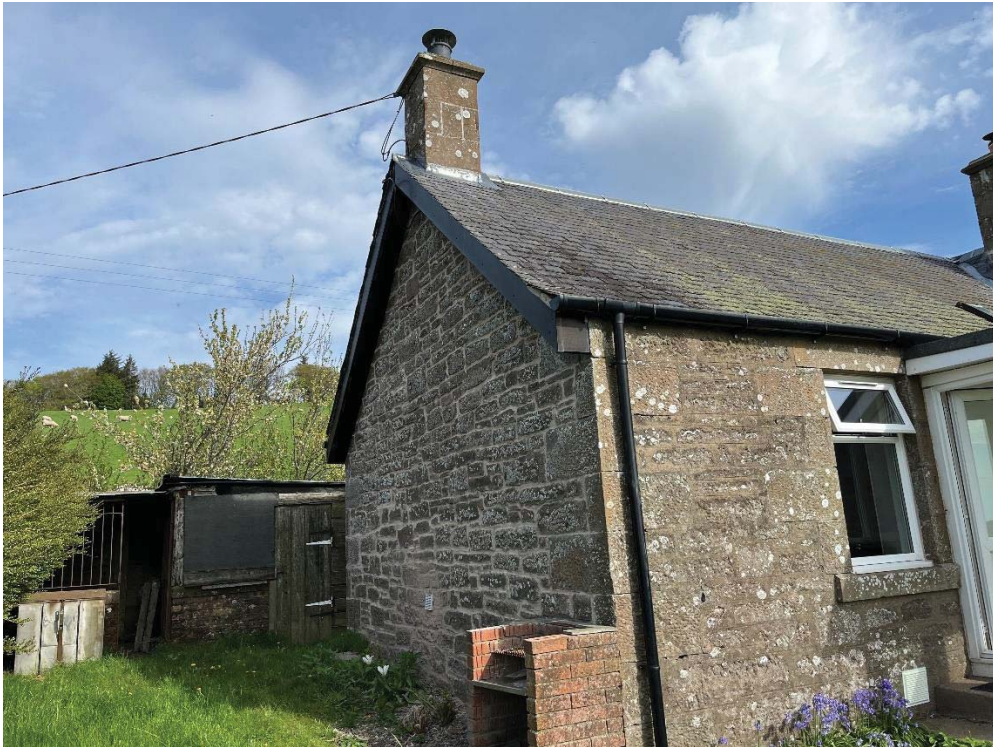
- d. The external wall finish to the west gable has been repointed and a vent installed to the chimney flue to provide ventilation.
 - e. The Living Room window has been replaced.

Repointed west gable wall. Vegetation removed.

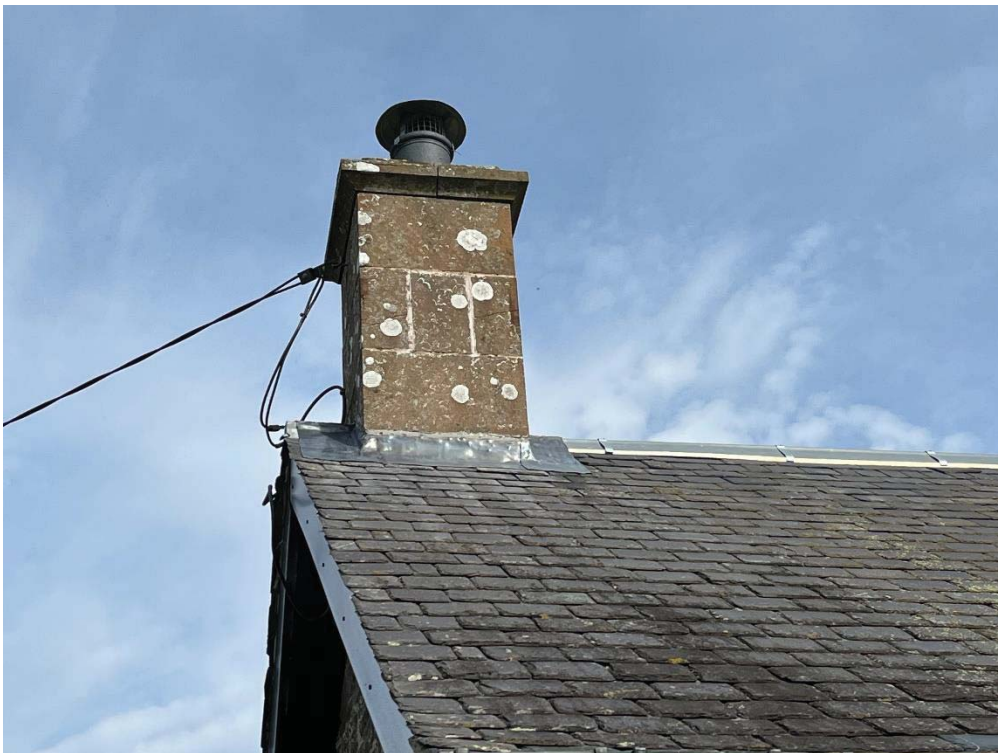
- b. Repairs have been carried out to the roof covering and from an external inspection from ground level it appears to be wind and watertight.
 - c. The chimney stacks have been repointed and the flashings repaired.

West elevation Chimney stack.

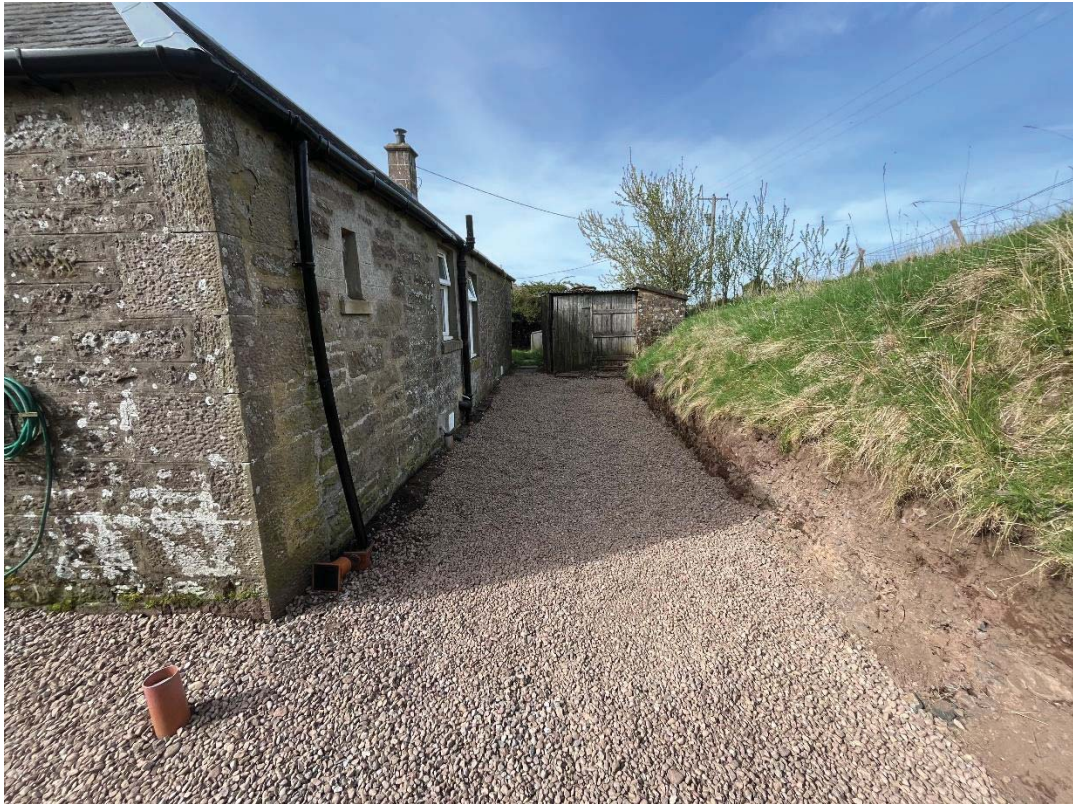
- f. A suitable surface water drainage system has been installed to the exterior of the property.
7. The Tribunal noted that there were works in the RSEO that were outstanding following the re-inspection. However, these works were either in progress and minor or needed much more time to be remedied. The Tribunal is satisfied that the Repairing Standard had been met even though these works had not been fully completed. These works were:

North elevation and garden excavated and reinstated where drainage installed.

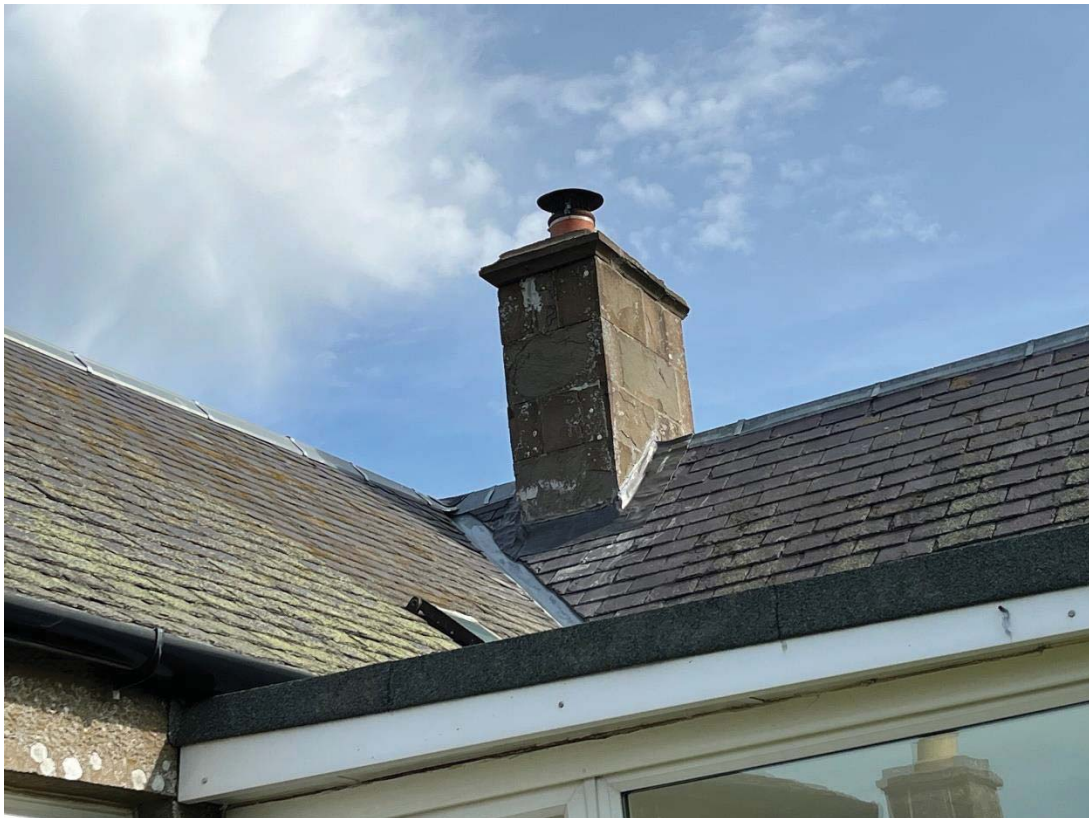
Main chimney stack.

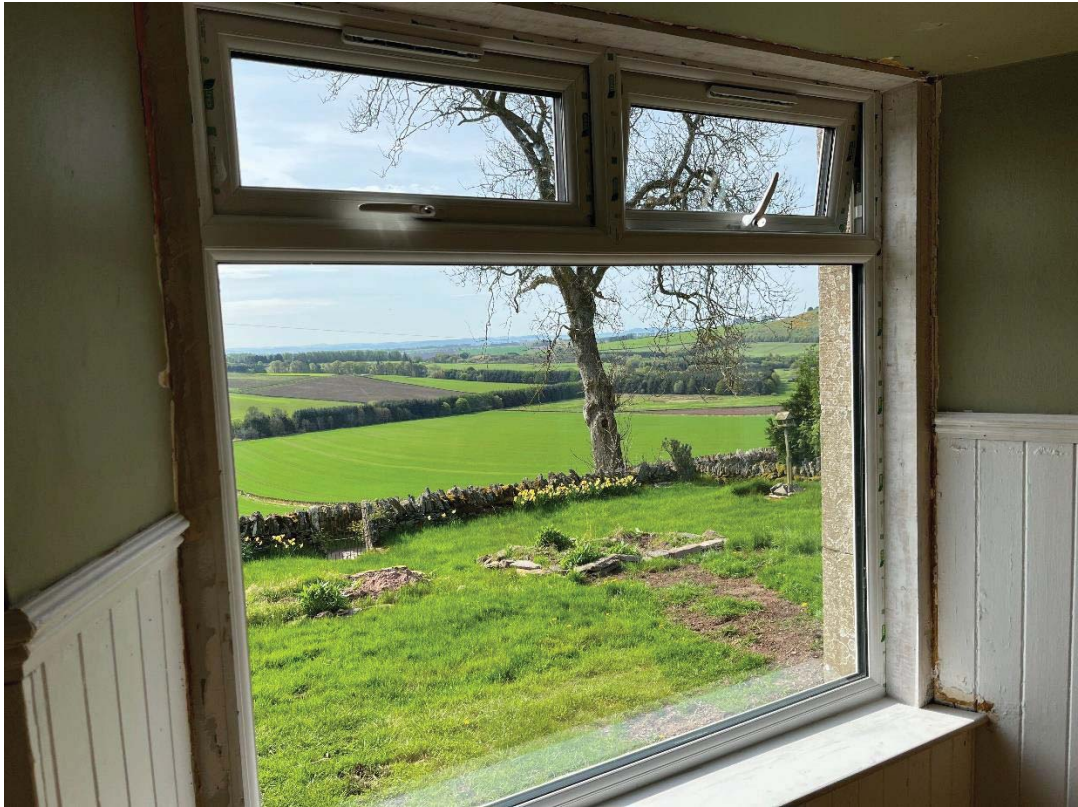
- a. Minor finishing works are outstanding adjacent to the newly installed window in the Living Room however these are cosmetic in nature.
 - b. High damp meter readings were recorded in the lower walls of the westmost Bedroom however this is not unexpected as the wall will take time to dry out following the recent repairs.

Replacement Double Glazed window in Living Room.
