**First-tier Tribunal for Scotland (Housing and Property Chamber)**

**Determination: Housing (Scotland) Act 2006: Sections 26 and 27**

**Chamber Ref: FTS/HPC/RP/25/0410**

### Inspection Photograph Schedule

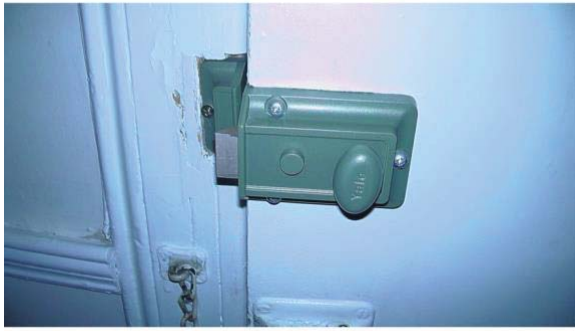
10. The front door is poorly secured and ill -fitting and has no functioning deadlock.
11. The doorbell does not work.
12. The carpets throughout are poorly fitted.

Photo 2 – Poorly secured and ill-fitting door

**61.2 Repair or replace the front door of the Property to ensure that it is secure and has a functioning deadlock.**

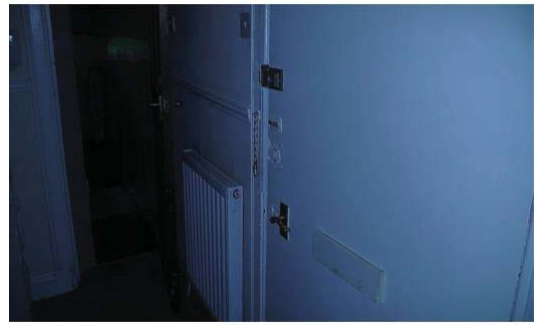
Photo 3 – No functioning deadlock

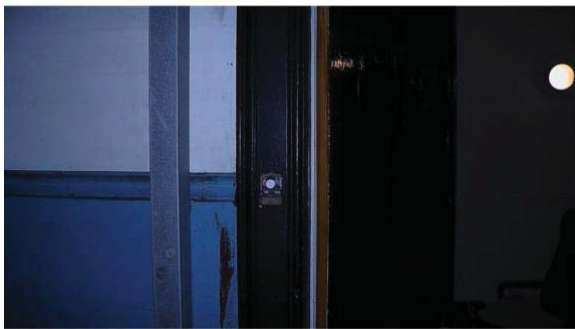
59. The tribunal determined that a functioning doorbell is not part of the repairing standard.

Photo 4 – Non-functioning doorbell

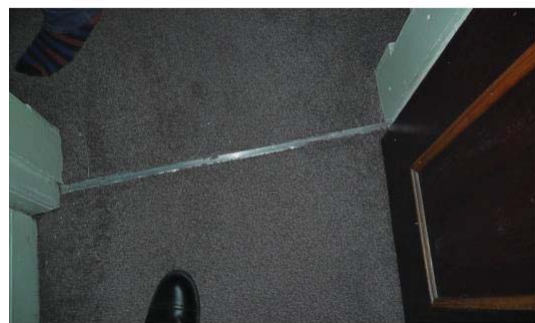
Photo 5 – Carpet not fixed under threshold plate

**61.4 Ensure that carpeting throughout the Property is properly fitted.**

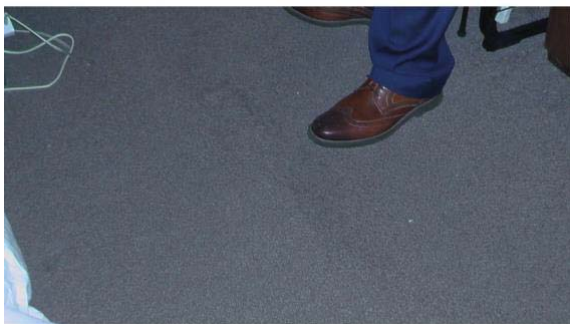
13. Flooring throughout the Property is uneven and there are poorly fitting floorboards.
14. The wall below the shower switch in the hall is rough.
15. Areas of plasterwork where electrical sockets have been replaced throughout the Property are in poor condition.

Photo 6 – Prominent flooring ridge in Bedroom

**61.3 Repair uneven flooring throughout the Property.**

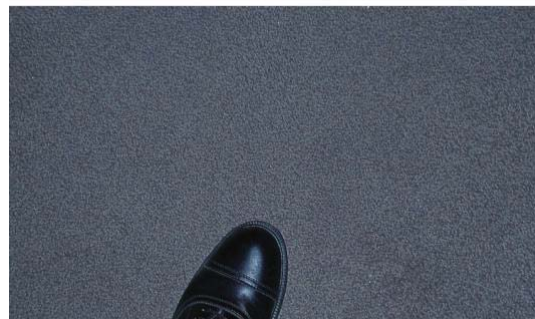
Photo 7 – Loose/damaged timber floor (Lounge)

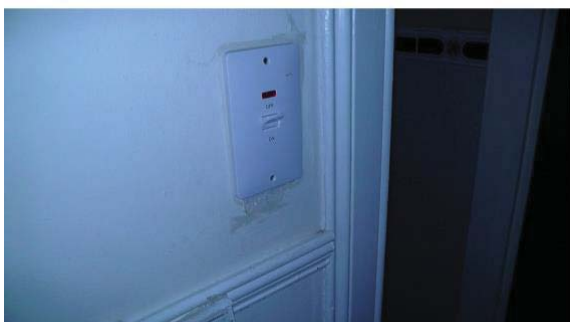
Photo 8 – Shower switch in Hallway

**61.5 Make good the décor around electrical sockets and the shower switch.**

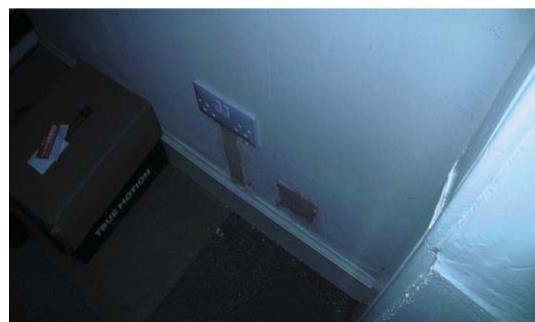
Photo 9 – Socket re-installation in Hallway

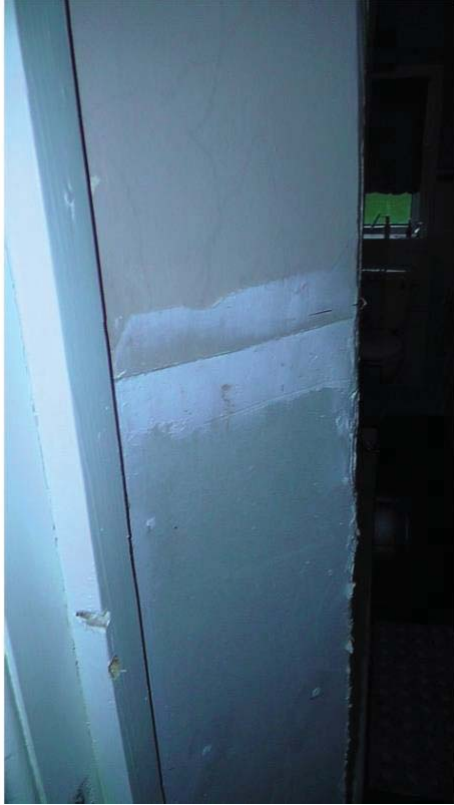
16. A section of tiling in the bathroom has been removed.
17. Sealant around the bath has been renewed.
18. Sealant at the kitchen sink has been renewed.

Photo 10 – Bathroom tile section removed

**61.6 Replace the detached section of tiling in the bathroom.**

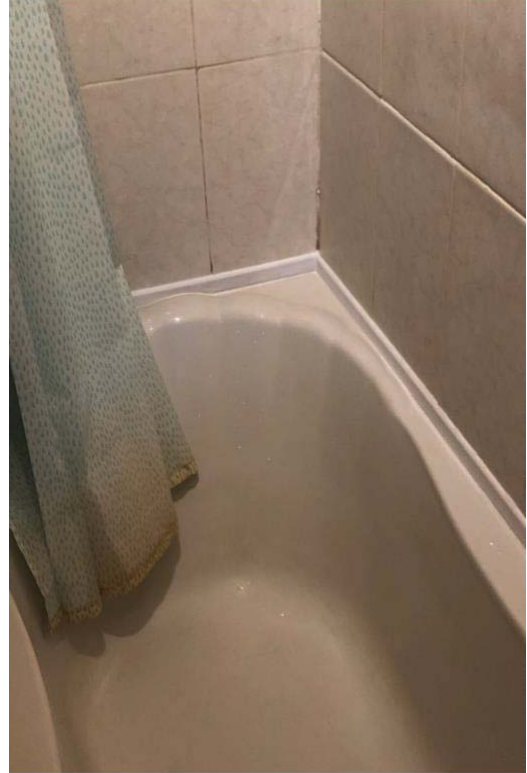
Photo 11 – Renewed Bathroom sealant

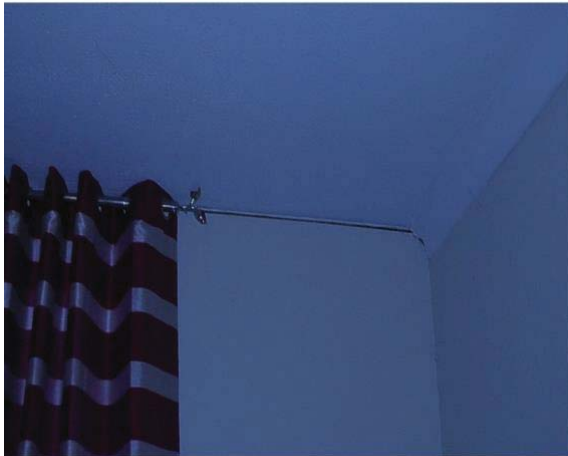
19. There is a small amount of mould on the bathroom walls.
20. There is a section of coving missing in the bedroom and there is a gap in the bedroom wall.

Photo 12 –Missing coving and gap in Bedroom wall

**61.7 Make good the missing coving and gap in the wall of the bedroom.**

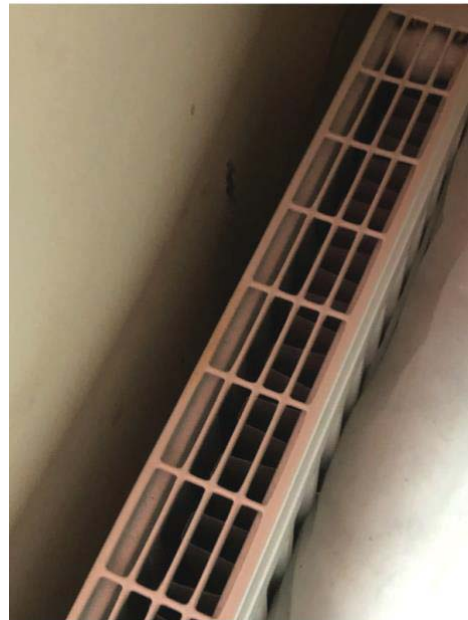
21. The radiator in the bedroom is not secured to the wall.

Photo 13 – Unsecured Bedroom radiator

**61.8 Make good the wall under the bedroom window and properly attach the radiator to the wall.**

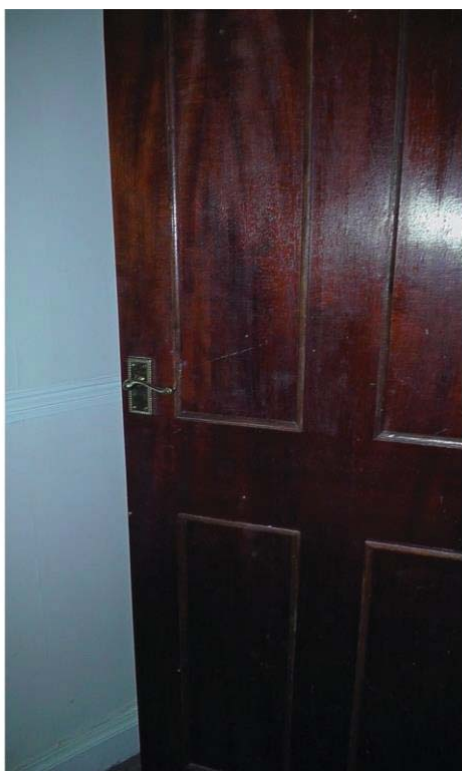
22. There is a gap in the wall beneath the bedroom window.
23. The bedroom door is suitably sized and is functioning.
24. There is exposed stonework and exposed lath and plaster in the bedroom cupboard.

Photo 14 – Fully functioning Bedroom door

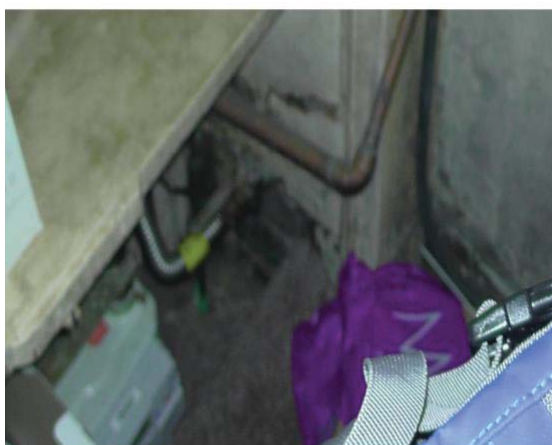
Photo 16 – Exposed stonework in Bed. cupboard

**61.9 Make good the exposed stonework and lath and plaster in the bedroom cupboard to ensure that no dampness or water ingress is possible.**

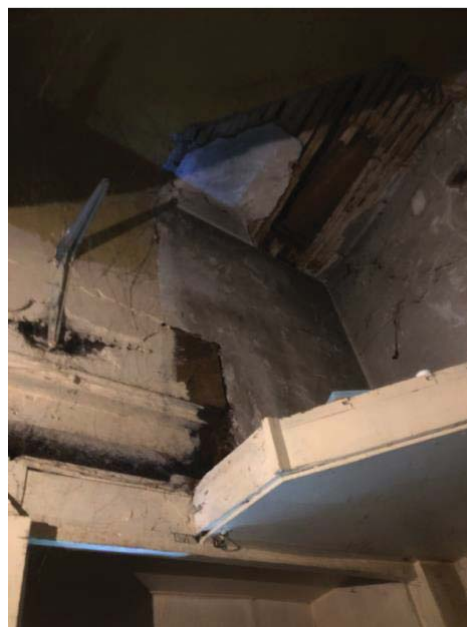
Photo 17 – Exposed lath and plaster in cup/b

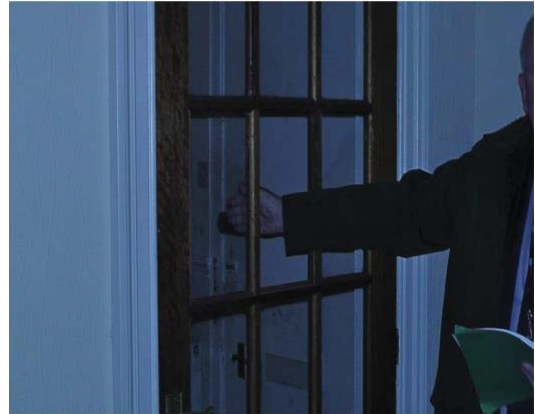
25. The living room door is glazed and there is a missing pane of glass.
26. There is a gap between the top of the living room door and the door frame.
27. The fireplace wall and the alcove in the living room is saturated and wallpaper is peeling from them. There is a “watermark” above the fireplace which extends across a significant section of the wall.

Photo 19 – Missing pane in Living room door

**61.10 Replace or repair the living room door to ensure that it fits the door frame and does not have a missing pane of glass.**

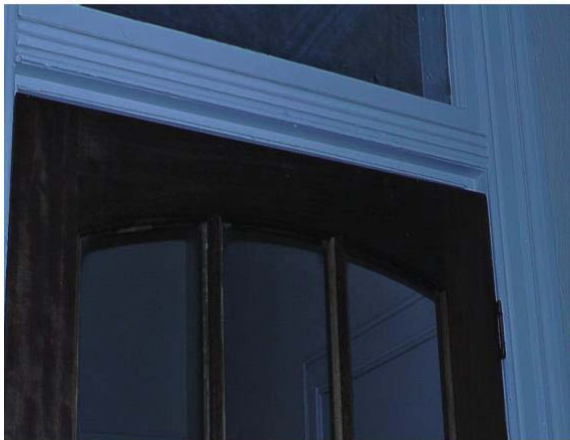
Photo 20 – Gap between Living room door + frame

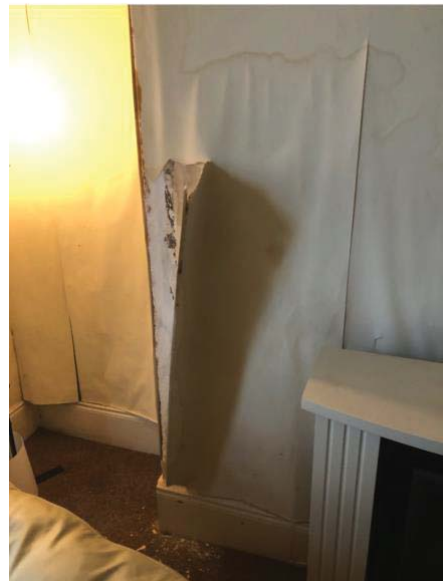
Photo 21 – Saturated fireplace wall

**61.11 Investigate and eradicate the dampness in the living room.**

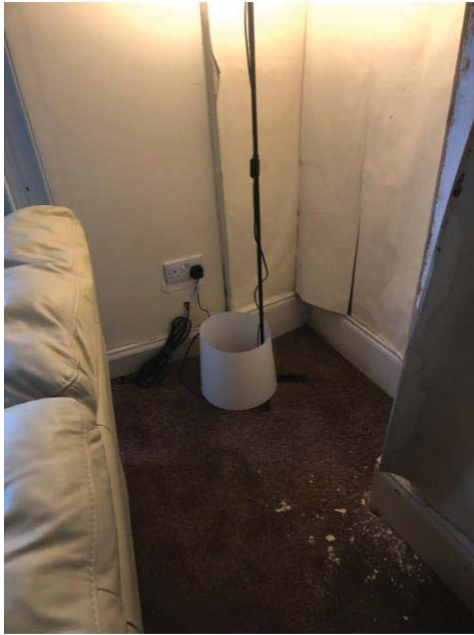
Photo 22 – Saturated alcove

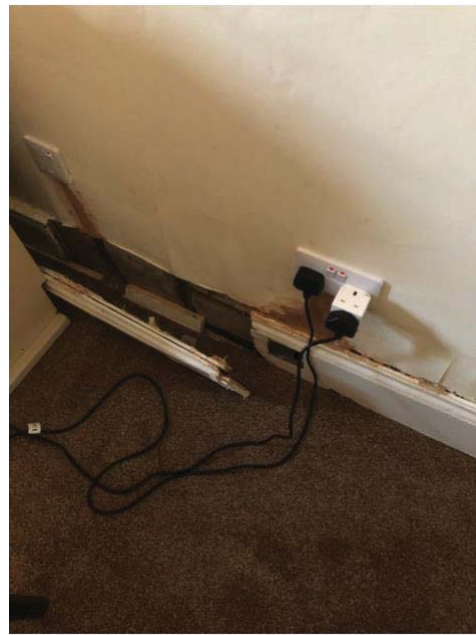
28. Skirting in the living room is detached.
29. There is historic water staining in the ceiling of the living room.
30. The kickboard below the kitchen sink has been re-instated.

Photo 23 – Detached skirting + damp wall

**61.12 Re-attach the skirting board in the living room.**

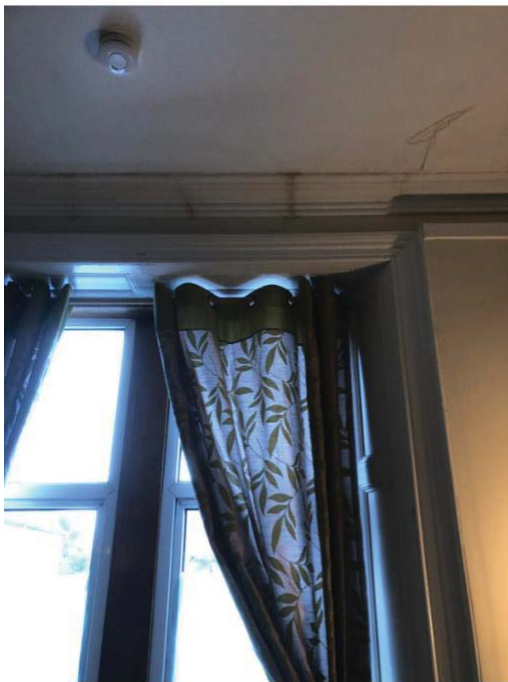
Photo 24 – Historic water ingress staining

**61.15 Make good defects in décor caused by historic water ingress.**

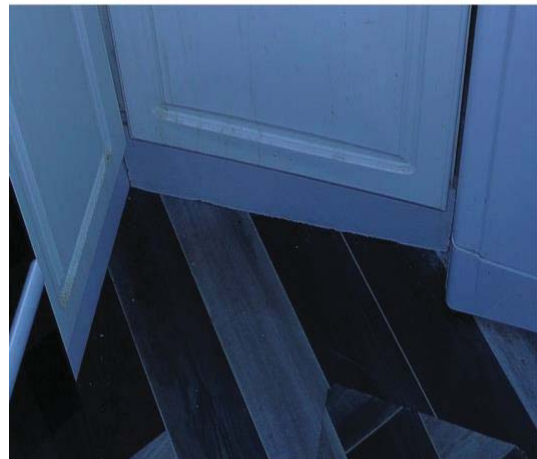
Photo 25 – Kickboard below Kitchen sink unit

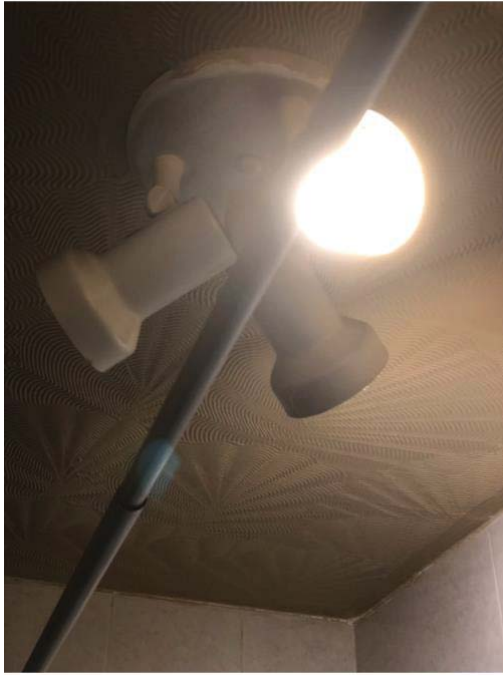
31. The light fitting in the bathroom is inappropriate for its location, it should be a sealed unit, and consequently does not meet the relevant regulations.

45. The Ordinary Member set out the findings from the Inspection.
46. The Ordinary Member said that, although not part of the application, it had been noted that the light fitting in the bathroom was not appropriate and constituted a safety issue. It was also noted that the stone mullion at the living room window had failed and that this was something which the landlord may want to address given that it is a safety issue and could also lead to a significant deterioration of the Property.

Photo 26 – Inappropriate light fitting in Bathroom

**61.13 Replace the light fitting in the bathroom with one that is safe and compliant with regulations.**

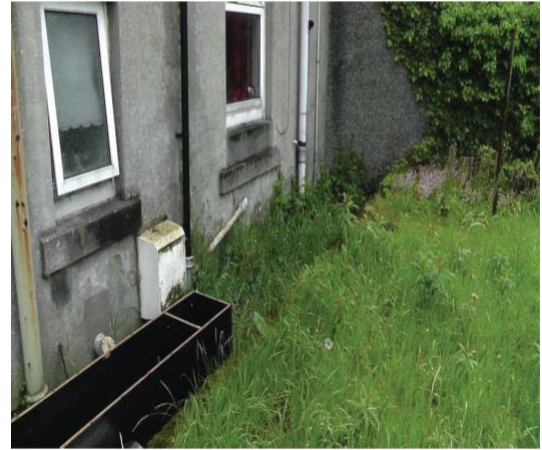
32. There is water staining on the external gable wall.
33. At the rear wall of the Property, there is a build-up of debris and vegetation creating the potential for damp penetration.

Photo 27 – Debris/vegetation build-up at rear

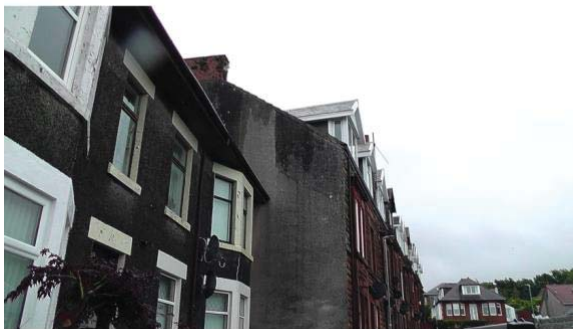
Photo 28 – Water staining on gable wall

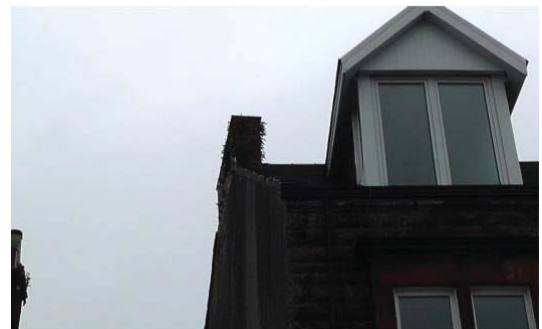
34. The condition of the chimney stack is poor.
35. At the gable wall (next to the fireplace wall in the living room of the Property) the ground level is raised indicating a possible damp bridge.

Photo 29 – Various chimney stack issues

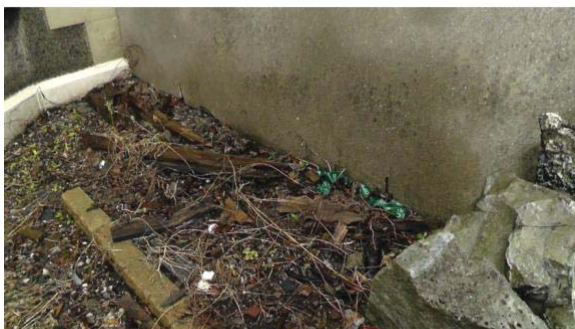
Photo 30 – Raised ground level + damp bridge

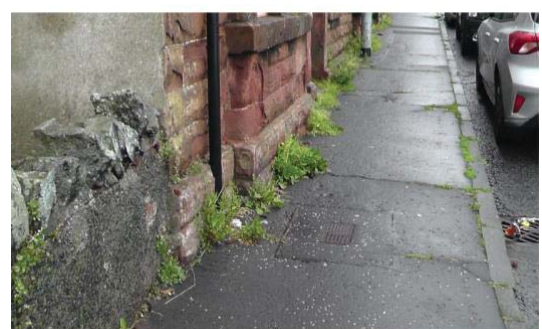
Photo 31 – Adjacent wall damp bridge

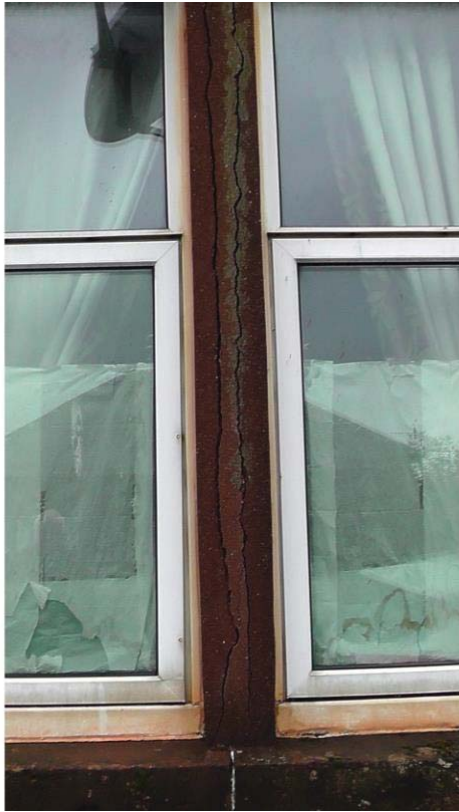
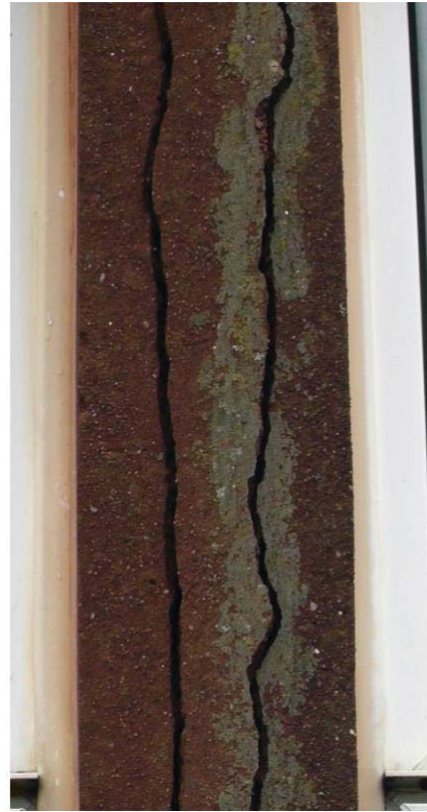
36. The stone mullion at the living room window is badly cracked.

Photo 32 – Failing stone mullion

Photo 33 – Close up of mullion
