**Decision with Statement of Reasons of the First-tier Tribunal for Scotland
(Housing and Property Chamber) under Section 24 of the Housing (Scotland)
Act 2006**

Chamber Ref: FTS/HPC/RP/24/4299

Re: 8 Whinknowe, Ashgill, Larkhall, ML9 3AP (“the Property”)

Schedule of photographs

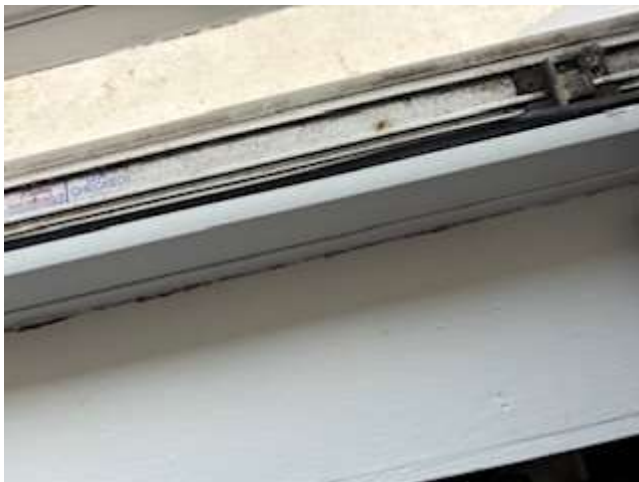
Bathroom Window

21. The window in the bathroom is uPVC framed type. It is opened by lifting the handle, which turns the latch. However, the mechanism within the window is not engaging with the handle. The window therefore never closes properly. The window also does not open fully. The rubber seal in the window is dried out and brittle.
22. The window is part of the structure of the Property. It is not in a reasonable state of repair, having regard to the age, character and prospective life of the

house, and its locality. In the circumstances, the failure to repair the window is a failure by the Respondent to comply with the repairing standard.

23. The Tribunal will require that the Respondent undertakes work to replace the window within 8 weeks.

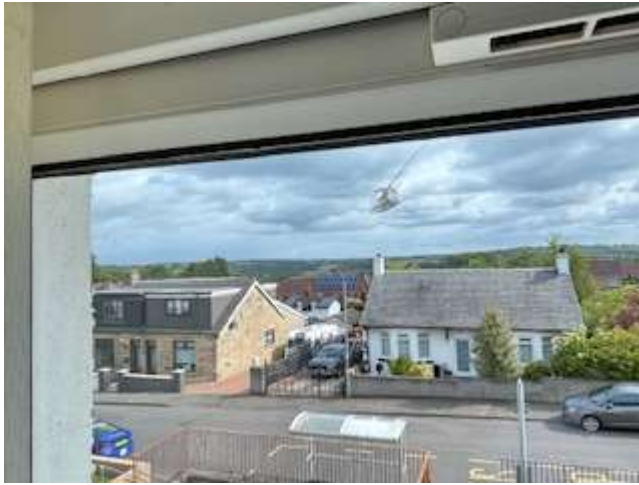
Front Bedroom Window

5. The front bedroom on the first floor of the Property has a sealed unit double-glazed pane. The external glazing has suffered significant impact damage, resulting in a hole, cracking and a piece of glass, approximately the size of a penny, becoming dislodged and sitting in the air gap between the panes.

6. The window is part of the structure of the Property. Whilst the damage caused is not sufficient to cause that area of the Property to fail to be wind or watertight, the damage is likely to affect the thermal performance of the unit. In any event, it cannot be said that a window displaying such damage is in a reasonable state of repair, having regard to the age, character and prospective life of the house, and the locality in which it is located. Accordingly, the Tribunal is satisfied that the failure to replace the glazing is a failure by the landlord to comply with the repairing standard.
7. The Tribunal will require that the Respondent undertakes work to replace the damaged glazing within 8 weeks.

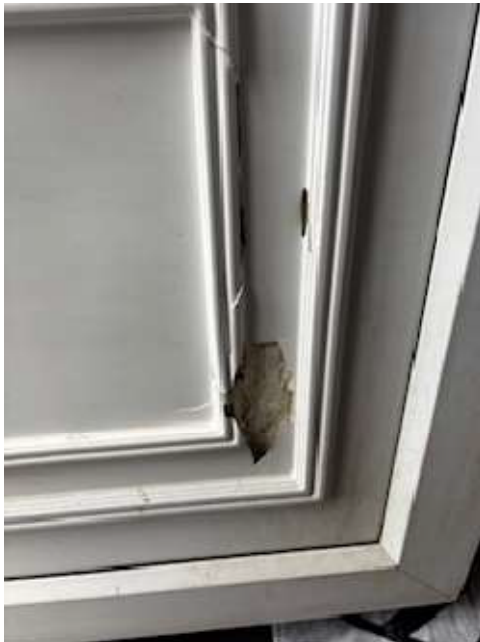
External door-kitchen

15. It follows that, for the reasons referred to by the Applicants, the condition of the door is not a breach of the landlord's repairing standard.
16. However, the Tribunal observed that the external face of the door had suffered significant impact damage. One of the uPVC panels had been pierced and shattered, exposing the interior insulation. Had that complaint been raised by the Applicant in the Application, it is likely that the Tribunal would have held that to be a breach of the landlord's repairing standard. We were told that the Respondent's agent had arranged for the door to be replaced as part of the works on 10 June 2025, so that issue will hopefully be resolved without the need for further proceedings.

Damage to exterior face

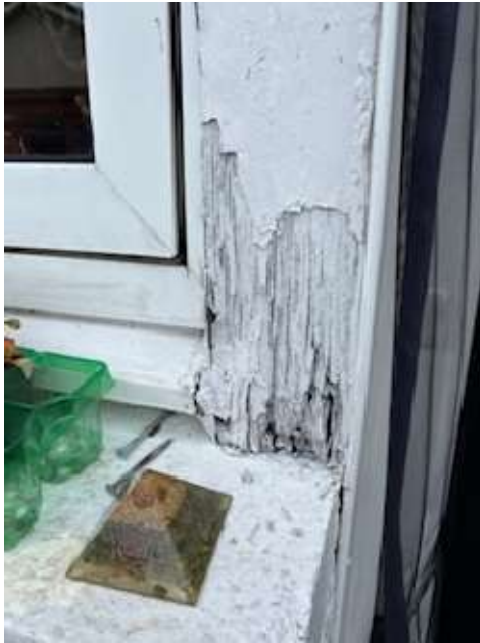
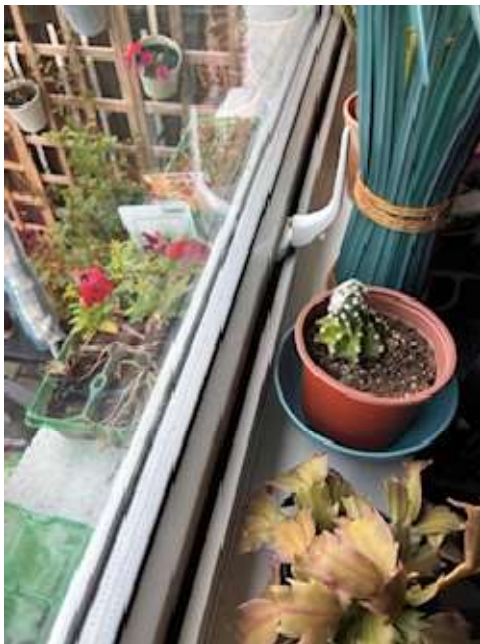
Kitchen Window

8. The window in the kitchen is a double-glazed unit. It is opened by using a handle, which is mechanically connected to a latch. The Tribunal observed that the rubber seal between the window and its frame has lost its pliability and is damaged. It is no longer sufficient to make the window wind and watertight.

9. Separately, the external timber facing surrounding the window is decayed and is also not wind or watertight.
10. The condition of the window and its surrounding fixings is such that the house is not wind and watertight in that location. Separately, the window and its surrounding fixings form part of the structure of the house, and are not in a reasonable state of repair, having regard to the age, character and prospective life of the house, and the locality in which it is located. Accordingly, the Tribunal is satisfied that the failure to repair/undertake repairs to the kitchen window is a failure by the landlord to comply with the repairing standard.

11. The Tribunal will require that the Respondent undertakes work to replace the defective window unit, and to replace the decayed external areas surrounding the window, all within 8 weeks.

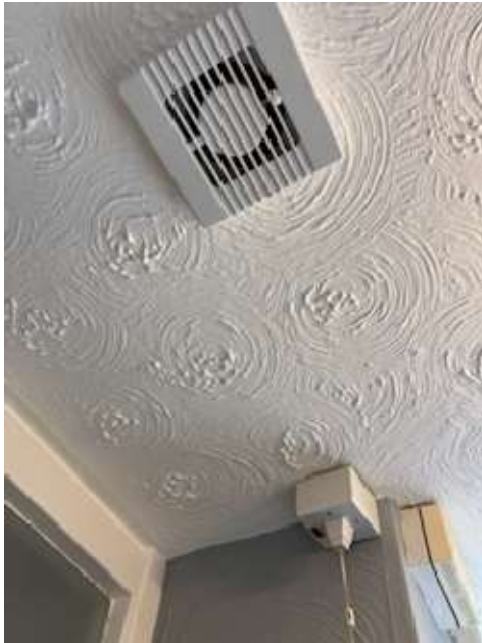
Bathroom Extract fan

17. The bathroom is fitted with a mechanical extractor fan. It is a new fan, which replaced a previous fan that had broken. The previous fan was connected to the bathroom light fitting, such that both came on when the switch was depressed. Since the new fan was fitted, it has not worked. The Applicants asserted that the person who fitted the fan said that he did not know how to connect it.

18. The bathroom fan is a fixture, fitting or appliance provided by the Respondent. It is not in working order. Accordingly, the failure to put the bathroom fan into working order is a failure by the Respondent to comply with the repairing standard.

19. The Tribunal will require that the Respondent arranges for the bathroom fan to be put into proper working order by a qualified electrician. The Tribunal will also require that the Respondent produces an Electrical Installation Condition Report ("EICR"). Those works must be completed within 8 weeks.

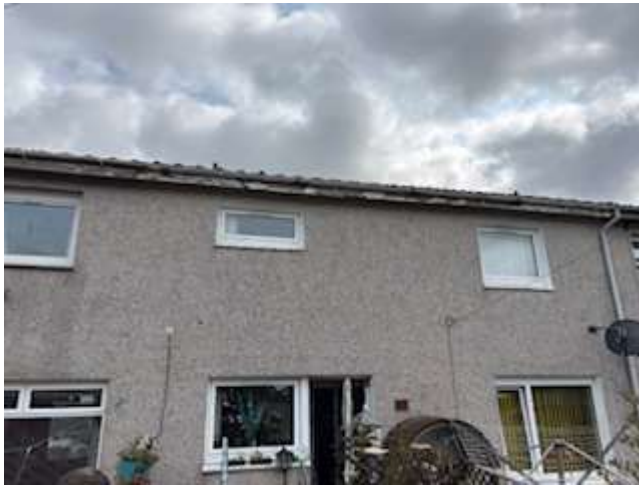
Rear Gutters

25. The Tribunal observed that the gutters did not appear to be graded correctly to ensure sufficient discharge to the downpipe connected. The fascia beneath the gutters is also showing signs of water damage and decay.

26. The gutters form part of the structure of the Property. They are not in reasonable state of repair. Accordingly, the failure of the Respondent to repair the gutters is a failure to comply with the repairing standard.

27. The Tribunal will require that the Respondent undertakes work to undertake such works as may be required to the gutters to ensure that surface water is collected and discharged to a downpipe leading to the public sewer. Thereafter, the Respondent is required to test the gutters for any escape of water and to repair any leaks evident from that test. The Tribunal will require that the Respondent attend to those repairs within 8 weeks.
