**First-tier Tribunal for Scotland (Housing and Property Chamber) ("the Tribunal")**

**STATEMENT OF DECISION OF THE TRIBUNAL  
UNDER SECTION 24(1)  
OF THE HOUSING (SCOTLAND) ACT 2006**

**65 Union Street, Cowdenbeath KY4 9SA ("the House")**

**Reference number: FTS/HPC/RP/24/4289**

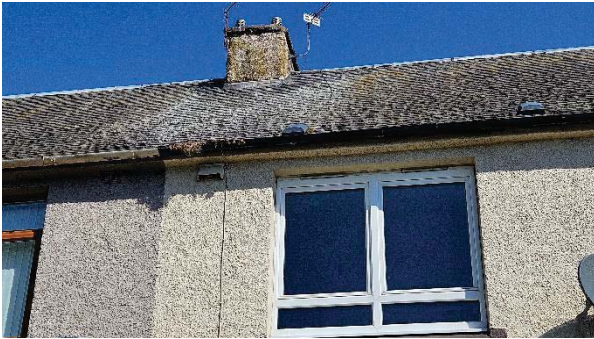
The gutter at the front of the House contains vegetation preventing it from operating as intended.

1 Visual vegetation evident to rainwater gutters at front roof pitch.

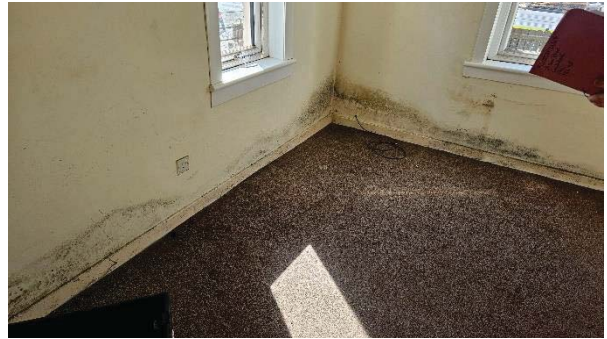
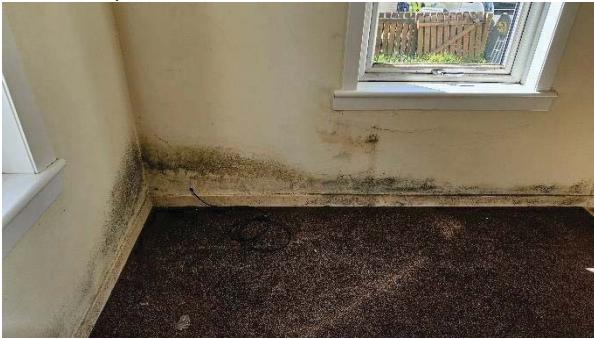
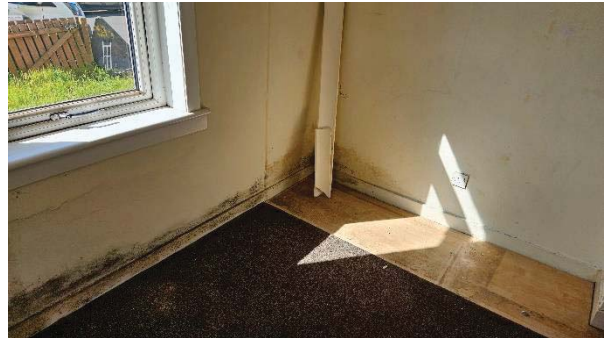
There is evidence of significant mould in the eastmost bedroom. The cause is uncertain but may be as a result of cold bridging from an uninsulated floor. High surface humidities were recorded on the external walls coinciding with the mould contaminated areas, giving rise to conditions conducive to mould growth. Ambient temperature, relative humidity and vapour pressure excess did not reveal any anomalies, however, surface temperatures at low level to walls was considered to be relatively poor, giving concern over the thermal performance. Mould is also present in the hall cupboard and it is suspected that there may be dampness in that area given the recording of elevated moisture readings and damage to internal paint finishes suggestive of water movement.

2 Visual mould growth evident at low levels to external walls within Eastmost Bedroom.

3 Visual mould growth evident at low levels to external walls within Eastmost Bedroom.

4 Visual mould growth evident at low levels to external walls within Eastmost Bedroom.

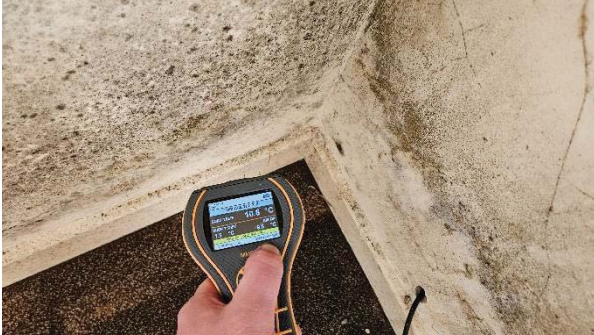
5 Condensation assessment within Eastmost Bedroom, surface temperatures were above dewpoint however, a high surface humidity was recorded.

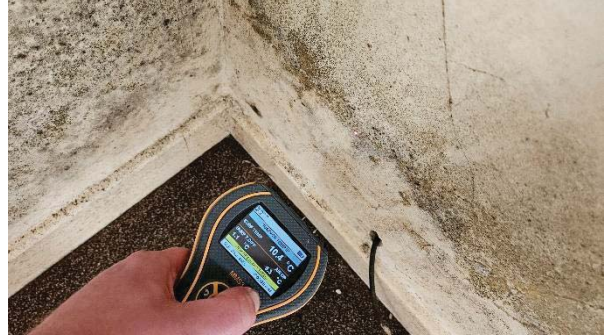
6 Condensation assessment within Eastmost Bedroom, surface temperatures were above dewpoint however, a high surface humidity was recorded.

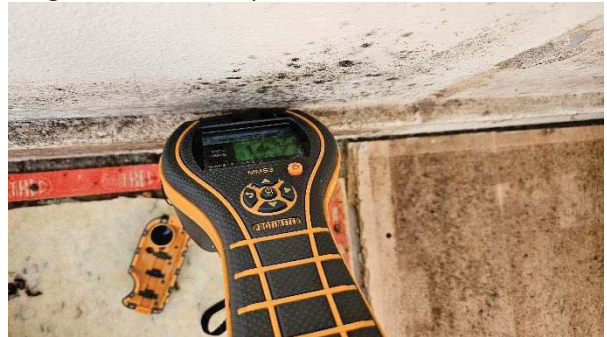
8 Quantitative moisture reading to timber within acceptable range.

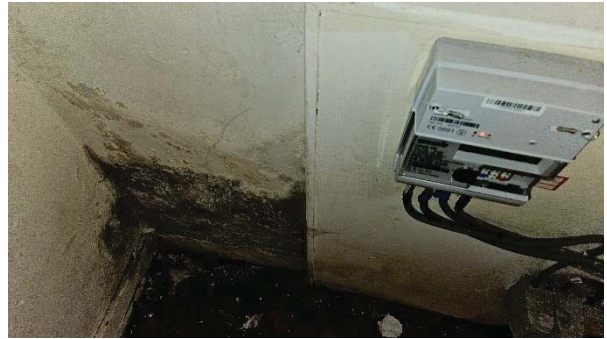
10 Heavy mould growth to external wall within Hall Cupboard.

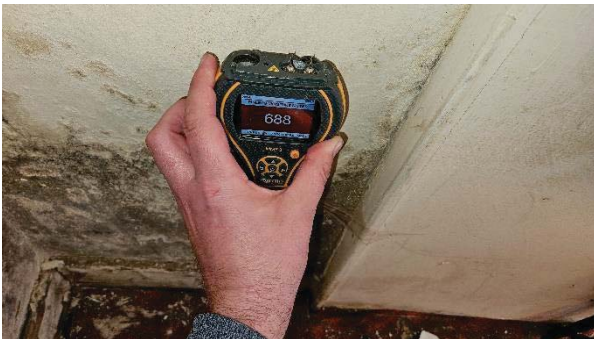
11 Elevated qualitative moisture readings recorded within Hall Cupboard.

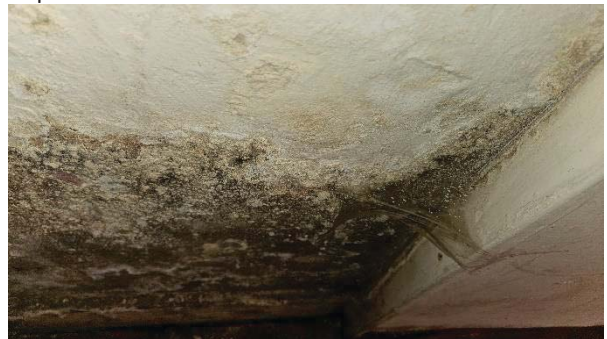
12 Blistering and deterioration of paint finish due to dampness.

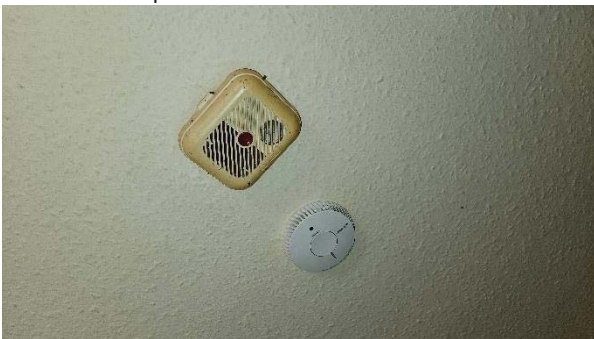
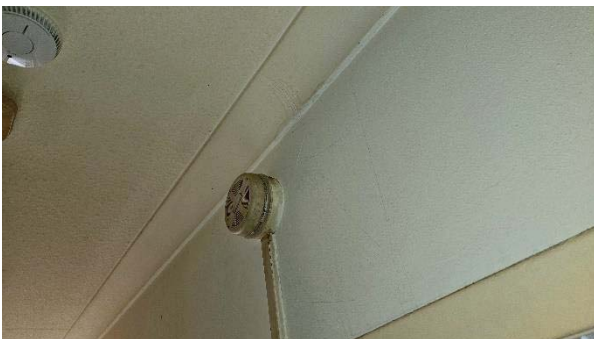
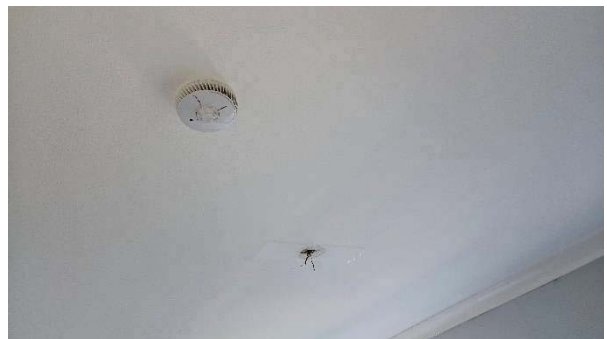
The smoke/heat alarms did not activate each other when any single one of them was tested. They appear not to be interlinked.

13 Smoke detector.

15 Smoke detector.

16 Heat detector.

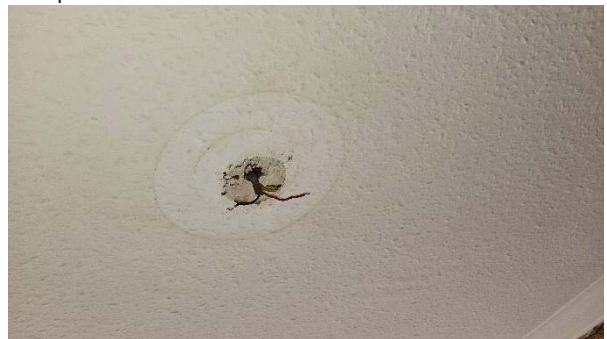
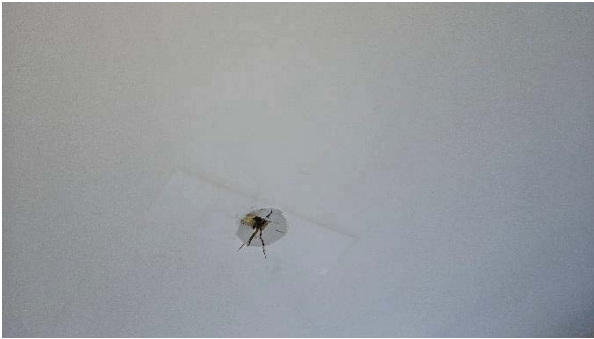
14 Example of missing light fittings – electrics not turned on.

17 Example of missing light fittings – electrics not turned on.

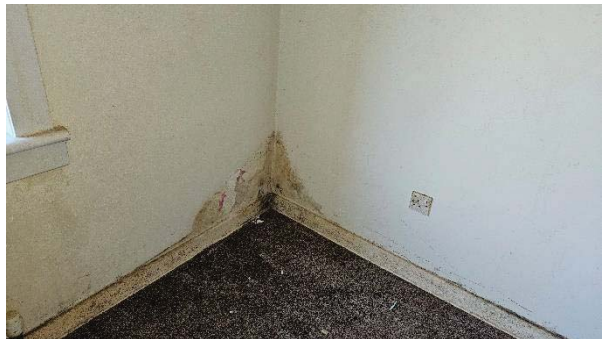
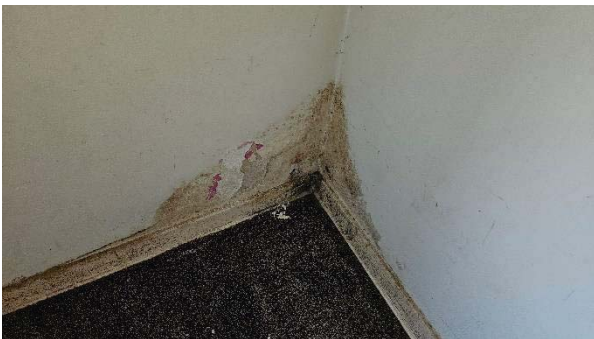
20 Rear Bedroom – dampness at corner to low level.

21 Rear Bedroom – dampness at corner to low level.

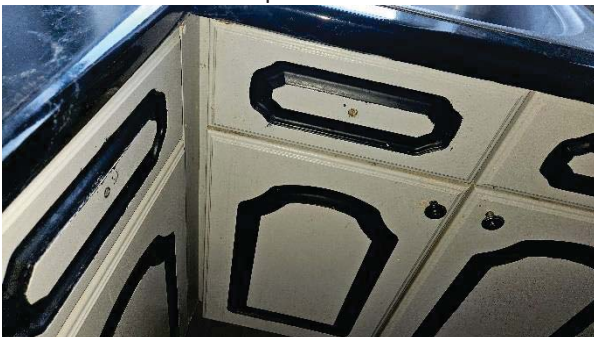
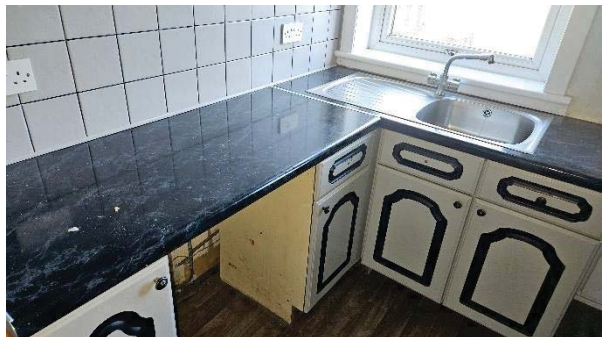
Handles are missing from kitchen cupboards and drawers and loose on others.

23 Missing handles to drawers.

24 Missing handles to drawers.

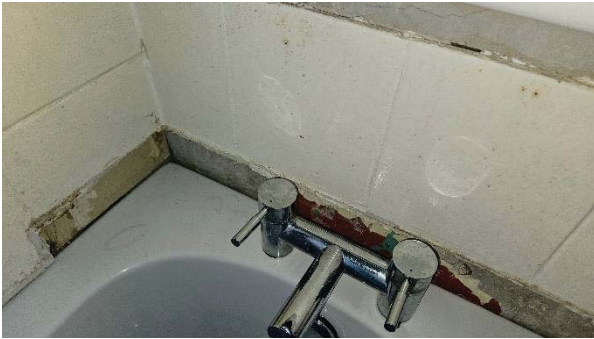
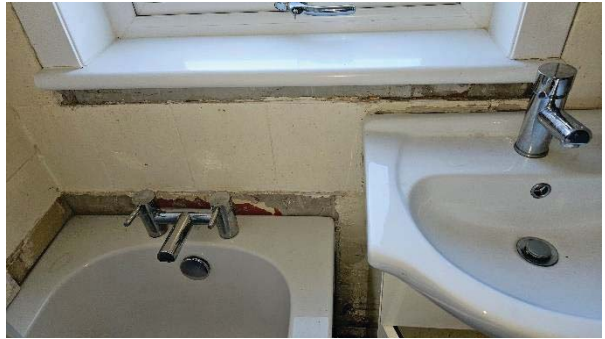
A number of tiles are missing from the bathroom wall.

25 Missing tiles at junction with bath and not sealed.

26 Missing tiles at junction with bath and not sealed.

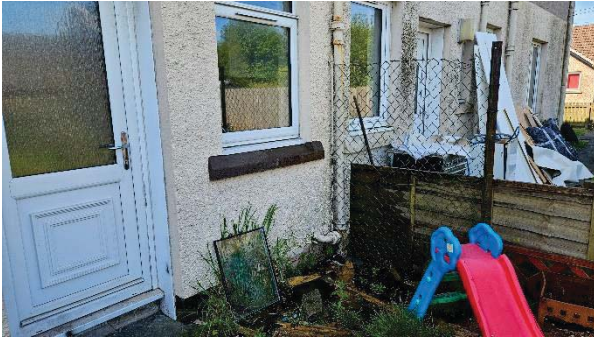
The Tribunal noted that the House was generally in need of maintenance and repair and observed that there is leak from the attic overflow, possibly from the neighbouring property and that the roof of a large shed in the rear garden has collapsed.

27 Overflow at eaves saturating base of wall and fence over rear elevation.

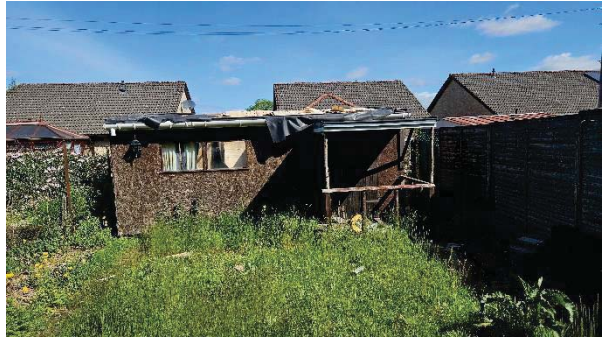
28 Dilapidated outbuilding with roof damaged.
