Decision of the First-tier Tribunal for Scotland (Housing and Property Chamber) under Section 24 of the Housing (Scotland) Act 2006

Chamber Ref: FTS/HPC/RP/24/5595

Re: 95 Stevenston Court, New Stevenston, ML1 4HW (“the Property”)

Schedule of Photographs taken during the Inspection on 1st July 2025

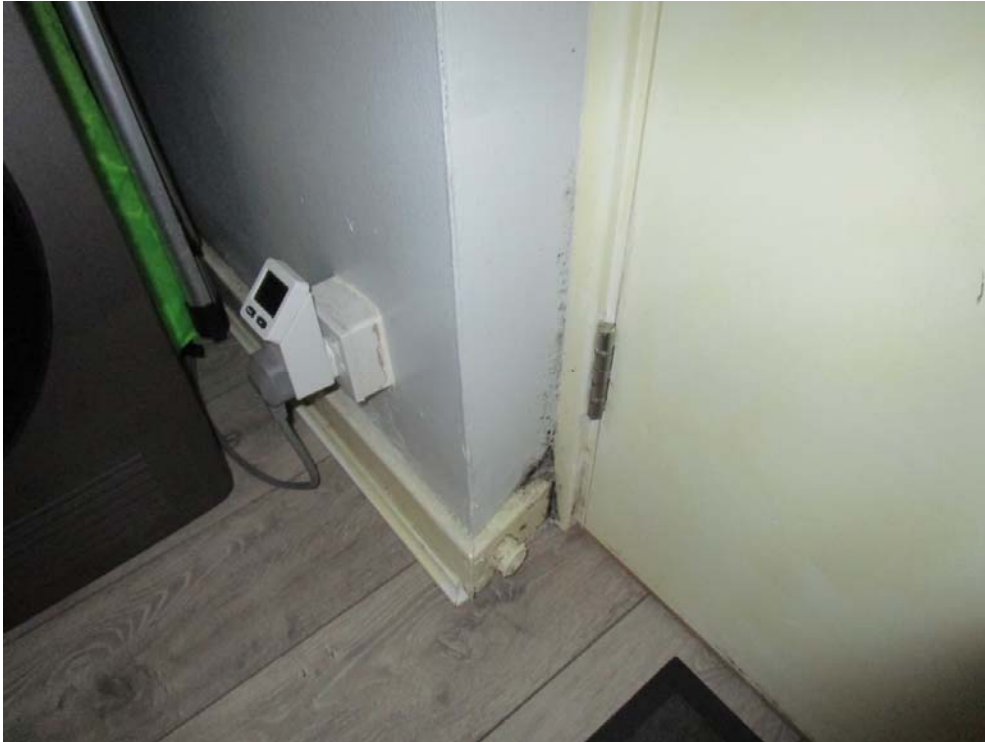
5. As one enters the Property from the common close, there is localised dampness immediately to the right of the doorway, from floor level upwards (see photograph 1). Damp meter readings were taken at the skirting and within the plaster board immediately above the skirting. The readings averaged at approximately 20% moisture, which is higher than would be expected from condensation related dampness.
6. There is an alcove adjacent to the area of dampness. The Applicant keeps a combined washing machine and tumble dryer in the alcove. The machine has an internal condensing unit as its drying function.

- (ii) The washer/dryer machine in the hall is likely to generate moist air in within the hallway, which will then accumulate on the cold surface of the wall leading into the common close.

1. Mould and dampness adjacent front door

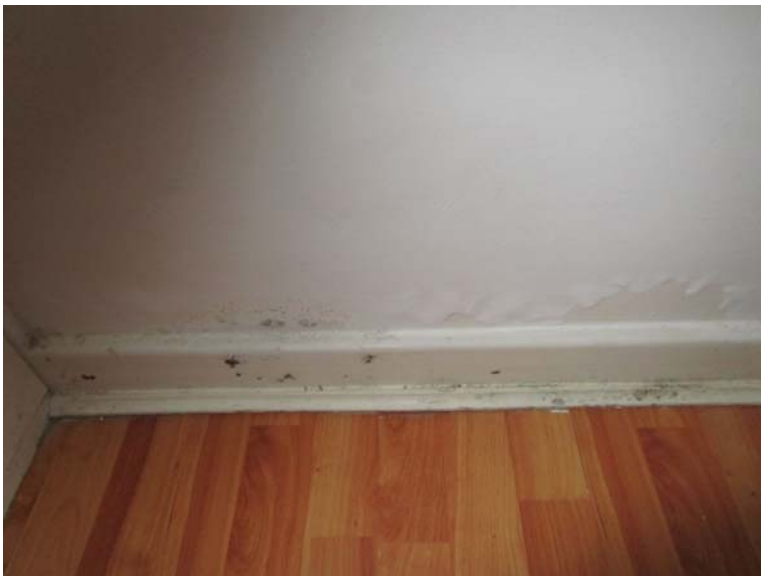
8. The master bedroom was a cramped space, dominated by a large bed on open frame. There is a television table with large screen television, and a "tallboy" set of drawers, running along one wall, which meets at a corner the wall in which the window is situated. There is also a fitted wardrobe. There was evidence of dampness within the wardrobe (see photograph 10), as well as along the wall behind the "tallboy" and television table (see photographs 2 and 4), and along the window wall. Damp meter readings were taken at the skirting and within the plaster board immediately above the skirting. The readings averaged at approximately 18% moisture, which is higher than would be expected from condensation related dampness.

2. Mould/ main bedroom

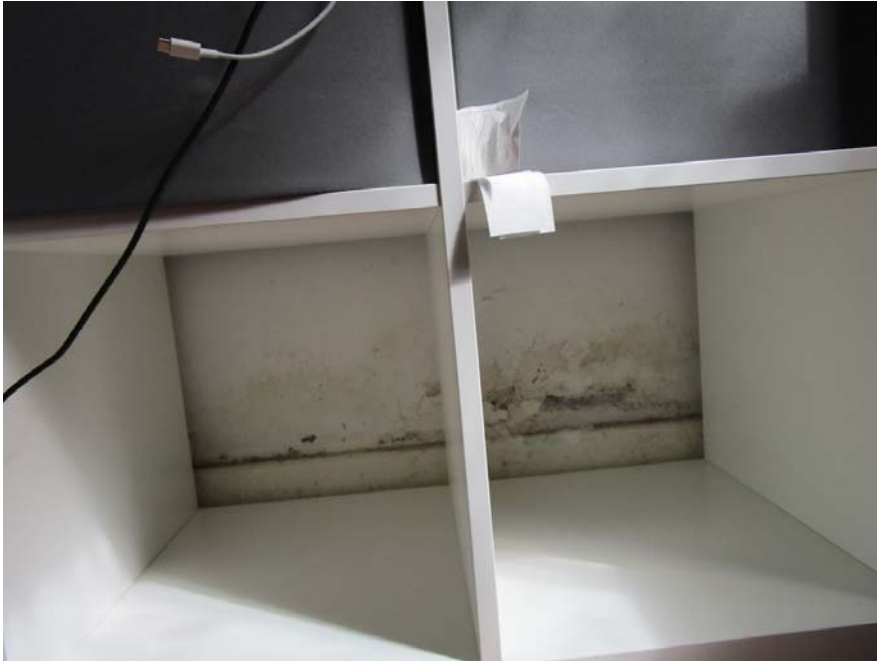
9. The second bedroom is used by the Respondent's children. There is a storage unit running along one of the walls, which meets at a corner the wall in which the window is situated. There was evidence of dampness behind the storage unit (see photograph 3), and along the window wall. Damp meter readings were taken at the skirting and within the plaster board immediately above the skirting. The readings averaged at approximately 20% moisture, which is higher than would be expected from condensation related dampness.

3. Mould/dampness bedroom 2

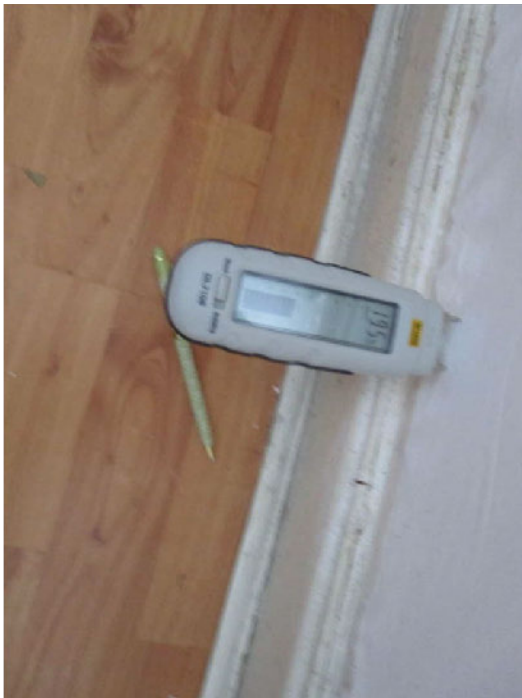
4. Moisture meter in bedroom

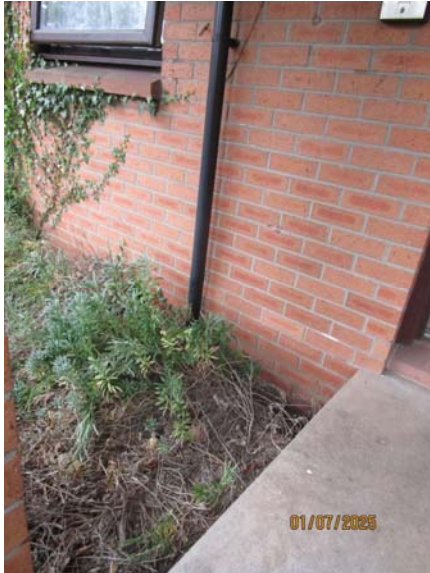
11. To the front of the Property, in the area under the living room window, there is vegetation. There was no visible staining to the wall. There is a rainwater downpipe adjacent to the entrance to the common close (see photograph 5).
12. To the rear of the Property, there is staining along the base of the wall (see photograph 9). The Applicant directed the Tribunal's attention to the gutter directly above the area of staining. The gutter was discoloured, suggesting that water was escaping or overflowing in that area.
13. Continuing along the rear elevation, to the north, the external face of the Property turns at a right angle to the west, and continues until it meets the rear elevation of the block comprising 105-115 New Stevenston Court. There

5. External wall adjacent close

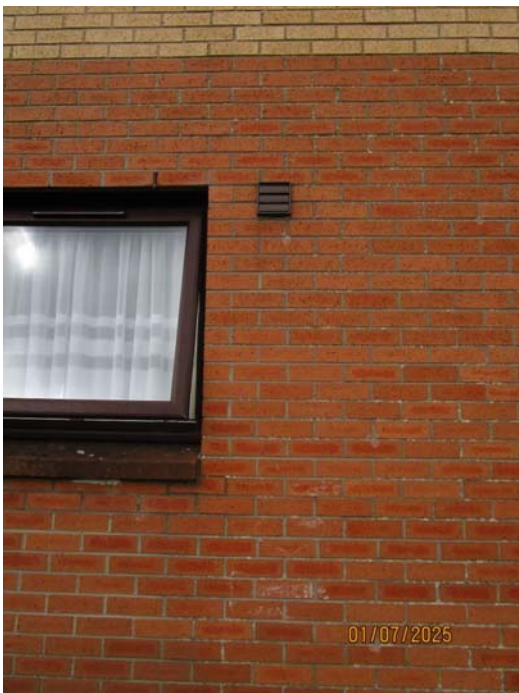
10. The kitchen units showed evidence of delamination. The extractor fan did not appear to be expelling much air. The fans on the external face were not opening when the fan was turned on (see photograph 7).

7. Fan at kitchen

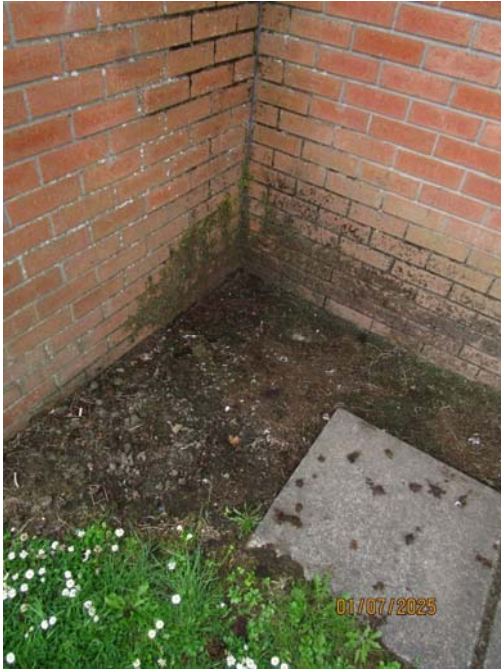
is heavy staining and mould in that area (see photograph 8). That area is through the wall from the second bedroom, behind the storage units.

8. Stained area of wall at bedroom

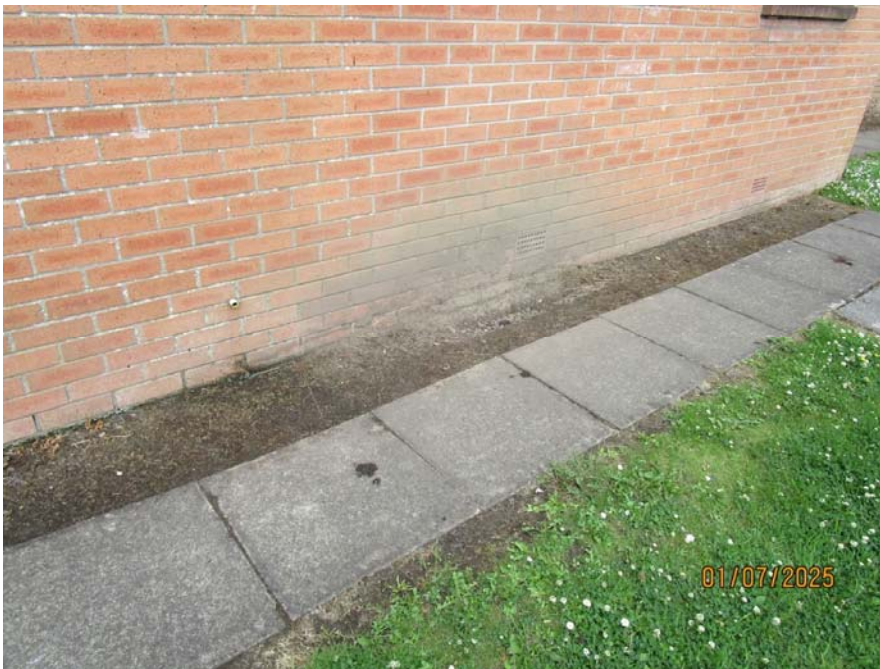
fabric of the building becoming saturated and not being allowed to dry. What is unclear at this point is whether that is as a result of moisture rising up from the ground, or excessive water running down from, for example, overflowing or leaking gutters and downpipes.

9. Staining at leaking gutter

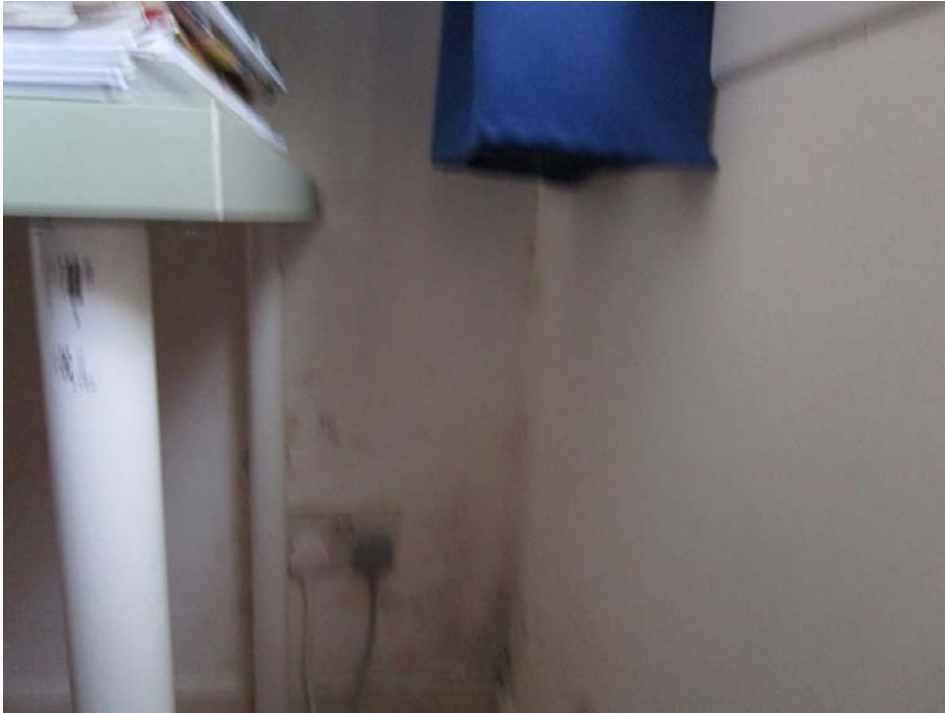
10. Dampness/mould main bedroom
