**Decision with Statement of Reasons of the First-tier Tribunal for Scotland
(Housing and Property Chamber) under Section 24(1) of the Housing
(Scotland) Act 2006**

Reference number: FTS/HPC/RP/24/2968

**Re: Property at Railway Cottage East, Easter Coltfeld, Alves, Elgin, Moray, IV30
8XA (“the Property”)**

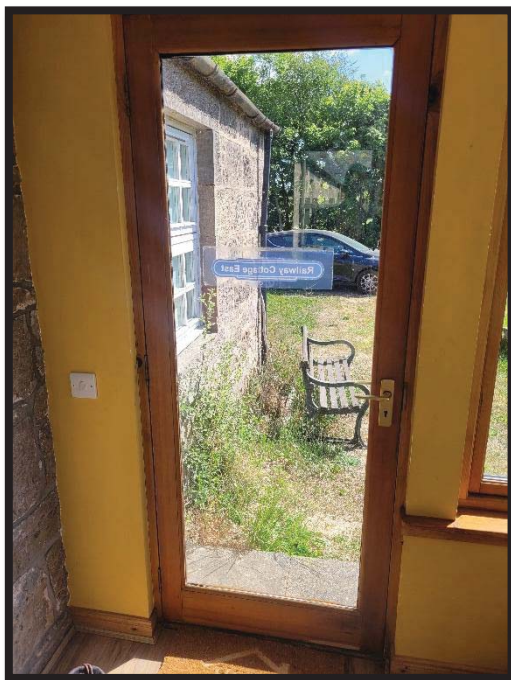
- 11 The inspection was restricted to the items contained within the application paperwork. The porch was inspected first. The outer door was found to be binding slightly at the threshold. When in the closed position, daylight could be seen around the door frame.

Photograph 3 Porch door: Binding slightly lower right corner, slight gaps at door seal when closed.

- 29 Following the hearing the Tribunal sought further information from Ledingham Chalmers regarding the window in Bedroom 1. On 24 June 2025 the Tribunal received an email from the Ledingham Chalmers confirming that works had been carried out to the window so that it could open and close, as well as to the seal between the door and frame in the porch. Ledingham Chalmers provided photographs as evidence of this.

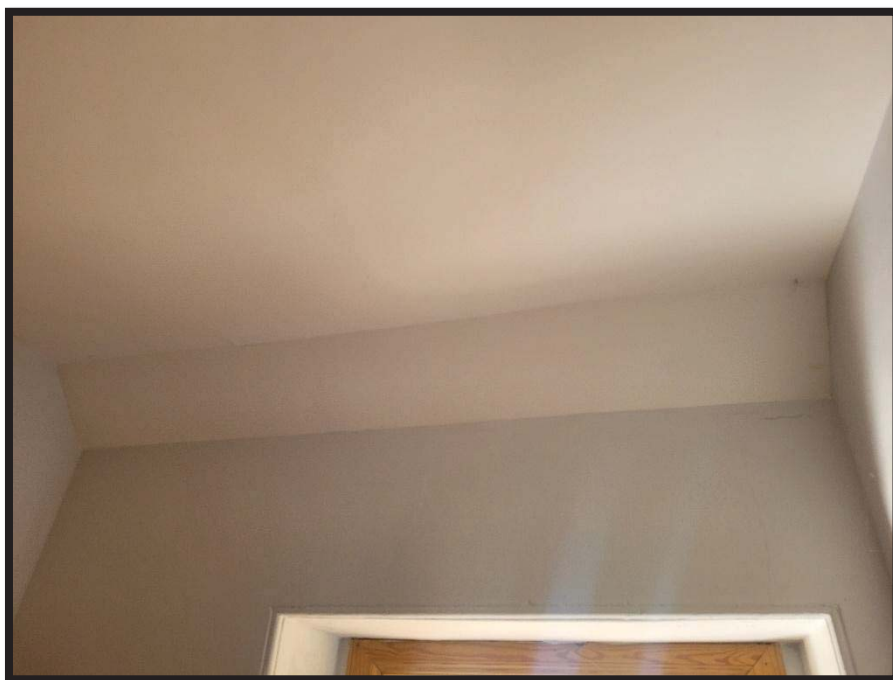
- 12 The hallway was inspected in relation to damp ingress. There was no obvious evidence of recent or previous water ingress to this area.
- 13 Bedroom 1 (left hand side) was inspected. The window could not be opened and appeared to be stuck fast with paint. The trickle vent could not be operated. Within the en-suite bathroom, the ceiling mounted extractor fan operated when the light was switched on and it had a run-on timer.

Photograph 4 Inner hallway: Ceiling shows no evidence of water ingress.

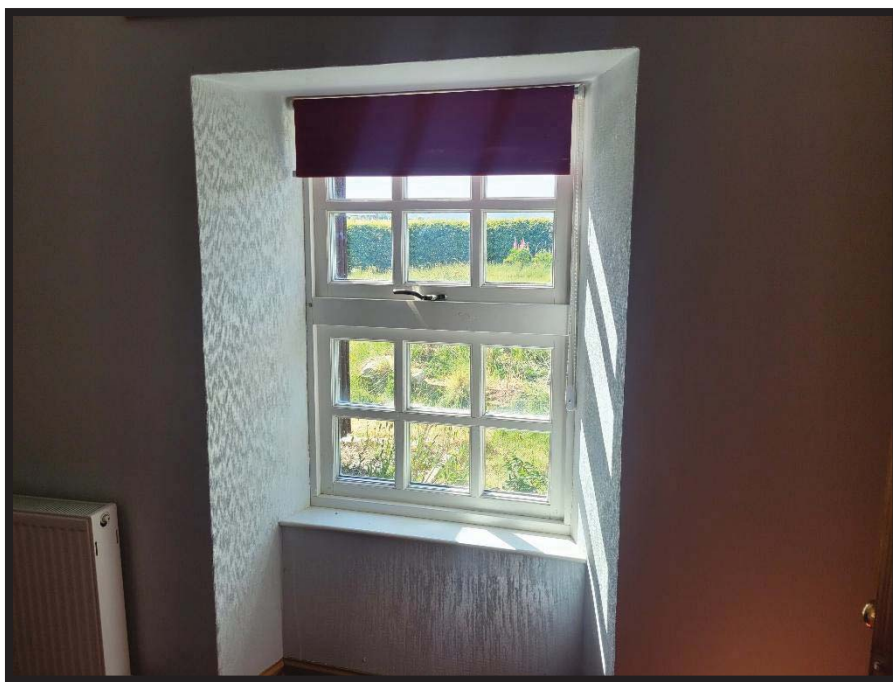
Photograph 5 Front left bedroom: Window stuck closed

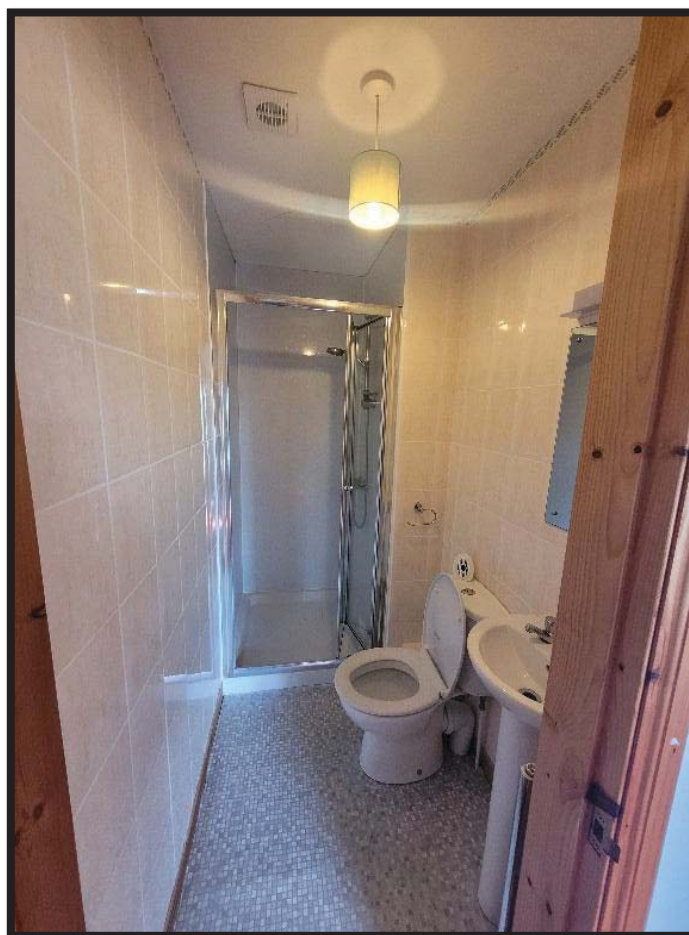
Photograph 6 Left Bedroom en-suite: Fan operational.

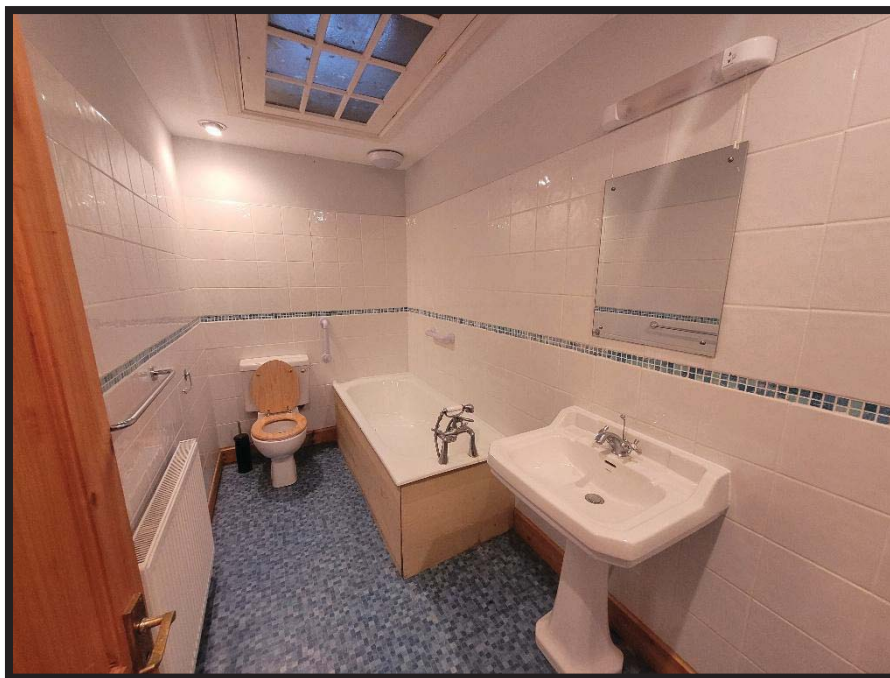
- 15 The main bathroom was inspected. There is a ceiling mounted extractor fan which operated when the light was switched on. There is a relatively large hatch in the ceiling, formed by a glazed door. This appears to admit light from the light tunnel. There was a certain amount of debris on the door, which was not opened.

Photograph 7 Main Bathroom: Debris on ceiling panel, fan operational.

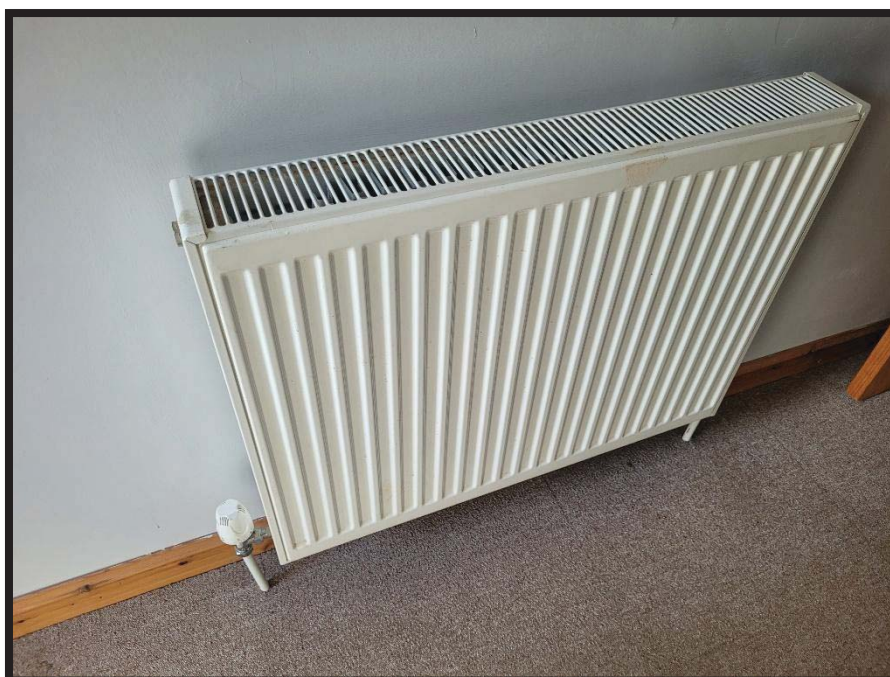
- 19 A number of TRVs attached to the radiators were tested. All appeared to open and close smoothly.
- 20 There are smoke alarms in the entrance hall, rear entrance hall and lounge and a heat detector in the kitchen. When tested, these were found to be interlinked.

Photograph 8 Kitchen: Typical radiator with operational TRV.

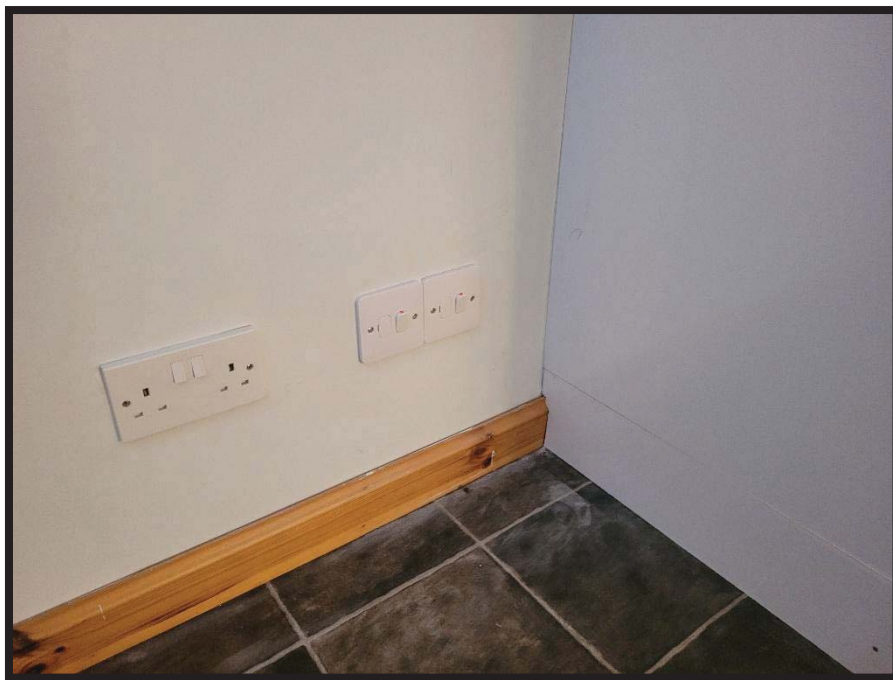
- 16 The kitchen was inspected. Electrical isolation switches are located adjacent to the integrated fridge and freezer.
- 17 The central heating boiler is located in the rear hall/utility room. It incorporates an electronic, programmable switch. There is no room stat. The switch for the washing machine could not be seen and is probably located behind the appliance. There is a stop cock located in the cupboard adjacent to the sink.

Photograph 9 Kitchen: Isolation switches for fridge/freezer.

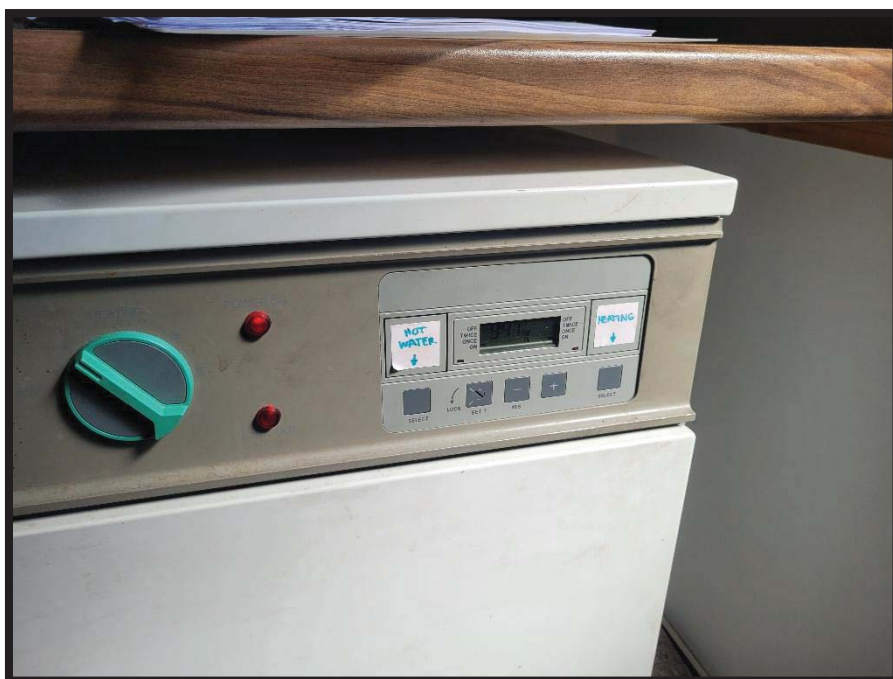
Photograph 10 Utility area: Boiler with integral programmer.

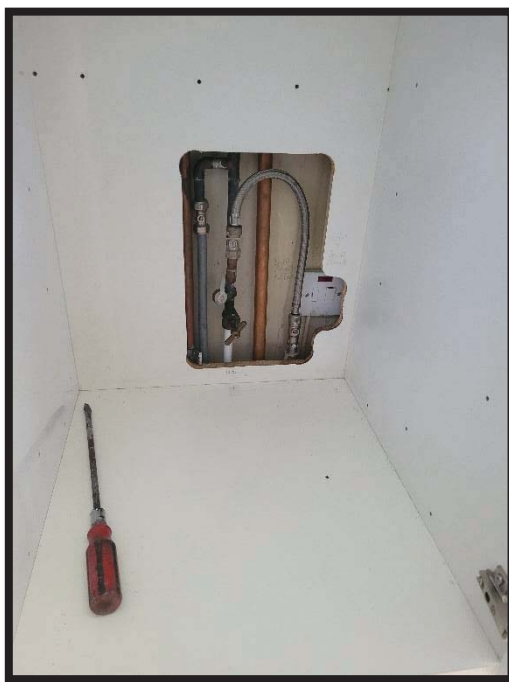
Photograph 11 Utility area: Internal water stop tap.

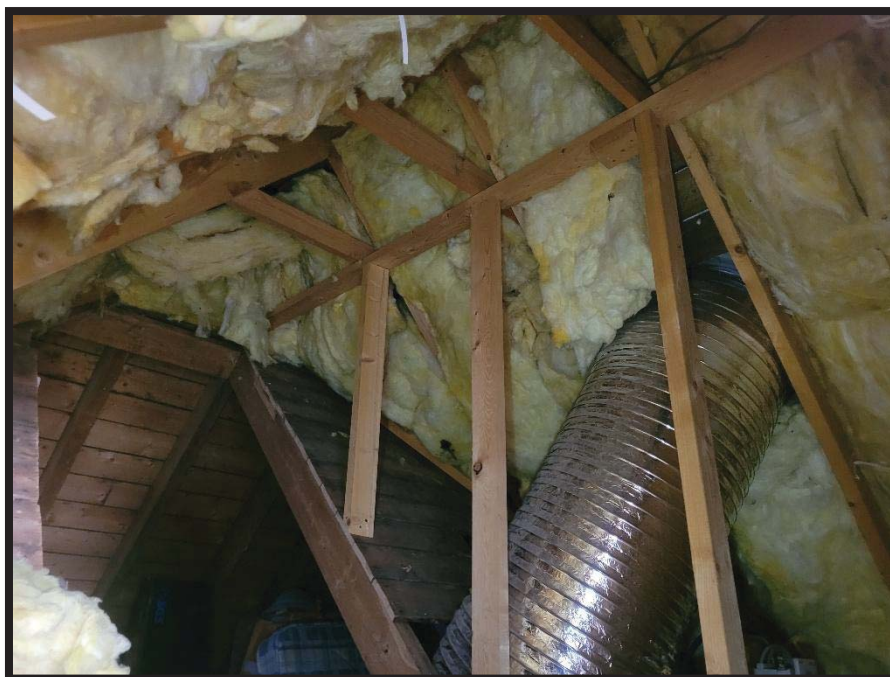
- 18 A limited inspection of the roof void was undertaken from the access hatch in the lounge. It could be seen that the underside of the roof of the rear extension

has been insulated with glass/rock wool. The roof void over the original cottage could not be clearly seen; part of this area appeared to have been floored.

Photograph 12 Main roof void: Insulation seen.

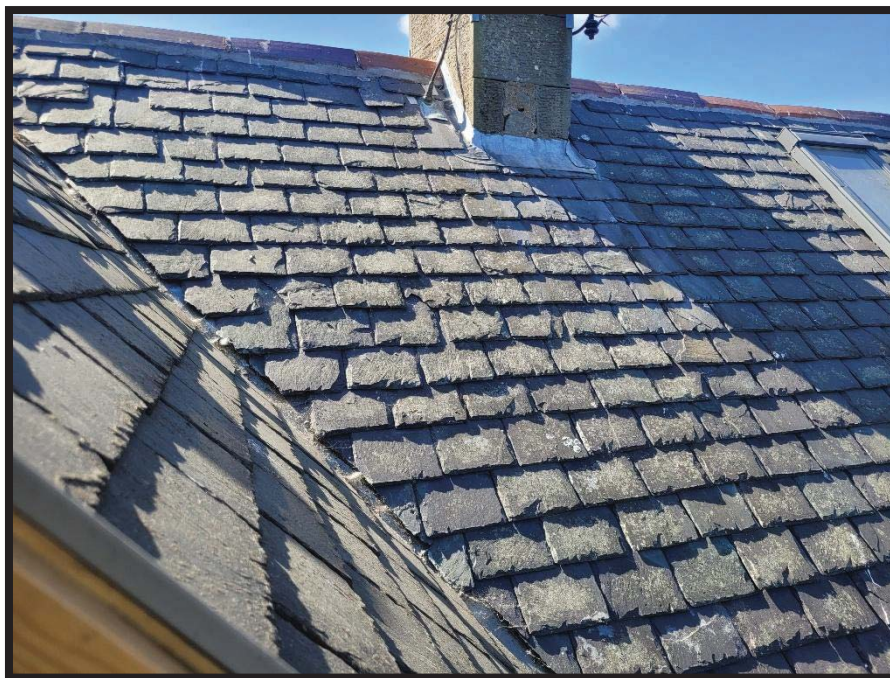
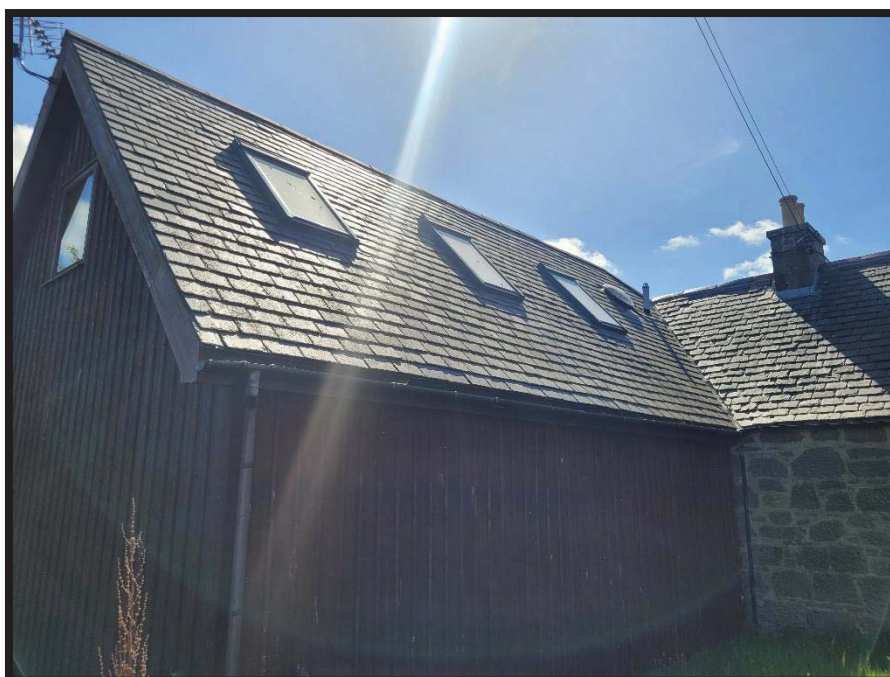
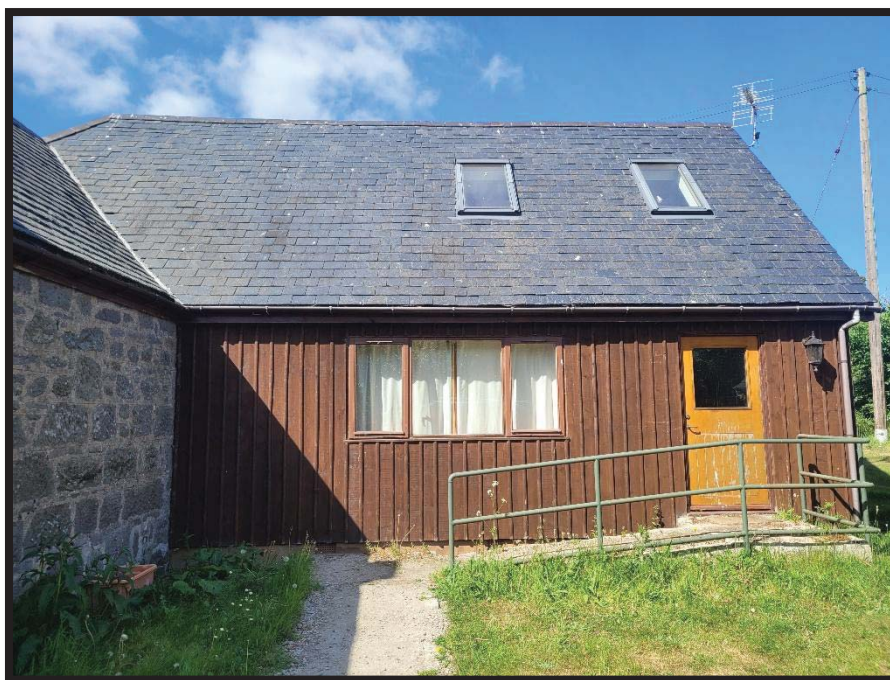
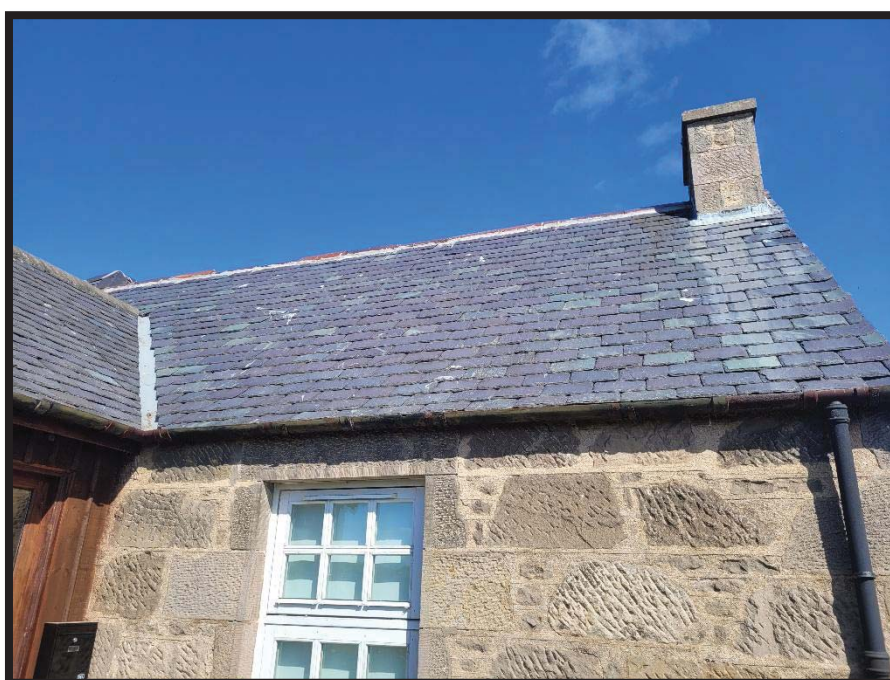
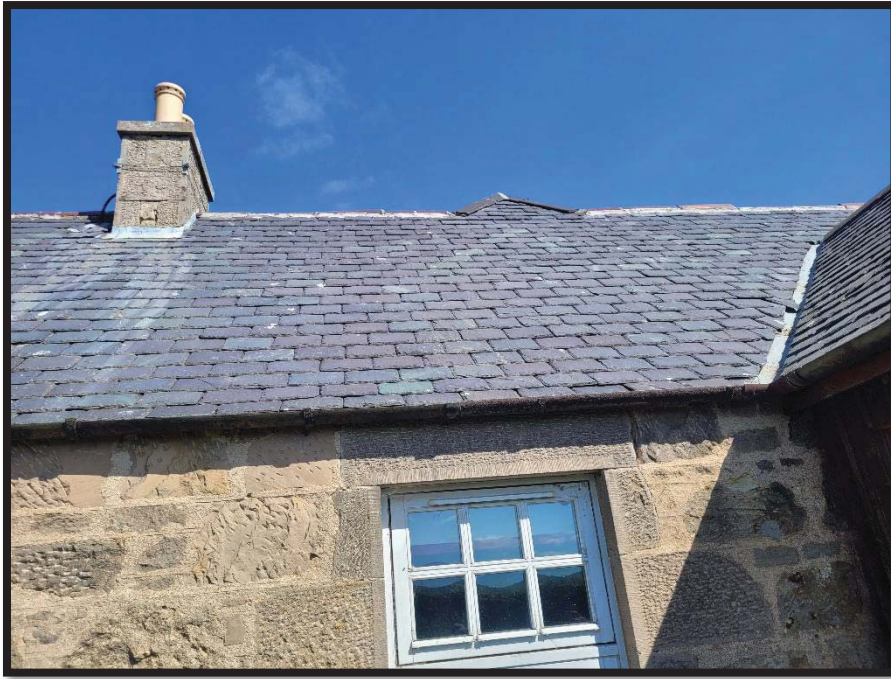
- 21 From a ground level inspection, it could be seen that there were approximately three missing slates to the original cottage and one to the rear extension and two loose slates overall. The chimney can to the right hand stack had been removed. The chimney haunching and top surface of the coping stones to the chimney could not be seen from ground level. The external cover to the light tunnel was in place. The pointing to the ridge tiles over the original building could be described as untidy, but appeared intact, as viewed from ground level.

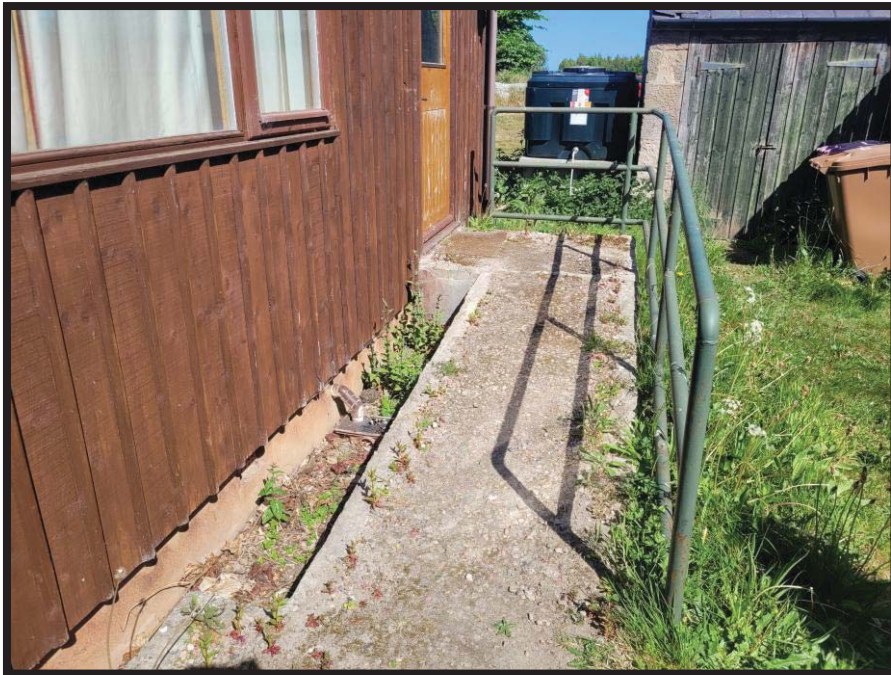
Photograph 18 Rear access ramp.

- 23 There was a certain amount of weathering to the paintwork to the front windows. No significant decay was evident.
- 24 There is a concrete access ramp to the rear door. The surface of the ramp was generally firm and even, but some areas were slightly weathered and the surface was beginning to deteriorate. The handrail was firm. There was a degree of vegetation growing over the edges of the paved areas.

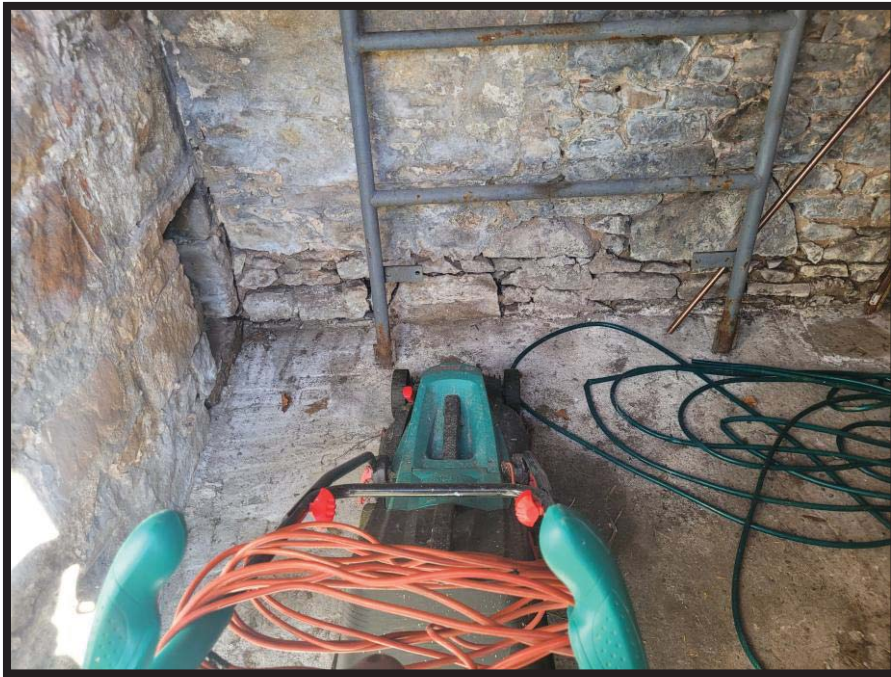
- 26 There was no obvious evidence of rodent infestation, in the form of droppings, nesting debris, odour or chewed building elements, either internally, externally or within the outbuilding.

Photograph 19 Interior of outbuilding showing no current evidence of rodents.
