Decision with Statement of Reasons of the First-tier Tribunal for Scotland (Housing and Property Chamber) under Section 24 of the Housing (Scotland) Act 2006

Chamber Ref: FTS/HPC/RP/24/4299

Re: 8 Whinknowe, Ashgill, Larkhall, ML9 3AP (“the Property”)

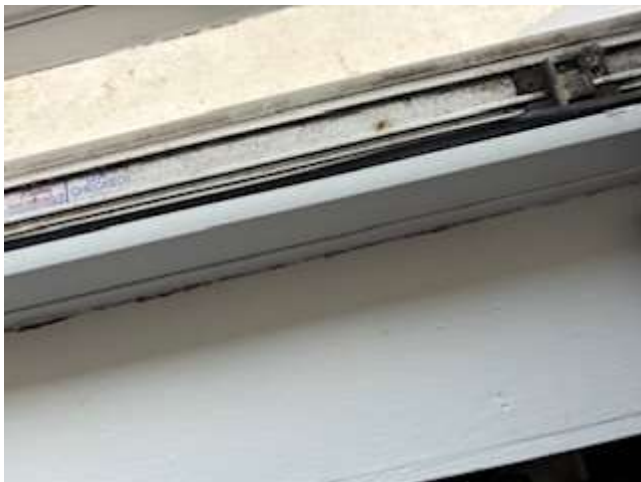
Bathroom Window

21. The window in the bathroom is uPVC framed type. It is opened by lifting the handle, which turns the latch. However, the mechanism within the window is not engaging with the handle. The window therefore never closes properly. The window also does not open fully. The rubber seal in the window is dried out and brittle.
22. The window is part of the structure of the Property. It is not in a reasonable state of repair, having regard to the age, character and prospective life of the

house, and its locality. In the circumstances, the failure to repair the window is a failure by the Respondent to comply with the repairing standard.

23. The Tribunal will require that the Respondent undertakes work to replace the window within 8 weeks.

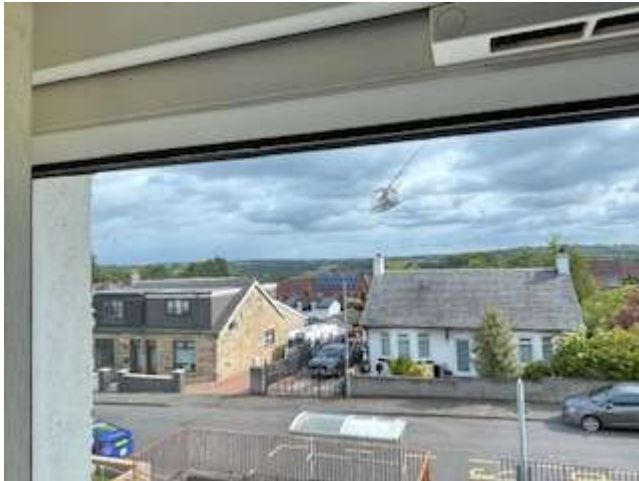
Front Bedroom Window

5. The front bedroom on the first floor of the Property has a sealed unit double-glazed pane. The external glazing has suffered significant impact damage, resulting in a hole, cracking and a piece of glass, approximately the size of a penny, becoming dislodged and sitting in the air gap between the panes.

6. The window is part of the structure of the Property. Whilst the damage caused is not sufficient to cause that area of the Property to fail to be wind or watertight, the damage is likely to affect the thermal performance of the unit. In any event, it cannot be said that a window displaying such damage is in a reasonable state of repair, having regard to the age, character and prospective life of the house, and the locality in which it is located. Accordingly, the Tribunal is satisfied that the failure to replace the glazing is a failure by the landlord to comply with the repairing standard.
7. The Tribunal will require that the Respondent undertakes work to replace the damaged glazing within 8 weeks.

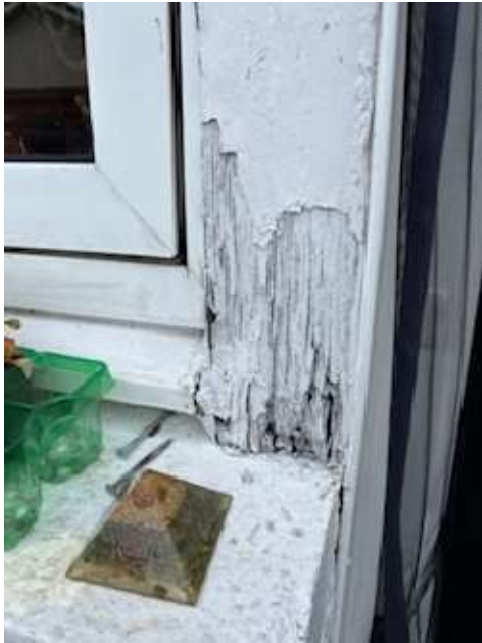
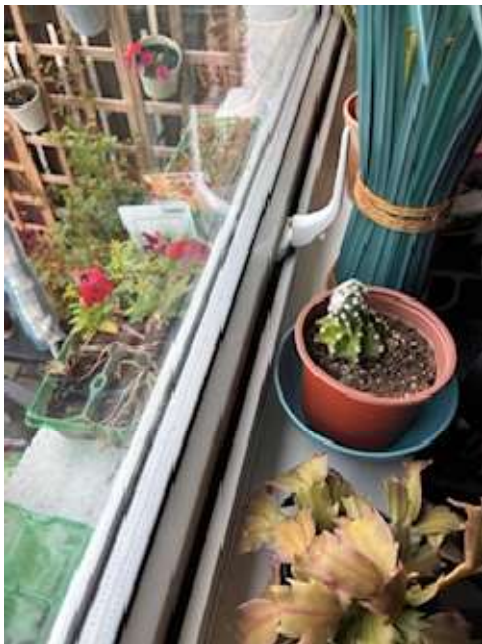
Kitchen Window

8. The window in the kitchen is a double-glazed unit. It is opened by using a handle, which is mechanically connected to a latch. The Tribunal observed that the rubber seal between the window and its frame has lost its pliability and is damaged. It is no longer sufficient to make the window wind and watertight.

9. Separately, the external timber facing surrounding the window is decayed and is also not wind or watertight.
10. The condition of the window and its surrounding fixings is such that the house is not wind and watertight in that location. Separately, the window and its surrounding fixings form part of the structure of the house, and are not in a reasonable state of repair, having regard to the age, character and prospective life of the house, and the locality in which it is located. Accordingly, the Tribunal is satisfied that the failure to repair/undertake repairs to the kitchen window is a failure by the landlord to comply with the repairing standard.

11. The Tribunal will require that the Respondent undertakes work to replace the defective window unit, and to replace the decayed external areas surrounding the window, all within 8 weeks.

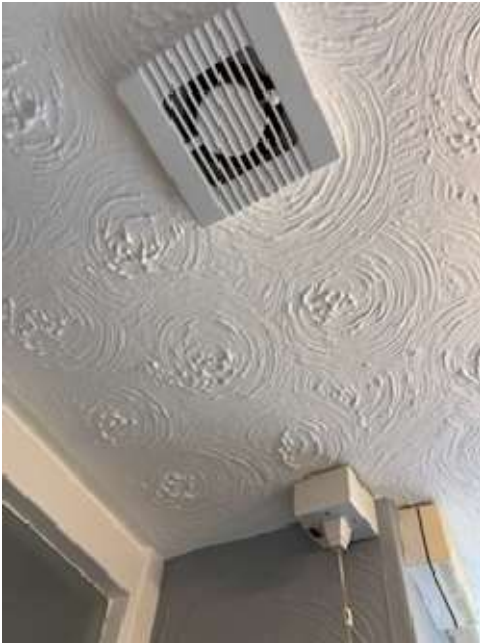
Bathroom Extract fan

17. The bathroom is fitted with a mechanical extractor fan. It is a new fan, which replaced a previous fan that had broken. The previous fan was connected to the bathroom light fitting, such that both came on when the switch was depressed. Since the new fan was fitted, it has not worked. The Applicants asserted that the person who fitted the fan said that he did not know how to connect it.

18. The bathroom fan is a fixture, fitting or appliance provided by the Respondent. It is not in working order. Accordingly, the failure to put the bathroom fan into working order is a failure by the Respondent to comply with the repairing standard.

19. The Tribunal will require that the Respondent arranges for the bathroom fan to be put into proper working order by a qualified electrician. The Tribunal will also require that the Respondent produces an Electrical Installation Condition Report ("EICR"). Those works must be completed within 8 weeks.

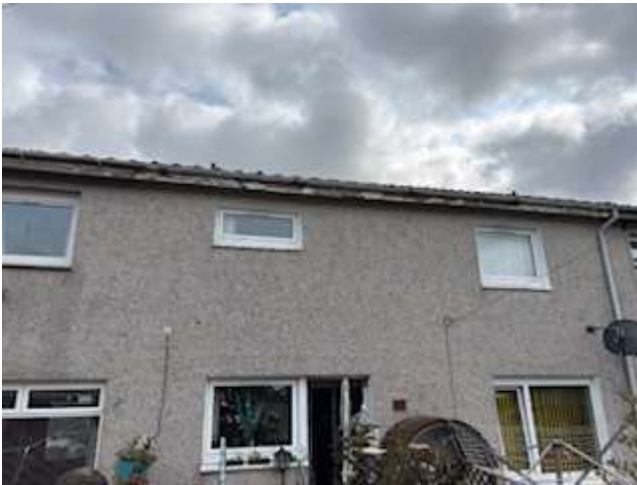
Rear Gutters

25. The Tribunal observed that the gutters did not appear to be graded correctly to ensure sufficient discharge to the downpipe connected. The fascia beneath the gutters is also showing signs of water damage and decay.

26. The gutters form part of the structure of the Property. They are not in reasonable state of repair. Accordingly, the failure of the Respondent to repair the gutters is a failure to comply with the repairing standard.

27. The Tribunal will require that the Respondent undertakes work to undertake such works as may be required to the gutters to ensure that surface water is collected and discharged to a downpipe leading to the public sewer. Thereafter, the Respondent is required to test the gutters for any escape of water and to repair any leaks evident from that test. The Tribunal will require that the Respondent attend to those repairs within 8 weeks.
