**STATEMENT OF DECISION OF THE TRIBUNAL UNDER SECTION 25 (1) OF THE
HOUSING (SCOTLAND) ACT 2006**

Chamber Ref: FTS/HPC/RP/24/2549

Wee Glen, Skyreburn, Gatehouse of Fleet, DG7 2HG ("the House")

First-Tier Tribunal for Scotland (Housing and Property Chamber) Re-inspection report

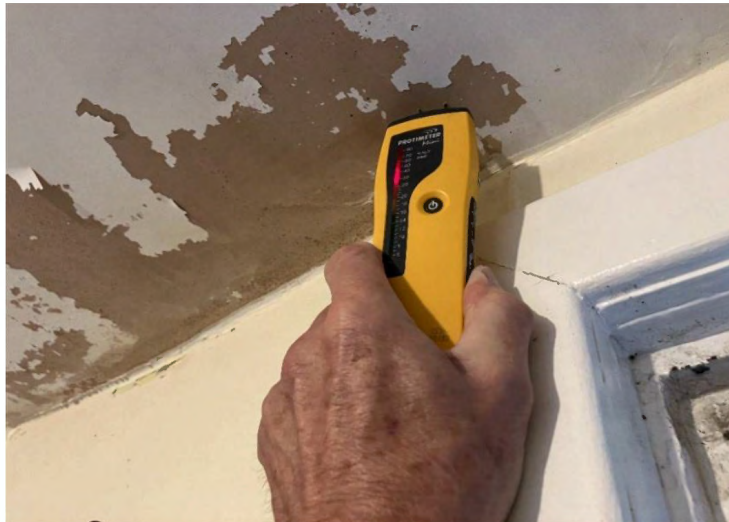
Utility room damp staining at ceiling 14-10-24

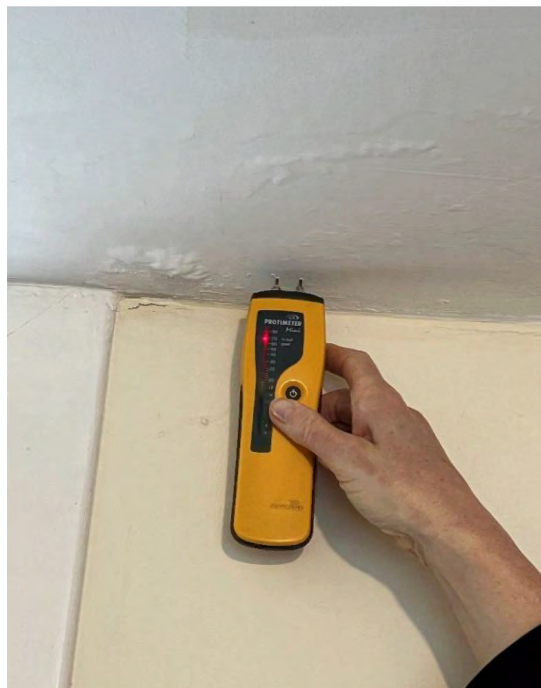
Utility room damp readings present at ceiling 31-07-25

Since the original inspection the property, including the utility room has undergone a scheme of internal redecoration and the previously flaking paintwork on the utility ceiling, repaired. Moisture readings taken at the ceiling adjacent to the rear wall remain high and at a level likely to cause further deterioration if left unrepaired.

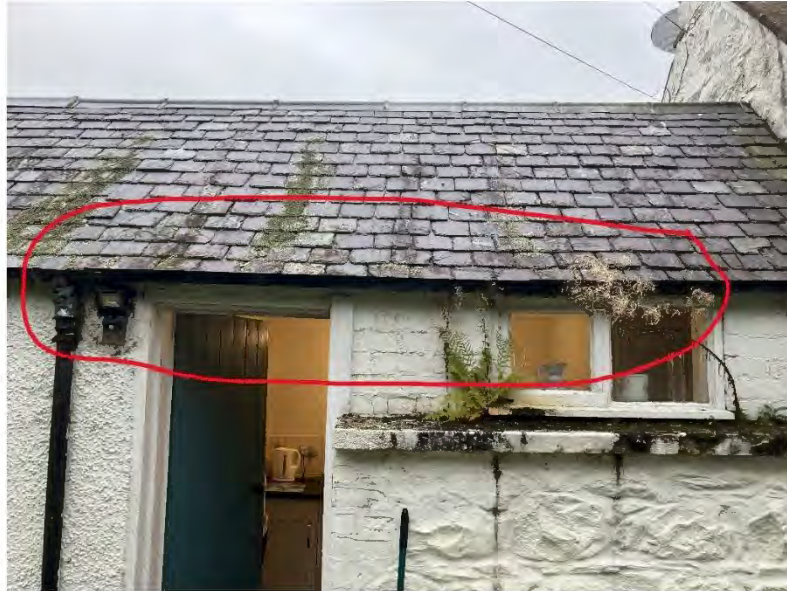
14-10-24

Area circled in red highlights badly corroded and broken rainwater goods and chipped slates immediately above and outside the utility area.

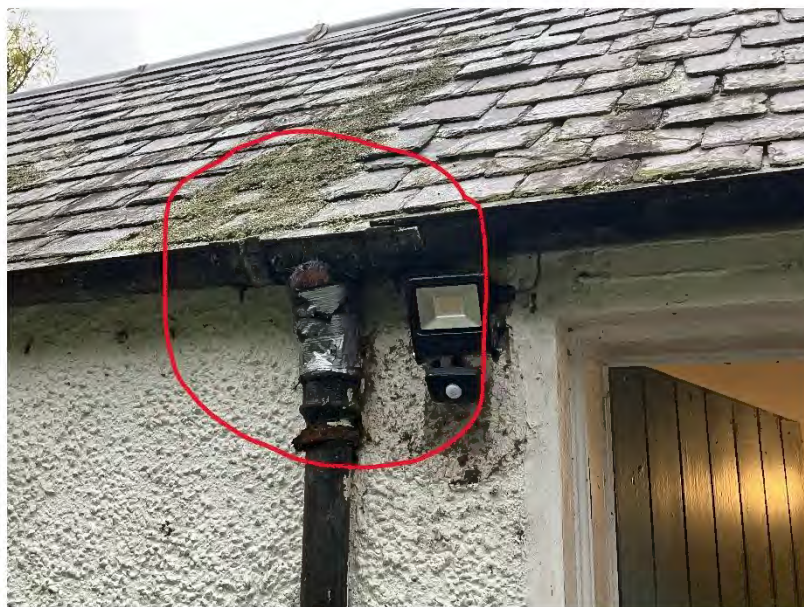
14-10-24

Temporary repair between corroded downpipe and gutter outside the utility area.

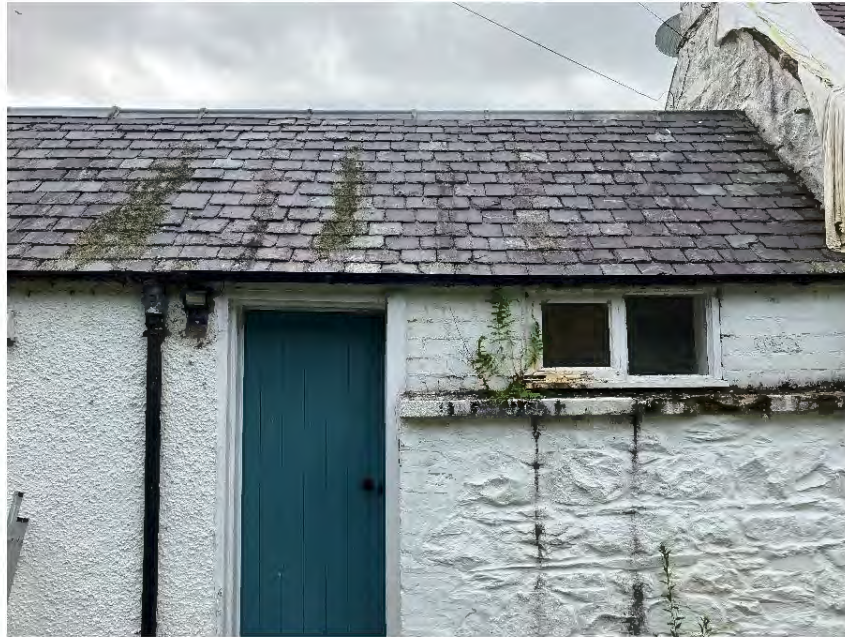
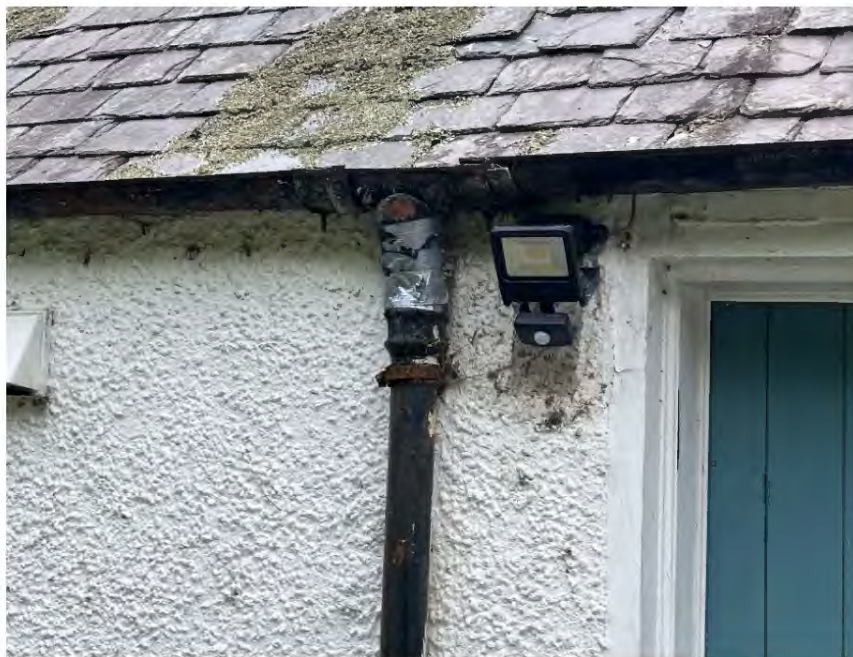
The corroded gutter and temporary repair at the rear wall of the utility area remain representing a potential/possible source of the damp/water ingress affecting the utility room ceiling

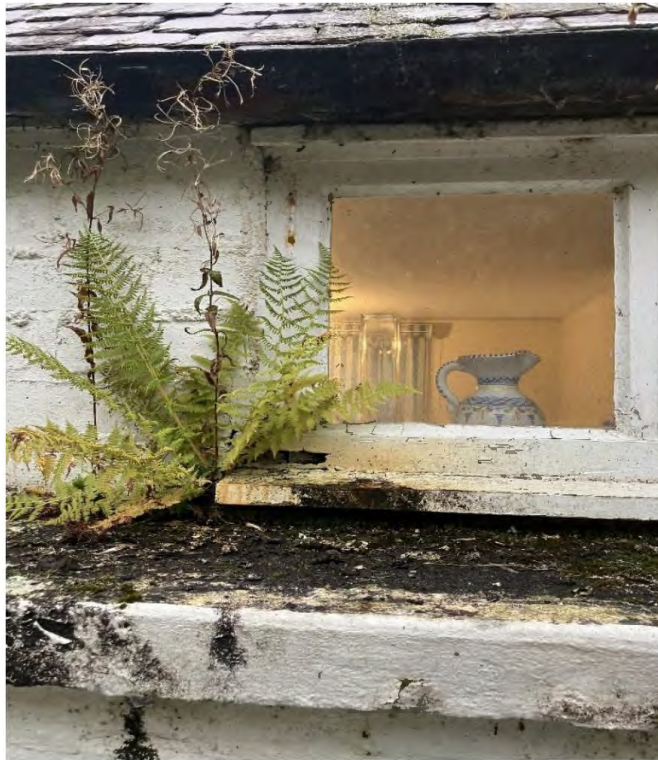
14-10-24

Rot and vegetation growth at window and sill of utility room.

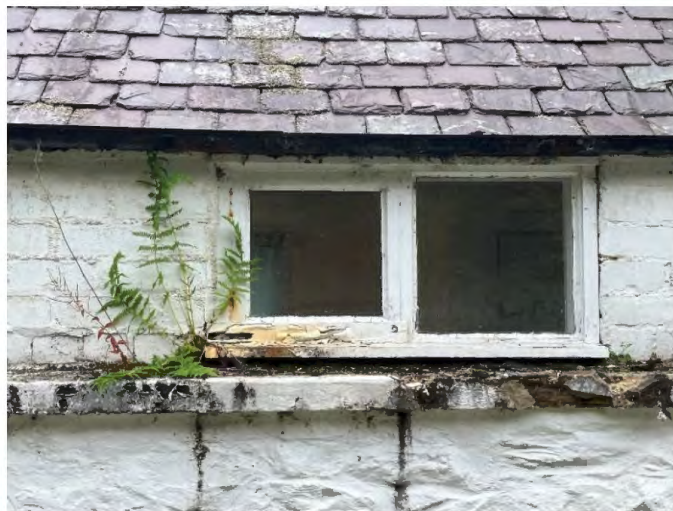
31-07-25

Rot and vegetation growth affecting rear window and sill of utility room remains.

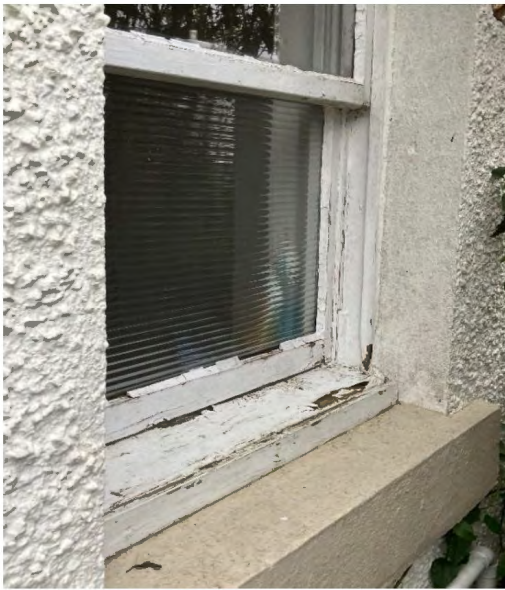
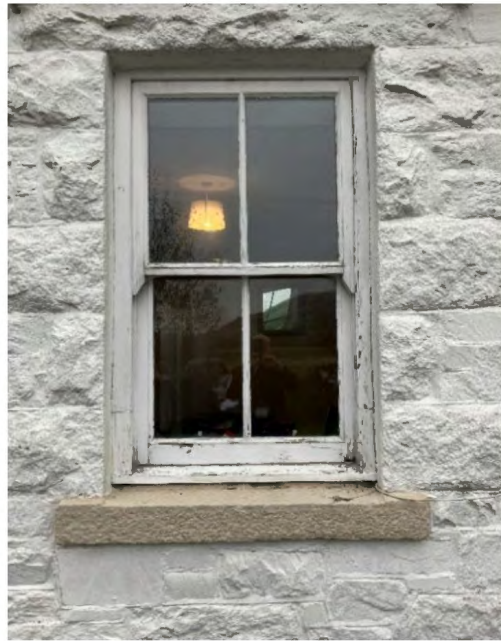
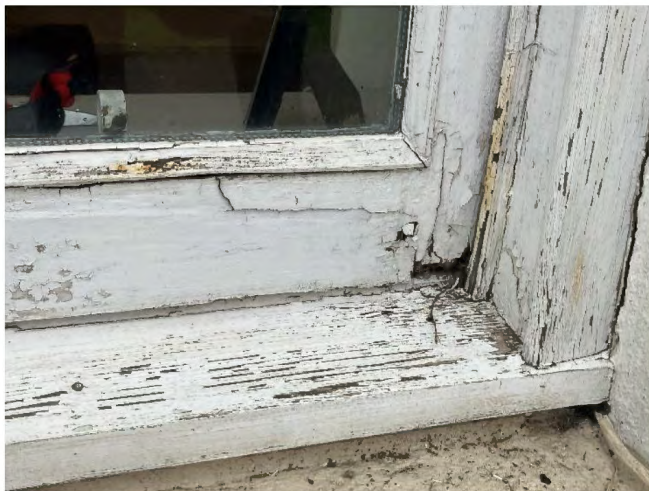
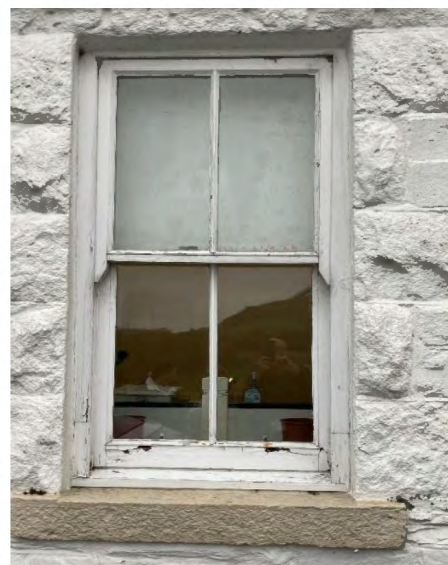
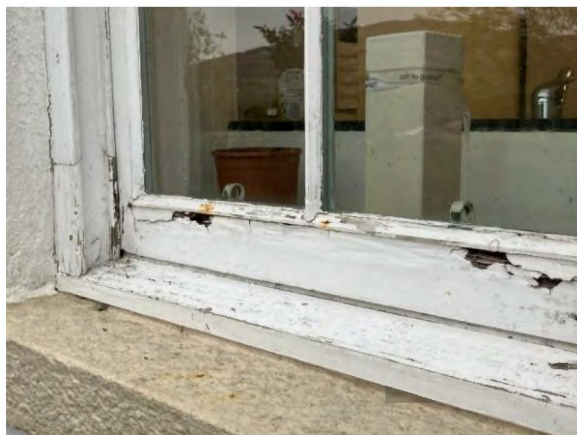
The five **photographs (1/1 – 1/5)** on the following page were taken during the original inspection of the property on 14 October 2024 and highlight localised areas of rot affecting sections of the windows and surrounding frames at the living room bathroom and kitchen widows.

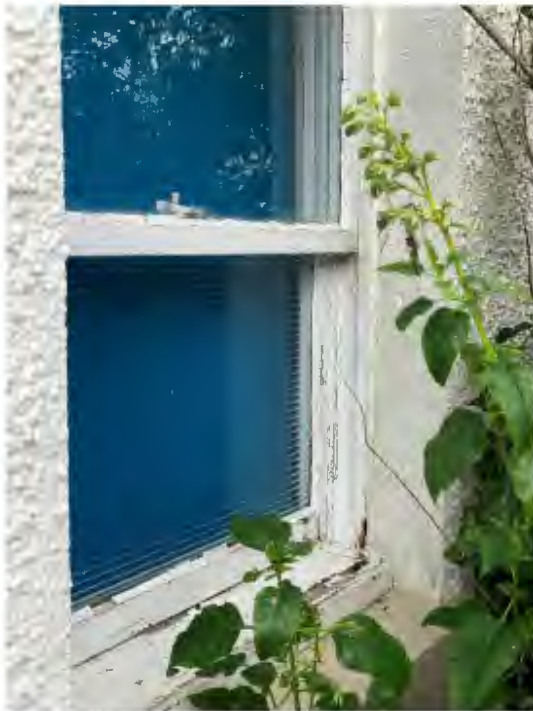
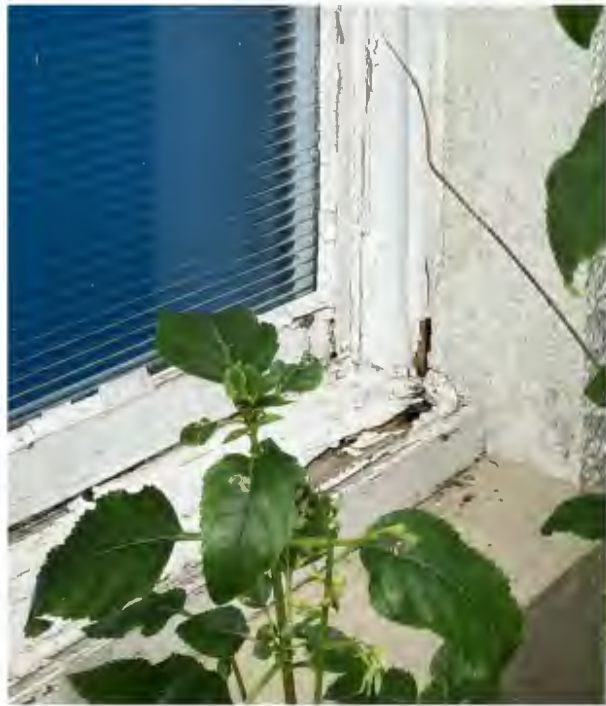
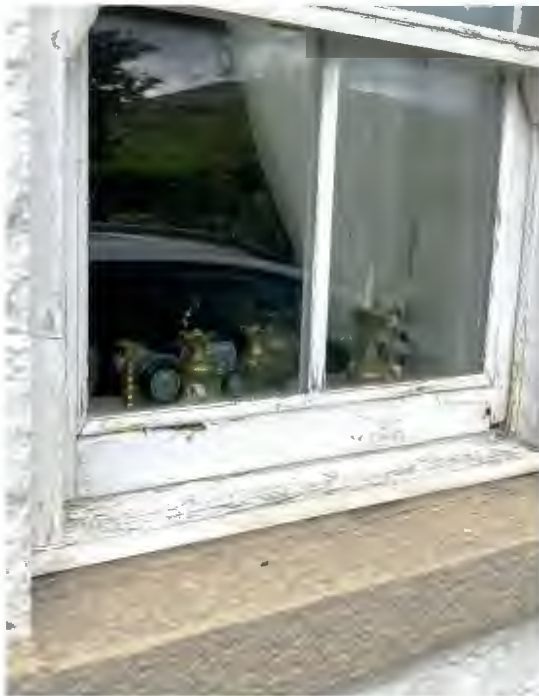
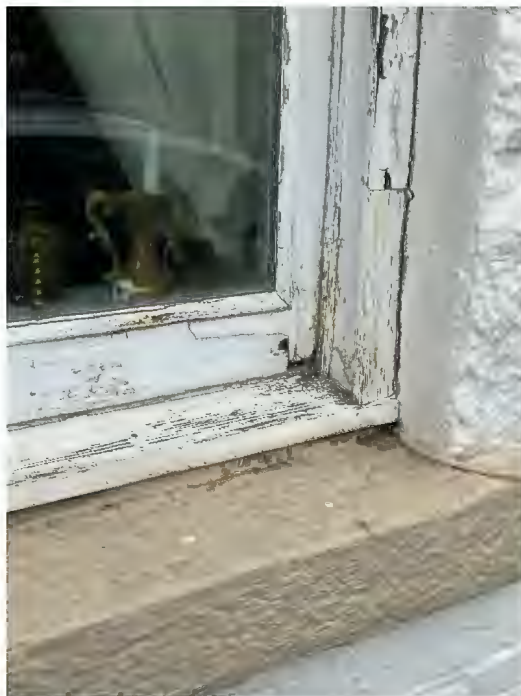
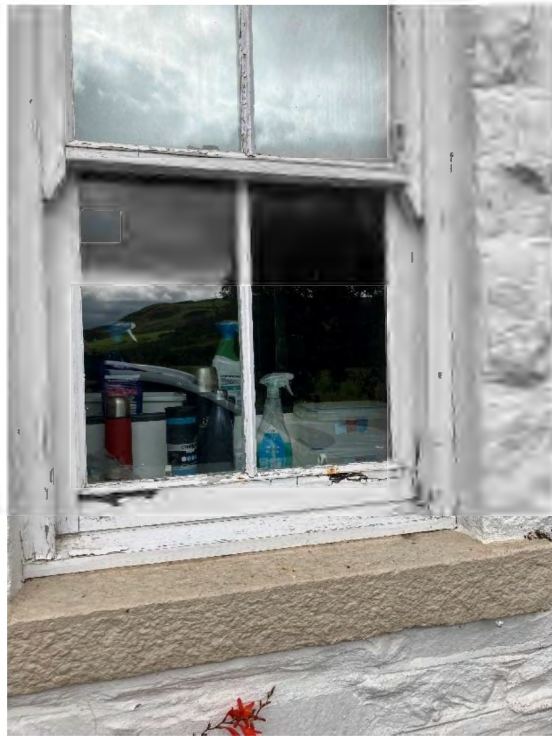
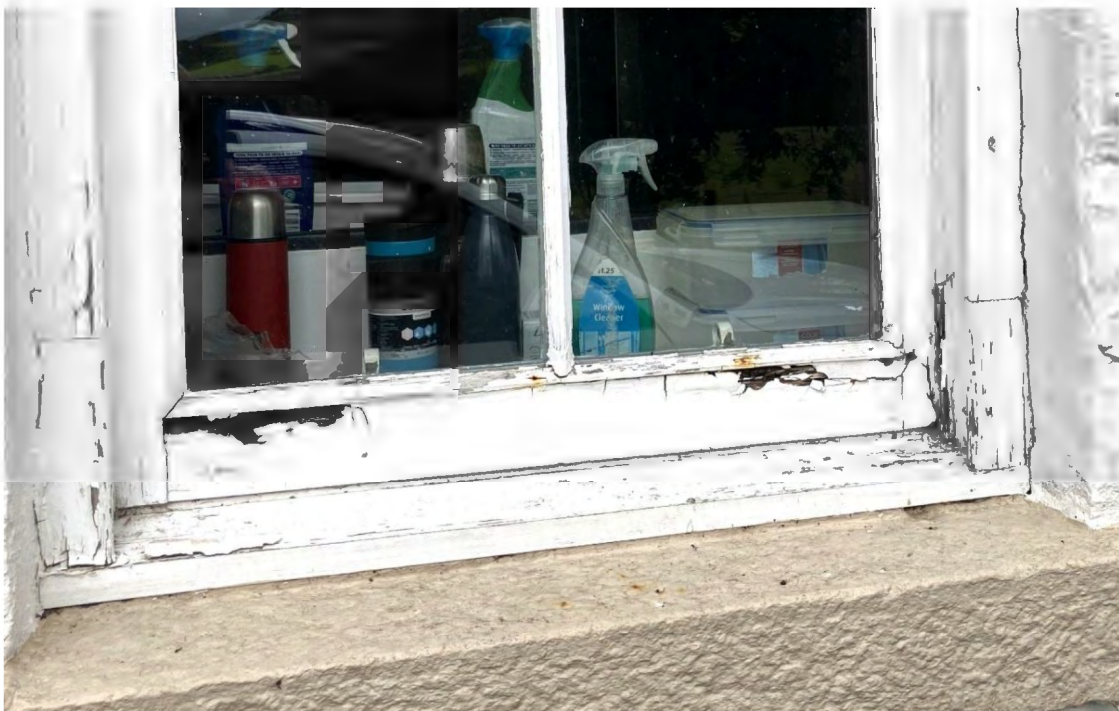
The following six **photographs (2/1 - 2/6)** were all taken during the reinspection on 31 July 2025 and confirm that no repairs have been completed to the timber window frames and sills where timber decay remains.

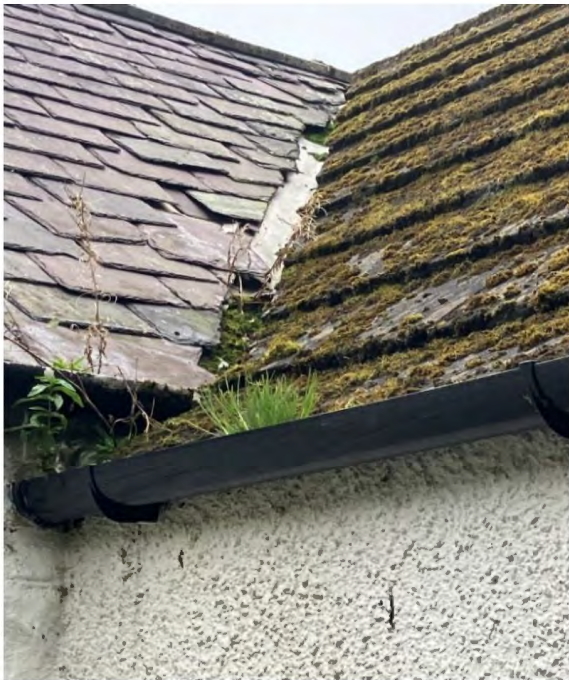
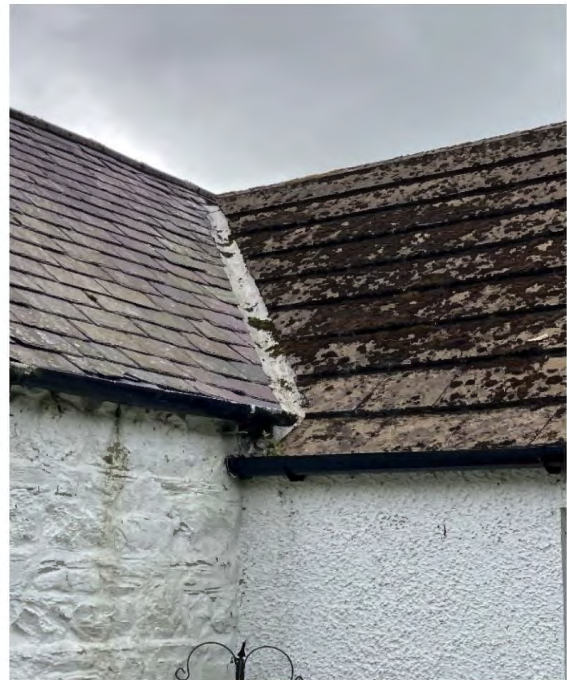
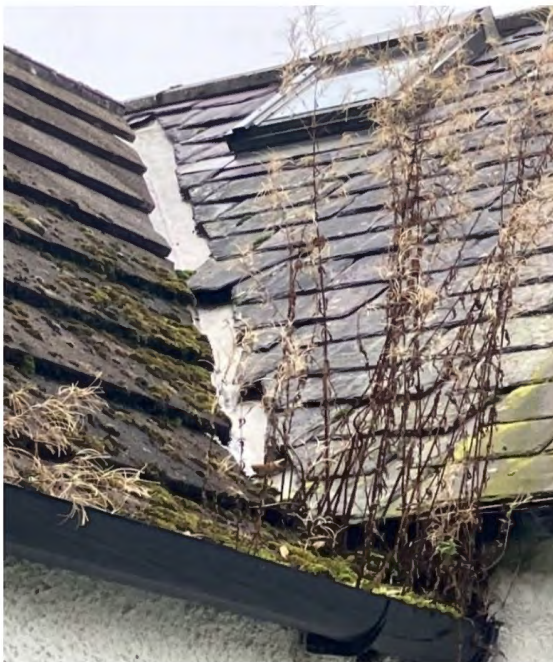
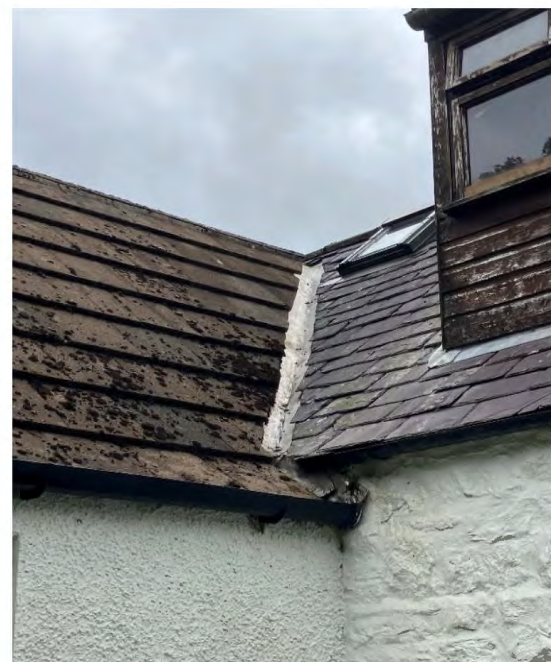
The loose slipped and missing slates around the rear valley gutters have been repaired and or replaced. Small areas of moss remain although the majority of the moss and vegetation has been cleared from the valley gutters since the original inspection.
