Decision with Statement of Reasons of the First-tier Tribunal for Scotland (Housing and Property Chamber) in terms of Section 24(1) of the Housing (Scotland) Act 2006

Reference number: FTS/HPC/RP/25/3407

Re: Property : 3 Westwood, Argyle Terrace, Isle of Bute PA20 OBE (recorded in the General Register of Sasines for the Burgh of Rothesay on 1 July 1999) (“Property”)

Schedule of Photographs taken during the
inspection by tribunal members on 4 March
2026

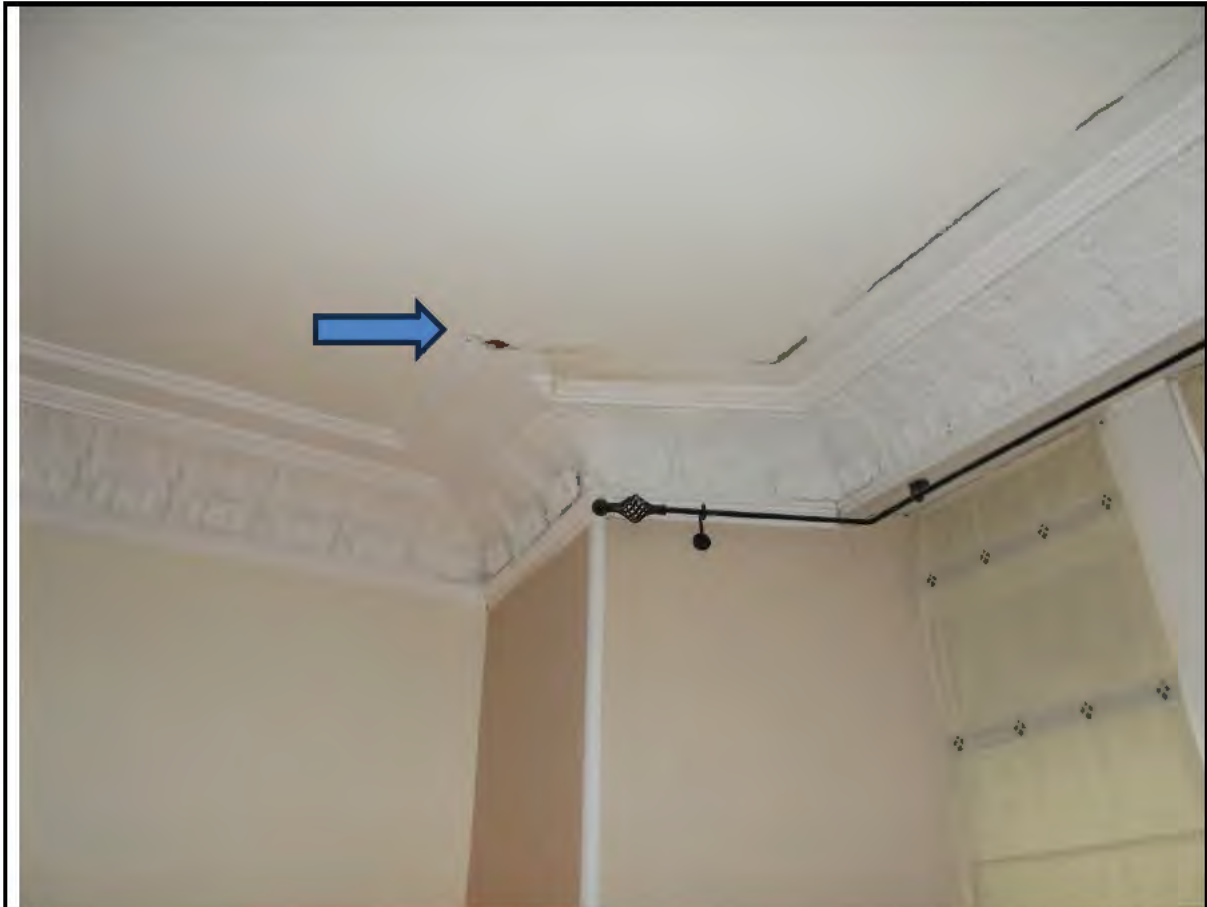
14.3.1 Living room – water penetration to side of window

1. Living Room ceiling near front elevation, to side of window, with reported water penetration from roof above at position arrowed.

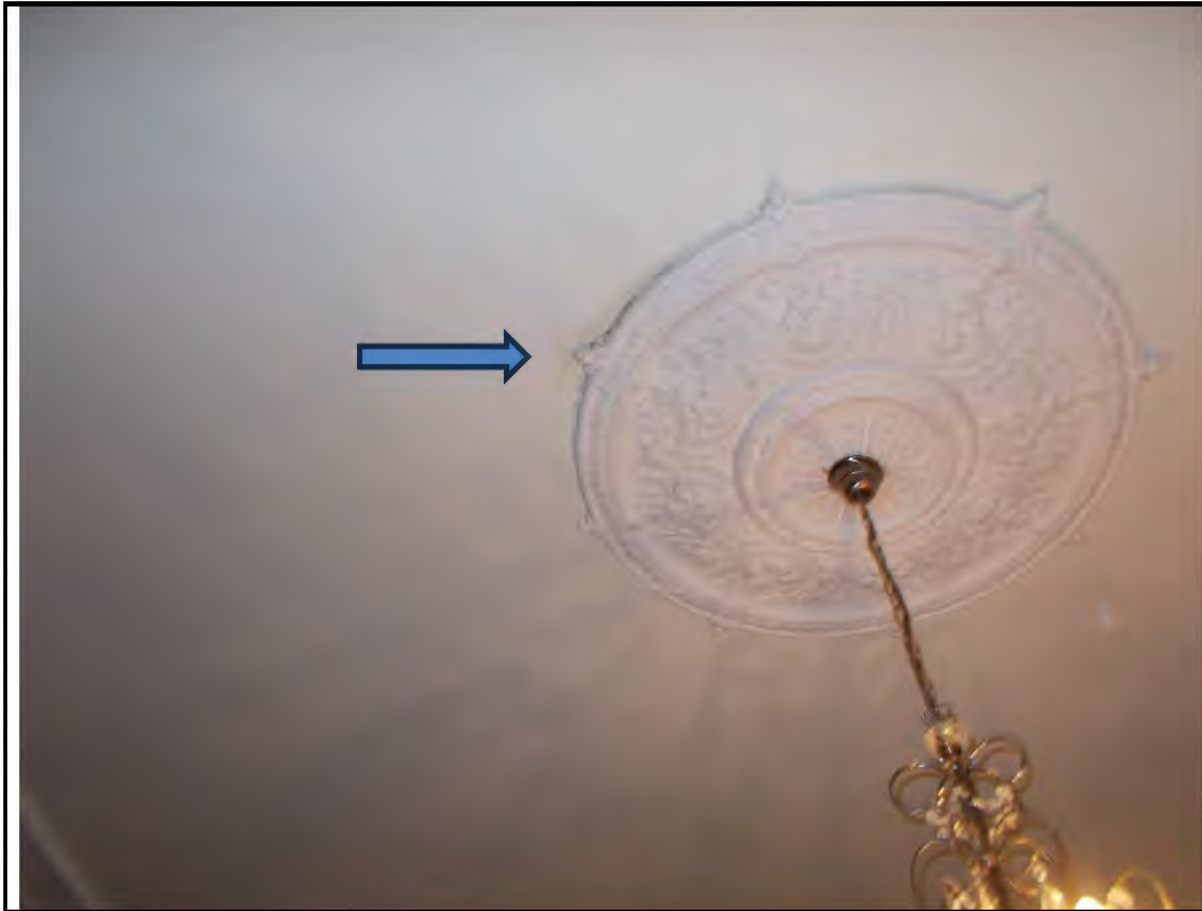
14.3.2 Front bedroom – water penetration at ceiling rose near centre of the room; water penetration on ceiling at bay window

2. Front Bedroom near centre of the room at rose around light fitting with reported water penetration in position arrowed. Source not identified as there is an apartment above.

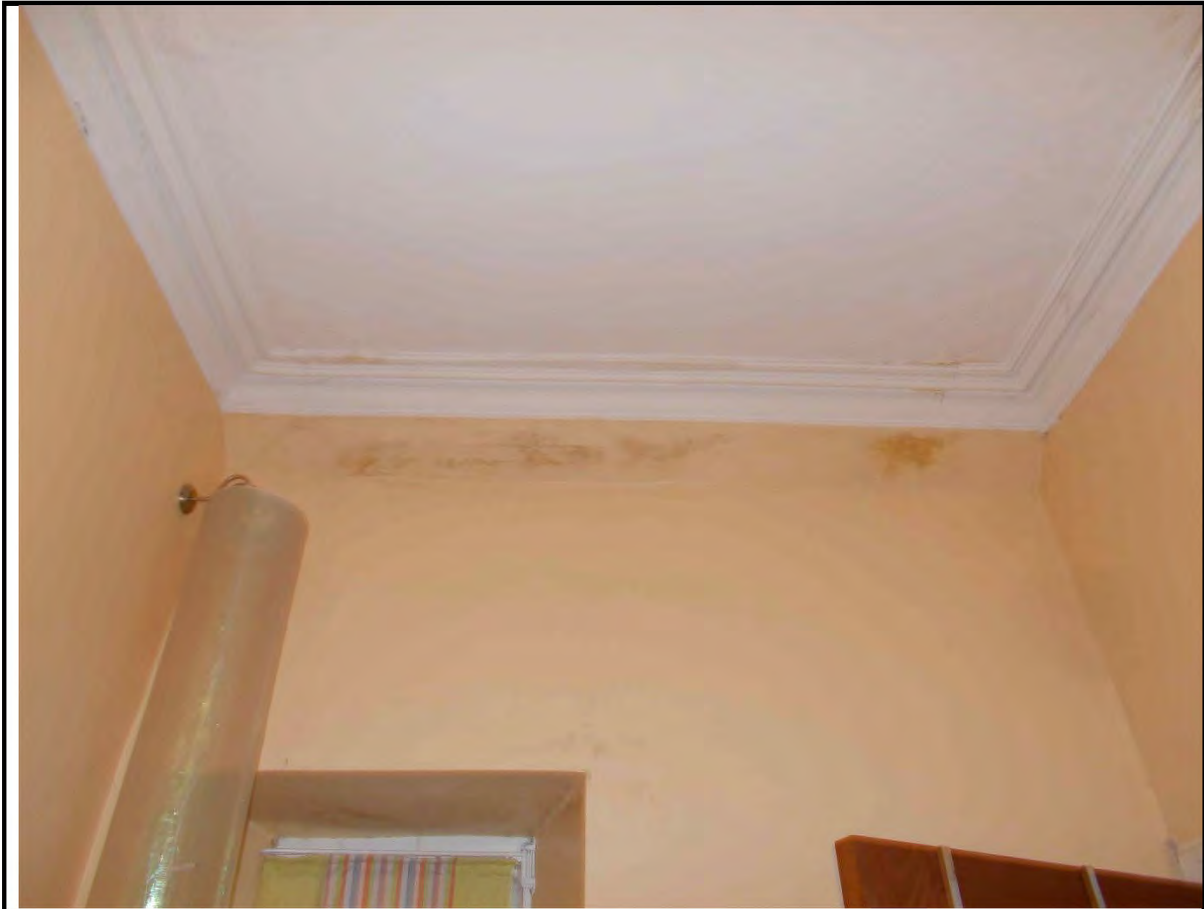
14.3.3 Dressing room – damp staining just below cornice on outer wall; water penetration at window

3. Dressing Room at outer wall just below cornice damp staining indicative of defects in roof/Velux/wall/gutter.

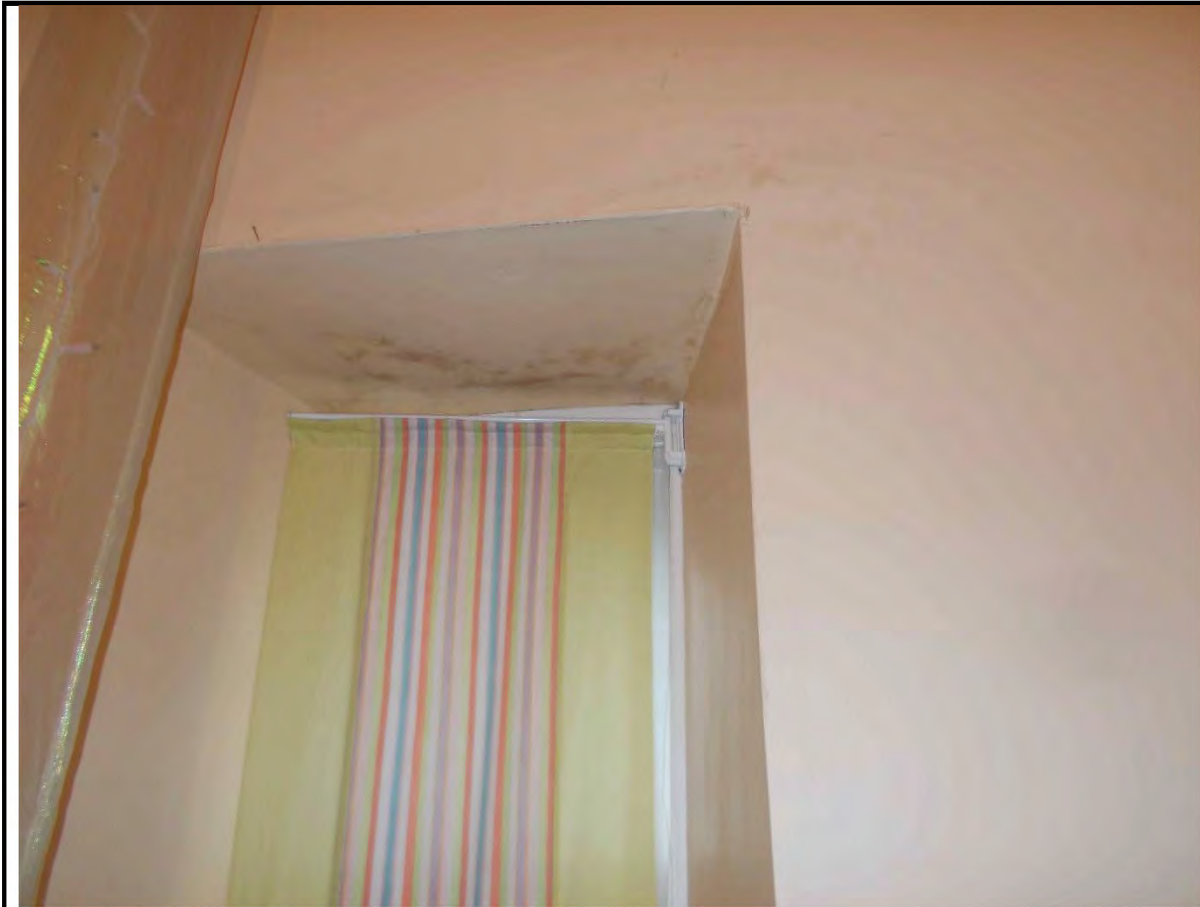
4. Dressing Room soffit of window in outer wall with reported water penetration indicative of defects in roof/Velux/wall/gutter.

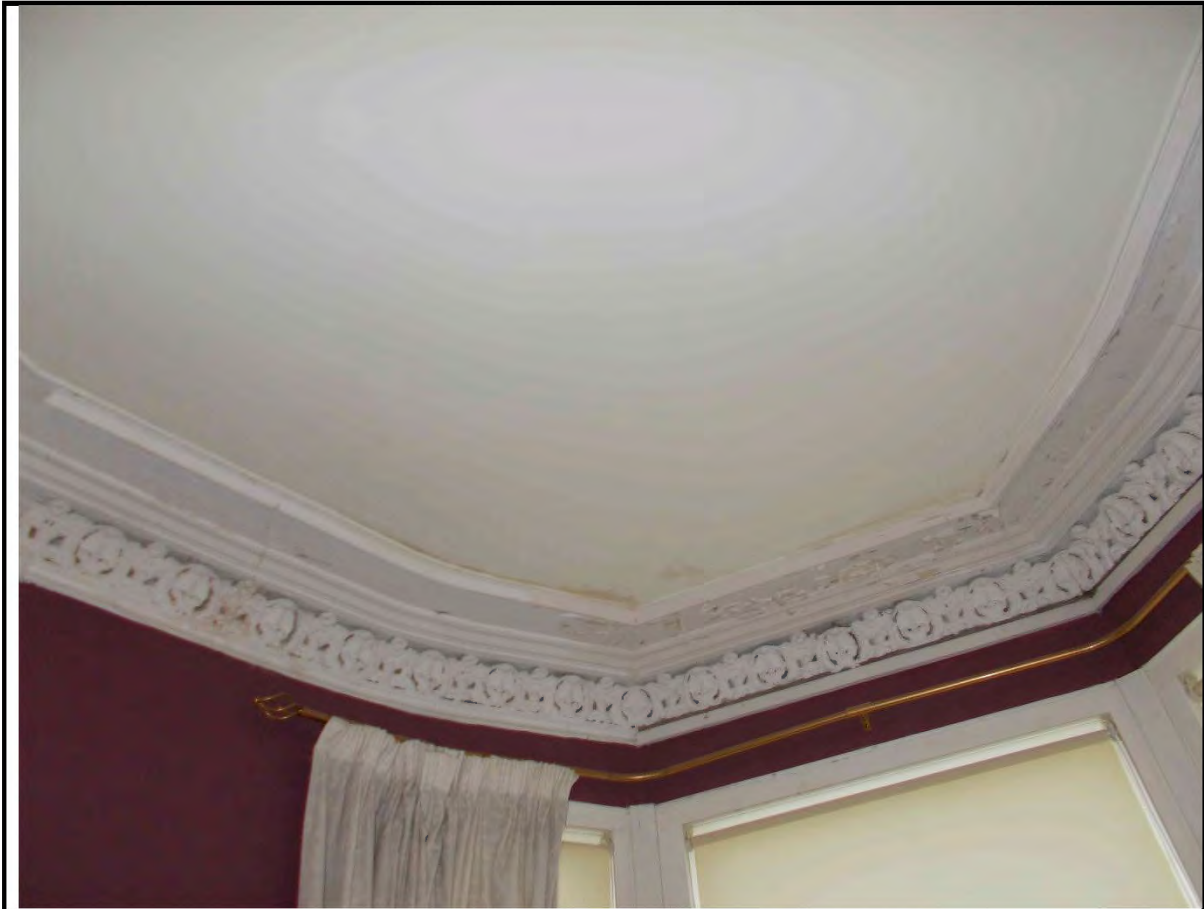
5. Front Bedroom Bay Window ceiling with signs of previous water penetration reported as not currently active.

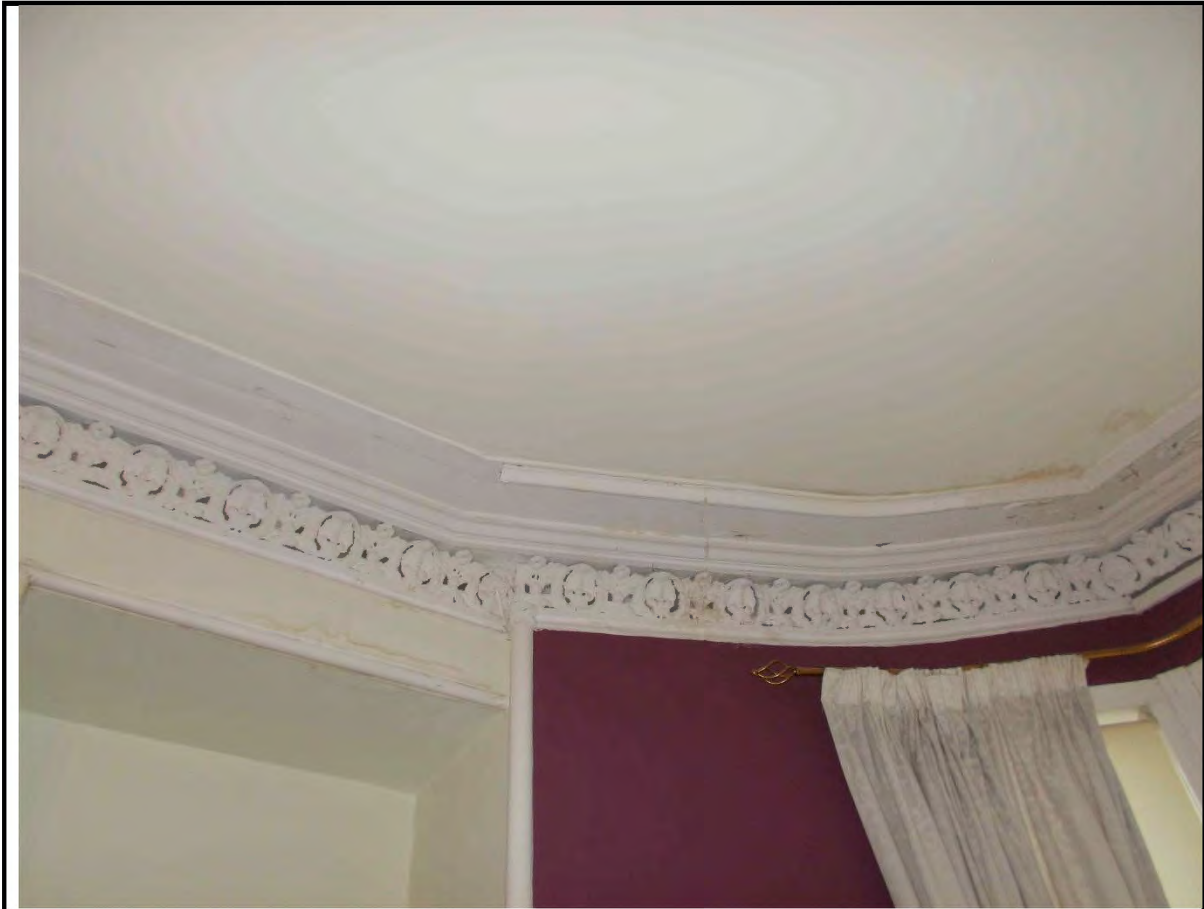
6. Front Bedroom Bay Window ceiling with signs of previous water penetration reported as not currently active.

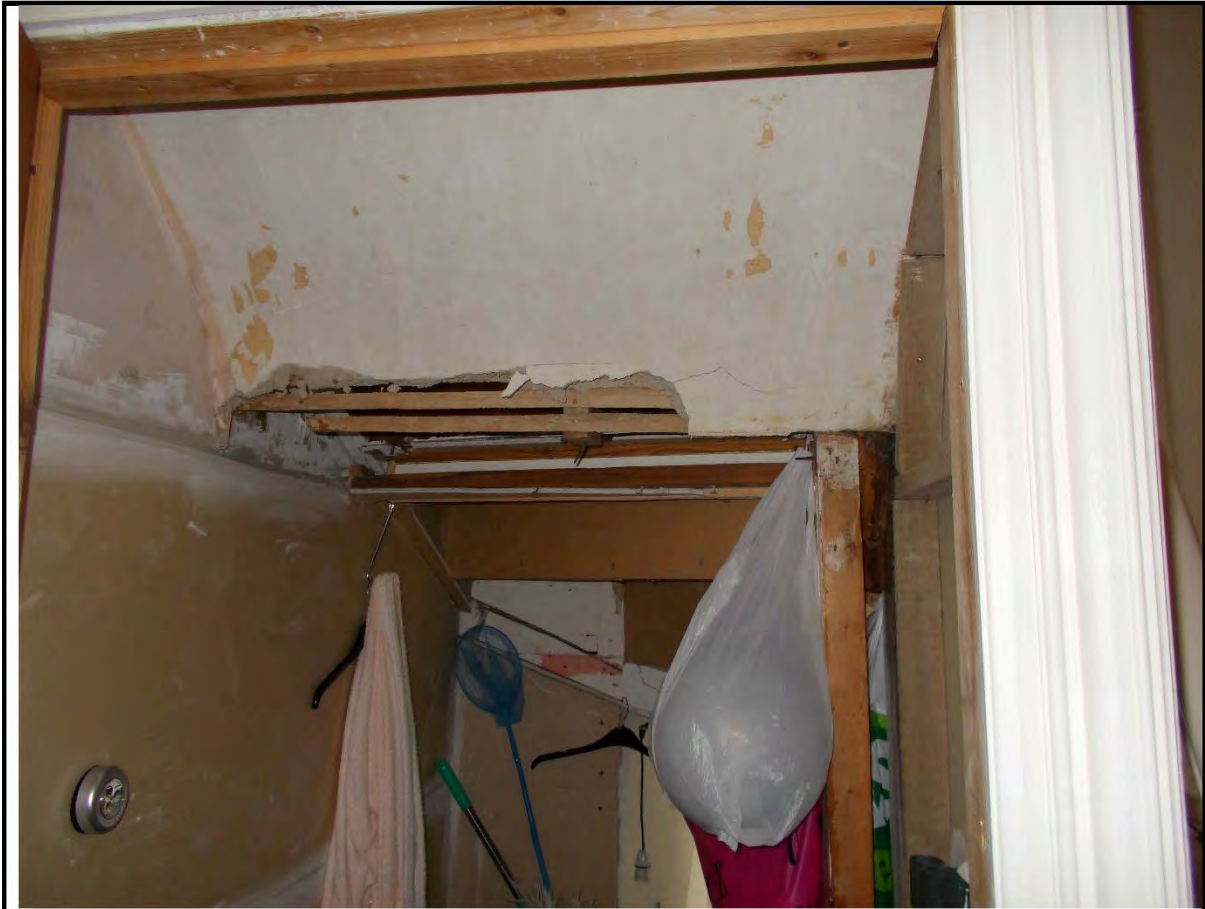
14.3.4 Cupboard below stair to attic – plasterwork damaged following reported water penetration

7. Cupboard below stair to Attic Level. Plasterwork damaged reportedly following water penetration.

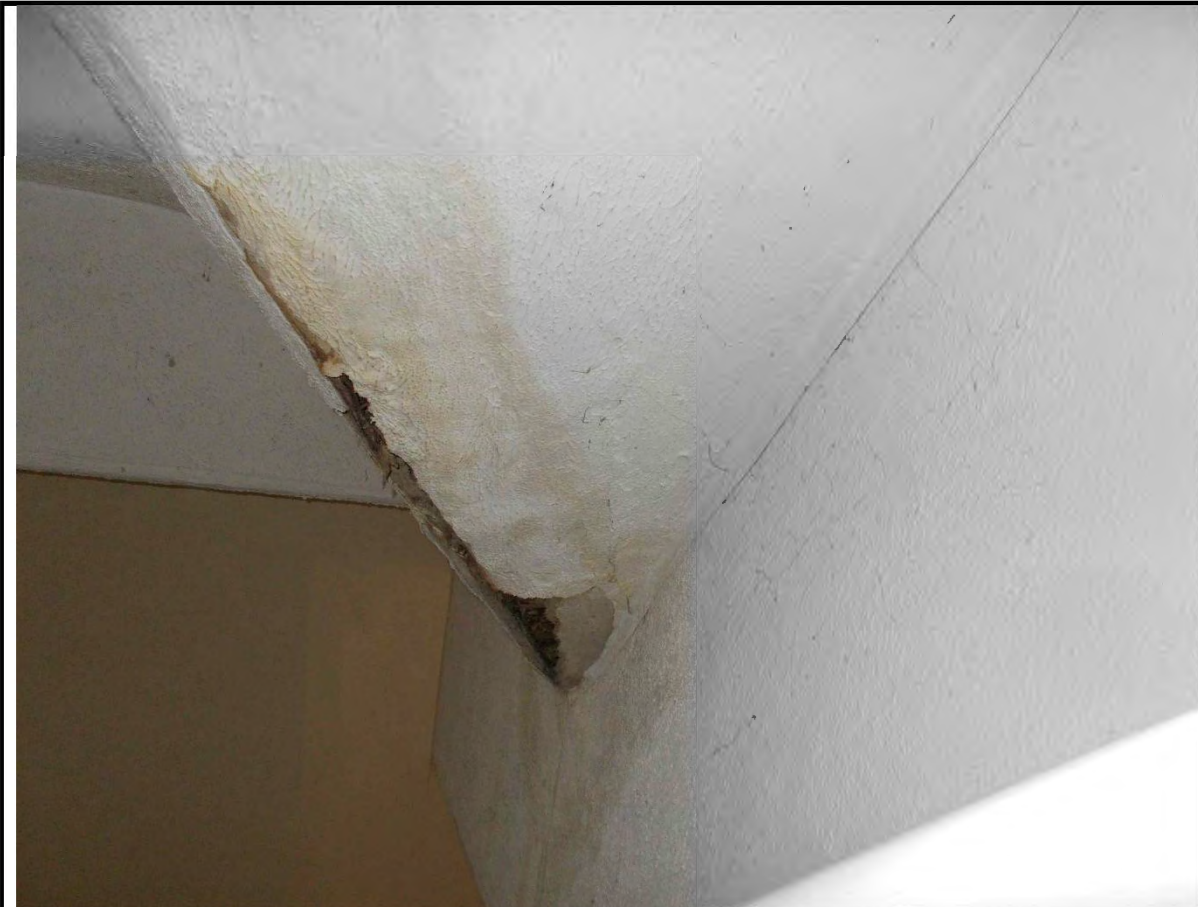
14.3.5 Stair to attic – water damage indicative of water penetration

8. Stair to Attic Level. Water damage reported indicative of water penetration at valley gutter.

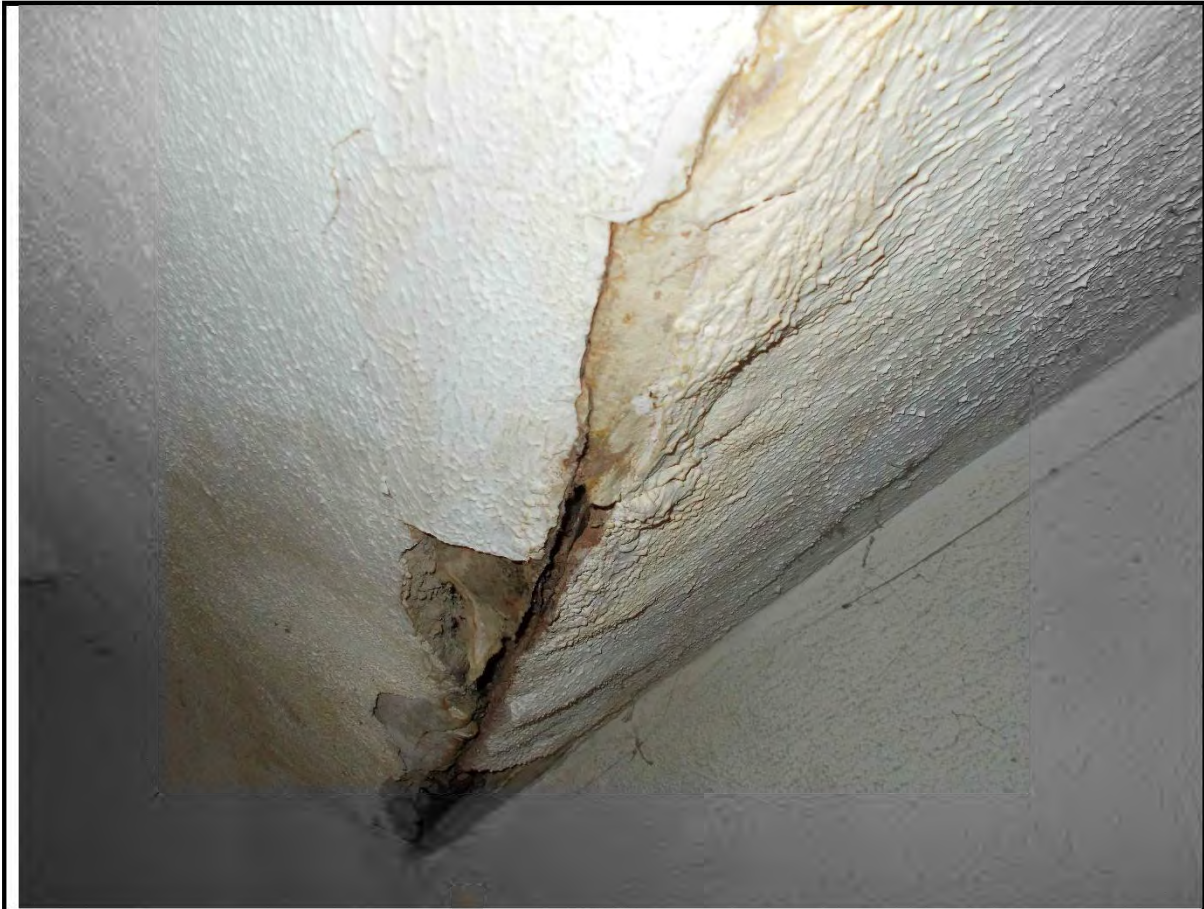
9. Stair to Attic Level. Water damage reported indicative of water penetration at valley gutter.

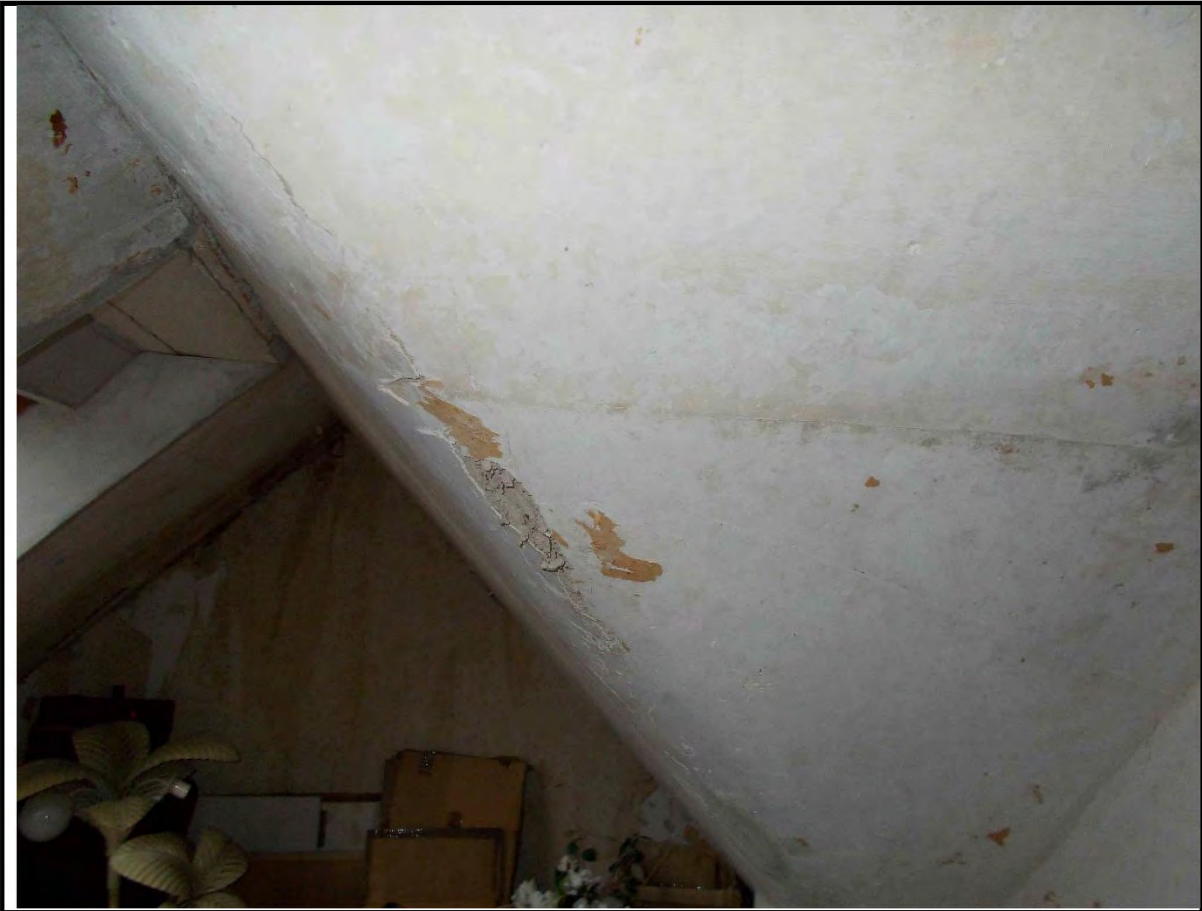
14.3.7 Attic storeroom (road side) – evidence of water penetration from valley gutter

10. Attic storeroom to rear. Indicated previous water penetration from valley gutter.

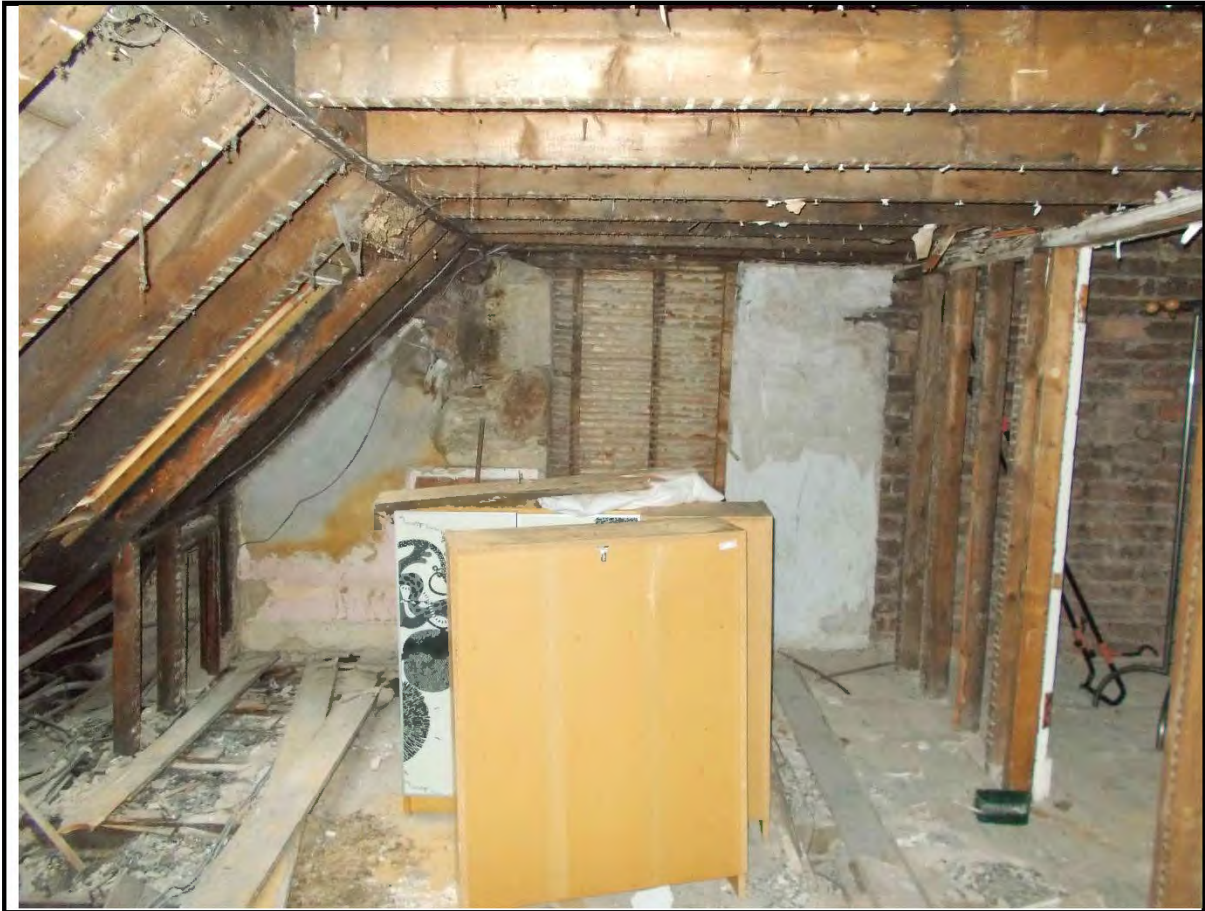
11. Stripped out attic area.

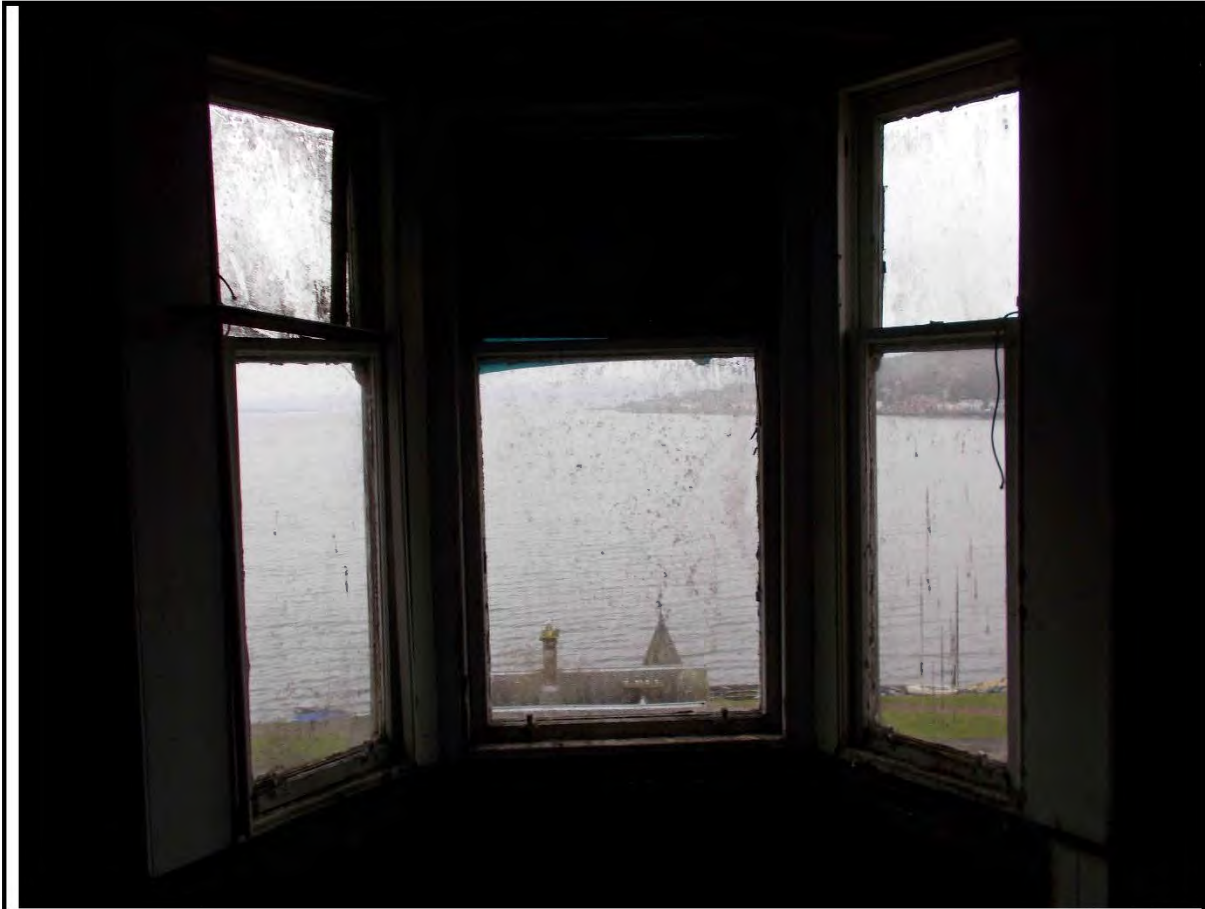
14.3.8 Attic- bay window in poor condition; water penetration at velux window

12. Attic Level Bay Window in poor condition.

7. The Tribunal noted that the Landlord had applied for planning permission to replace a window in the Property. Mr Price said that he understood that planning permission had been granted to replace the bay window in the attic space. He said that he had instructed a window fitter, Garry Higgins, who had ordered a new window and was waiting to hear from the manufacturer when it would be available for fitting.

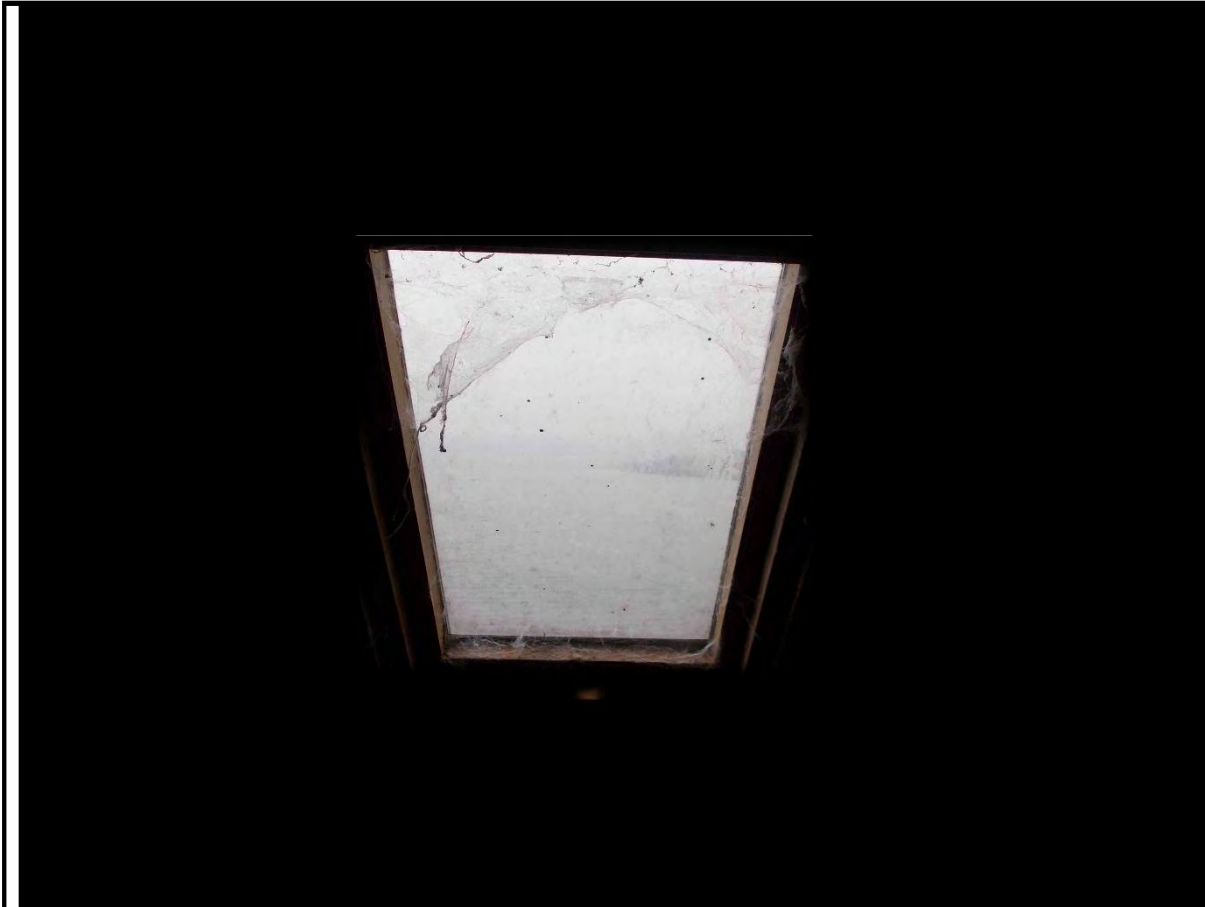
13. Velux window over Dressing Room below.

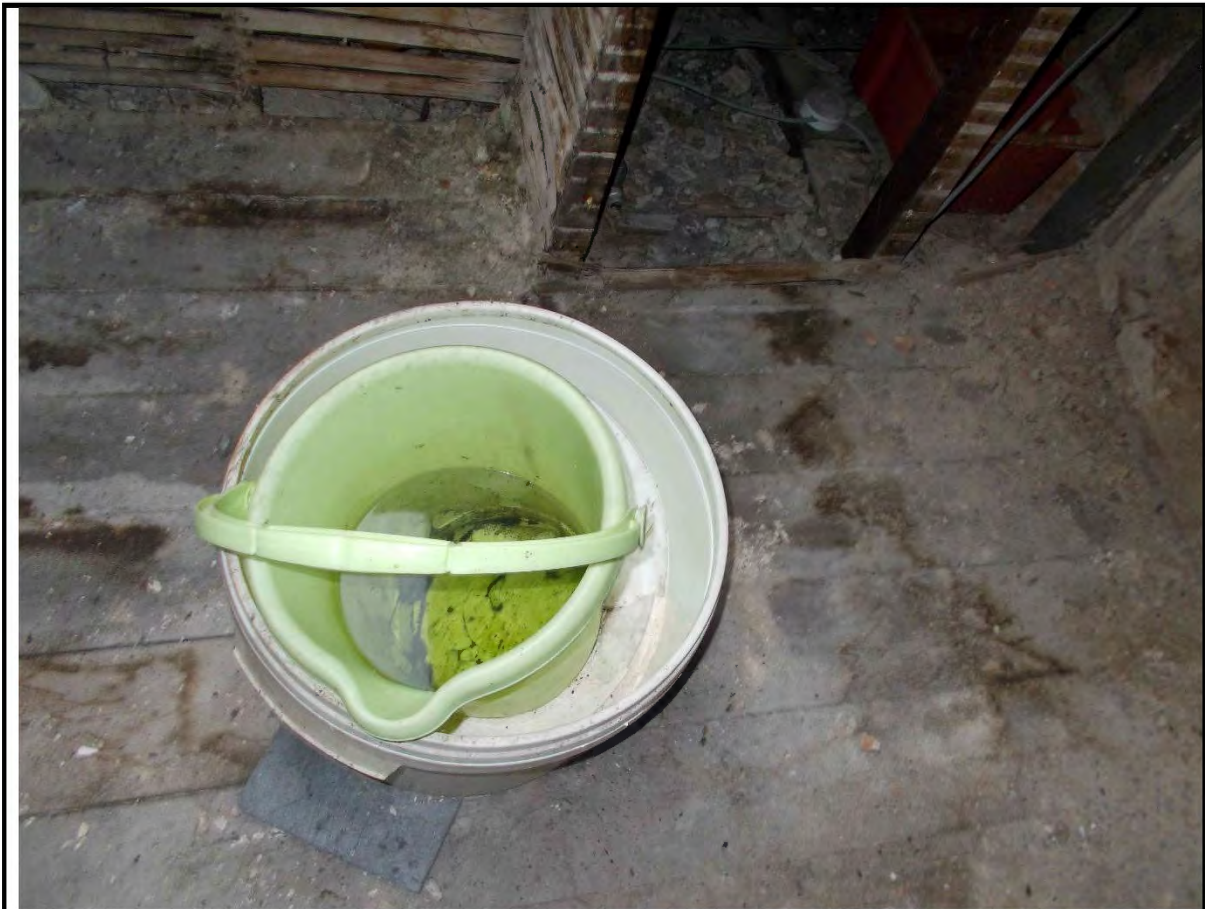
14. Water collected in bucket below Velux window above Dressing Room below.

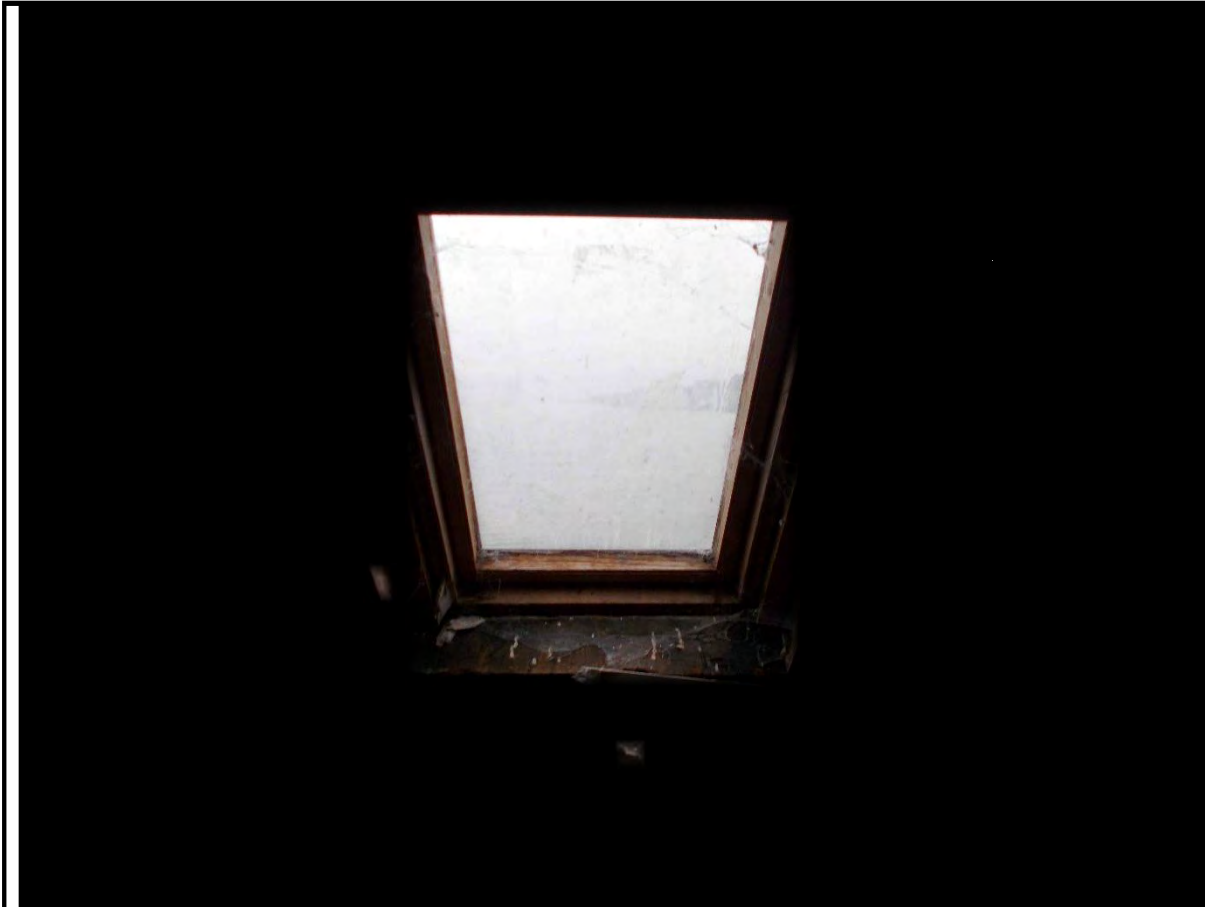
15. Velux window above Living Room below.

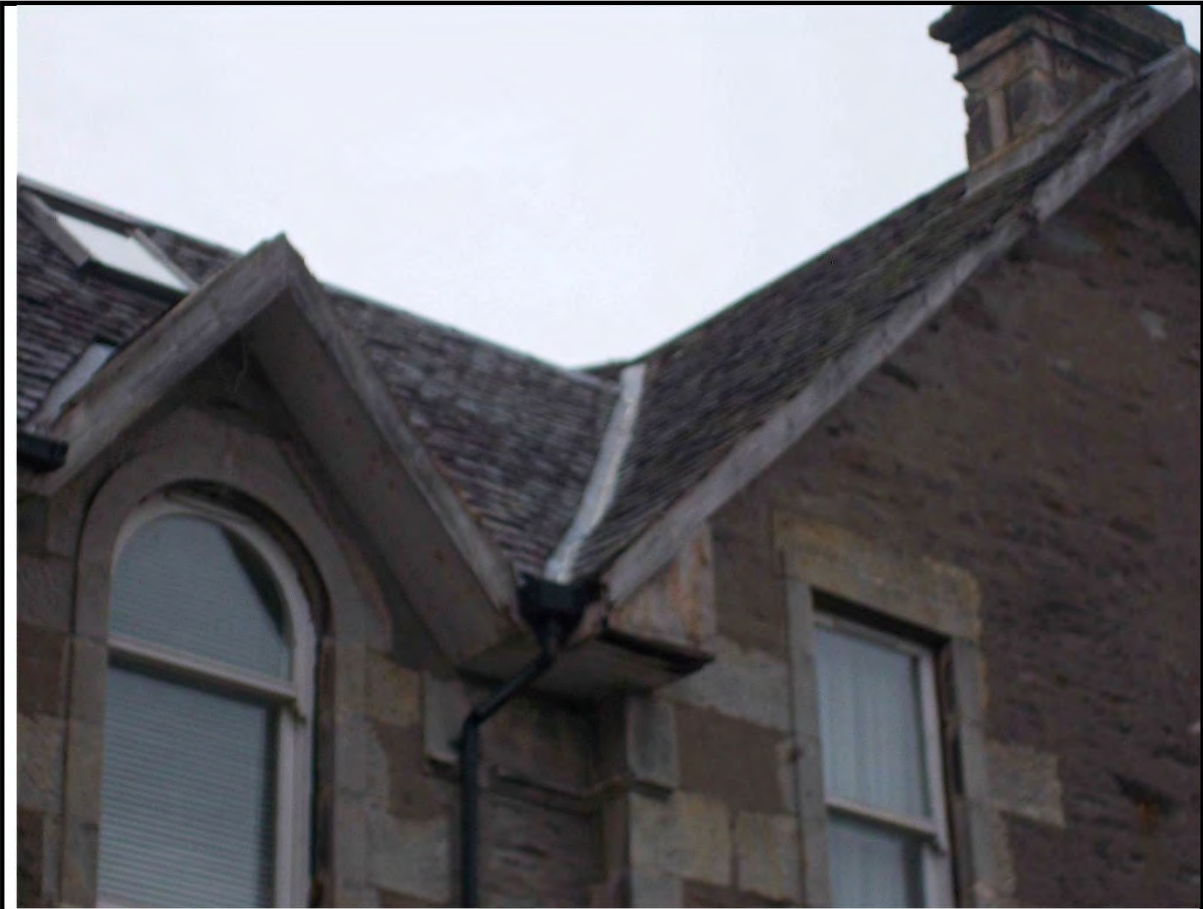
16. Valley Gutter over stair to Attic Level.

8. The Tribunal noted that there are a number of areas of water ingress in the Property. Mr Price said he was fairly sure it was all due to the window in the attic space. The Tribunal noted there is damage to the ceiling on the staircase from the first floor to the attic space which appeared to be due to the valley gutter on the other side of the roof. Mr Price said that he did not know about water ingress on the stair. He said that he had contacted a roofer, Ian McMillan trading as Wright Pryce, and he had agreed to examine the roof. Mr Price said that if the roofer does not get to the job within the next month then he will look at the roof himself.

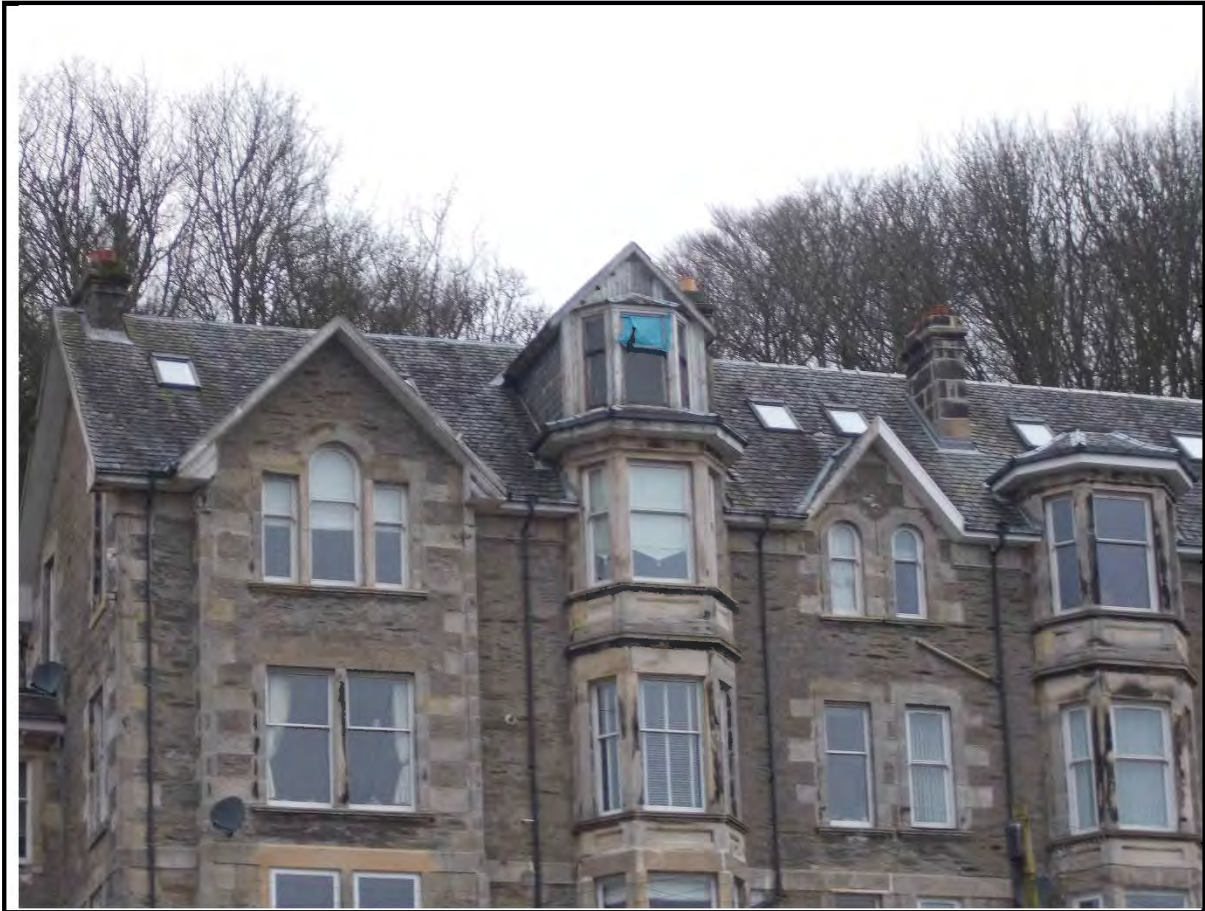
18. Detail of Attic Level Bay Window

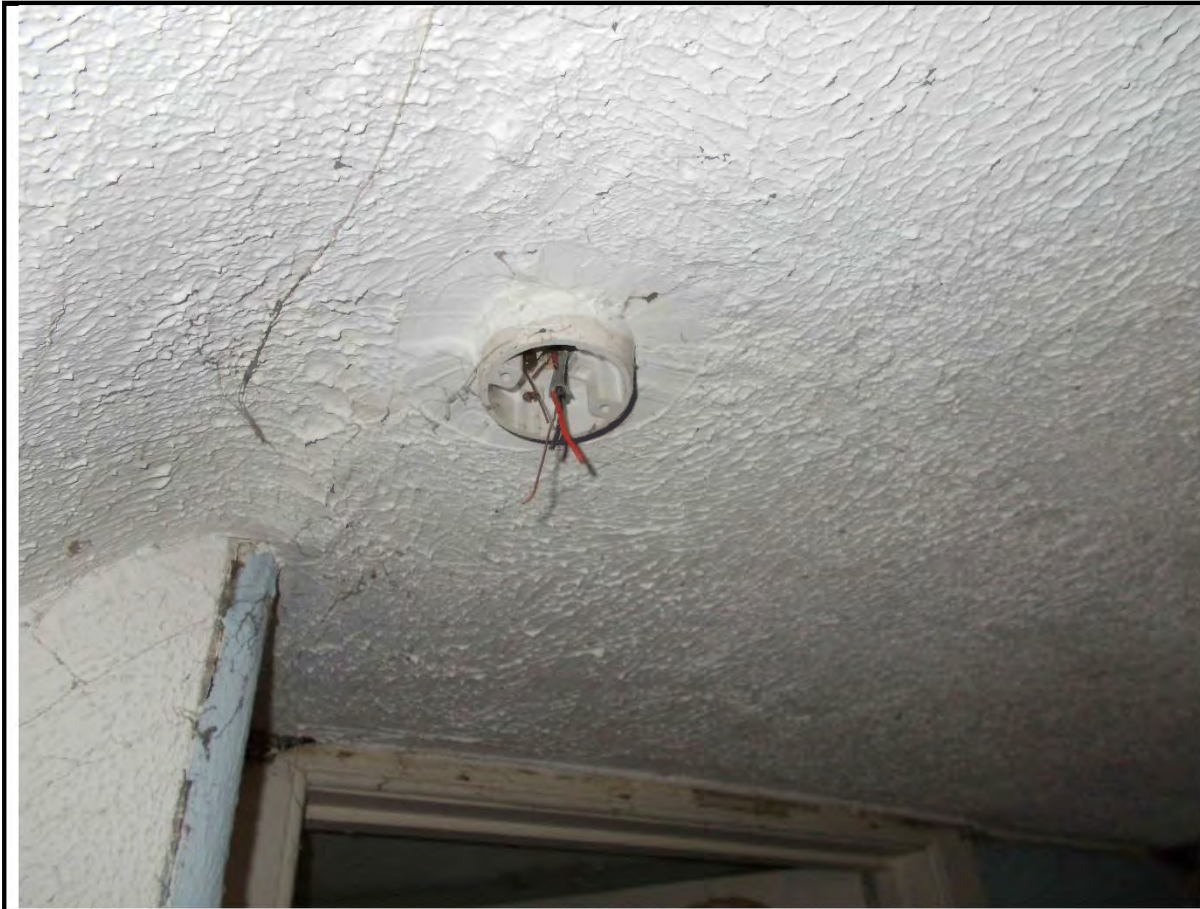
14.3.6 Attic landing – exposed electrical wiring

17. The installations in the house for the supply of water, gas and electricity and for sanitation, space heating and heating water are not in a reasonable state of repair as there is exposed wiring at the attic landing. In addition, the Repairing Standard now requires that installations for the supply of electricity must include a residual current device. An electrical contractor should be instructed to inspect the installation and carry out the works necessary to comply with this requirement.

21. Exposed electrical wiring on Attic Level Stair Landing ceiling.

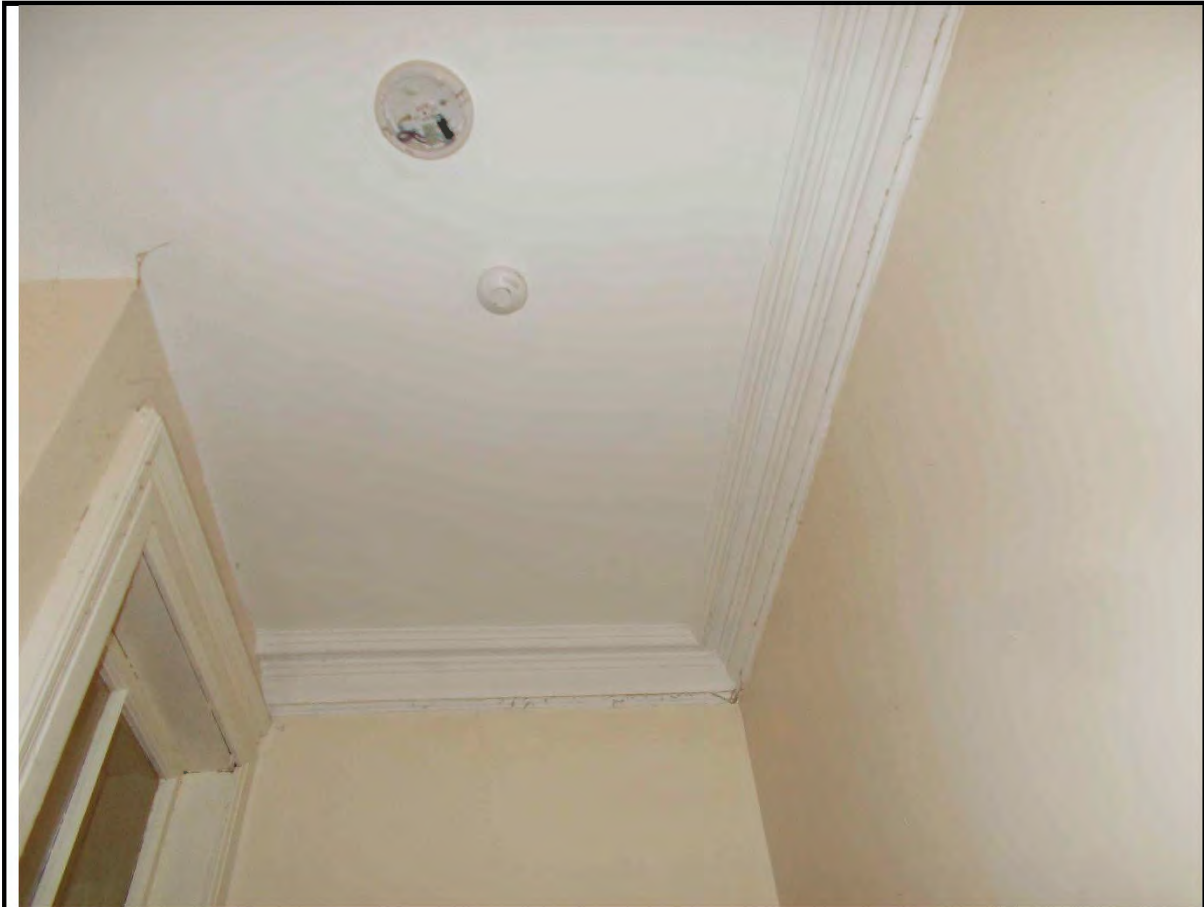
22. Base plate for removed Smoke alarm in Hallway at Kitchen door.

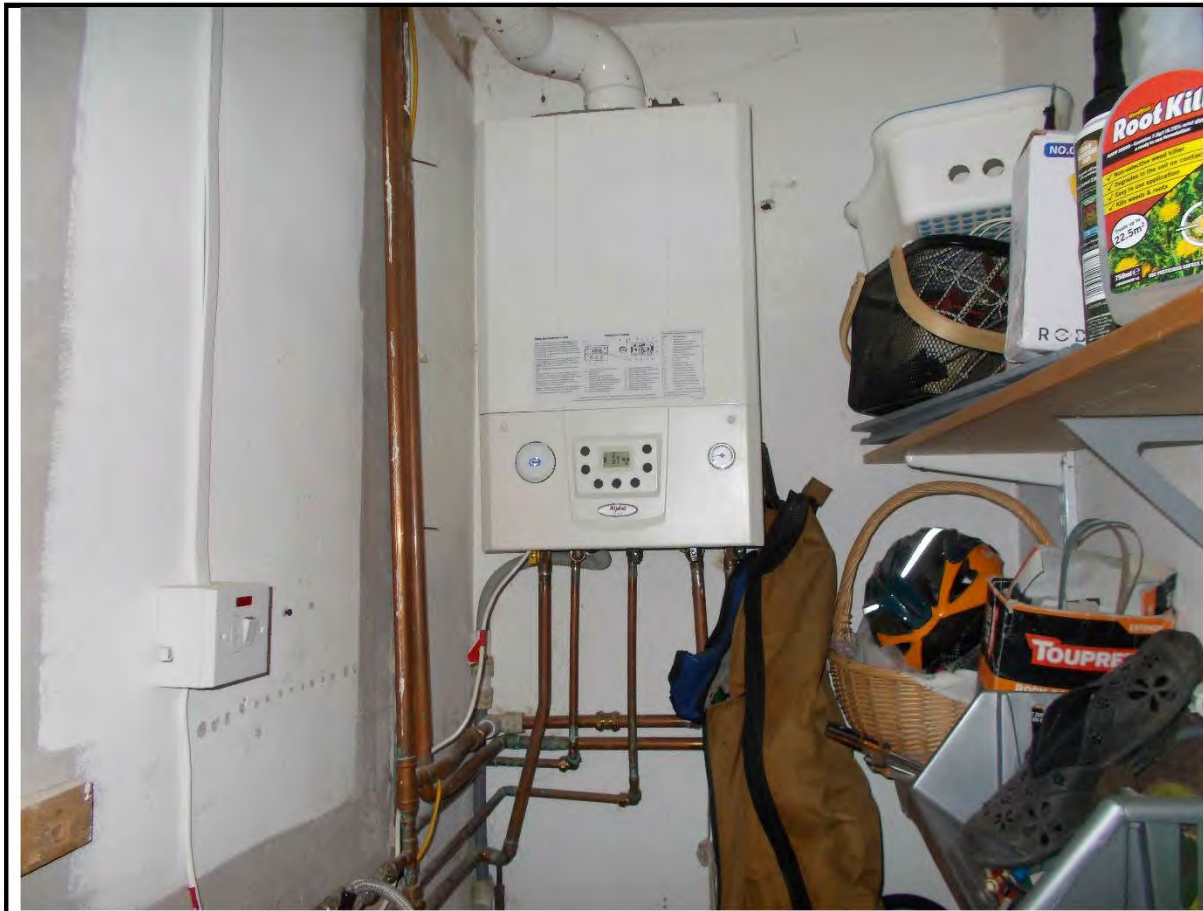
18. The Tribunal noted that the Property has a gas boiler which is situated in a cupboard in vestibule just inside the exterior door. The Tribunal observed that there was no carbon monoxide detector in the vicinity of the boiler. The Tribunal therefore conclude that the Property does not have satisfactory provision for giving warning if carbon monoxide is present in a concentration that is hazardous to health.

23. Heating Boiler
