Statement of Decision of the Housing and Property Chamber of the First-tier Tribunal for Scotland under Section 26 (1) of the Housing (Scotland) Act 2006

Chamber Reference number: FTS/HPC/RP/25/2727

Re: Property at 24 Loanburn Avenue, Penicuik EH26 8BX (“the Property”)

Schedule of photographs taken on 21 January 2026

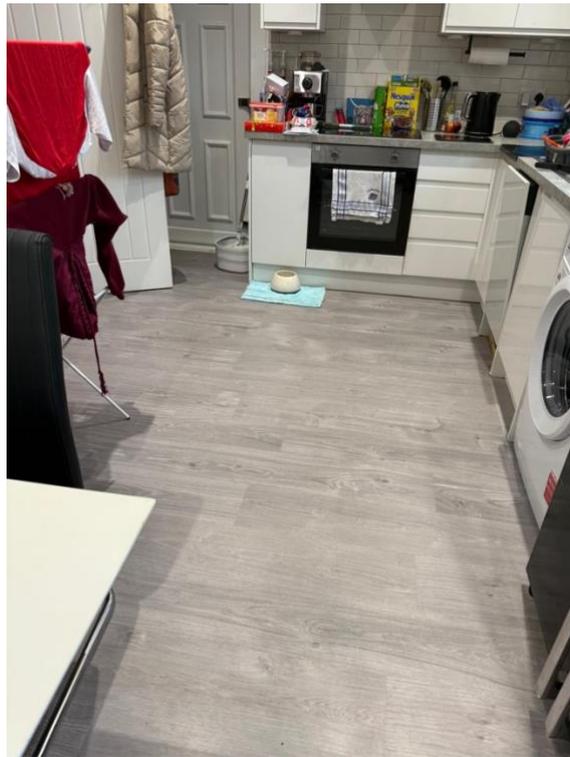
- (iv) The lock on the front door has been replaced and the tenant is satisfied with it.
 - (v) The flooring throughout the hall and kitchen has been replaced, but there is already wear between the two areas. Although not an issue that merited an RSEO, the Tribunal would recommend that a threshold be fitted to prevent further wear. The flooring in the hall was uneven in places but not such as to merit an RSEO.

Photograph 2: Kitchen – flooring

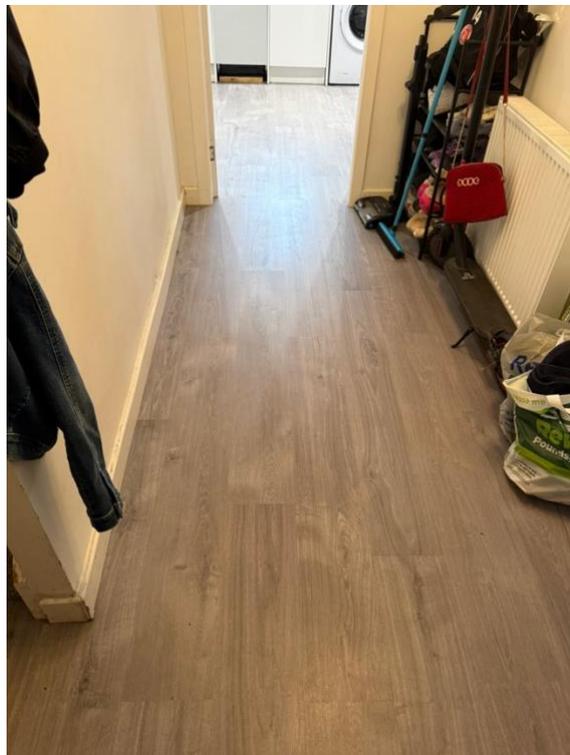
Photograph 3: Hallway: flooring

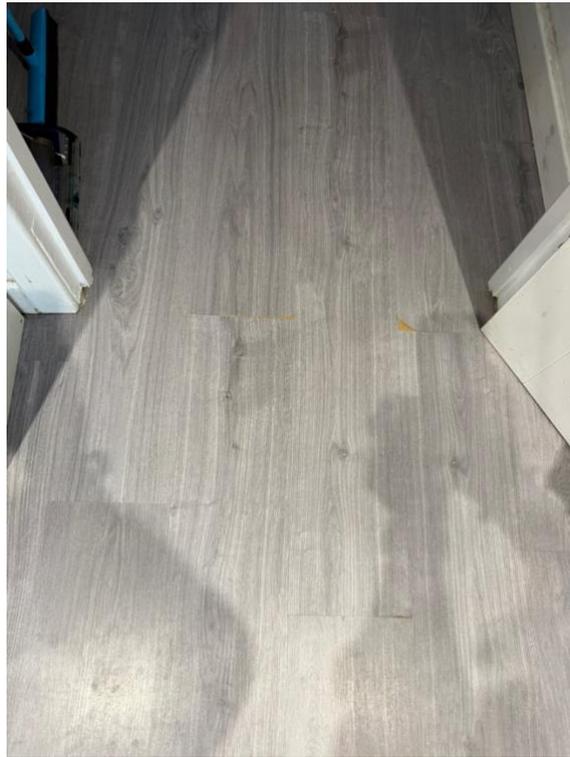
Photograph 4: Kitchen/hallway: flooring – wear at door threshold

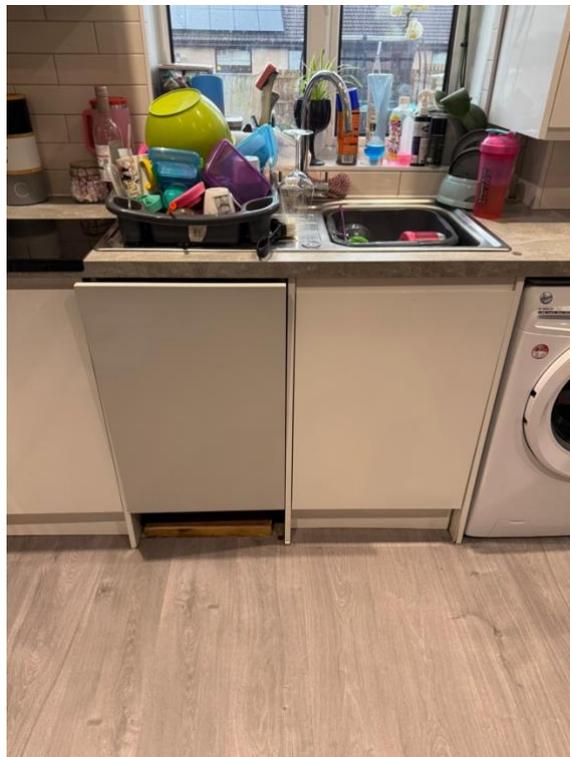
- (vi) The kitchen units show some signs of damage but are still fully functional.
 - (vii) There is no kickboard beneath the dishwasher, but that is not a repairing standard issue.

Photograph 7: Kitchen: sink and dishwasher

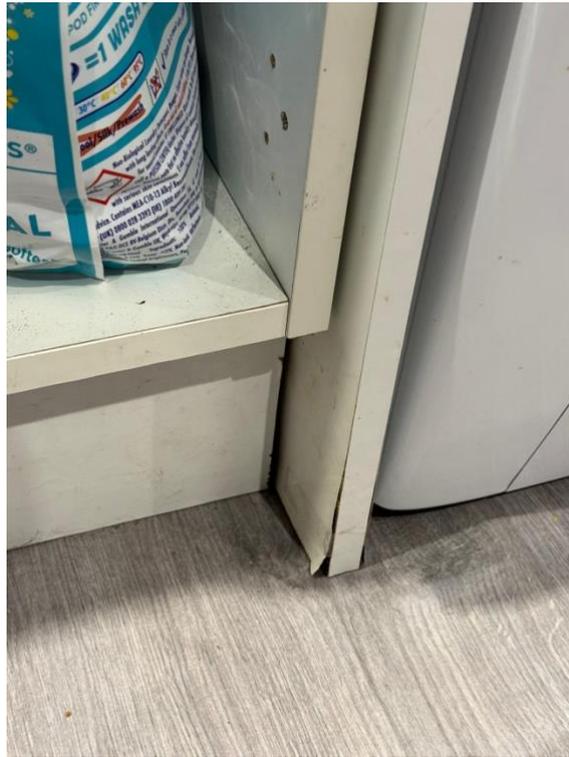
Photograph 8: Kitchen: Under-sink unit: water damage

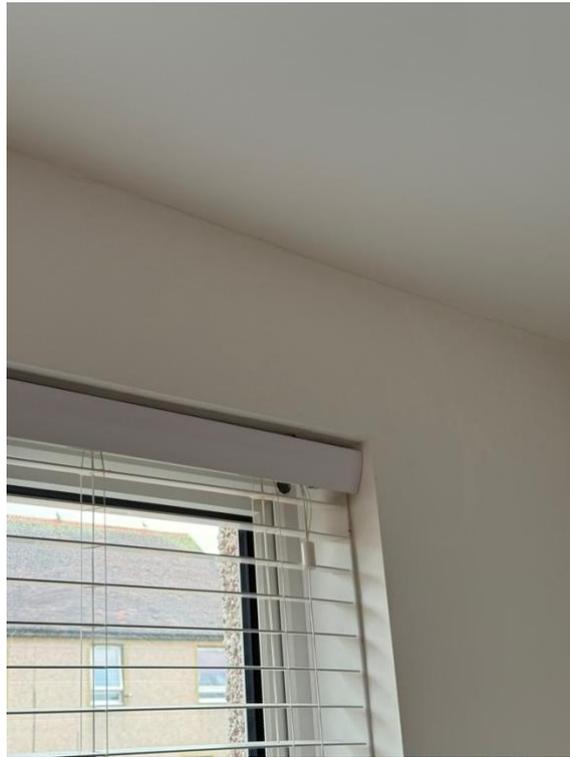
- (viii) There are shrinkage cracks in plasterboard in various places in the Property, but they do not appear to be structural, so would not merit a RSEO.

Photograph 12: Living room: cracking to plaster

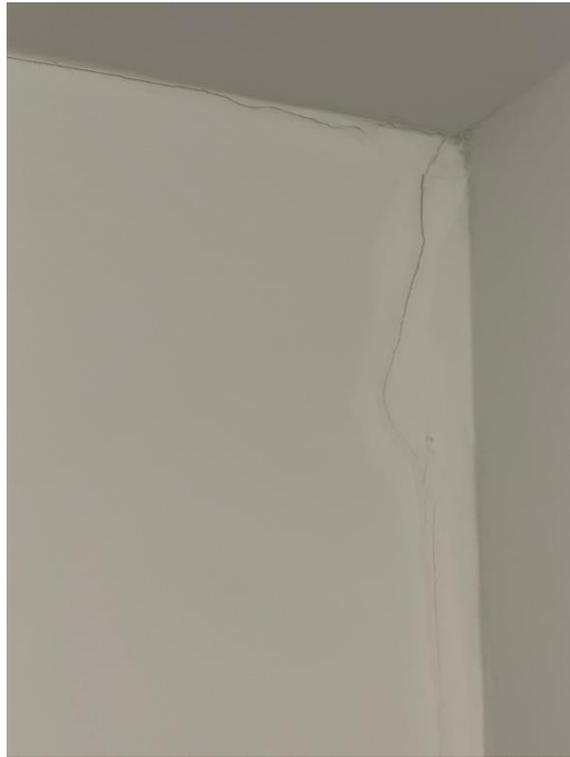
Photograph 14: Bedroom: example of cracking to plaster

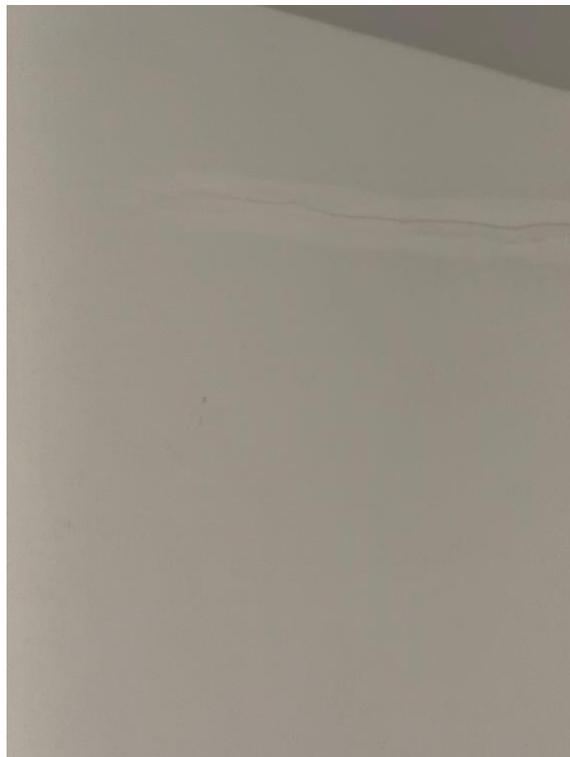
Photograph 15: Bedroom: example of cracking to plaster

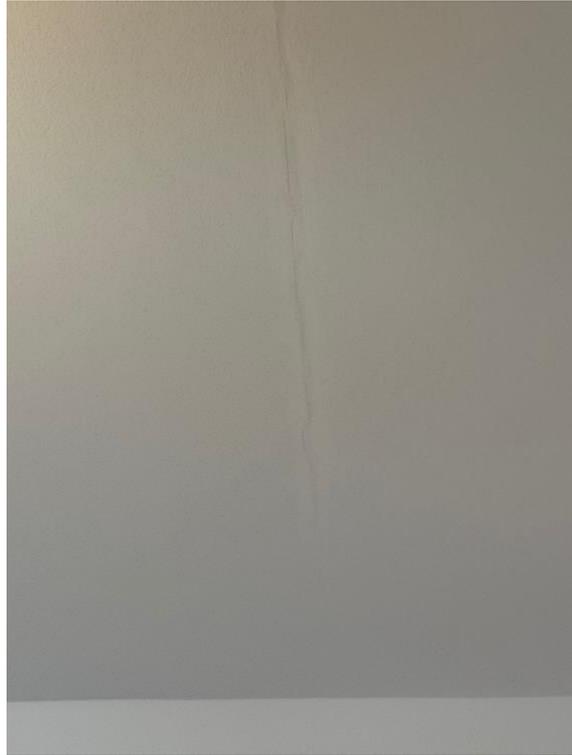
Photograph 16: Bedroom: example of cracking to plaster

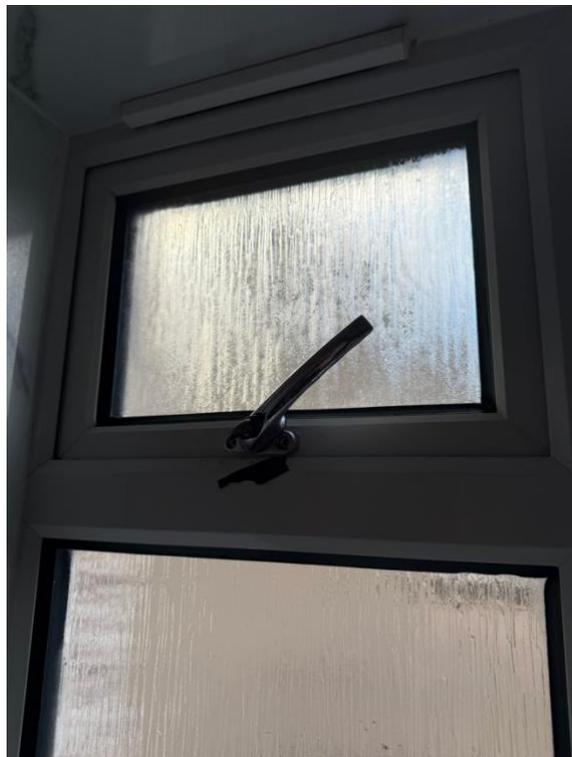
- (iii) The window latch in the bathroom is defective. The window could not easily be fully closed and was difficult to open. It appeared that an attempt by the landlords to fix it has not been successful.

8. The Tribunal is of the view that the Property fails to meet the repairing standard in respect of the blocked waste pipe on the rear wall and the issue with the bathroom window.
9. The Tribunal decided to make a Repairing Standard Enforcement Order in respect of the matters described in Paragraphs of this Decision,

Photograph 17: Bathroom: window

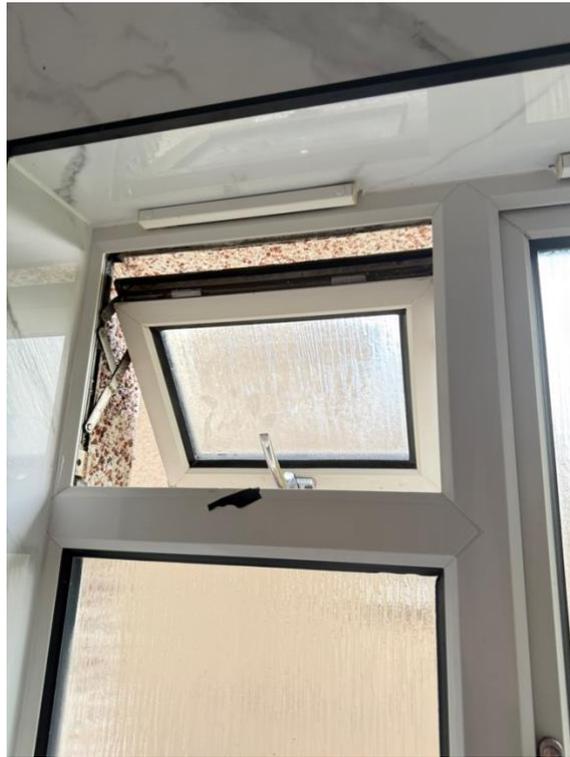
Photograph 18: Bathroom: window

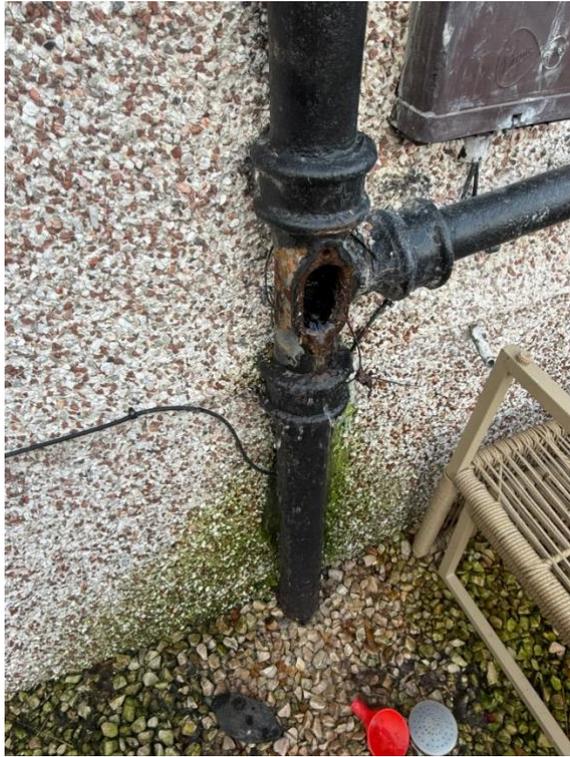
- (ii) There is a blocked waste pipe to the rear of the Property, beneath the kitchen window. When the kitchen tap was turned on, water poured out at the junction of the soil pipe and the waste pipe of the kitchen. The blockage appears to be further down the pipe.

Photograph 20: Rear elevation: Water running from rear soil pipe (kitchen tap running)
