Statement of Decision of the First-tier Tribunal for Scotland (Housing and Property Chamber)

Case Reference Number: FTS/HPC/RP/25/2643

Re: 9 Kenmuiraid Place, Bellshill, North Lanarkshire, ML4 2AL (“the house”)

Schedule of Photographs taken during the inspection by tribunal members on 23 April 2026

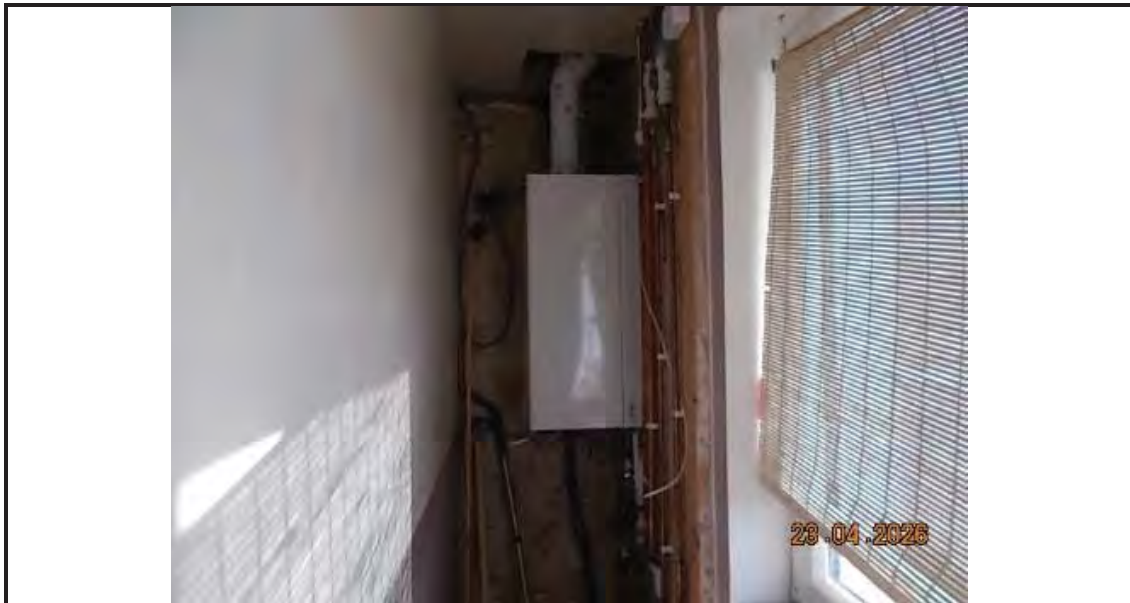
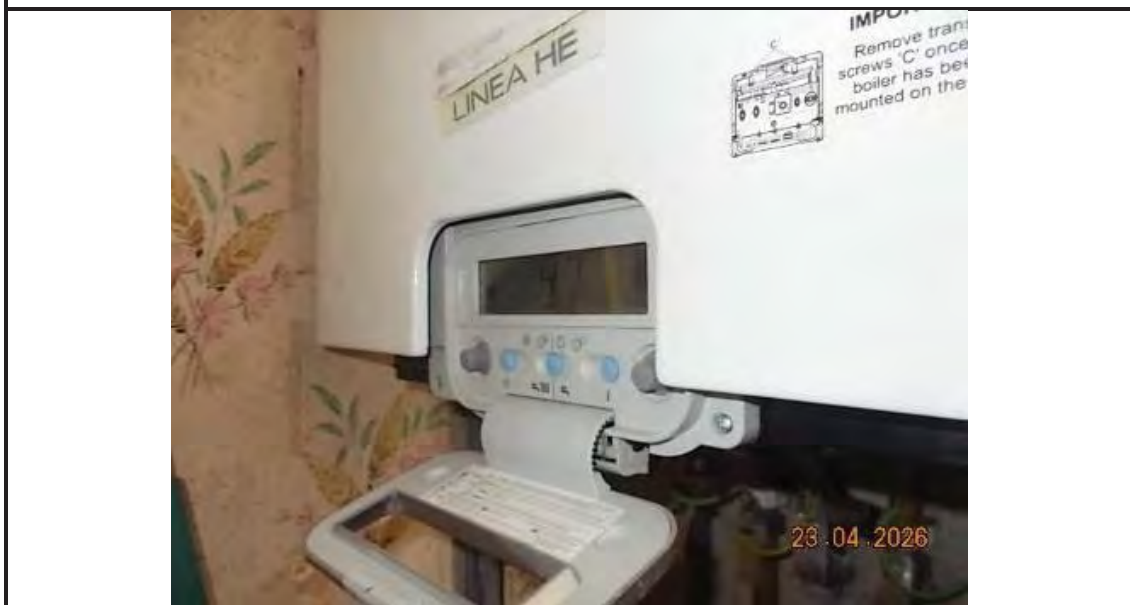
43. The tribunal observed during its inspection that the gas boiler is located in the smaller front bedroom on the first floor of the house. It is located in a narrow corner and is attached to the front wall. It was possible to read the figures on the digital screen.
44. Mr Swiffen told the tribunal that due to the boiler's location, it was difficult to access it to reset the temperature or adjust the hot water settings. It was difficult to see the digital readings. He also suggested that if the 'utility room' was in fact intended to be a bedroom, that it was not permitted to locate a boiler within a bedroom.

45. Mr Paszkiewicz said that the boiler had always been in its current location, and had been before the landlord bought the house from the council. It had been approved by building standards as part of the work for the loft conversion, which was carried out from approximately 2013 to 2023.
46. The tribunal notes that while the boiler is located in an unusual place, the gas safety certificate confirmed that it was operational. It was also possible to read the digital screen during the inspection (see photograph 2).
47. The tribunal therefore determines that there is no repairing standard issue to be considered with regard to the location of the boiler.

1. Boiler in smaller room, first floor at front of property

2. Boiler in smaller room, first floor at front of property

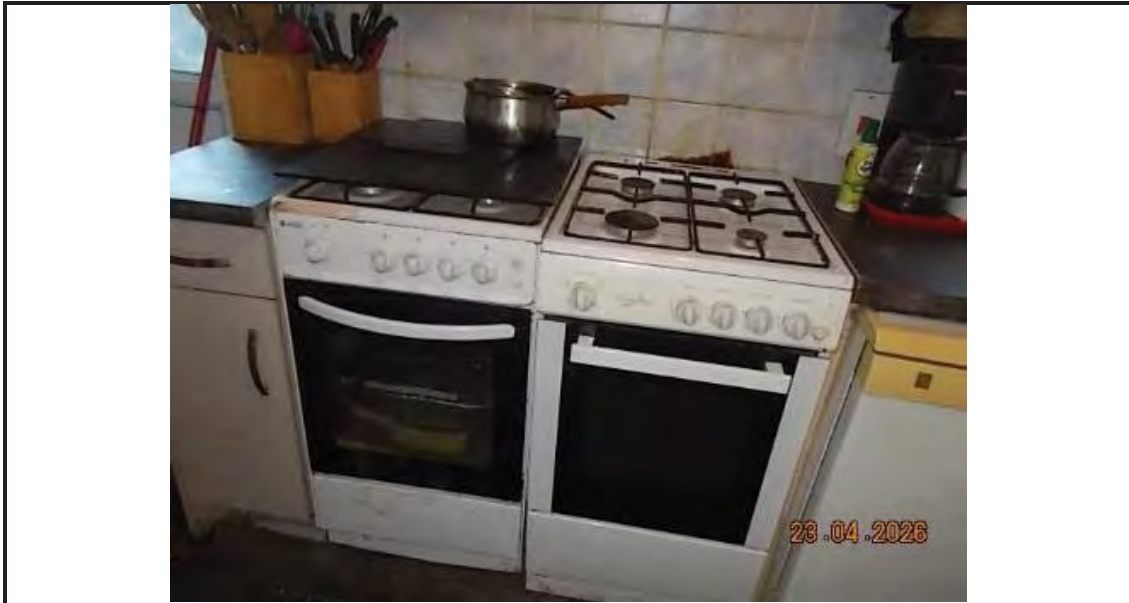
48. The tribunal observed during its inspection that there were two gas cookers located next to each other in the kitchen. The parties agreed that only one of these were connected to the gas mains.

49. The landlord explained that there had previously been a larger range cooker in the space, which was broken during a previous tenancy. Both cookers had been provided at the start of the tenancy, one of which was brand new. Mr Paszkiewicz said that the intention had been to give the tenants a choice, and that there had never been any intention to connect up both cookers.

51. Both parties confirmed that no inventory relating to the house had been produced at the start of the tenants' tenancy.
52. The tribunal took the view that, regardless of the landlord's intention, there were two cookers in the property at the start of the tenancy. In the absence of an inventory or any other documentation to record what was being provided, both cookers were therefore appliances provided by the landlord under the tenancy. As such, both cookers are required to be in a reasonable state of repairs and in proper working order. The absence of a gas connection means that one of the cookers was not in proper working order at the time of the tribunal's inspection..

3. Gas cookers in Kitchen

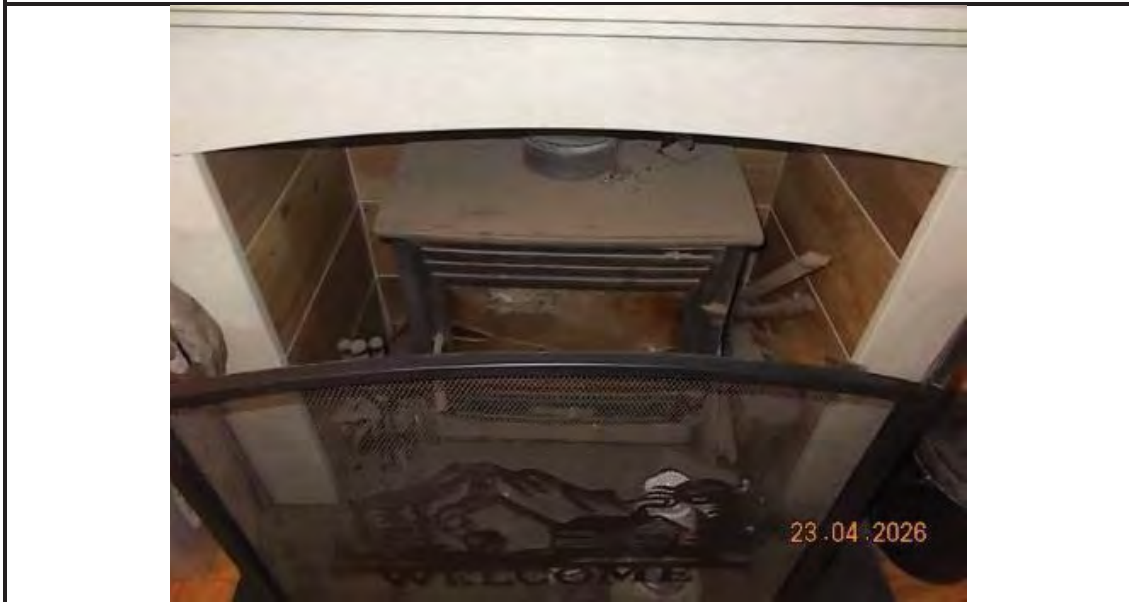
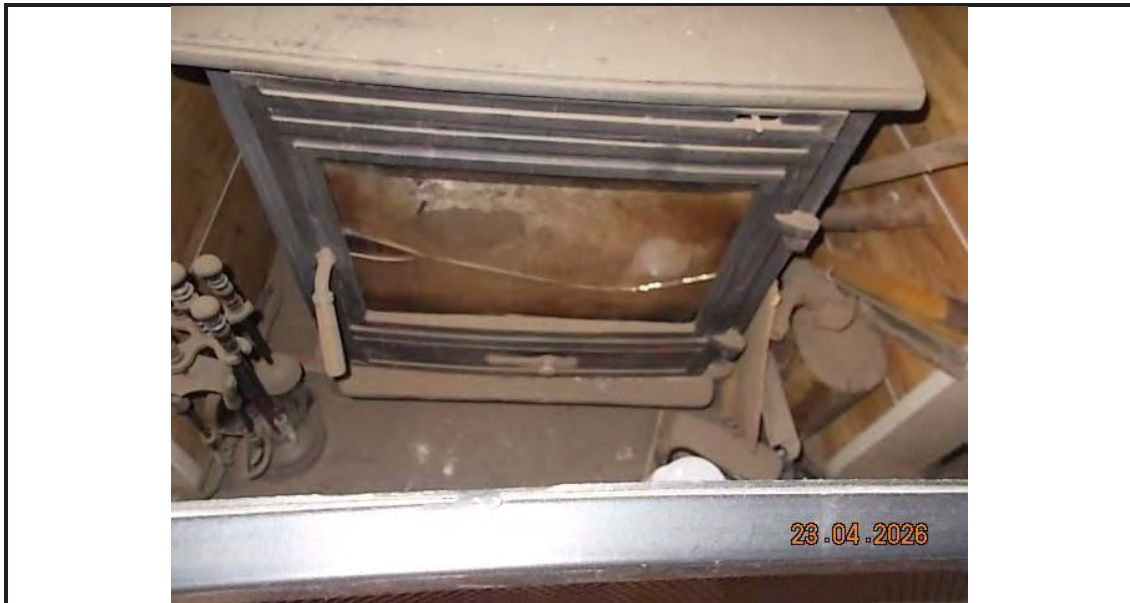
- c) The wood burner in the living room was not in use at the time of the inspection, but it was noted that there was a large crack in the glass to the door. The flue pipe extended up into the top of the former fireplace. (photographs 5- 7).

53. The tenants told the tribunal that, although they had used the wood burner during their first winter in the house, they had not been able to use it last winter. The chimney had not been swept since they moved in. The sealant had also melted away. They had asked the landlord to get someone to come and sweep the chimney and fix the sealant, but Mr Paszkiewicz had said that it was up to them to do this. Miss Smith said that it was recommended that the chimney should be swept twice a year, both before and after the winter.

54. Mr Paszkiewicz said that the chimney had been lined around 6-7 years ago. He said he did request a tradesman to look at the sealant but was not allowed access. There had never been an issue with the glass door at the front of the wood burner, but now there was a large crack in it. He suggested that using excessive temperature could have caused the damage.

55. Miss Smith said something had fallen down the chimney and had caused the crack in the glass. She said that she was worried the glass door was not safe, with her young grandchild living in the house.

4. Wood burner

5. Wood burner

58. Responsibility for any works required to the sealant, however, sits with the landlord. The tribunal is unable to determine whether the sealants visible are a primary sealant or are simply decorative. It cannot therefore determine whether the sealant is in a reasonable state of repair and in proper working order. The tribunal will require the landlord to have the sealants inspected by an appropriately qualified specialist contractor and send a copy of the contractor's report to the tribunal for approval.

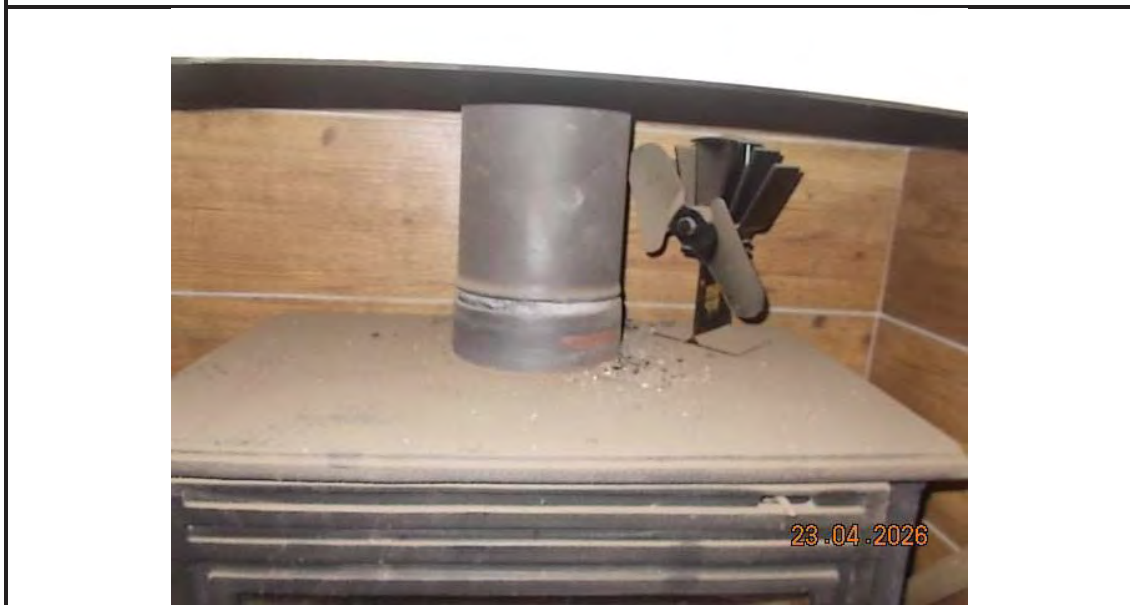
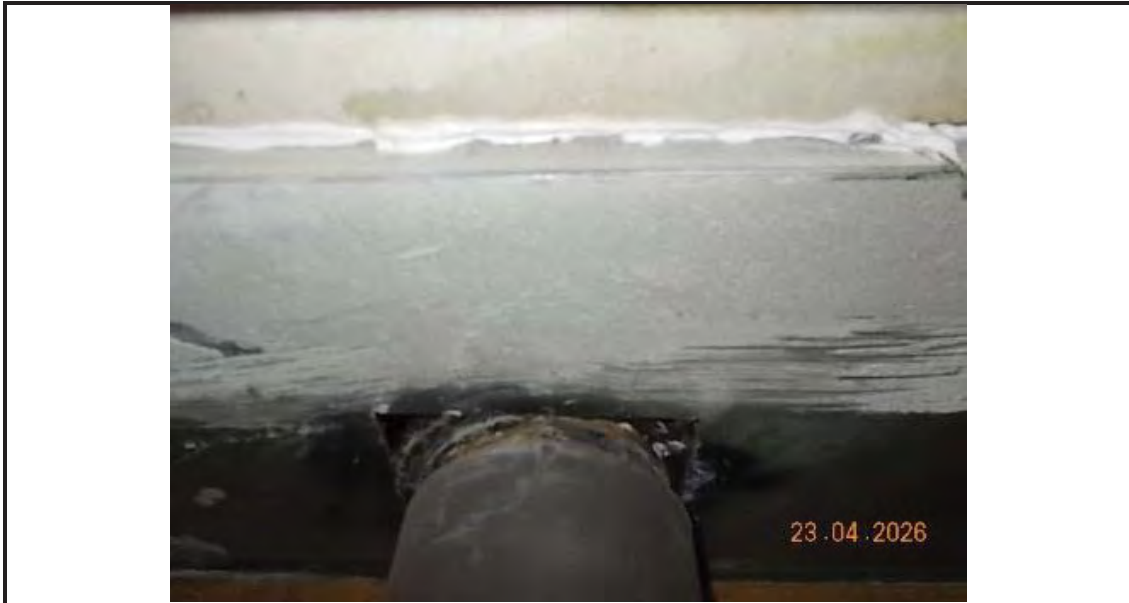
6. Wood burner flue connector

7. Wood burner flue connector

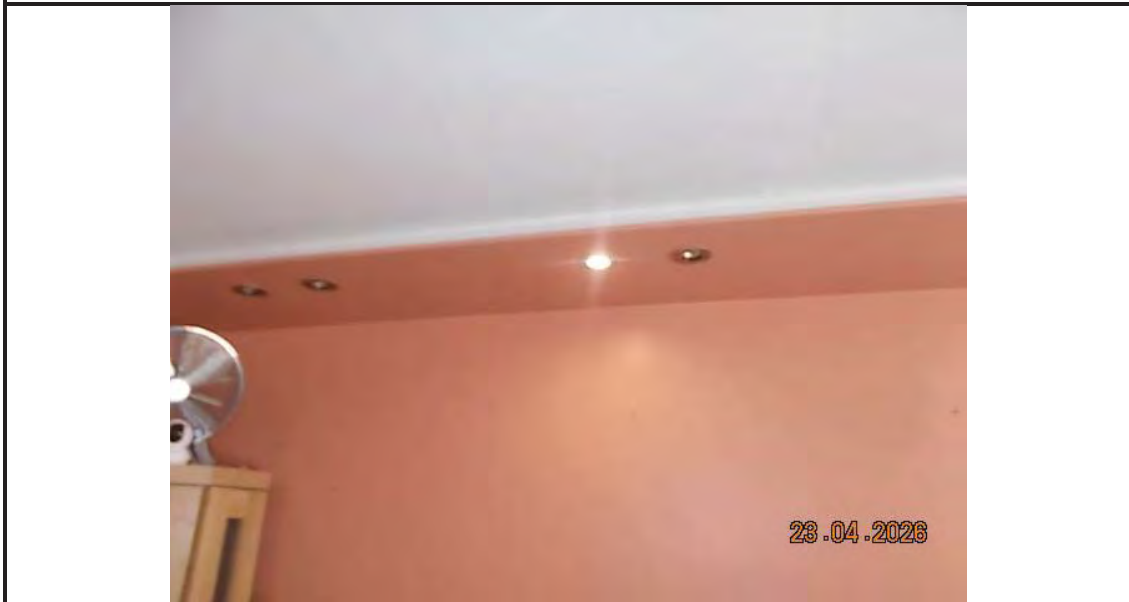
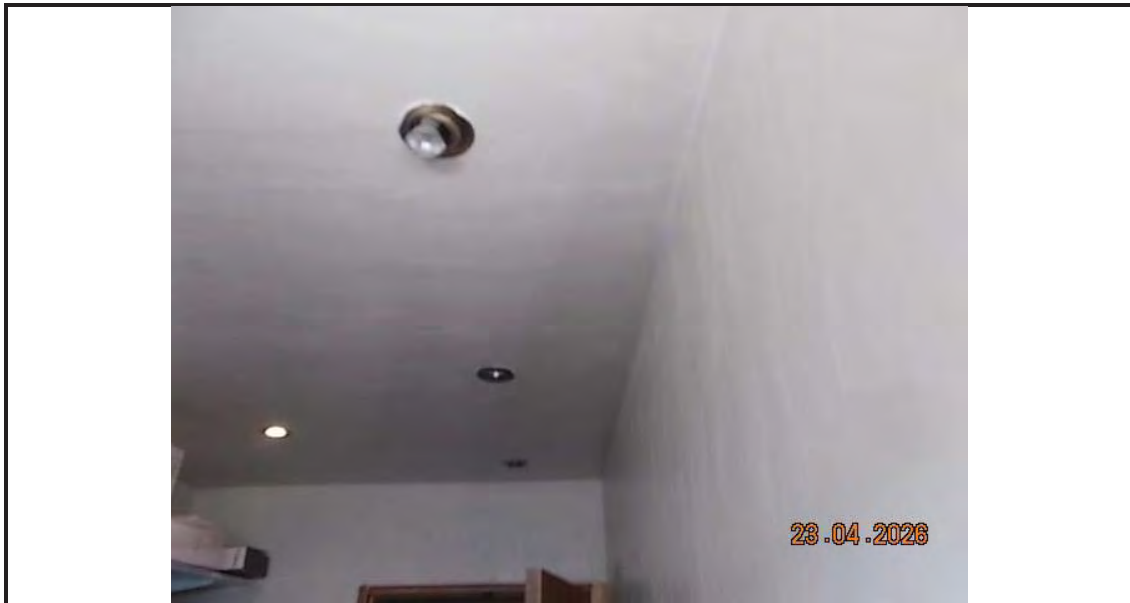
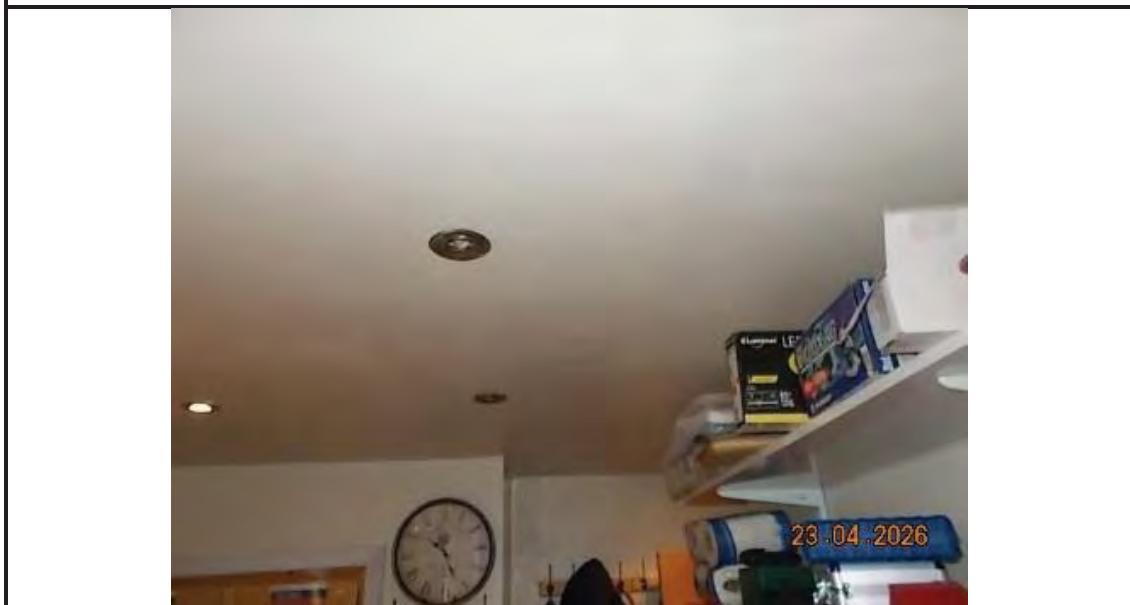
59. At its inspection, the tribunal observed that some of the lights in the living room, kitchen and smaller front bedroom on the first floor were not operational when tested.
60. The EICR dated 23 April 2026 stated that the electrical installation, including the lights, was in a satisfactory condition as at that date. There were no category C1 or C2 observations with regard to the lights. The tribunal therefore determines that the lights are in a reasonable state of repair and in proper working order. The tribunal notes that the reason why some of the lights are not operational may be that the light bulbs are defective and/or require replacement. Replacement of light bulbs is generally the responsibility of the tenant.

8. Lights not operational in Living Room

9. Lights not operational in Kitchen

10. Lights not operational in smaller room, first floor at front of property

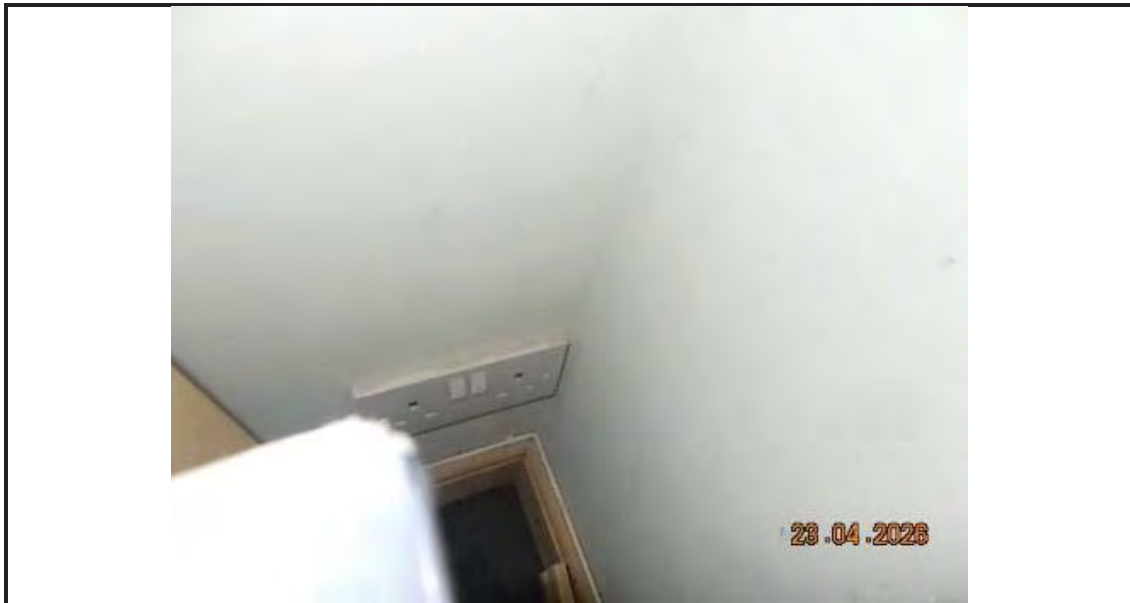
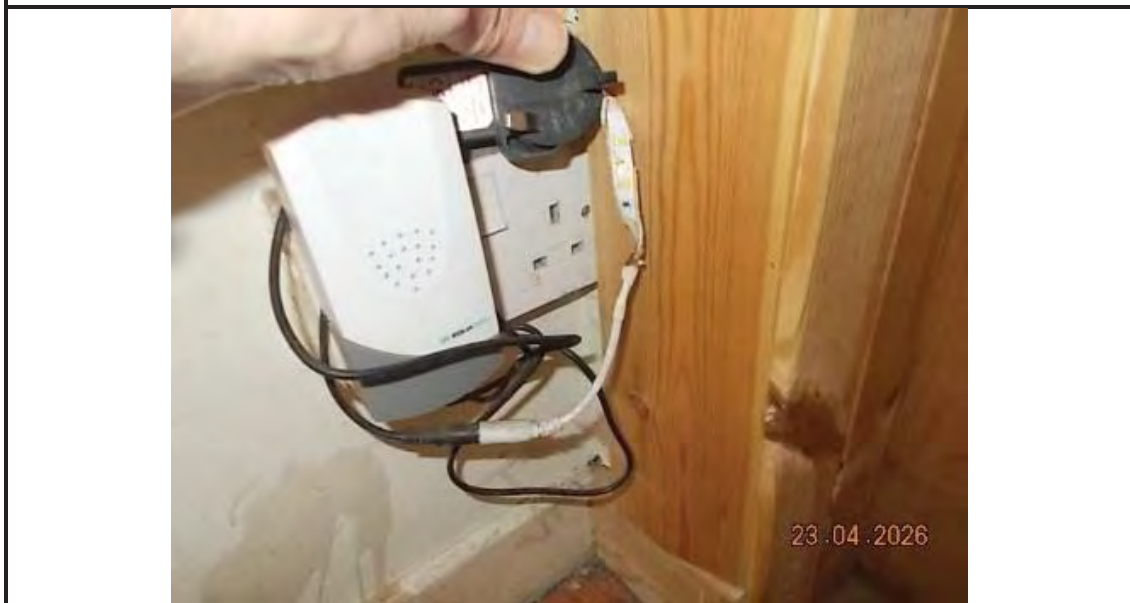
61. The EICR dated 23 April 2026 stated that the electrical installation, including the electrical sockets, was in a satisfactory condition as at that date. There were no category C1 or C2 observations with regard to the sockets. The tribunal therefore determines that the electrical sockets in the house are in a reasonable state of repair and in proper working order.

11. Socket outlet in rear bedroom at first floor level

12. Socket outlet in hallway at front door ground floor level

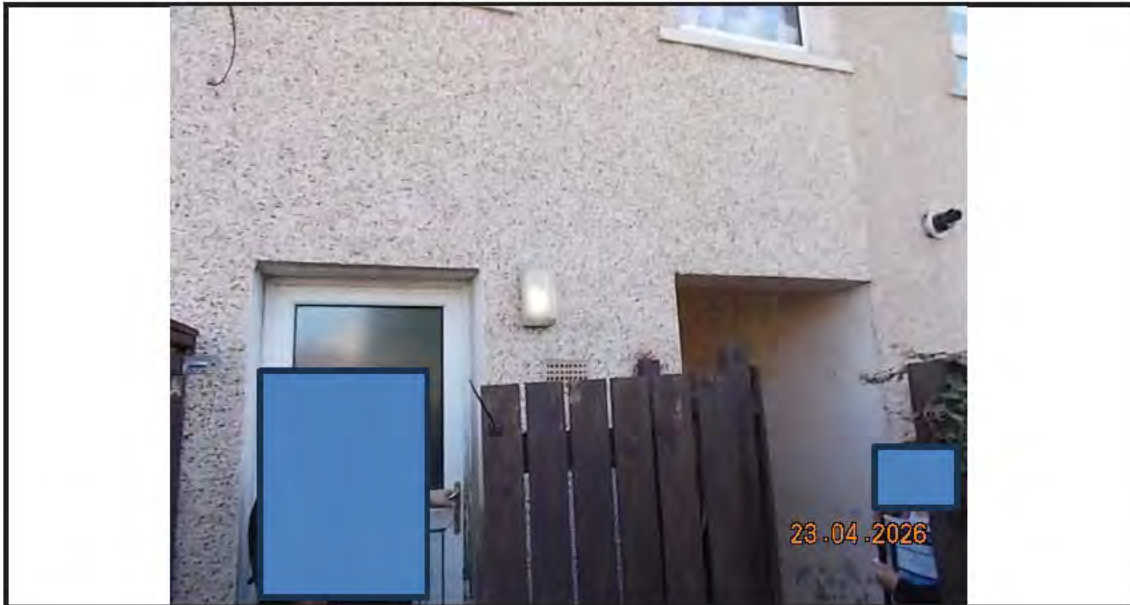
- f) The outdoor light at the rear of the house was operational when tested (photograph 13).
- g) Cable connectors, which the landlord's representative thought were connected with an electric shower, were observed on the surface of the wall adjacent to the boiler (photograph 14).

62. The tribunal observed at its inspection that the outdoor light at the rear of the house was operational when tested. As noted above, the EICR dated 23 April 2026 stated that the electrical installation, including the lights, were in a satisfactory condition as at that date.
63. The tribunal therefore determines that the rear outdoor light is in a reasonable state of repair and in proper working order.

13. Outdoor/back light

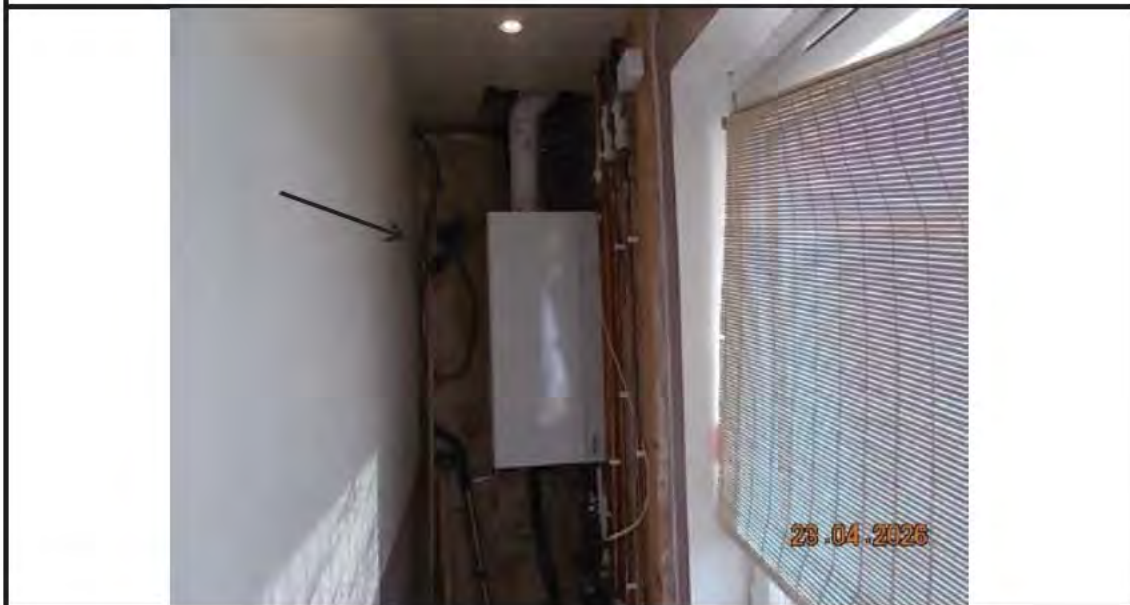
64. Mr Swiffen clarified during the tribunal's inspection that this complaint related to the cable connectors, which he stated were from the boiler, which were observed on the surface of the wall adjacent to the boiler. Mr Paszkiewicz stated that he thought they were related to an electric shower.
65. The tribunal notes that while these connectors may be unsightly, there is no indication that they are unsafe in the EICR. The boiler itself was passed as part of the PAT test certificate. It is however noted that in the EICR there is a C3 observation that a conduit should be provided.

14. Cable connectors on wall arrowed

66. The tribunal therefore determines that the wiring in the smaller front bedroom is in a reasonable state of repair and in proper working order. The tribunal makes an observation that the EICR indicates that conduit should be provided, but does not require this. The landlord should give serious consideration to this matter.

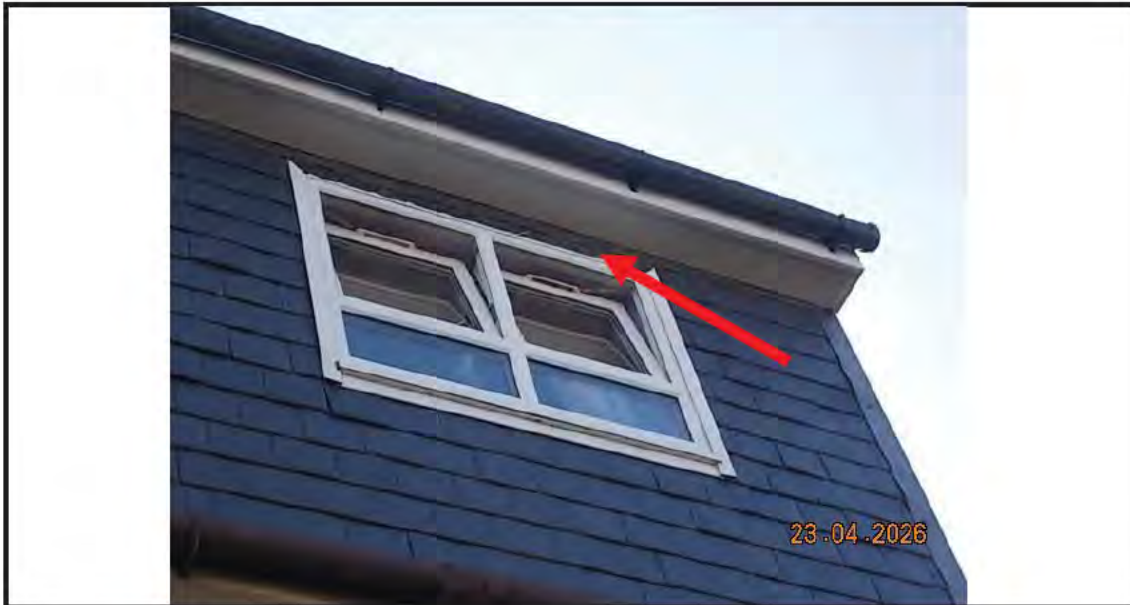
- h) The trim/ plastic facing above the window in the dormer to the second floor rear bedroom was missing (photograph 15).
- i) The outer face of the front door was undamaged. There was a small area of damage on the inner face of the front door (photographs 16 and 17).

67. The tribunal observed at its inspection that the trim/ plastic facing above the window in the dormer to the second floor rear bedroom was missing.

68. Mr Paszkiewicz acknowledged that the plastic facing was missing and required replacement. He told the tribunal that he had not been aware of this until seeing it during the inspection. The tribunal observed that the issue had in fact been notified to the landlord in the tenant's notification letter of 8 September 2025.

69. The tribunal determined that the plastic facing above the window was not in a reasonable state of repair and in proper working order as at the date of its inspection.

15. Missing trim (arrowed) above window in dormer to second floor rear bedroom

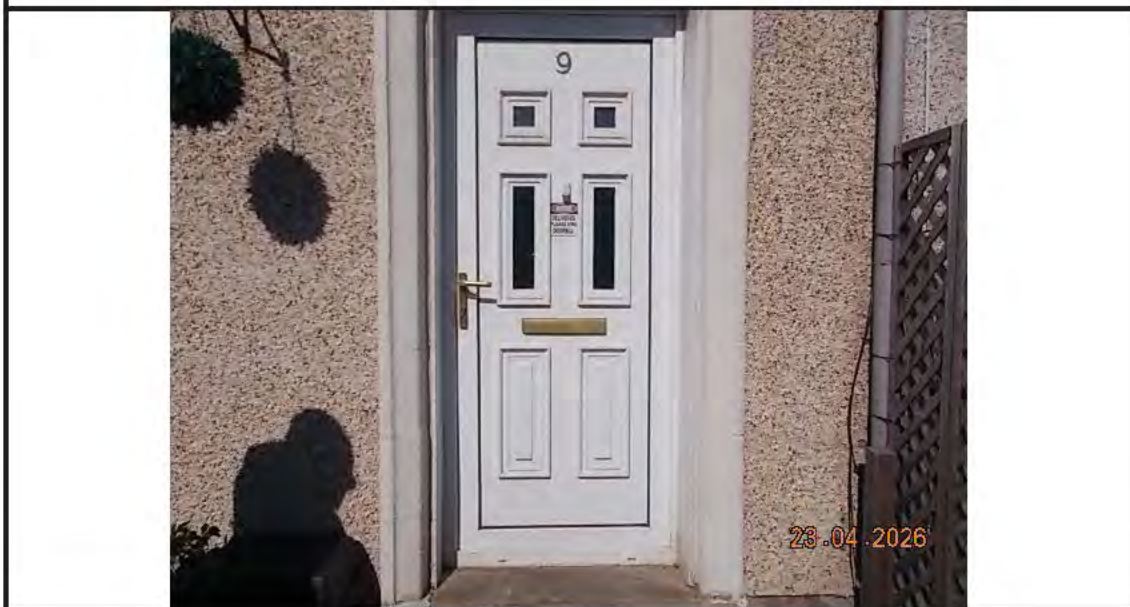
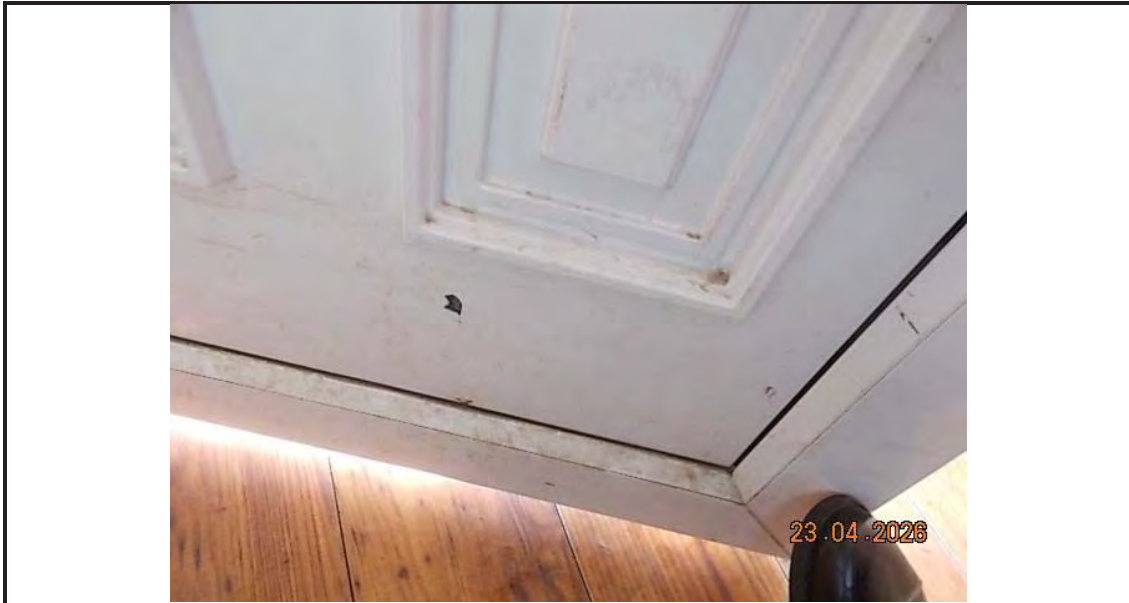
70. At its inspection, the tribunal observed that the outer face of the front door was undamaged. There was a small area of damage on the inner face of the front door. There was also a damaged area on the lower right panel of the outer face of the rear door.

71. Mr Paszkiewicz said that he did not know what had caused the damage, He suggested that it may have been caused by one of the tenants' dogs or by furniture being moved.

72. The tribunal determined that the damage observed was cosmetic in nature and that both doors were wind and watertight and in a reasonable state of repair.

16. Front door outer face (undamaged)

17. Front door inner face with damaged area

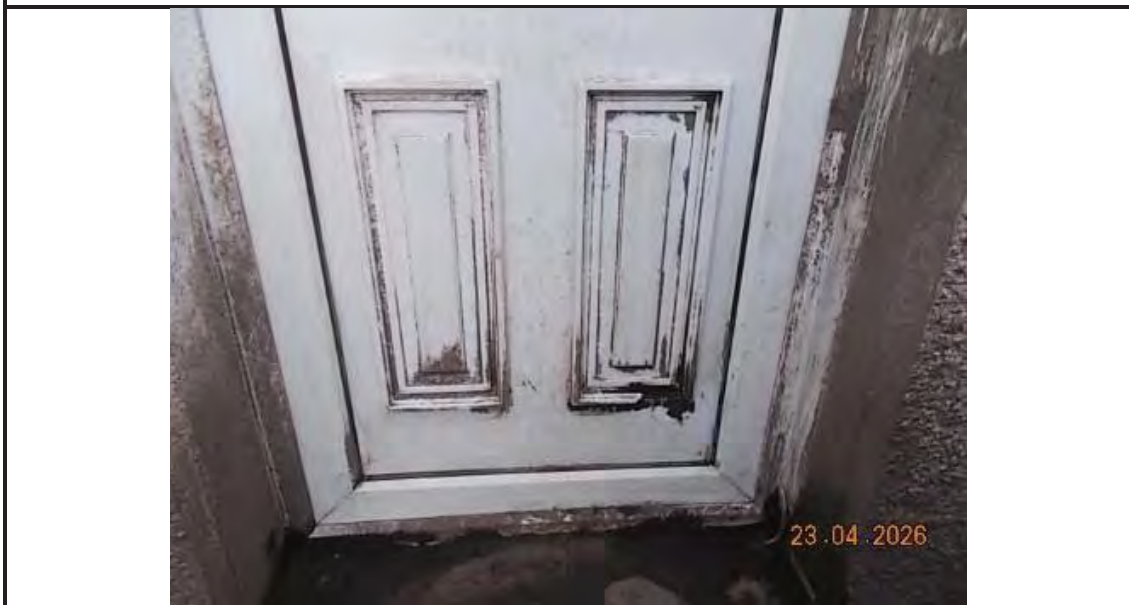
- j) There was a damaged area on the lower right panel of the outer face of the rear door (photograph 18).
- k) No excessive movement of the floor in the second-storey (first floor) bathroom was found and it was noted to be generally level and stable.

18. Rear door outer face with damaged area to lower right panel

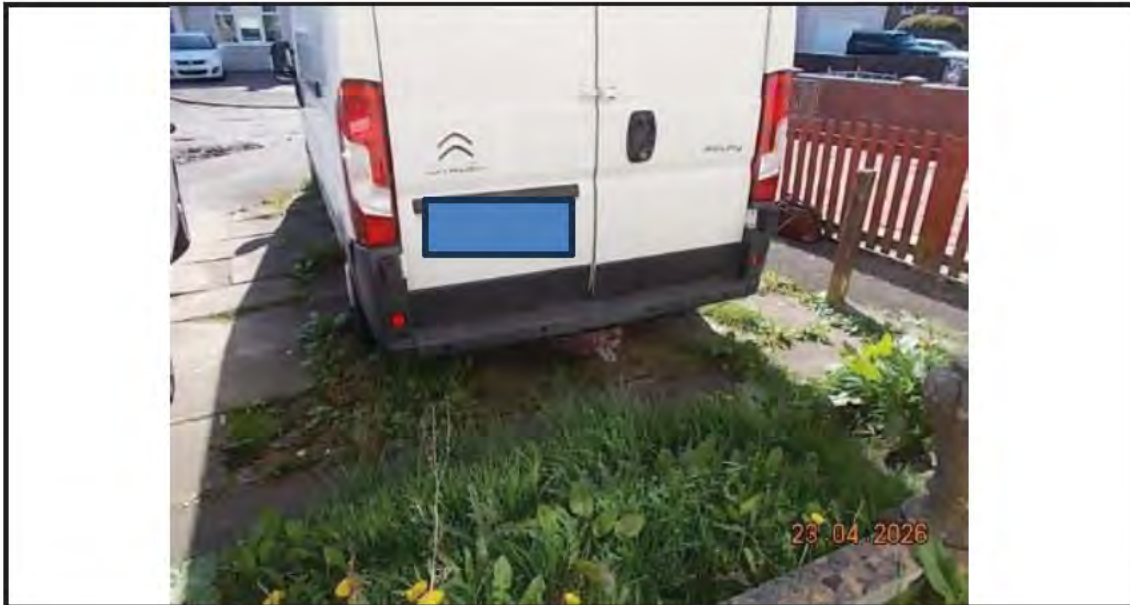
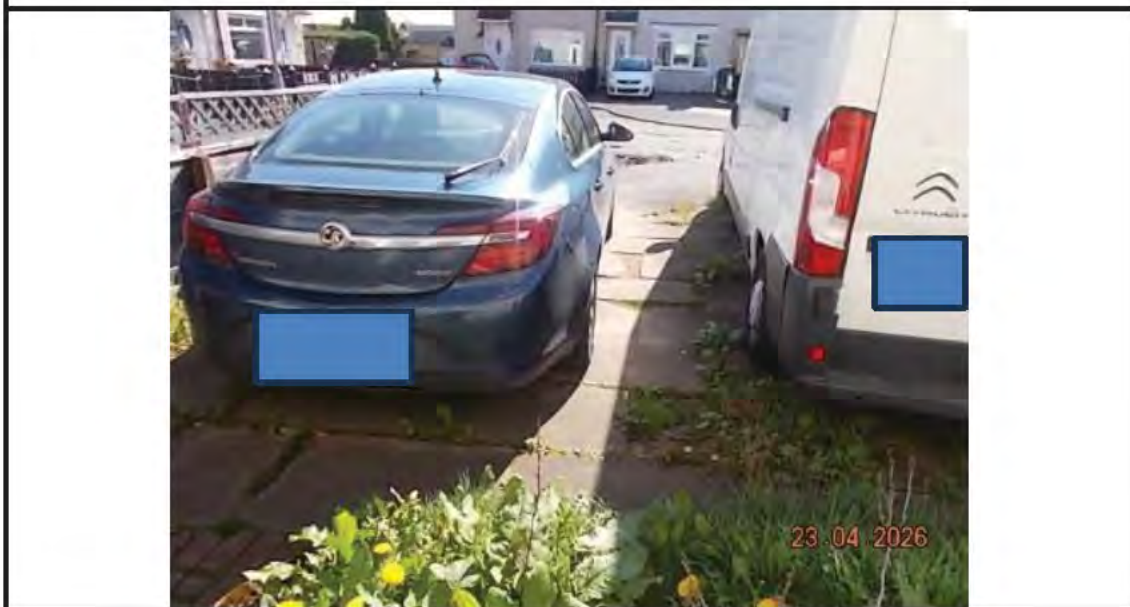
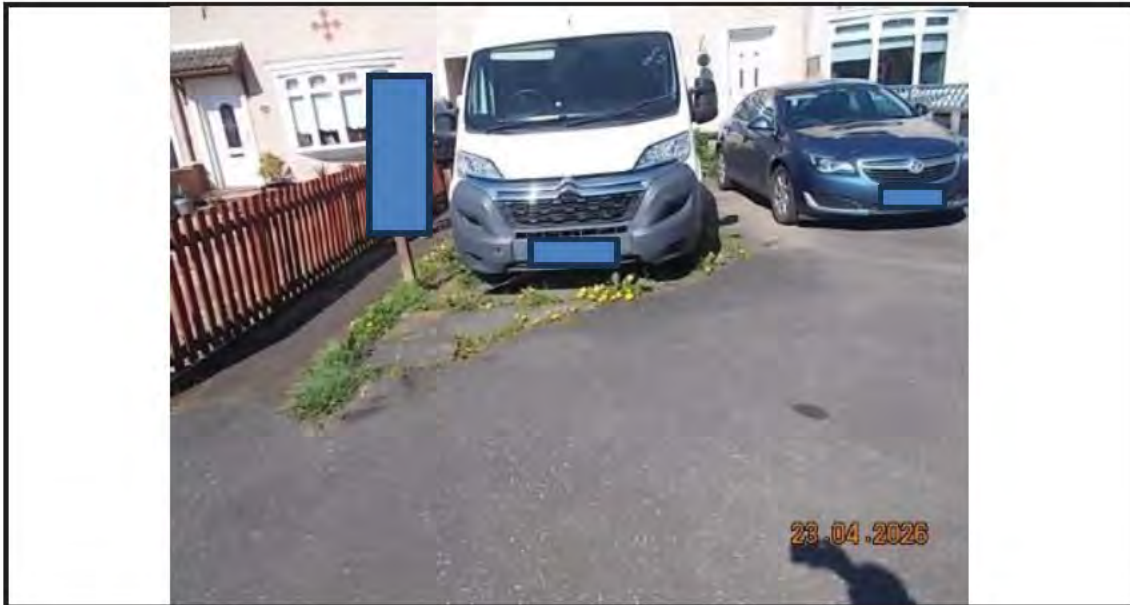
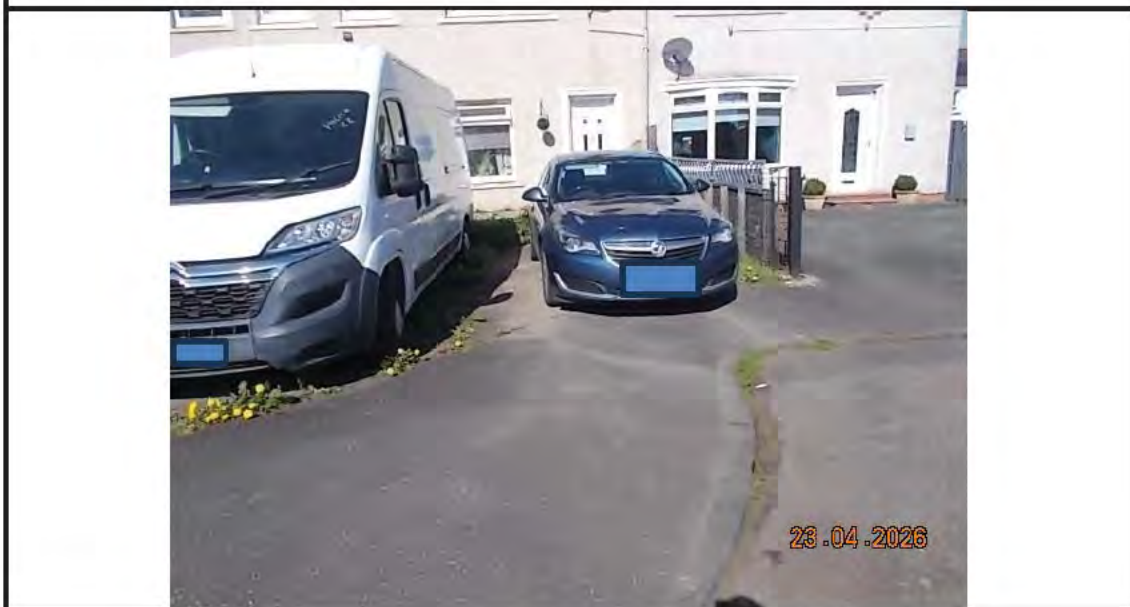
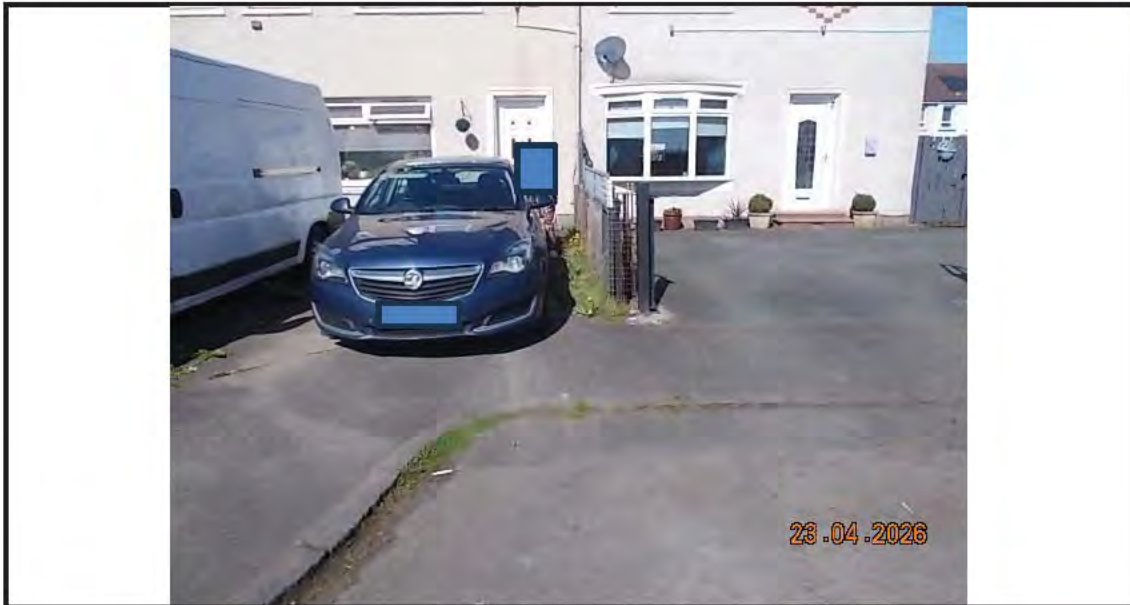
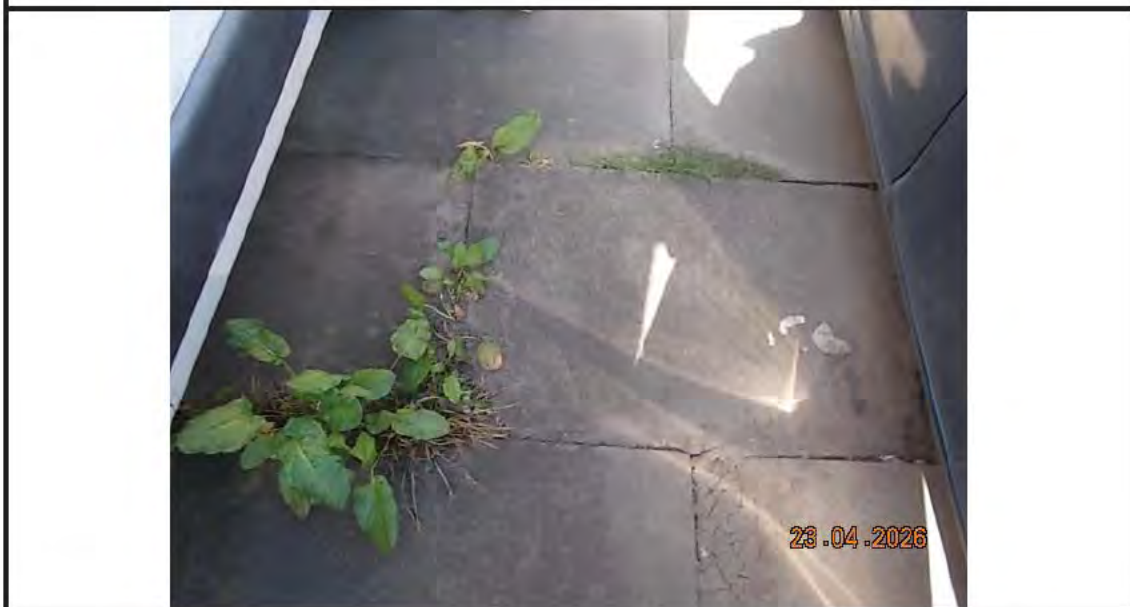
76. The tribunal observed during its inspection that there was a paved area/driveway to the front of the house on which were parked both a car and a van. A number of displaced paving slabs were visible around the parked vehicles.

79. In the tribunal's view, the comparison between a caravan and a commercial van is not valid as the weight and its distribution of a caravan is less and generally they do not have driven axles. It is difficult to determine how much of a contribution the parking of a van may have made. Parking areas are generally not covered by the repairing standard but there is expected to be a hazard free access to the entrance.

80. The tribunal determined that there were trip hazards on the most direct and obvious route to be taken by a tenant or a visitor to the property, between the public footpath and the front door of the house. This rendered that area of the driveway not in a reasonable state of repair and in proper working order at the time of the tribunal's inspection.

19. Driveway to front of House

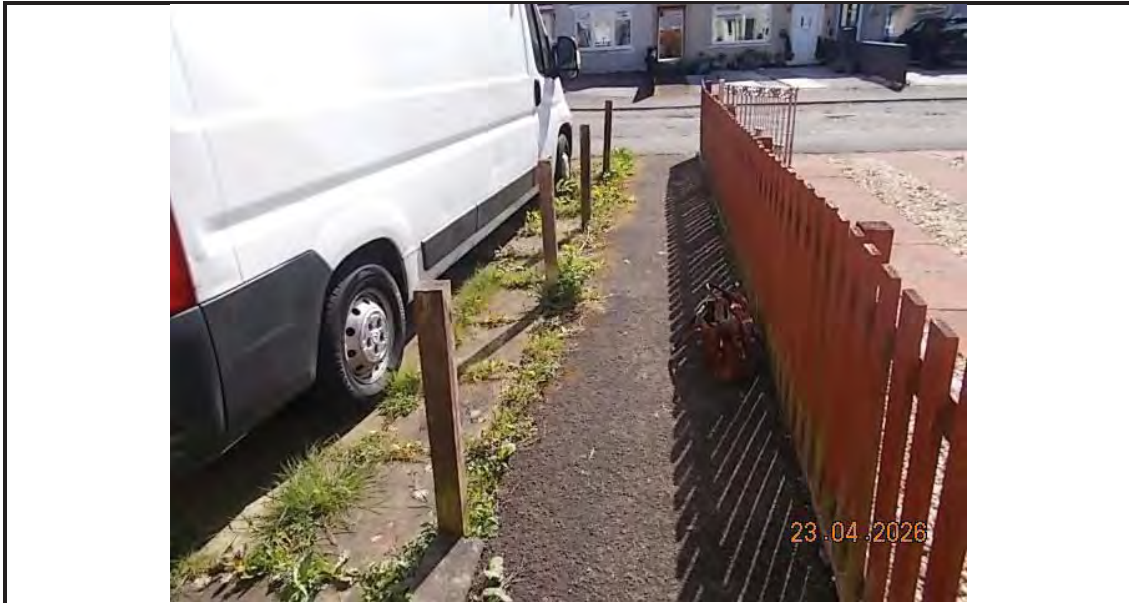
81. The tribunal observed at its inspection that there was a line of posts along the left hand side of the paved area / driveway at the front of the house where a fence had previously been present. It also observed that the fence at the rear of the house was partially collapsed and in a poor state of repair.

82. Miss Smith said that the rotten fencing at the front of the house had fallen down during the tenants' tenancy and was now in the back garden. The tenants had offered to fix it, but the landlord had refused.
83. Mr Paszkiewicz agreed that both the front and back fences needed to be replaced. He said that the rear fence was shared with a neighbour, who had agreed to pay their share of the cost.
84. The tribunal determined that the fences at both the front and rear of the house were not in a reasonable state of repair and in proper working order at the time of its inspection.

25. Line of posts to former fence to front of House
