Statement of Decision of the First-tier Tribunal for Scotland (Housing and Property Chamber)

Case Reference Number: FTS/HPC/RP/25/2643

Re: 9 Kenmuiraid Place, Bellshill, North Lanarkshire, ML4 2AL (“the house”)

Schedule of Photographs taken during the inspection by tribunal members on 23 April 2026

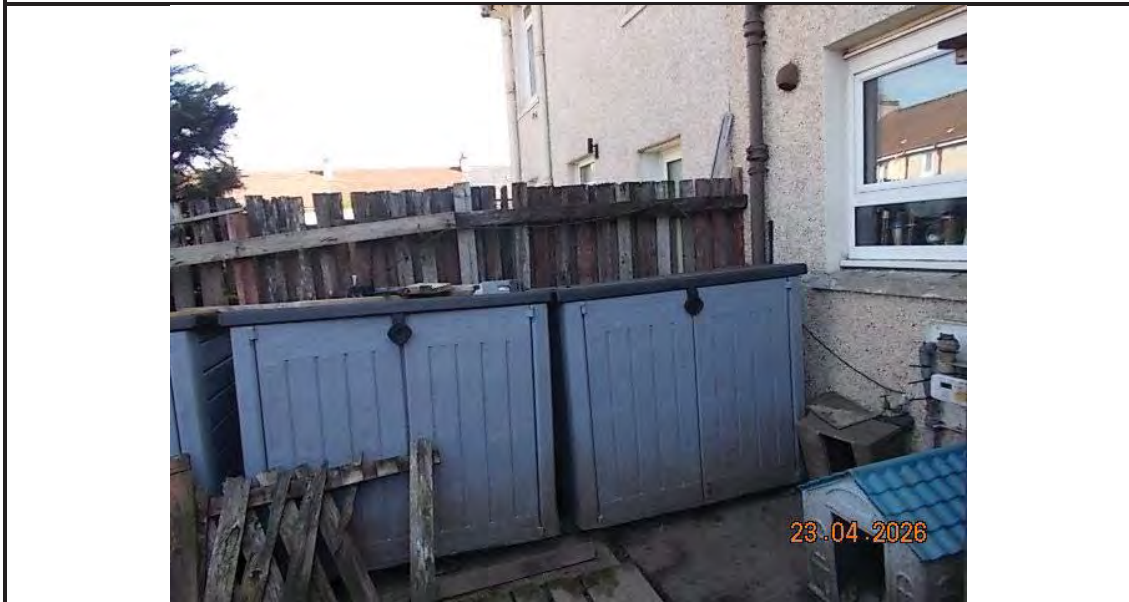
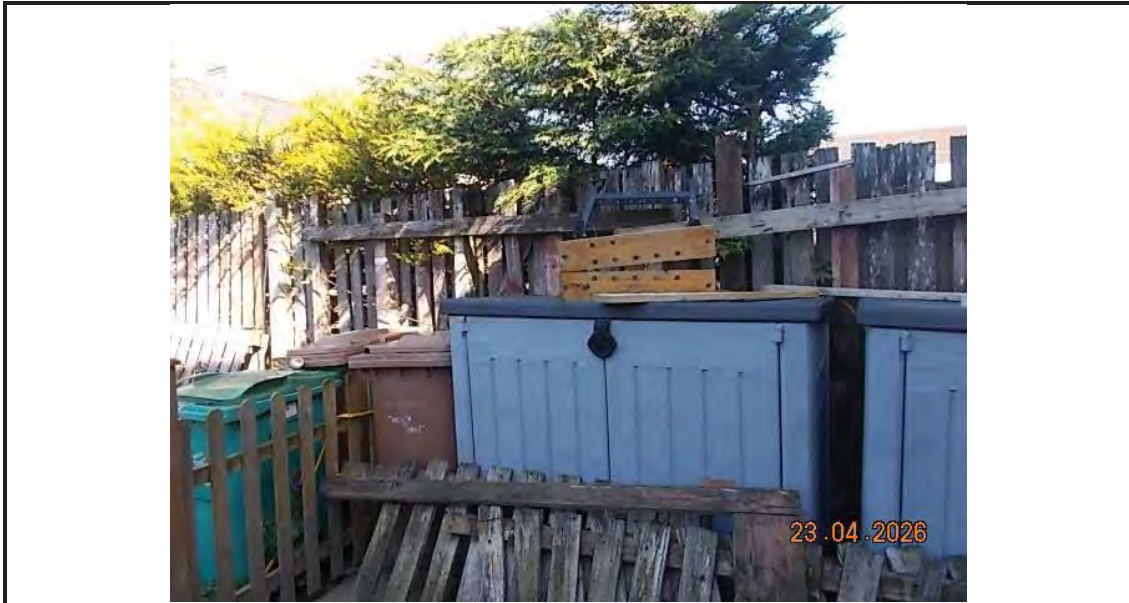
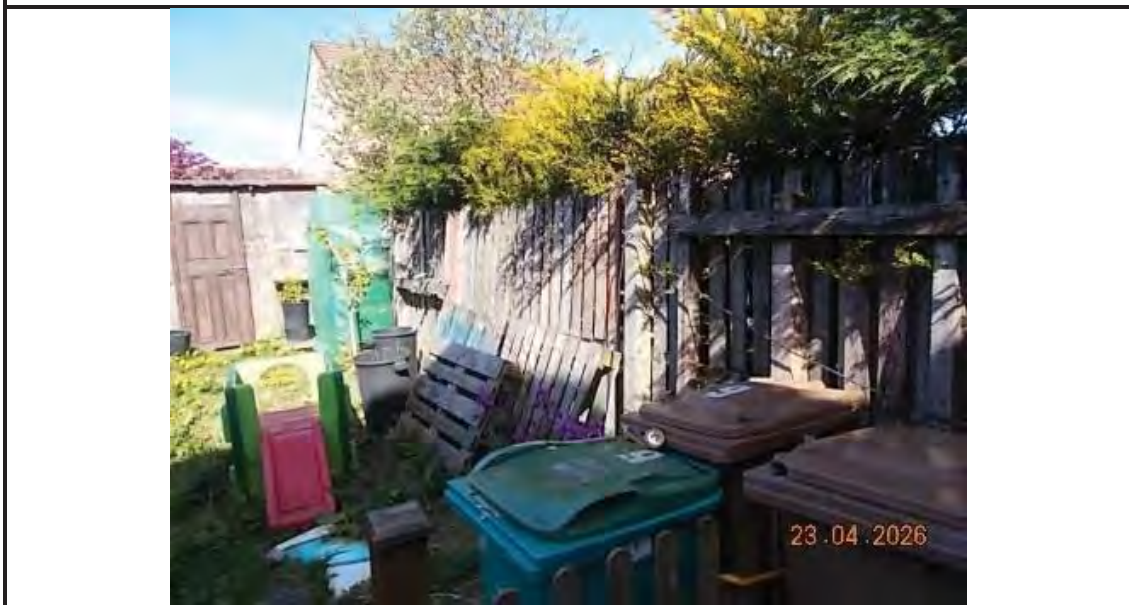
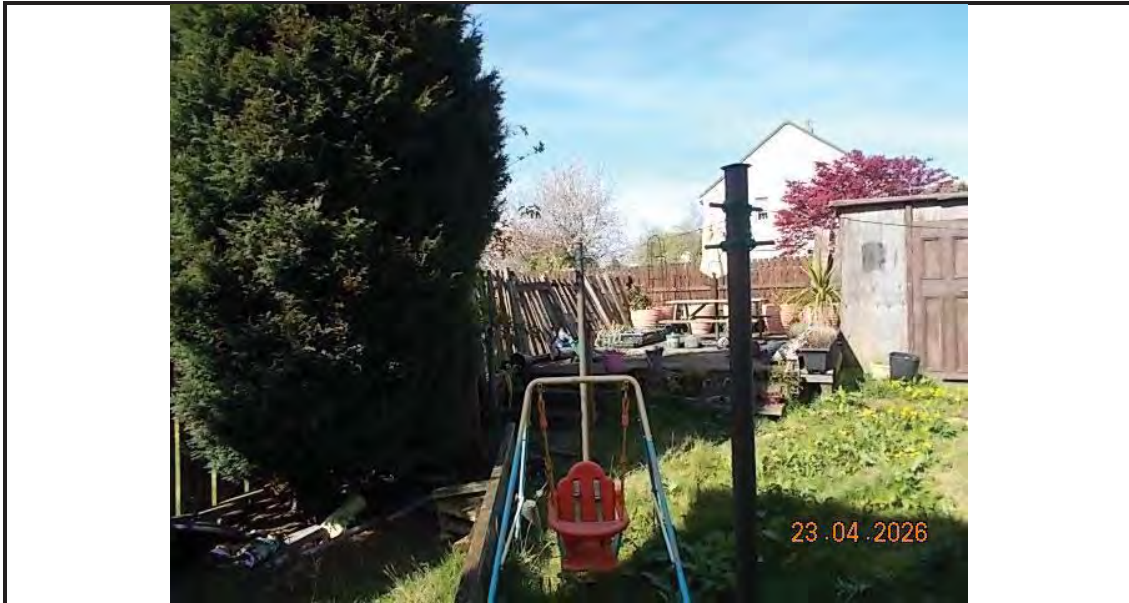
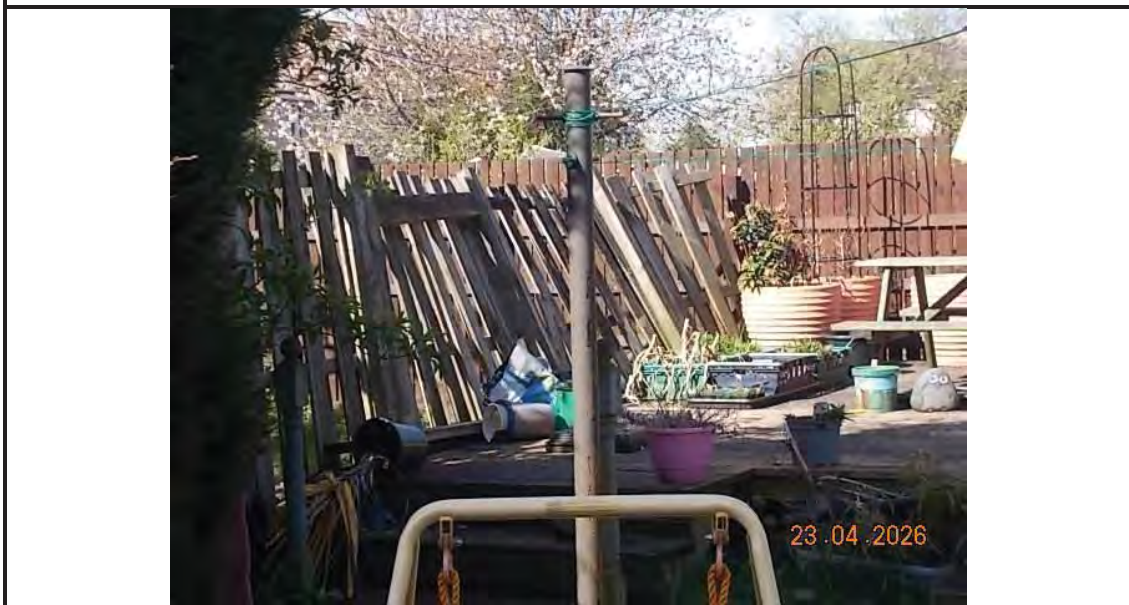
- n) The fence at the rear of the house was partially collapsed and in a poor state of repair (photographs 26-30).
- o) The banister on the right hand side at the top of the stairs (going downwards) was found to be stable but not completely rigid. If some pressure was applied to it, the banister moved slightly.

81. The tribunal observed at its inspection that there was a line of posts along the left hand side of the paved area / driveway at the front of the house where a fence had previously been present. It also observed that the fence at the rear of the house was partially collapsed and in a poor state of repair.

82. Miss Smith said that the rotten fencing at the front of the house had fallen down during the tenants' tenancy and was now in the back garden. The tenants had offered to fix it, but the landlord had refused.
83. Mr Paszkiewicz agreed that both the front and back fences needed to be replaced. He said that the rear fence was shared with a neighbour, who had agreed to pay their share of the cost.
84. The tribunal determined that the fences at both the front and rear of the house were not in a reasonable state of repair and in proper working order at the time of its inspection.

26. Fence to rear of House

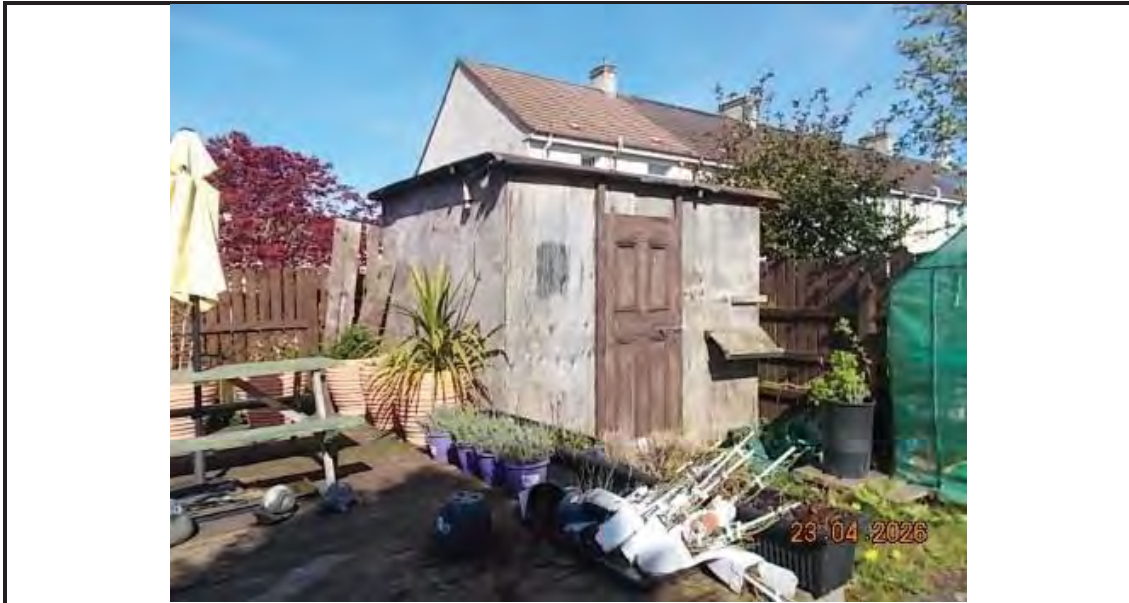
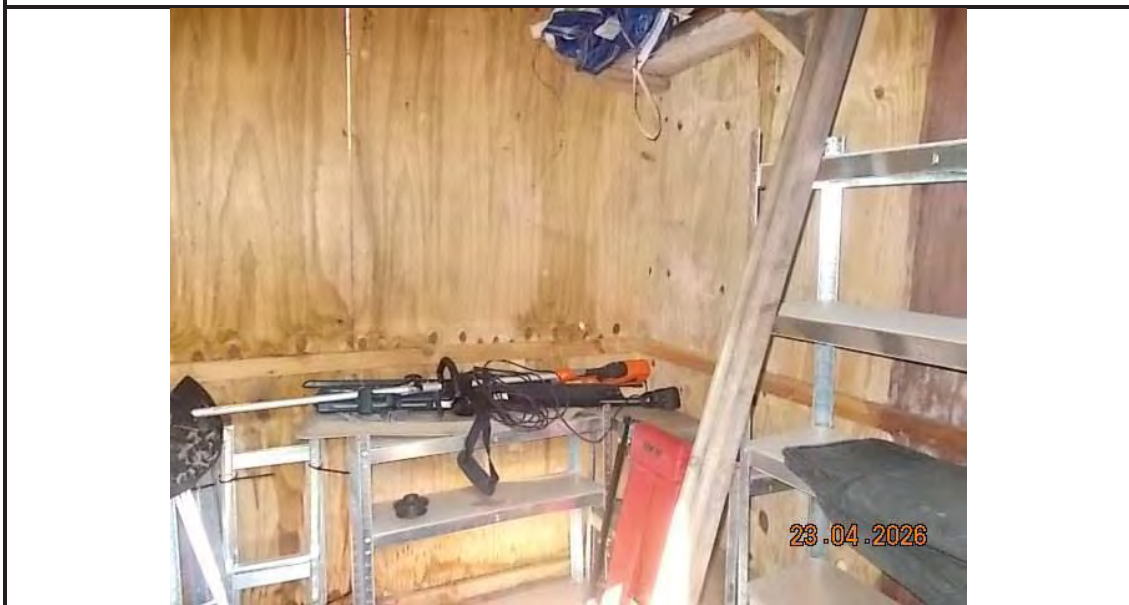
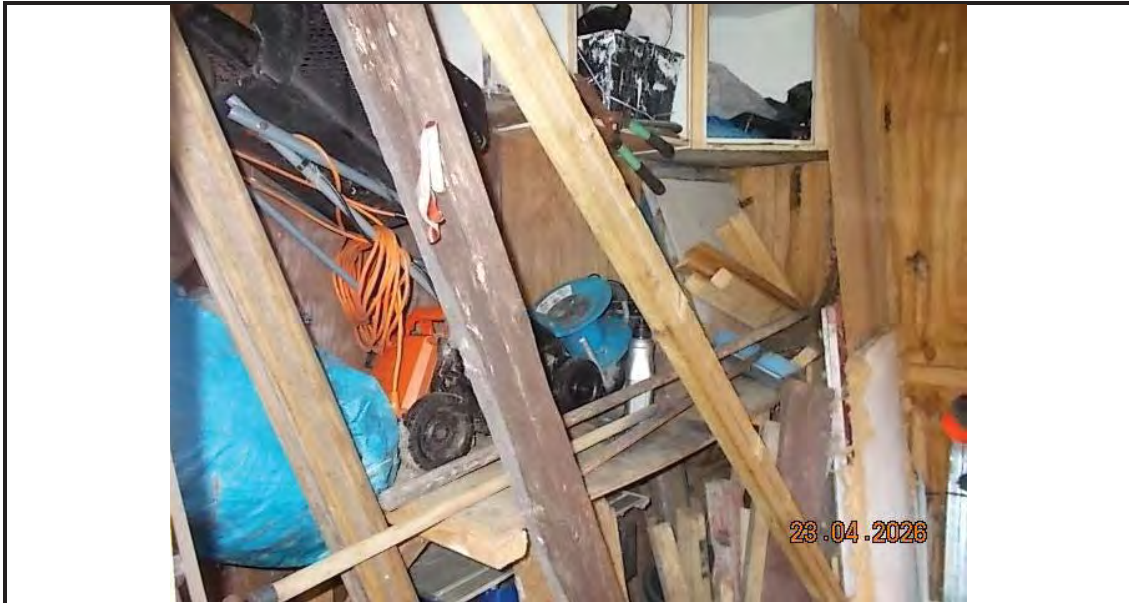
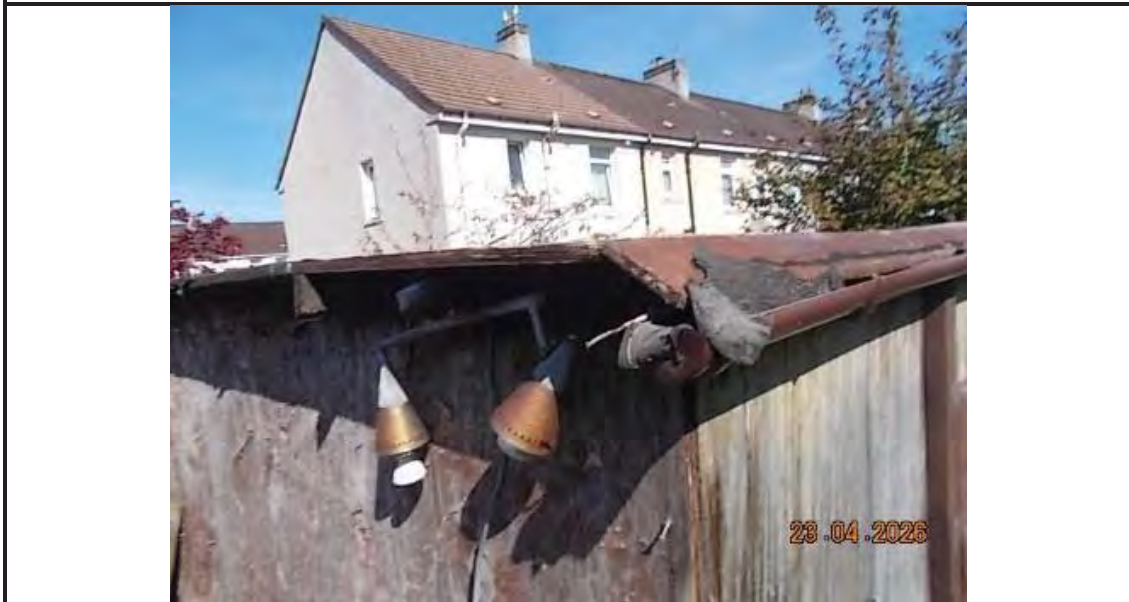
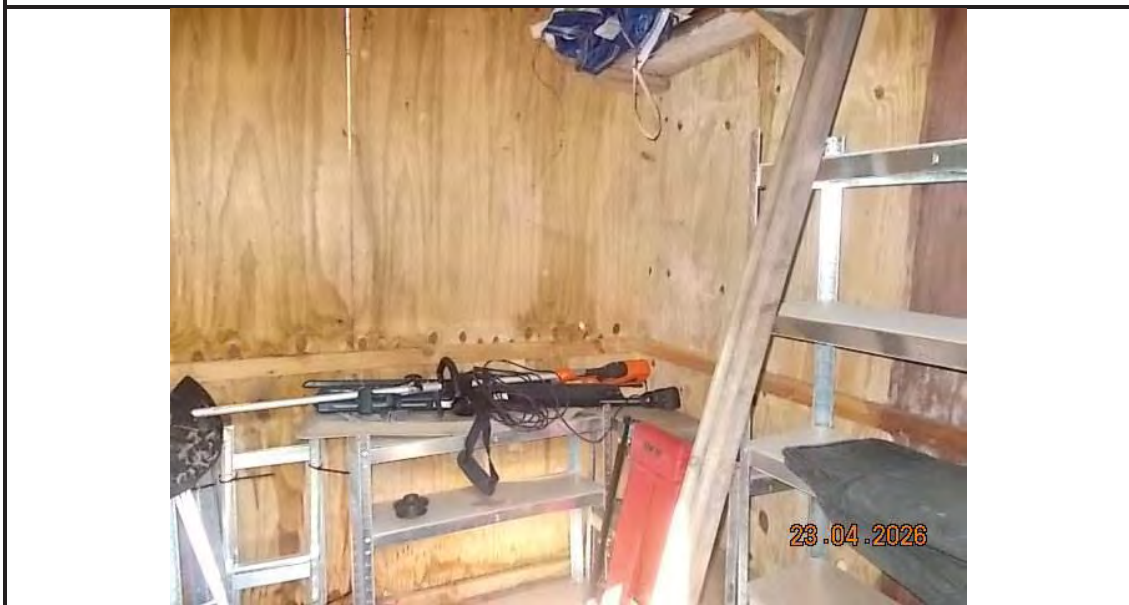
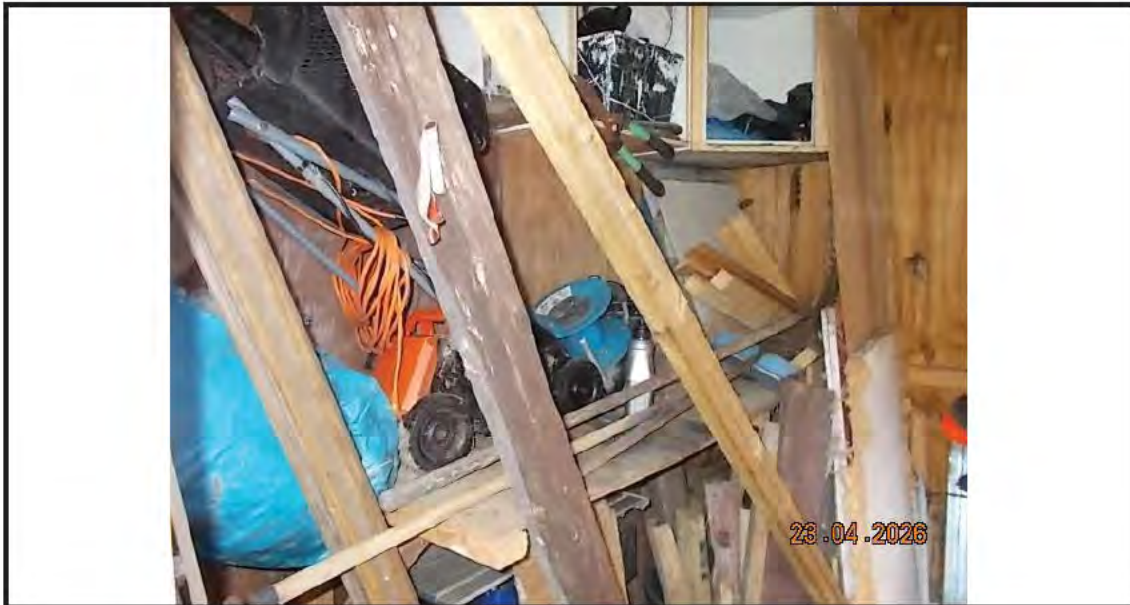
- p) The shed in the rear garden was in a poor state of repair internally and the roof covering was missing. Various items were stored in the shed (photographs 31-34 and 52-53).

31. Shed

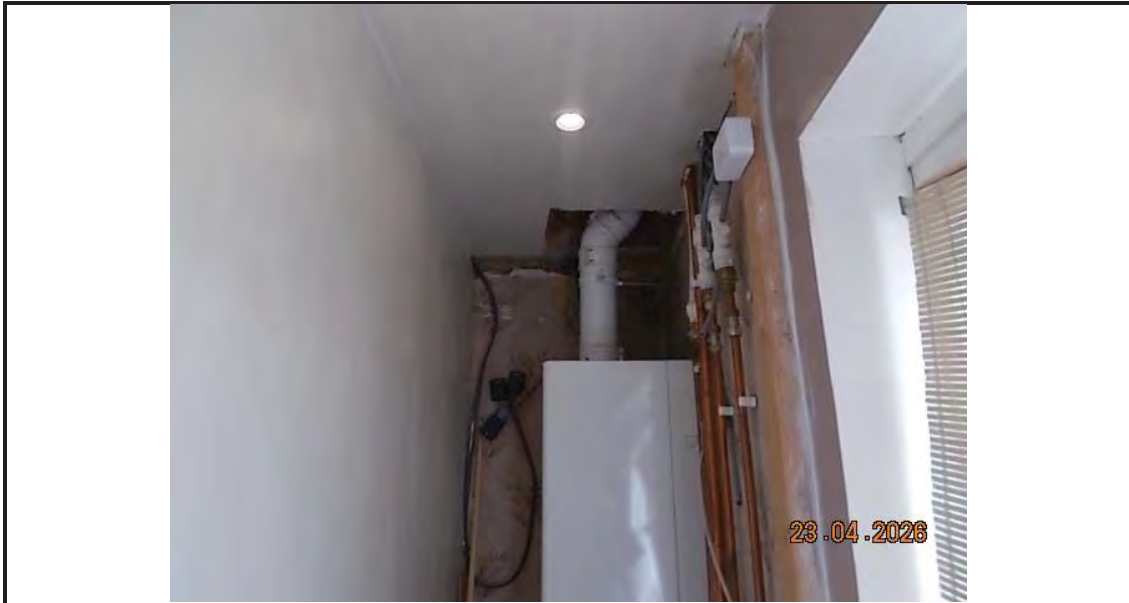
35. Area of displaced ceiling lining in smaller room, first floor at front of property

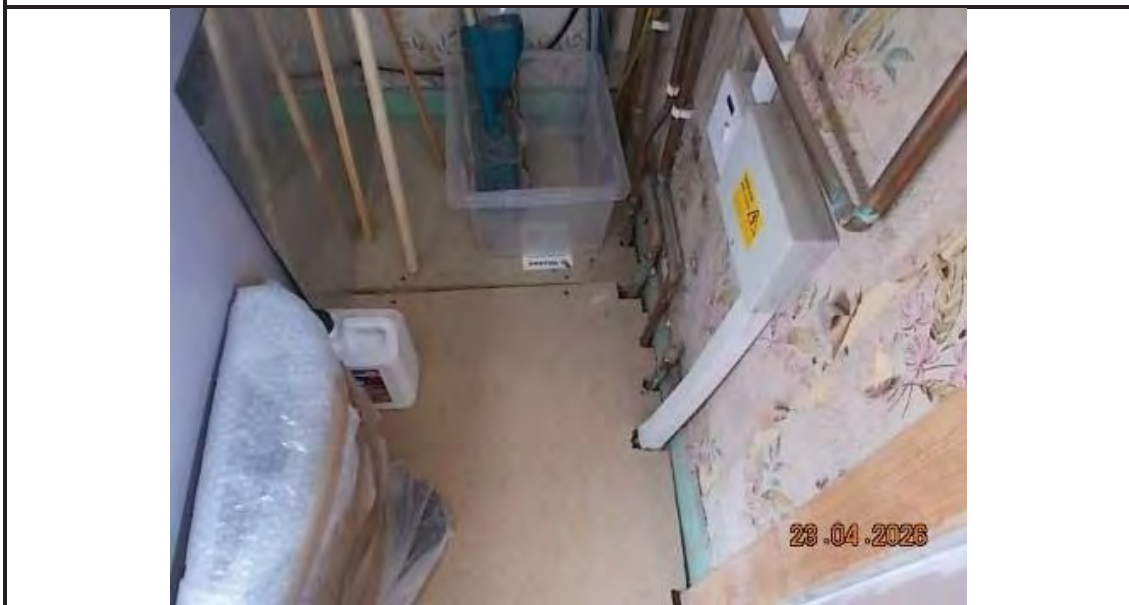
36. Area of flooring in smaller room, first floor at front of property

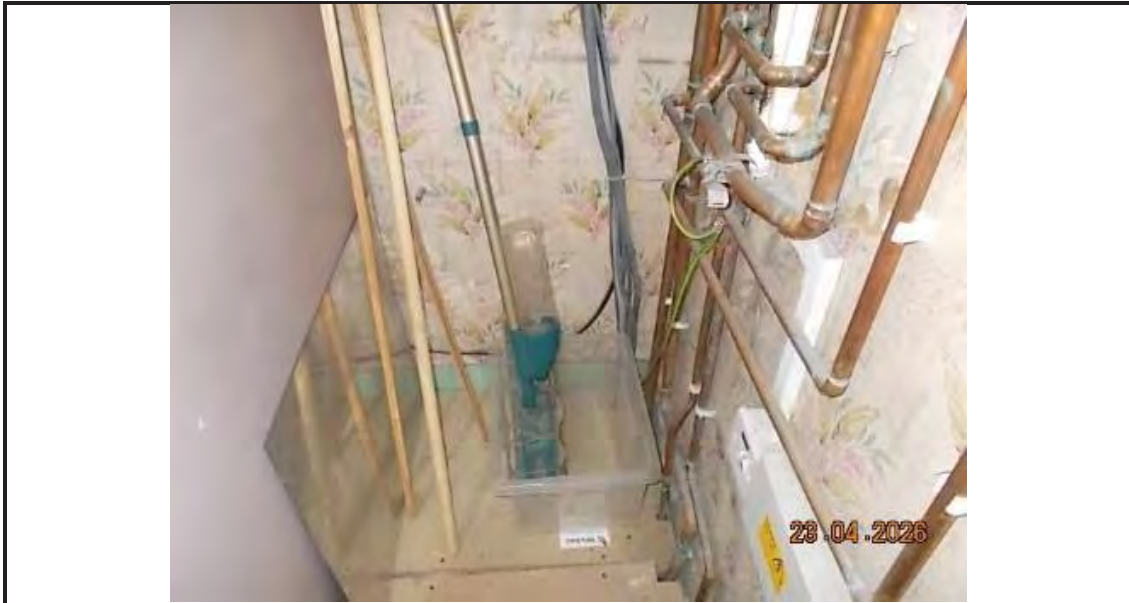
- s) While a plastic container had been placed underneath the boiler, the boiler was not observed to be leaking at the time of the inspection (photograph 37).

37. Plastic container placed to catch any leakage from boiler

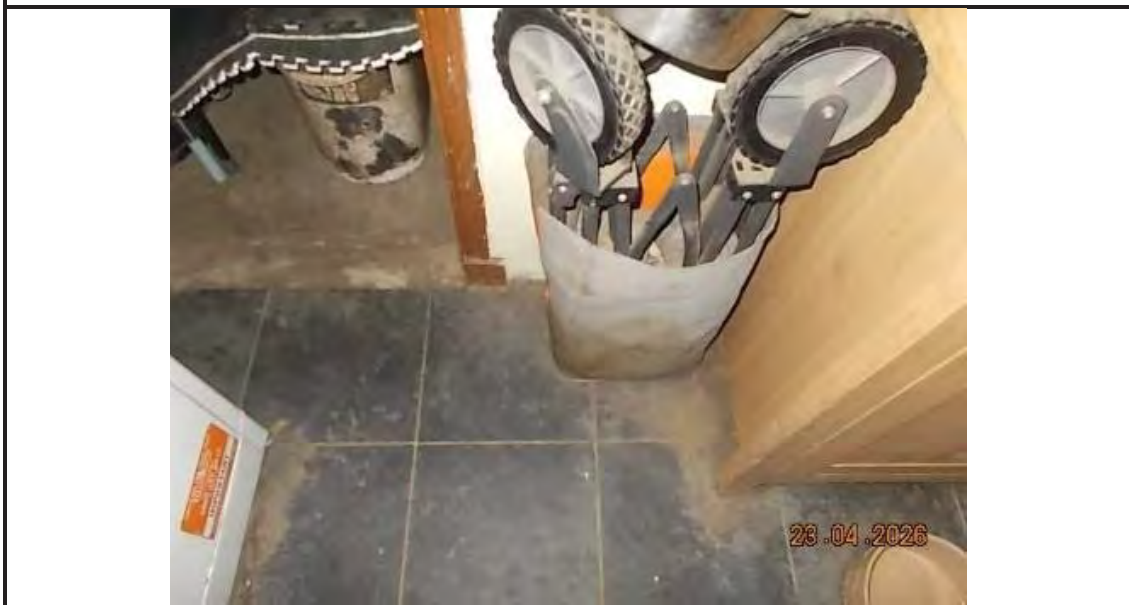
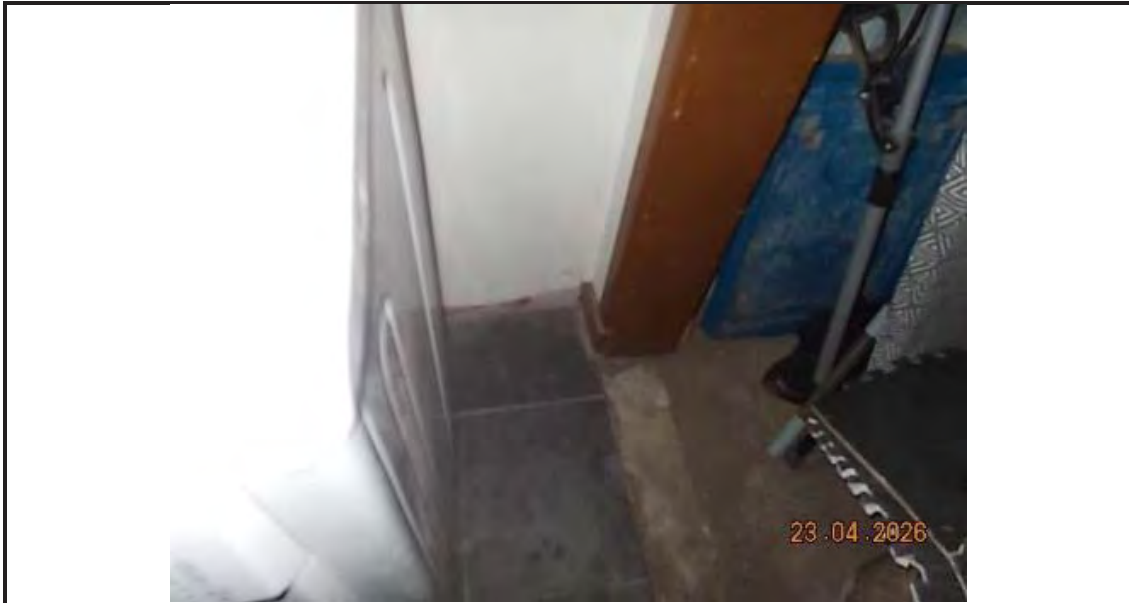
38. Kitchen wall to living room, floor/wall intersection with no skirting board

39. Kitchen wall to adjacent attached property, floor/wall intersection with no skirting board

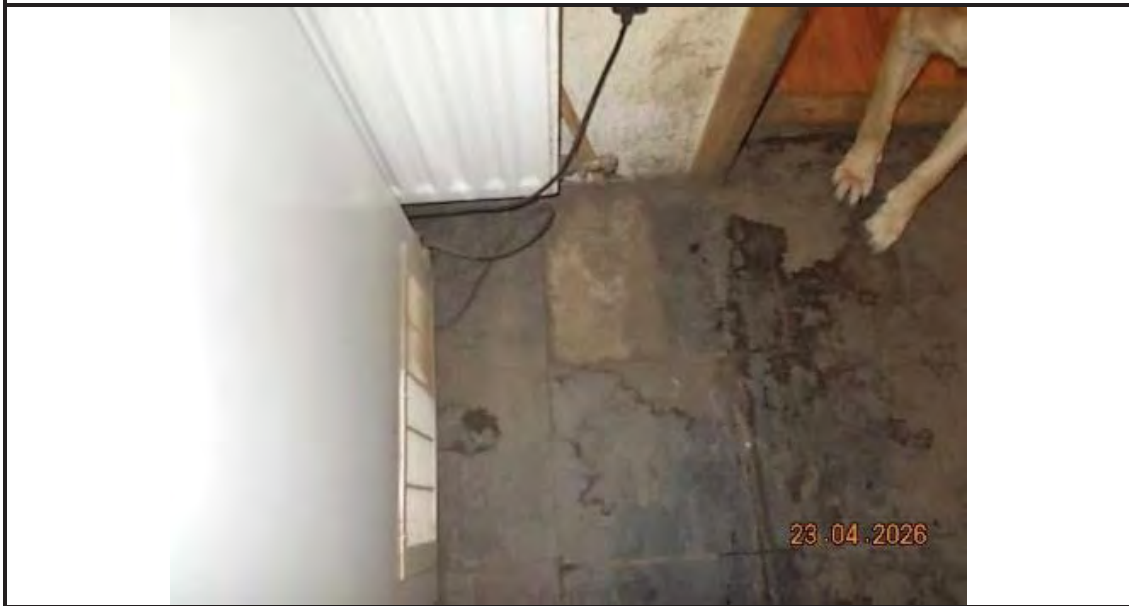
- u) There were two tiles missing from the slate flooring in the kitchen (photograph 40).
- v) There were no 'cover strips' at the carpet joints between the small front bedroom and the first-floor landing and between the larger front bedroom and the first-floor landing (photographs 41-42).

40. Gap to slate tile floor finish in Kitchen

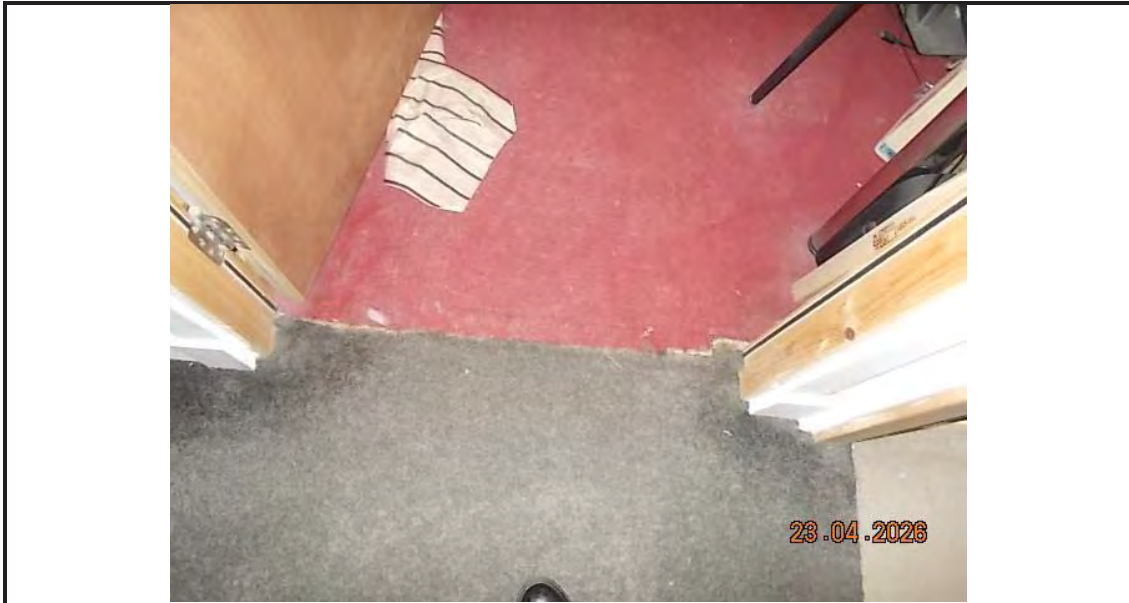
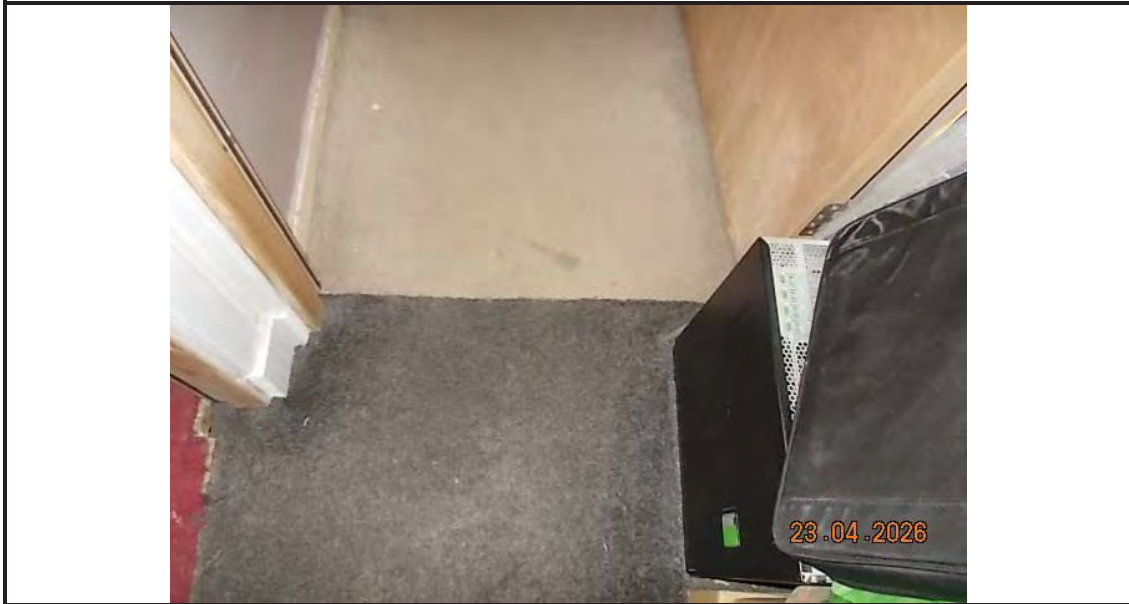
41. "Cover strip" missing at carpet joint, smaller room, first floor at front of property to landing

42. "Cover strip" missing at carpet joint, larger room, first floor at front of property to landing

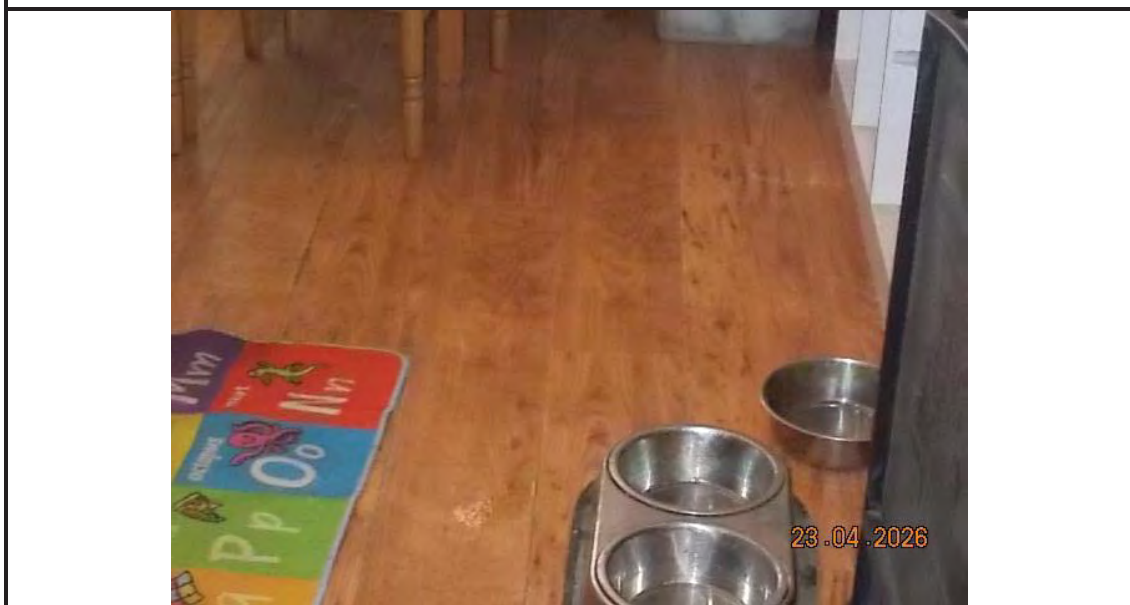
- x) There was laminate flooring throughout the living room, which was in a reasonable condition (photograph 46).
- y) There was an uncarpeted section of flooring in the small front bedroom underneath the boiler. The rest of the room was carpeted (photograph 47).

46. Floor finish to Living Room

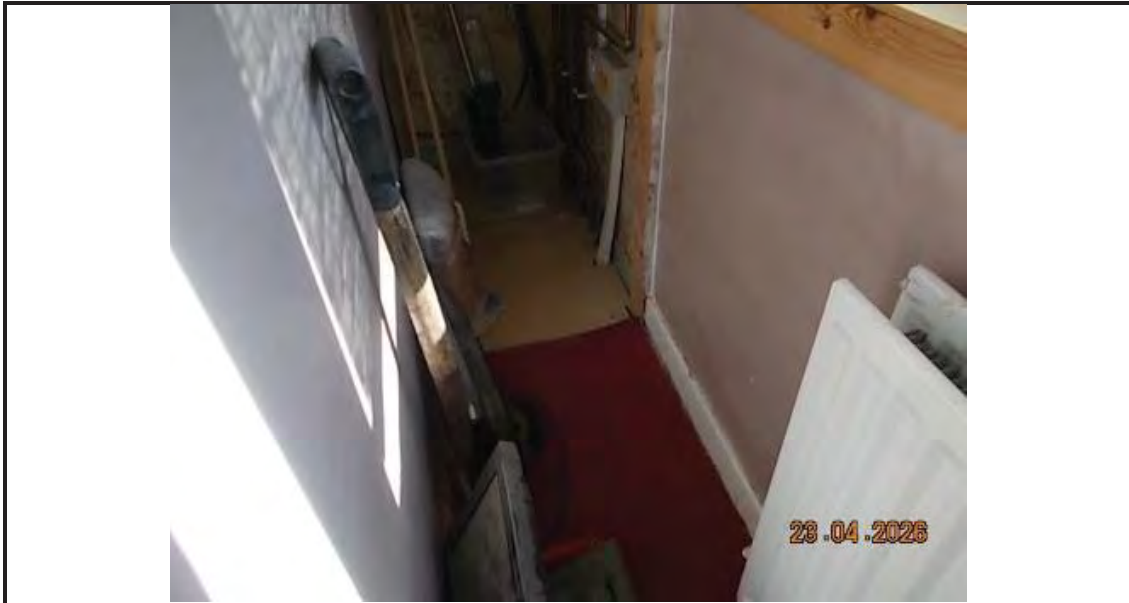
47. Carpet to smaller room, first floor at front of property

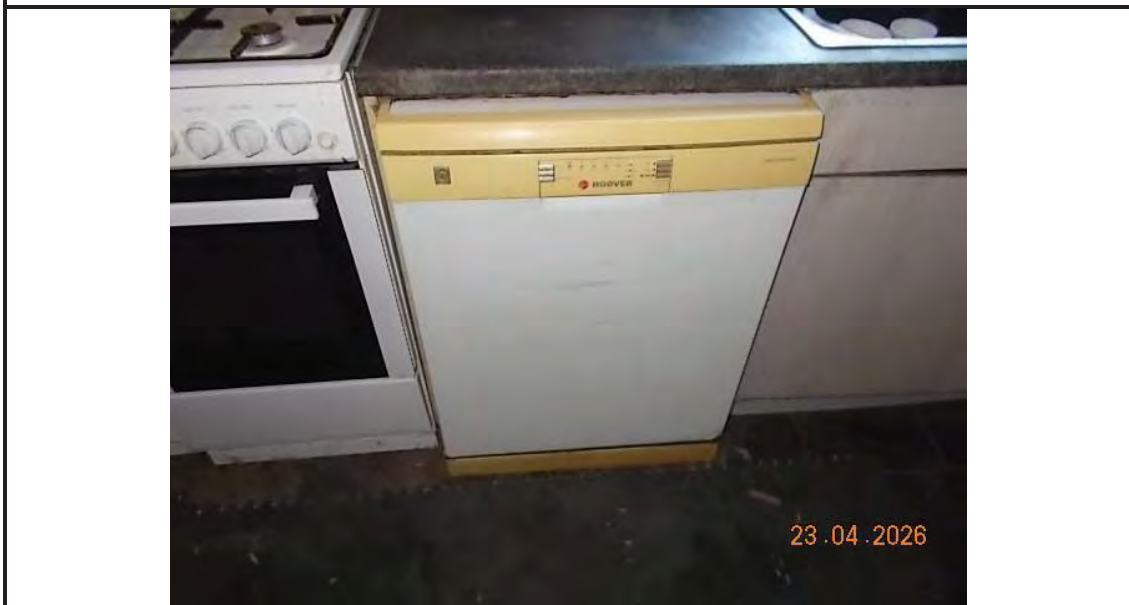
- z) The dishwasher appeared to be in reasonable condition but was not tested by the tribunal (photograph 48).
- aa) The toilet roll holder in the first floor bathroom was broken (photograph 49).

48. Dishwasher

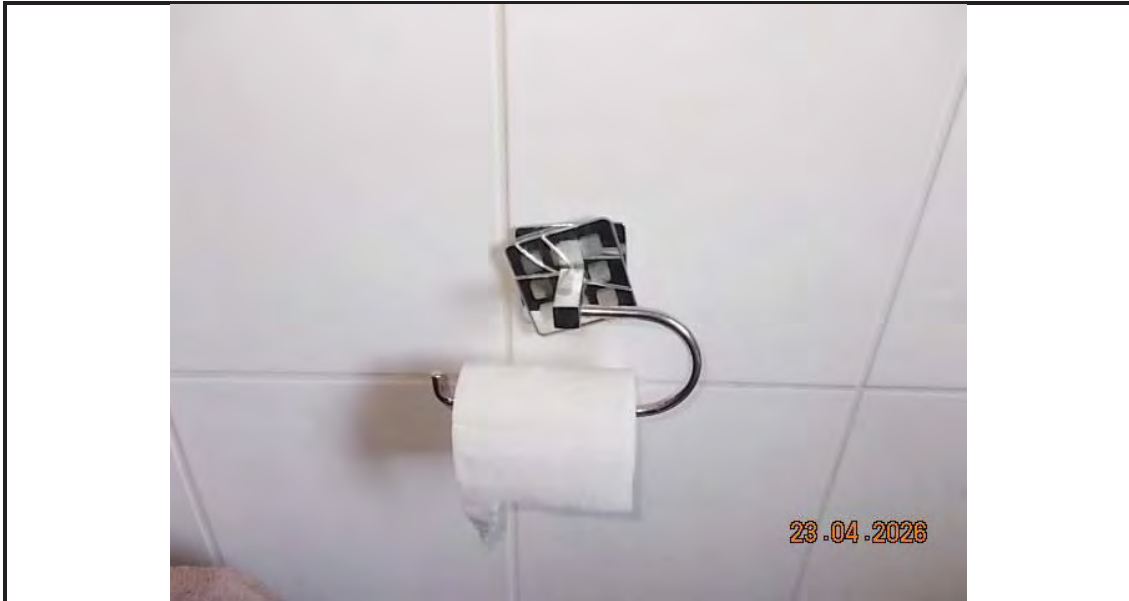
49. Toilet roll holder in Bathroom at First Floor level

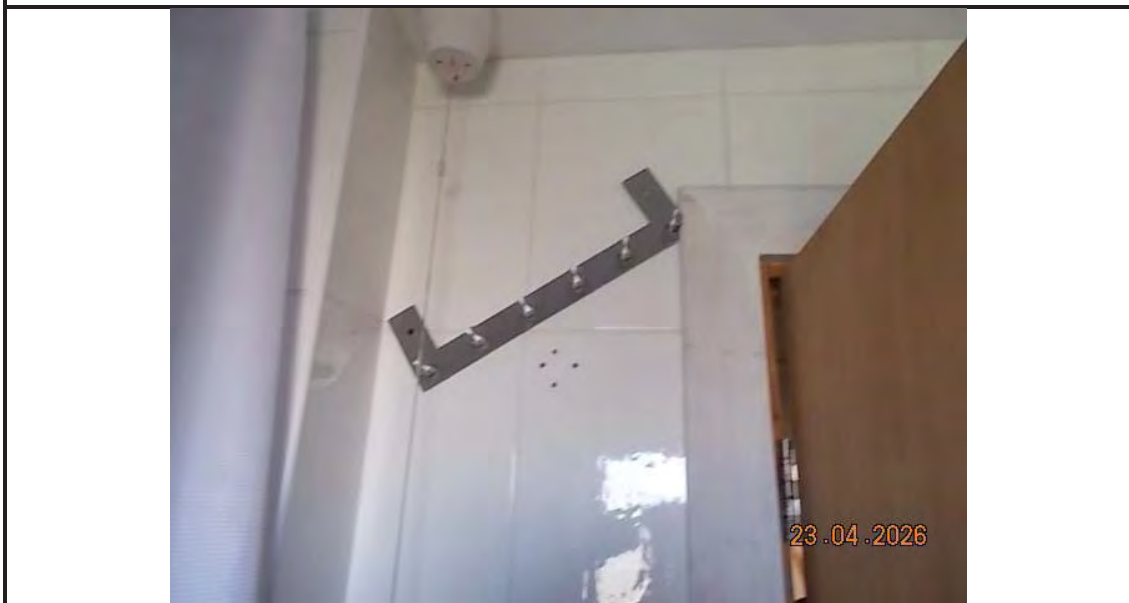
50. Coat hanger in Bathroom at First Floor level

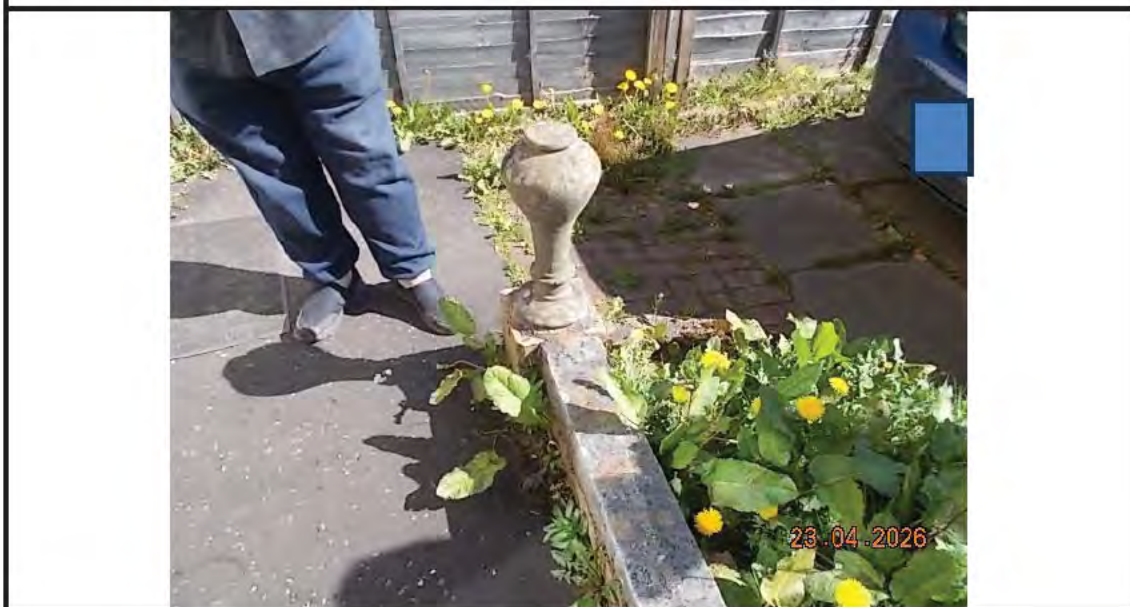
- dd) There was a decorative concrete finial to the raised planter in front of the house at the right hand side (when facing the house) which was loose and could be lifted off the iron pin on which it was intended to be secured. (photograph 54).

54. Low planter

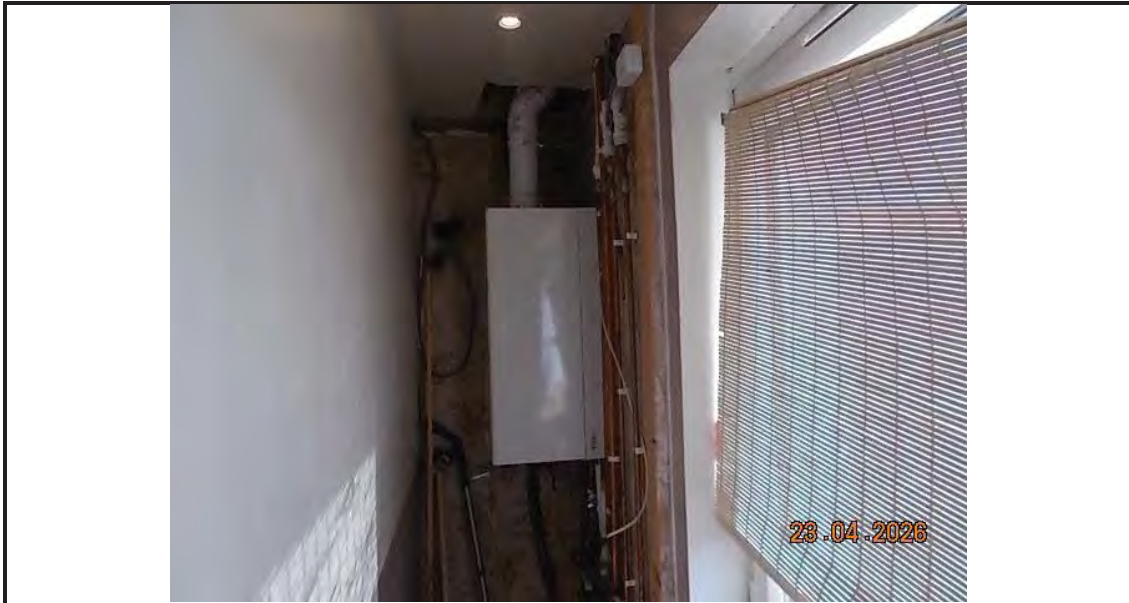
55. Undecorated areas in smaller room, first floor at front of property
