**Statement of Decision of the Housing and Property Chamber of the First-tier Tribunal for Scotland under Section 26 (1) of the Housing (Scotland) Act 2006**

**Chamber Reference number: FTS/HPC/RP/25/4283**

**Re: Property at Flat 2/2, 68 Quarry Street, Hamilton ML3 7AU (“the Property”)**

## Inspection summary and schedule of photographs

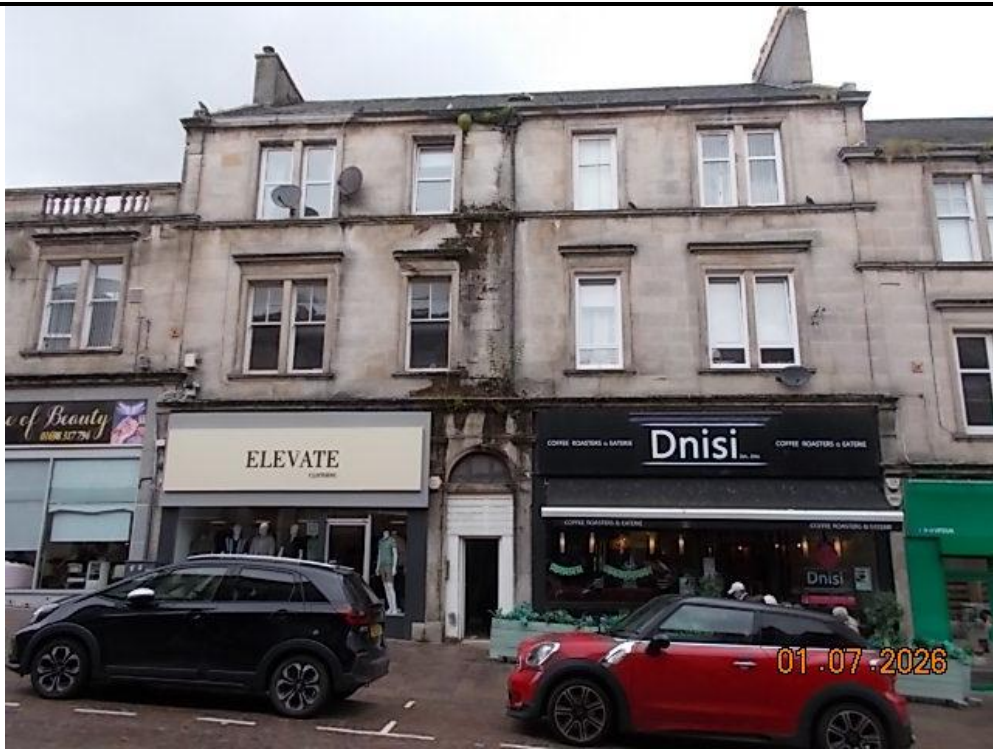
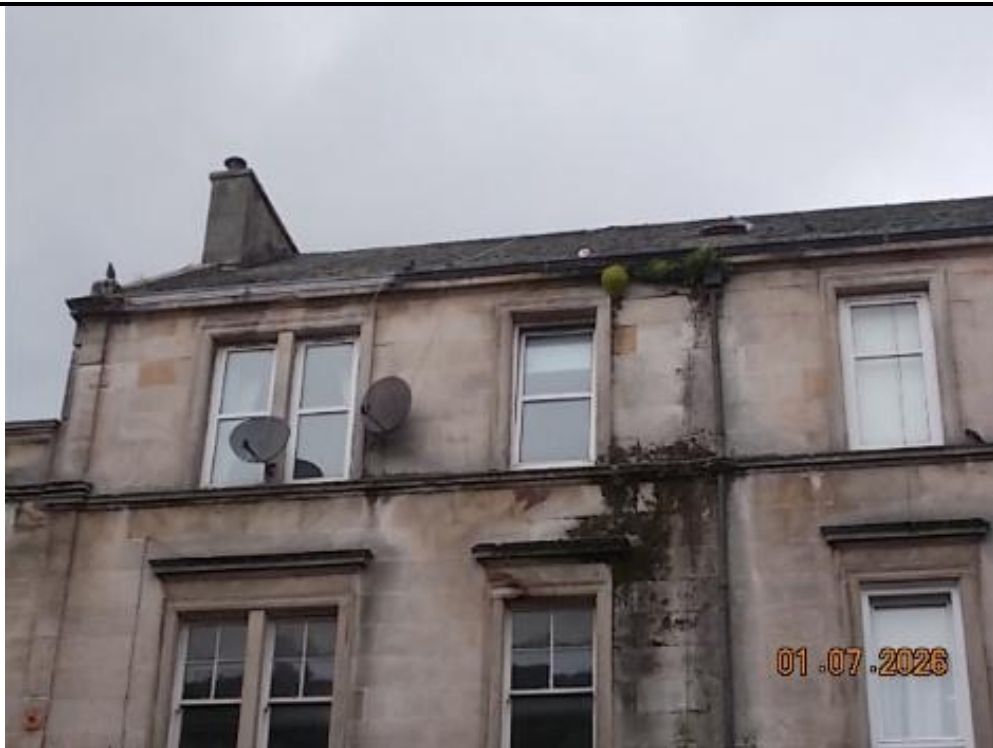
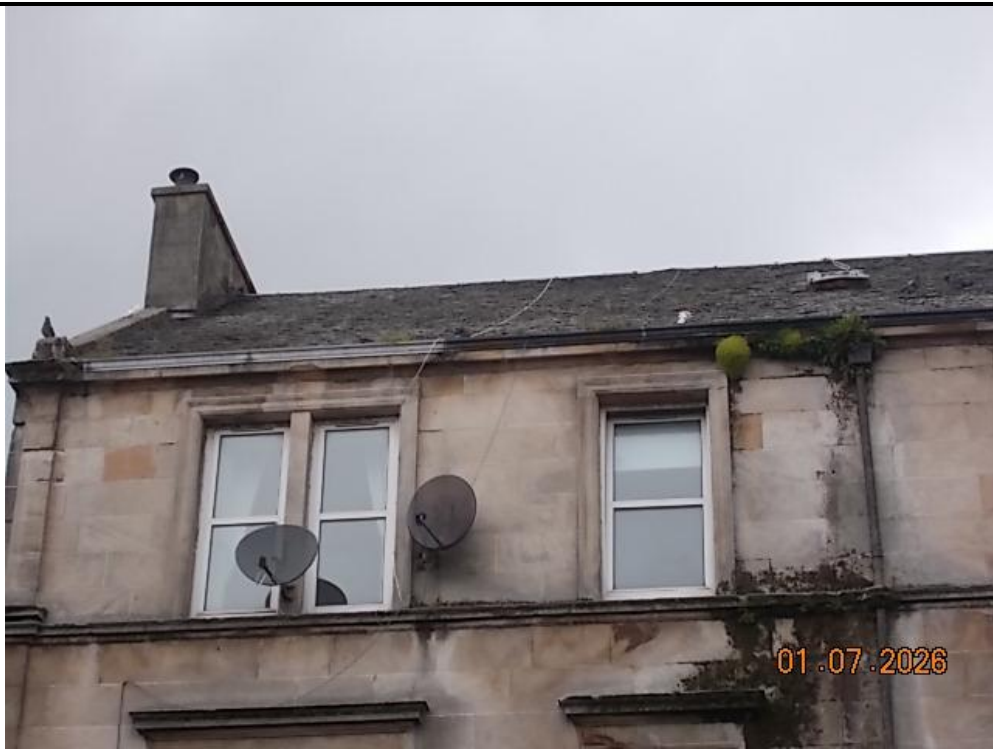
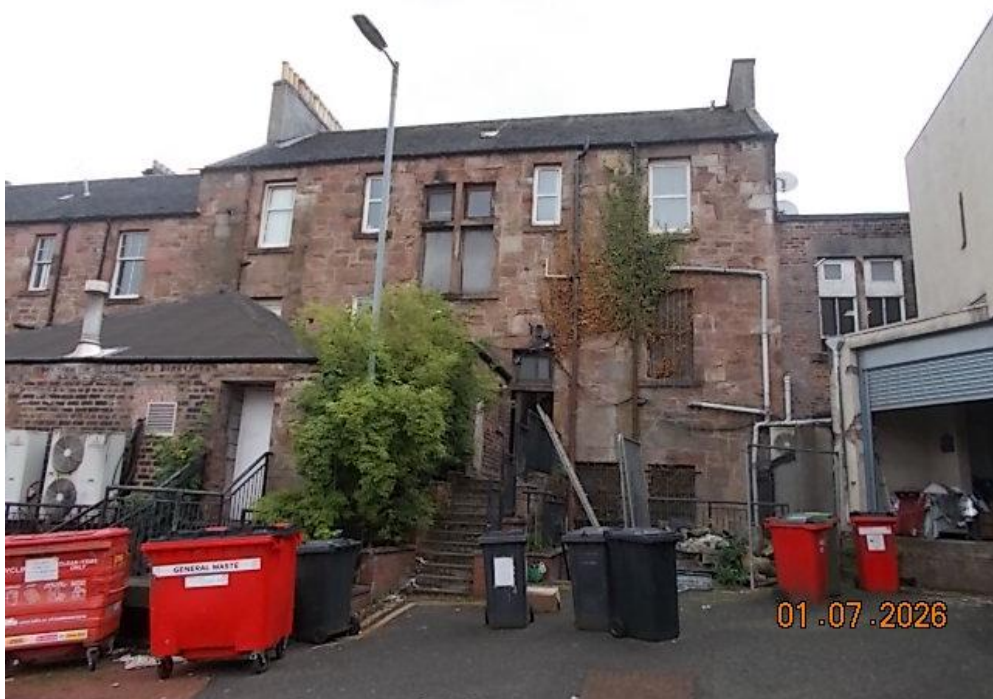
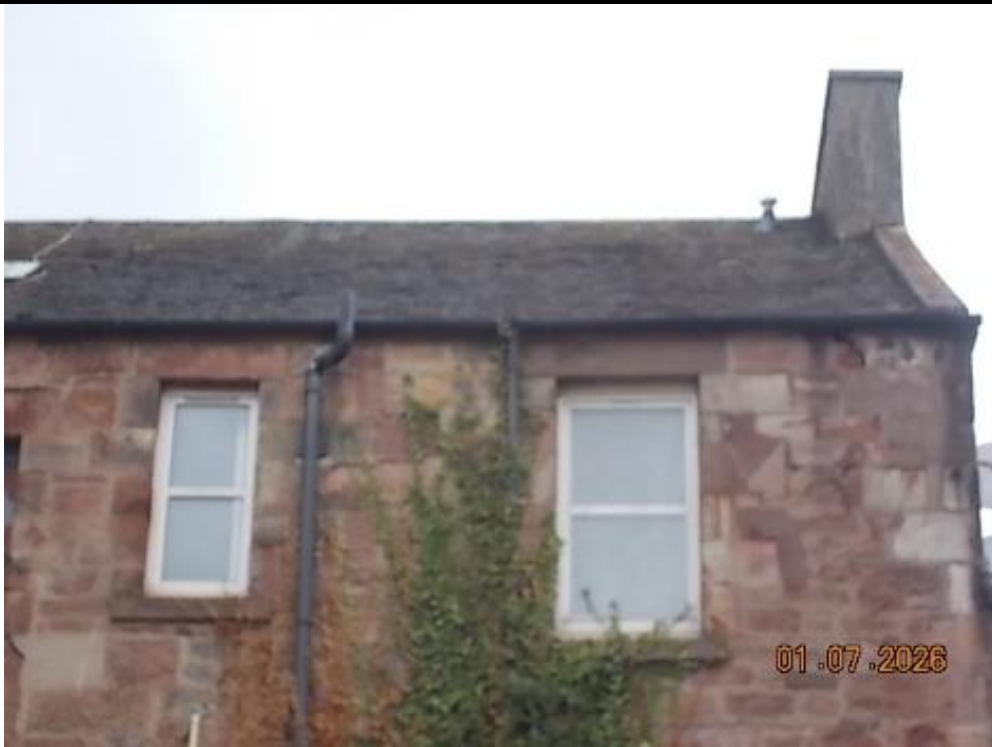
- (i) evidence of slipped, displaced or otherwise defective slates to the entire roof area on both front and rear slopes, accumulations of debris and vegetation growth in both front and rear gutters and evidence of water discharge down the front elevation.

1. Evidence of slipped, displaced or otherwise defective slates to entire roof area on both front and rear slopes. Accumulations of debris and vegetation growth in both front and rear gutters. Evidence of water discharge down front elevation. [Photos 1-5]

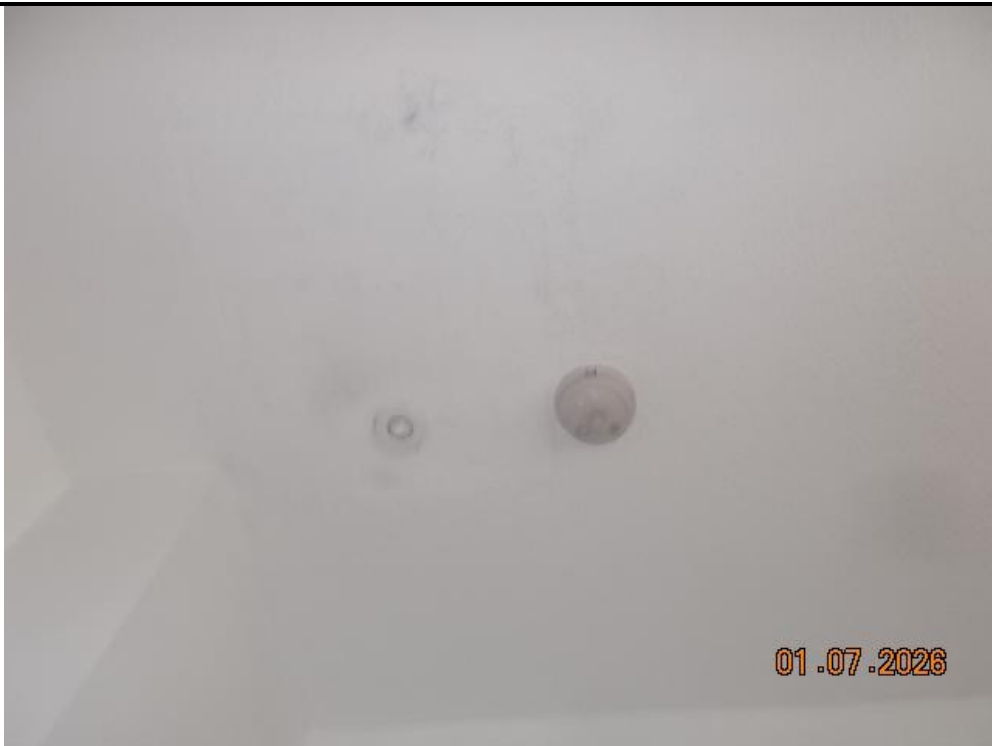
6. Kitchen ceiling

- (ii) evidence of a previously patched area of ceiling near a spotlight in the kitchen approximately 800x600mm. There was some discolouration of finish but no evidence of mould growth at present.

2. Evidence of a previously patched area of ceiling near a spotlight in the Kitchen approximately 800x600mm. Some discoloration of finish but no evidence of mould growth at present. [Photo 6]

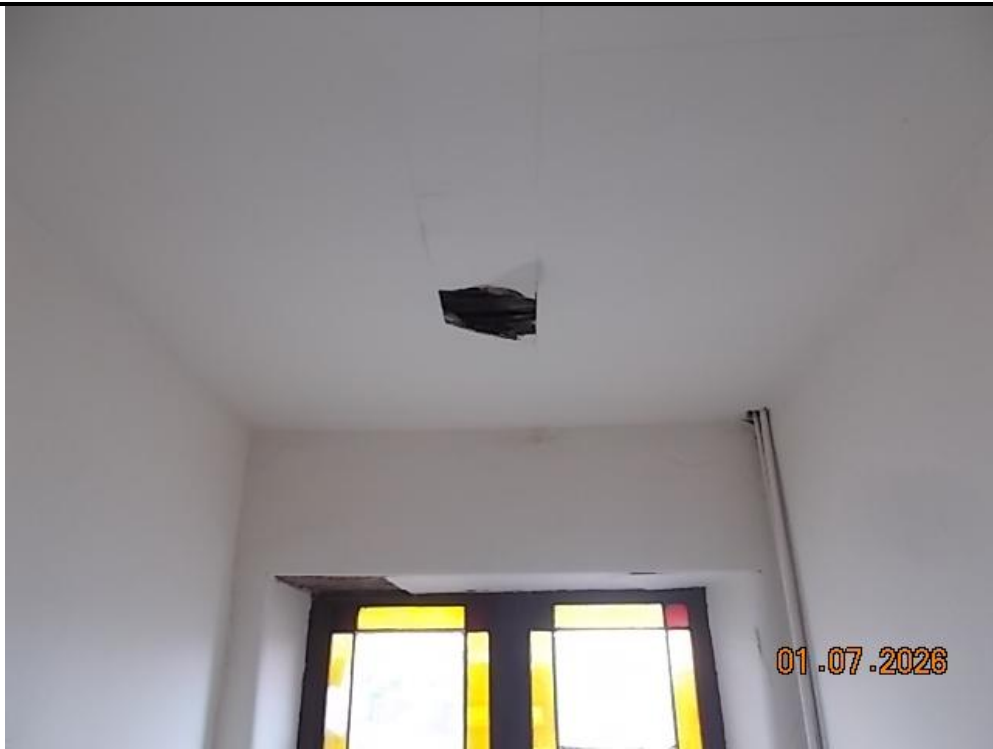
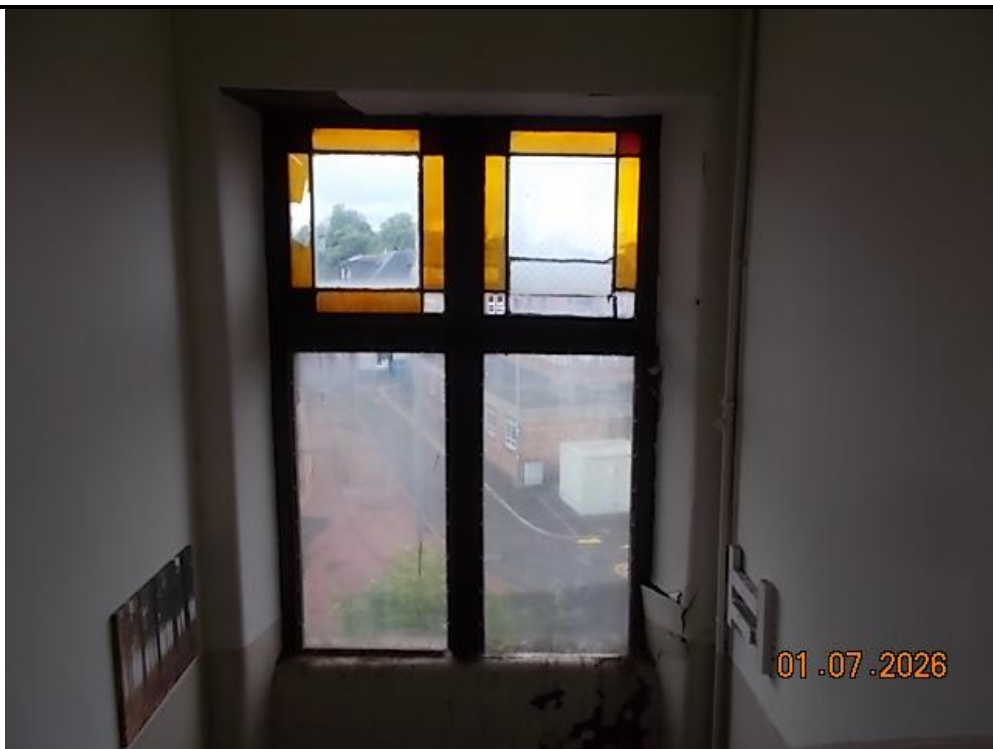
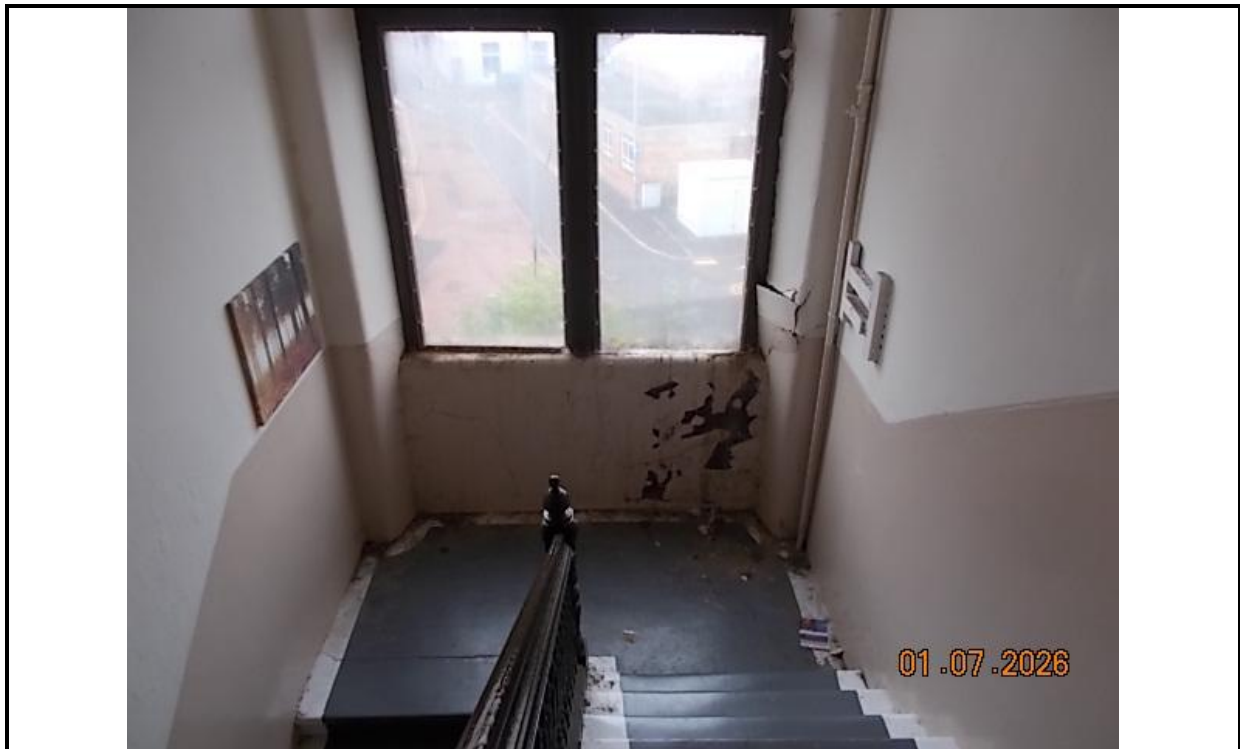
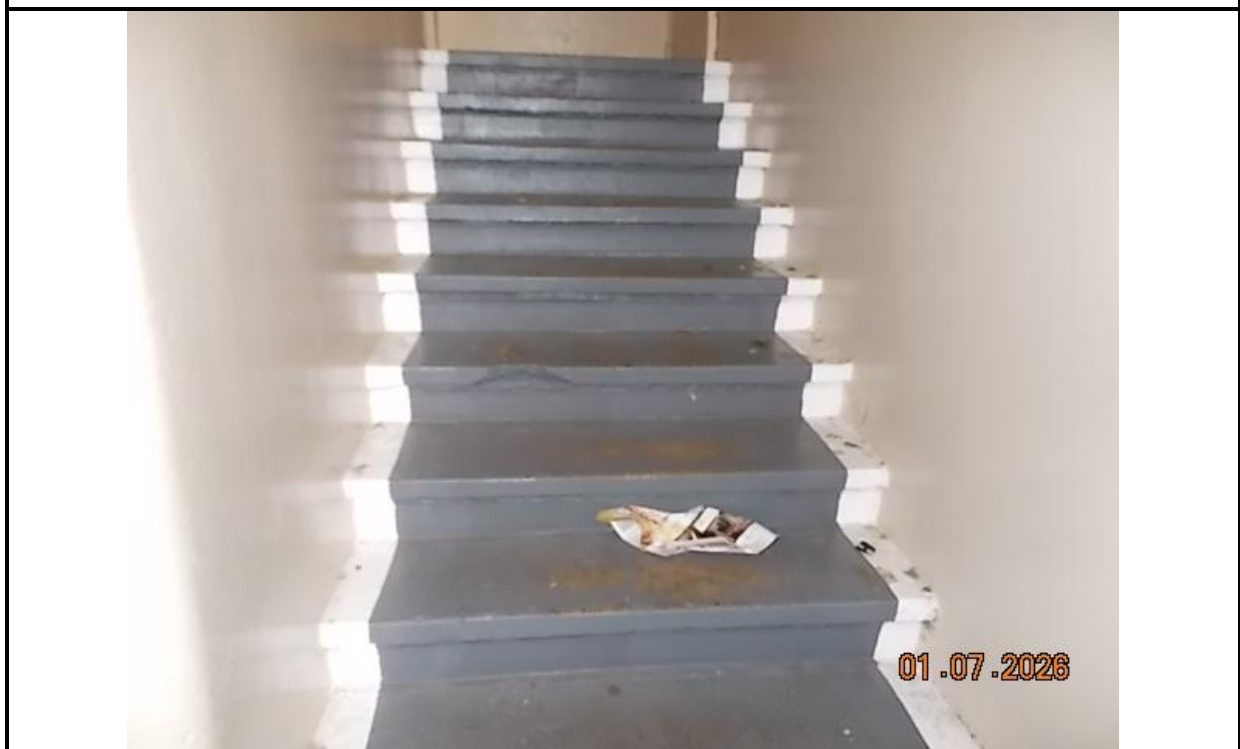
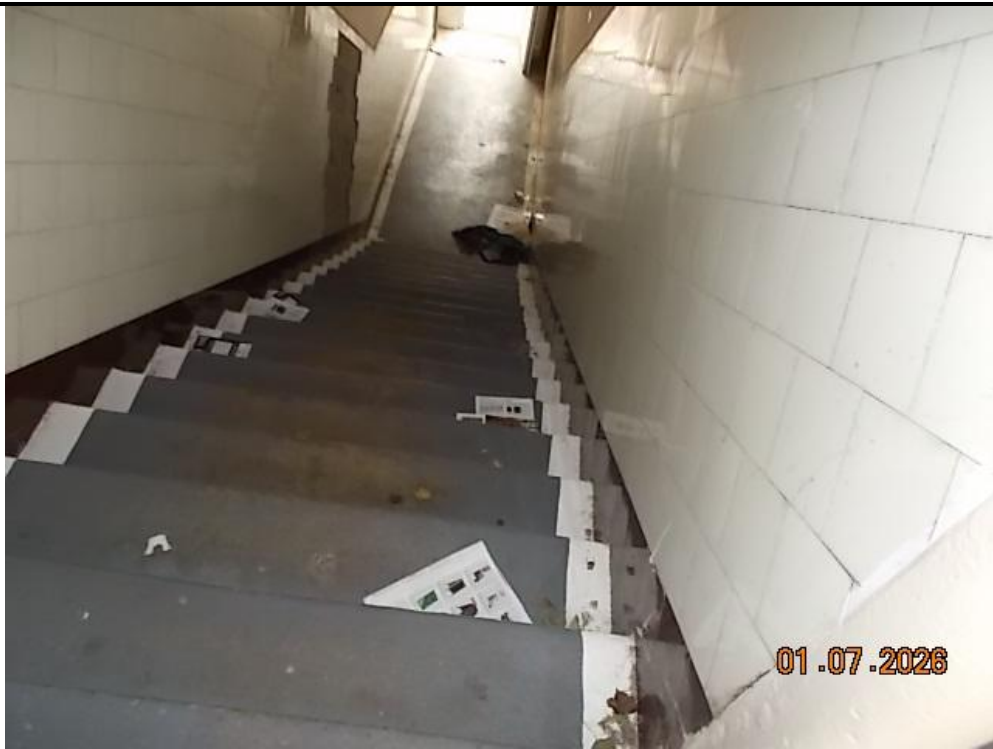
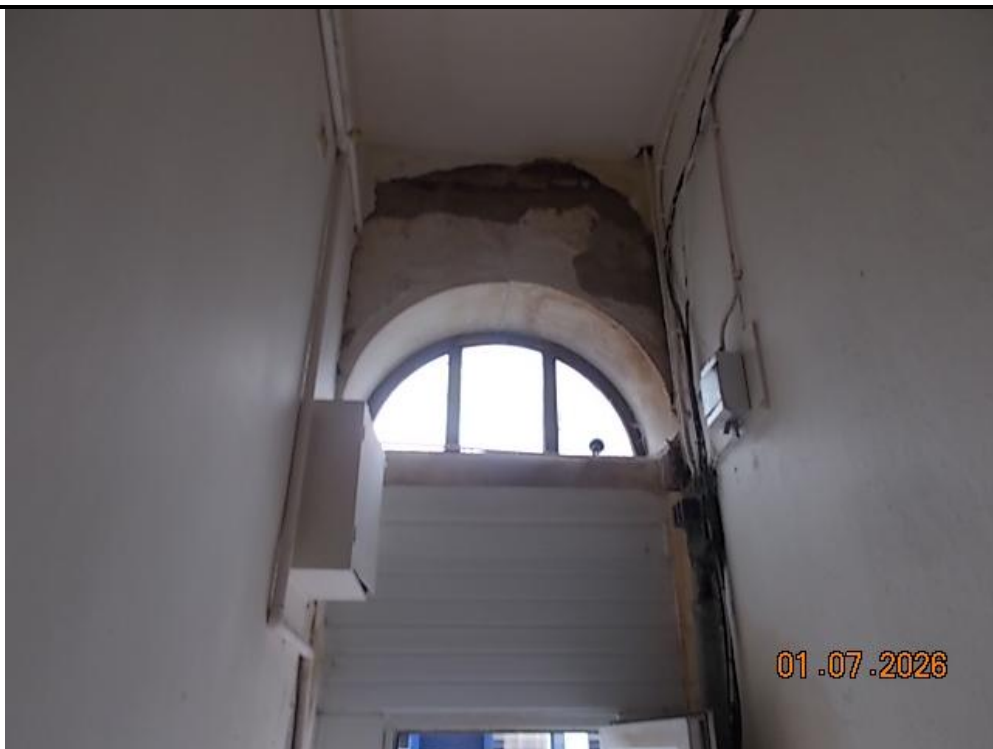
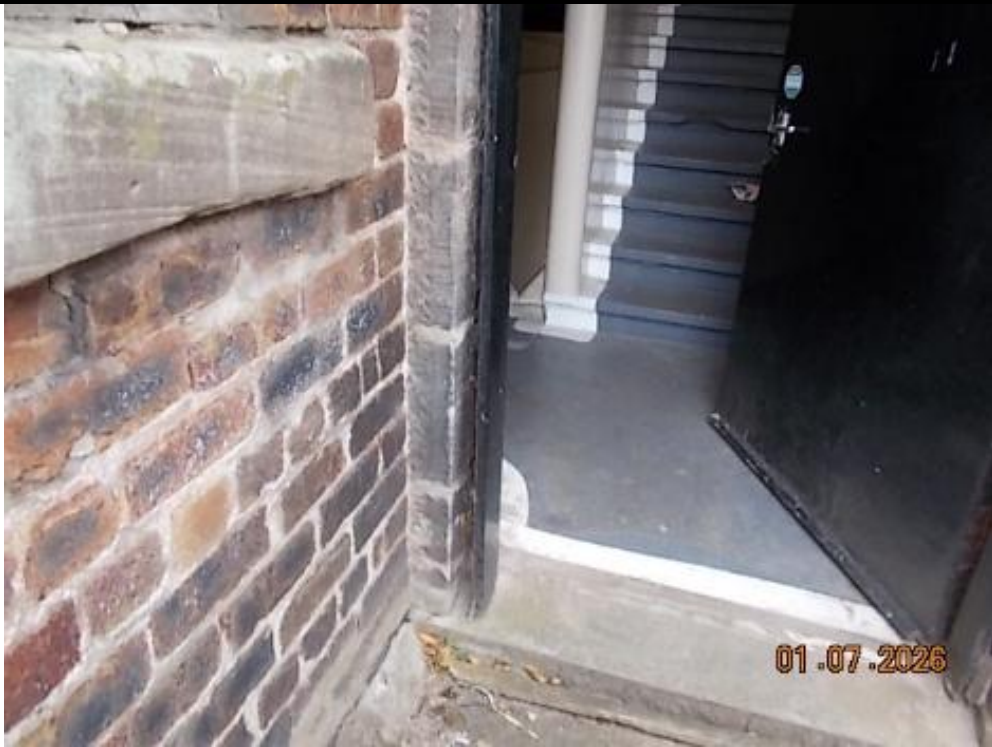
- (iii) a small section of ceiling (approx. 300x300mm) is missing at the underside of the roof space in the common stairwell. There was missing plaster to the soffit to the top-level window in the common stairwell. The top-level windows to the common stairwell have been patched with Perspex. There is evidence of water penetration displacing wall plaster below windows and general damage to wall plaster at all levels in the common stairwell. There is also missing plaster and wall tiling, and there are bird droppings and an accumulation of rubbish in the entrance passage.

3. Small section of ceiling approx. 300x300mm missing at underside of roof space in common stairwell. Missing plaster to soffit to top level window in common stairwell. Top level windows to common stairwell patched with Perspex. Evidence of water penetration displacing wall plaster below windows. General damage to wall plaster at all levels in common stairwell. Missing plaster, wall tiling, bird droppings and accumulations of rubbish in entrance passage. [Photos 7-13]
