**STATEMENT OF DECISION: Housing (Scotland) Act 2006 Section 24 (1)**

**Chamber Ref: FTS/HPC/RP/25/4288**

**RE: Property known as 98 Calder Place, Hallglen, Falkirk FK1 2QQ  
("The Property")**

Schedule of photographs taken on 13 July 2026

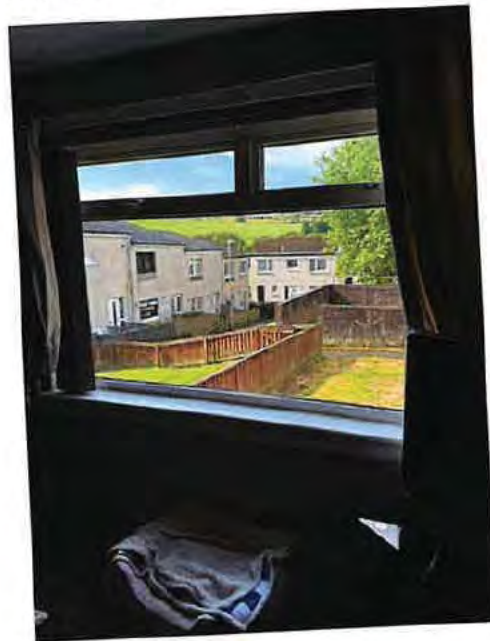
- g) Some air movement was noticed under the living room window.
- h) The upstairs family bathroom has never had an extractor fan fitted within it.
- i) The television aerial on the roof of the Property is not secured fully to the Property.

- 11) The Tribunal was satisfied that the windows within the Property were wind and water tight as well as being in a reasonable state of repair standing their age. Whilst some of the handles were loose, the handles allowed the windows to be opened and closed as well as securing them. In terms of the window in the family bathroom, whilst there is no latch fitted to the window, it does open and hold sufficiently for it to be used as well as having a trickle vent fitted. Further, whilst some air movement could be felt below the window in the living room, the window was water tight and the level of air movement was not considered unreasonable and not an issue of disrepair for the Property.

*Photograph 2: Living room: Casement window*

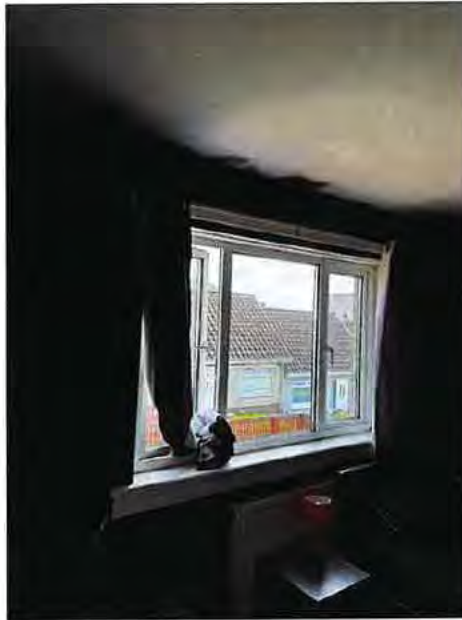
- m) The gate in the back garden of the Property is not properly attached to a post and cannot be operated normally or as intended.
- n) There is mould within the rear bedroom of the Property affecting the internal walls of the said bedroom as well as the ceiling of same.

- a) Whilst the Tribunal had sight of the invoice from M Stewart Roofing & Maintenance, which suggested issues may be caused by condensation rather than other cases, the level of mold in the back bedroom was significant.

*Photograph 12: Bedroom 3: Casement window – rear showing patches of black mould at ceiling level*

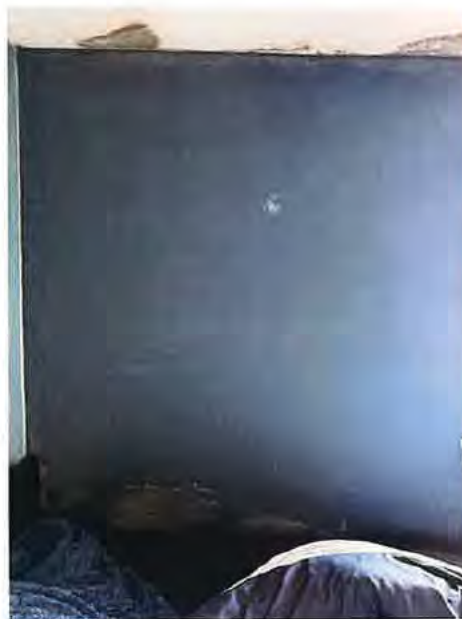
- d) The pattern of the mould on the bedroom ceiling was unusual to be solely attributable to lifestyle condensation.
  - e) Whilst most damp meter readings taken by the Ordinary Member of The Tribunal were within the normal range and all in the upstairs bathroom were within the normal range, some of the readings showed slightly raised moisture levels (see the attached schedule of photographs). There has been a recent prolonged period of dry and hot weather.

*Photograph 13: Bedroom 3: Section of rear wall showing staining and black mould at ceiling level*

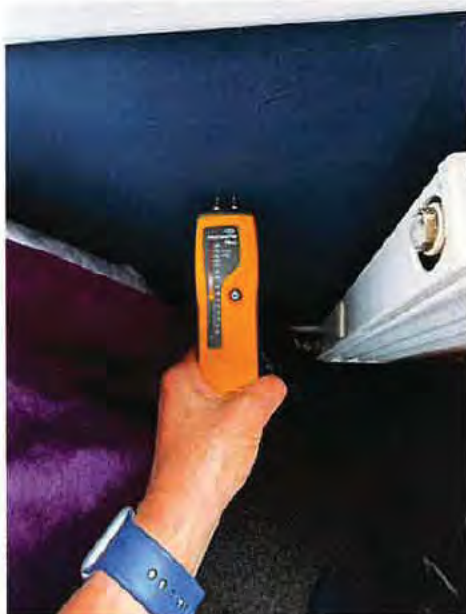
*Photograph 16: Bedroom 3: Rear wall – damp meter showing slightly raised moisture levels*

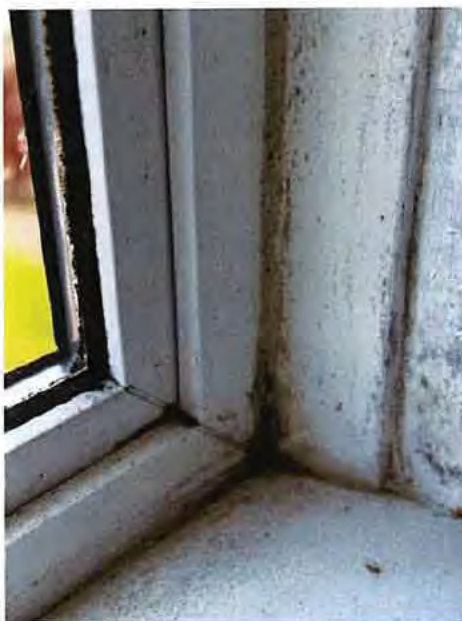
*Photograph 17: Bedroom 3: Mould around window frame*

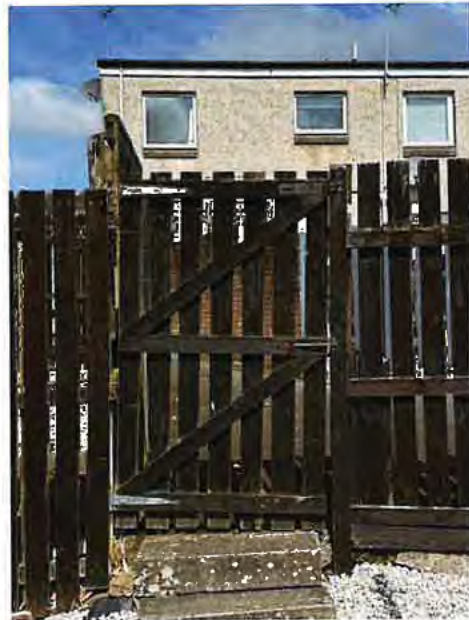
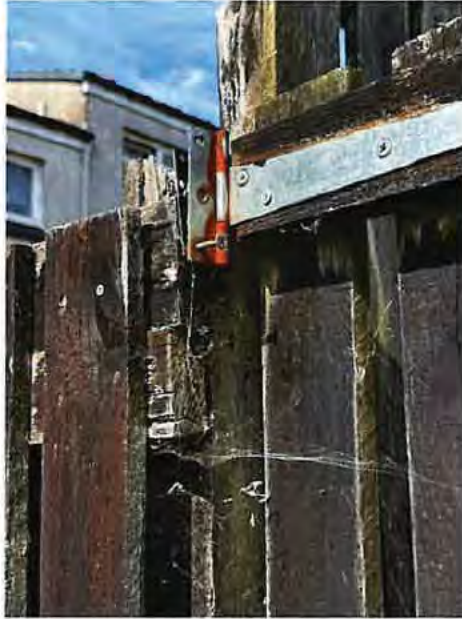
- a) It was clear that the gate in the back garden was not in a reasonable state of repair. It was barely supported when closed and it could not be opened and operated in a normal fashion requiring the gate to be lifted to move it. Further, the top hinge for the gate was only loosely attached to the supporting post which was also rotten.

*Photograph 21: Rear garden: Gate*

*Photograph 22: Rear garden: Gate*

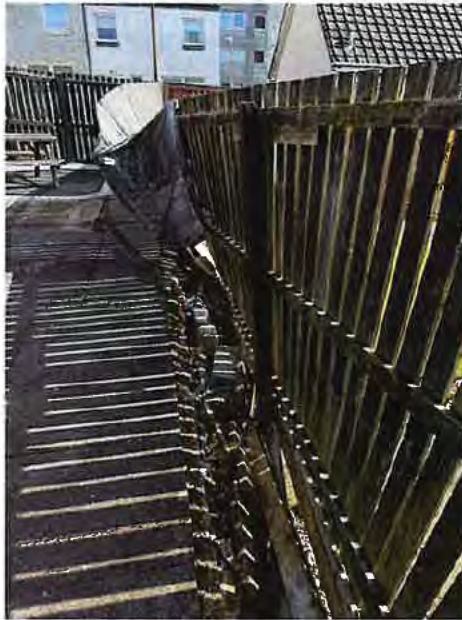
- l) The boundary fence between the Property and the neighbouring property at 96 Calder Place, Hallglen, Falkirk is wholly within the boundary of that property.

- 13) There clearly is an issue with dilapidated fencing along the boundary with the neighbouring property. However, both parties were in agreement that the fence complained of sat wholly out with the boundaries of the Property and within the neighbour's garden. It is therefore the neighbour's property, and the Tribunal cannot order the Landlords to remedy problems on property belonging to third parties.

*Photograph 23: Rear garden: Right-hand side fencing*

- 17) Whilst the Tribunal was unable to make an order regarding the fence along the boundary with the neighbouring property due to it being situated out with the Property's garden, the fence is clearly in a dangerous condition and could cause injury and efforts should be made to have it dealt with by the neighbouring proprietor.
- 18) Whilst the Tribunal has issued a Repairing Standard Enforcement Order to allow further investigation into damp and mould within the Property it was noted on inspection that the Tenant had located a bed under the window of the rear bedroom as well as one along the external wall. Further, it appeared that blankets and other items were being deliberately placed along the edge of one of the beds to act as a barrier against the mould. The effect of doing so is to restrict the airflow around that item of furniture which could make the issue worse.

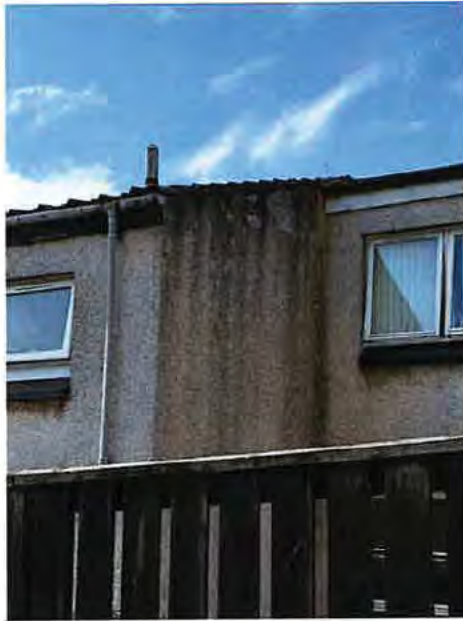
- j) The roughcasting to the rear (side) elevation of the Property whilst discoloured, patched and marked, appears intact.
- k) The guttering to the front and rear of the Property shows signs of age through discolouration and there had been some historic water ingress to the rear of the Property.

- 14) Whilst the roughcasting to the rear of the Property was marked and had been patched, it was intact. There was no evidence to suggest that it had failed or was causing any issues for the Property.

*Photograph 24: Rear left-handside elevation - staining and patches to roughcast*

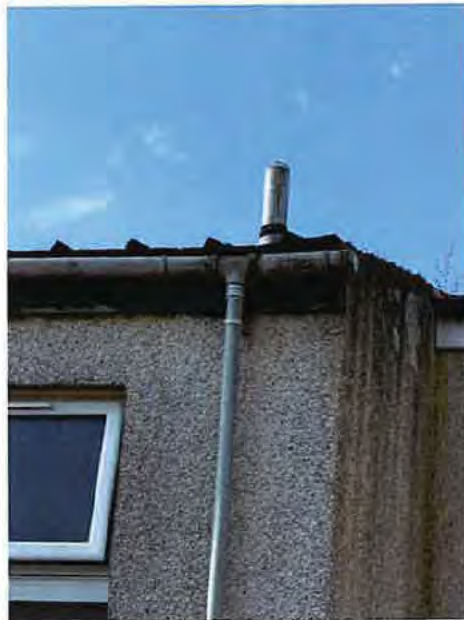
- c) The gutters to the front and rear of the Property and the associated fascia boards are clearly old and discoloured which might be attributable to water damage.

*Photograph 25: Section of rear guttering*

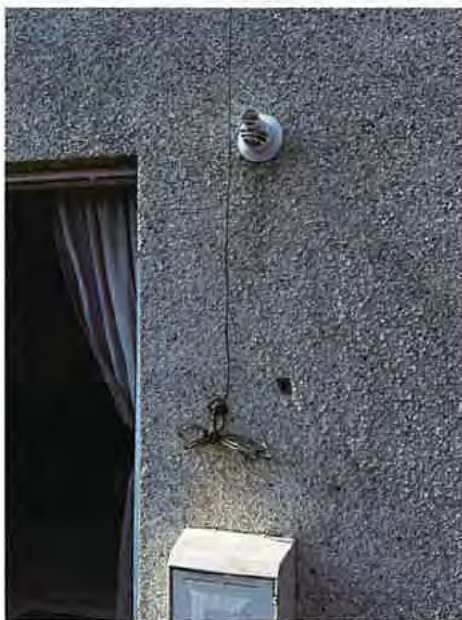
- b) It was agreed by the Landlords that the unused television aerial was not properly fixed to the Property and should be removed.
- 16) The Tribunal could not be satisfied that the Property was substantially free from rising or penetrating damp and therefore meets the Tolerable Standard for the following reasons:

*Photograph 27: Aerial wire to rear elevation*

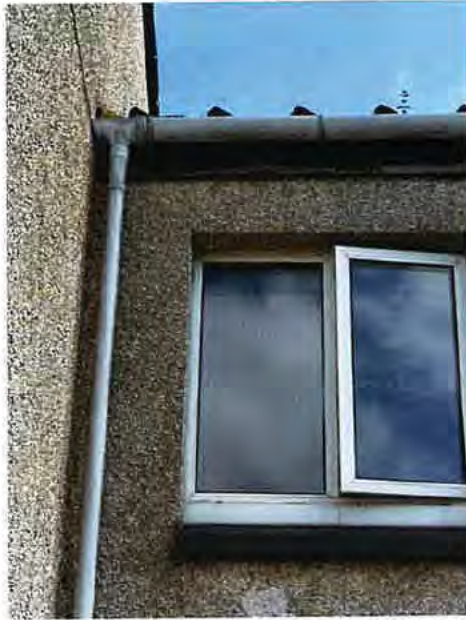
*Photograph 28: Section of front guttering*
