Statement of Decision of the First-tier Tribunal for Scotland (Housing and Property Chamber) under section 60(5) of the Housing (Scotland) Act 2006

Chamber REF:PRHP/RP/13/0119

Re 46 Townend Street, Dalry, KA24 4AD being the subjects registered in the Land Register of Scotland under title number AYR3661 ('the Property')

First-Tier Tribunal for Scotland (Housing and Property Chamber) Re-inspection report

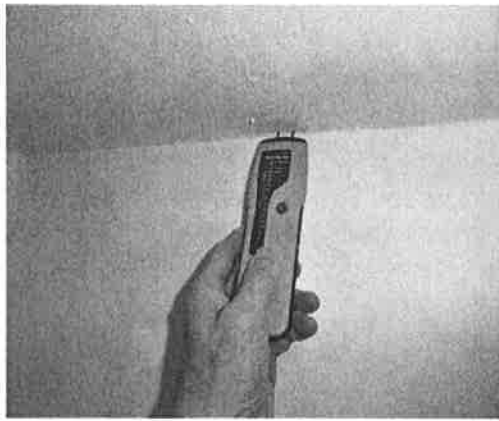
1. Living room ceiling/wall

Moisture content of around 60/65% at Living room and kitchen mutual wall, plasterboard lining and ceiling. Some slight staining remains evident at the living room ceiling

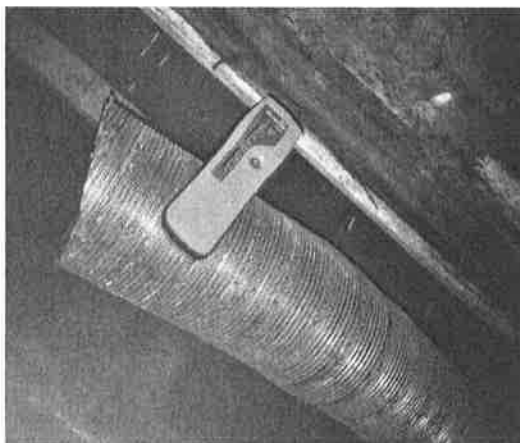
2. Front roof pitch rafter

Moisture content of around 60% at front rafter. Other residual staining at rafters adjacent to former chimney breast is now dry.

A significant proportion of the underfelt between the timber sarking and slates above the kitchen and living room is missing or has disintegrated.

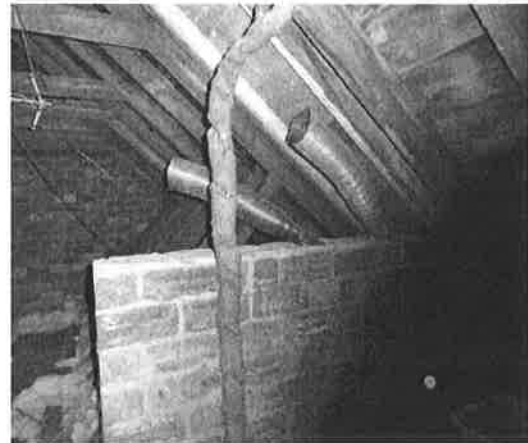
4. Remains of chimney breast in attic

In accordance with the terms of the original RSEO the chimney head has been removed together with a significant proportion of the chimney construction within the roof void. This was completed around February/March 2014. A sufficient period of time has elapsed since its removal to confirm that it is no longer the source of the damp in the kitchen and living room.

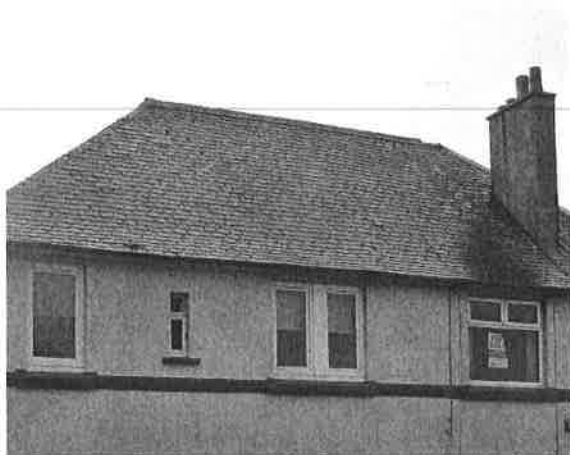
5. Front roof pitch.

Random historic repairs are evident to roof slating, specifically at the front roof pitch and a number of repairs remain outstanding. The roof slating is almost entirely original and is displaying considerable evidence of wear and tear.

Roof slating on the front roof pitch is in a relatively poor condition and is almost certainly remains the source of the dampness. Historically repairs to the roof slating have been completed and Mrs. Mair of 4 Square Property provided a receipted, although unheaded, invoice dated 1st September 2017 for the sum of £120. This was for the replacement of 14 slates "on various parts of the roof".

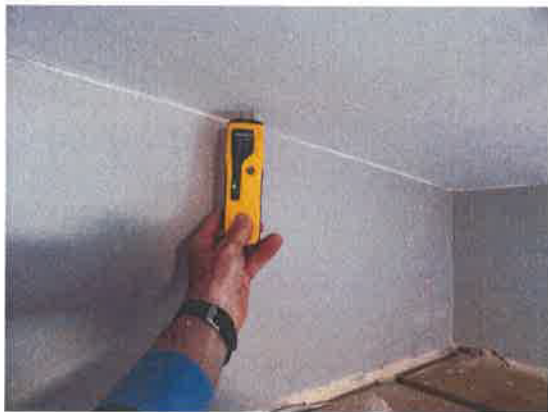
2. Kitchen ceiling 4 May 2018

7.1 There was no evidence of dampness at the kitchen ceiling. Moisture readings were taken where damp had previously been identified. No evidence of damp was noted. Since the previous inspection (15 January 2018) a section of new plasterboard on the ceiling, running the width of the room and extending into the kitchen by approximately 500mm had been erected. The surrounding area has been redecorated and it blends well with the original ceiling.

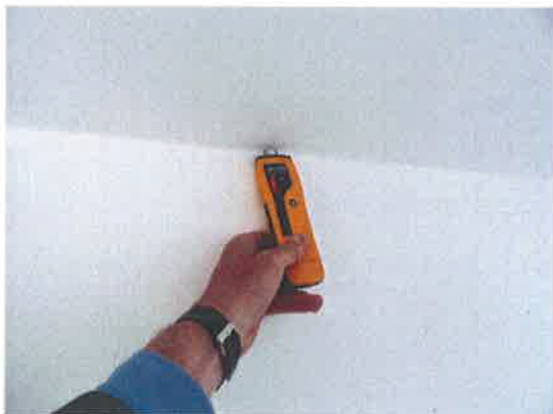
4. Living room ceiling 4 May 2018

7.2 The ceiling plaster in the living room adjacent to the chimney breast and mutual wall with the kitchen was dry. At the previous inspection, moisture readings proved positive at a significant section of ceiling plaster in this area. The Ordinary member of the Tribunal took damp meter readings randomly at the same area and identified that most of the ceiling plaster was dry. There were two small, and very localised areas, displayed positive readings of between 25 – 50%. However the immediate surrounding plaster and corresponding area within the roof void were dry. They considered that it is likely that these isolated readings reflect relatively minor residual damp in the plasterwork which should become dry through time.

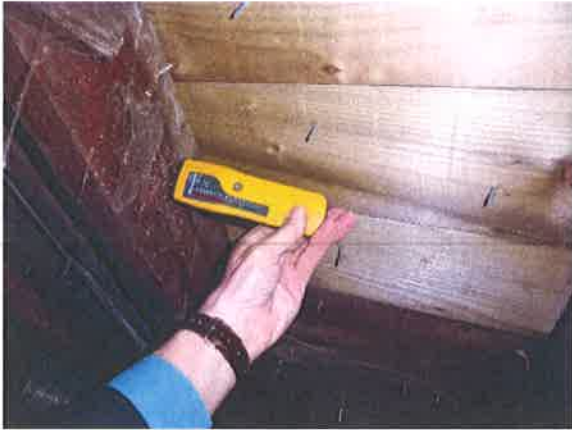
6. Roof timbers 4 May 2018

7.3 There was no evidence of recent water ingress in the roof void. Sections of timber sarking in the roof void had recently been renewed as part of a roof repair. However moisture readings taken at the surrounding area, corresponding with the ceiling plaster above both the kitchen and living room, and at the adjoining roof framing identified no sign of recent water ingress.
