Certificate of Completion of the First-tier Tribunal for Scotland (Housing and Property Chamber) under section 60(5) of the Housing (Scotland) Act 2006

Chamber REF:PRHP/RP/15/0256

Re 7 Muirpark Drive, Bishopbriggs, G64 1RB being the subjects registered in the Land Register of Scotland under Title Number GLA190885 ('the House')

Re-inspection report

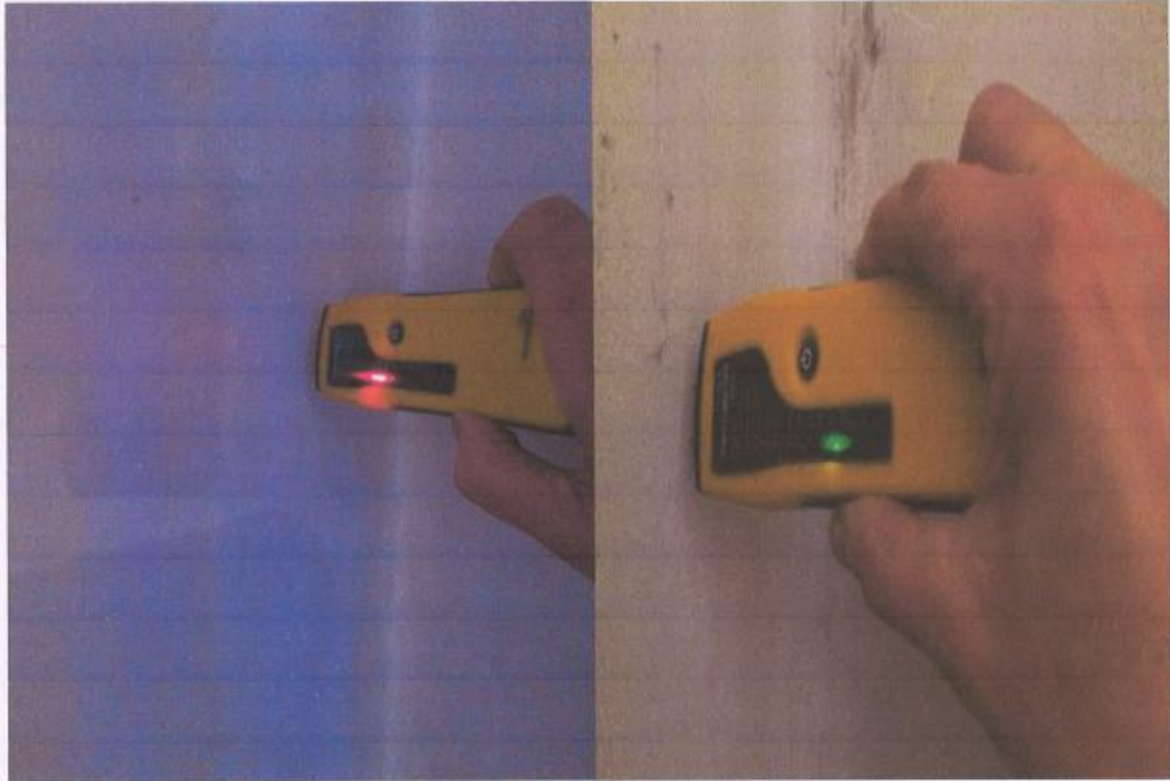
Some mould growth was apparent to the wall finishes in the living room. The internal finishes of the outside wall had been identified as damp by the tenant during my re-inspection in December 2016 and this was confirmed by readings taken by my damp meter. However, since the work carried out by the landlord's contractor and according to the readings taken on 10 February 2017, there seems to be a slight improvement in the levels of moisture in this wall. The tenant confirmed that she is not using a dehumidifier.

Living room wall - Damp meter reading
19 December 2016

Living room wall – Damp meter reading
10 February 2017

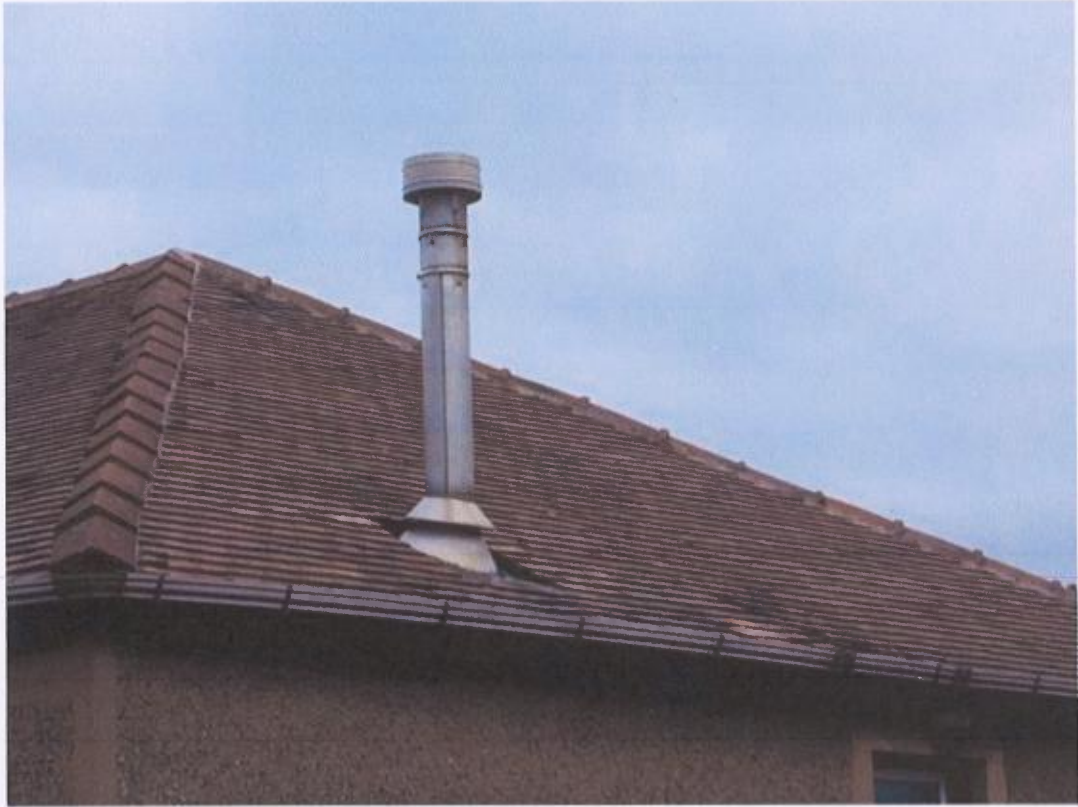
The landlord has paid for piecemeal repairs to the roof. Some re-pointing of tiles – notably ridge and hipped end tiles - has been carried out and the defective guttering has been repaired, although the tenant now contends that this is leaking again. This was not apparent on my inspection. However, there remain some areas of the roof where there still appear to be missing tiles – for example, on the side pitch above the door and near the apex and on the front pitch, above the guttering.

Roof – side pitch – 10 February 2017

- The landlord was advised to instruct a roofing contractor with a view to investigating and repairing missing tiles to the roof and defective guttering.

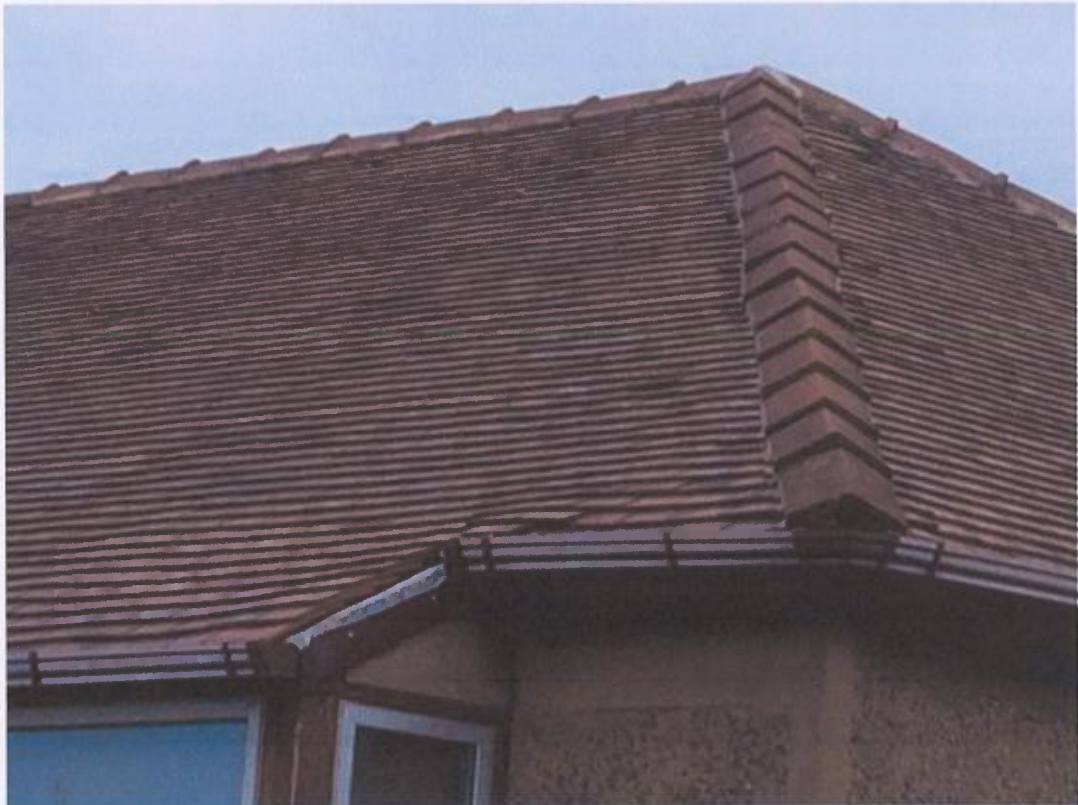
Roof – front pitch – 10 February 2017
