First-tier Tribunal for Scotland (Housing and Property Chamber)

Decision re Variation of RSEO: Housing (Scotland) Act 2006 Section 25

Re-inspection report

Property: 8/10 Ballingry Road, Ballingry KY5 8EX

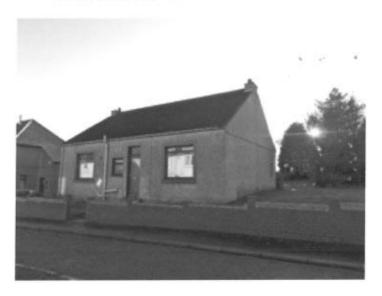
The two areas of damaged roughcasting have not been rectified by the landlord. The landlord advised that he intended to have this work done at the same time as the windows and doors were replaced. He indicated that the work would be weather dependent but accepted that he should be able to get it done within a period of three months.

Front Elevation

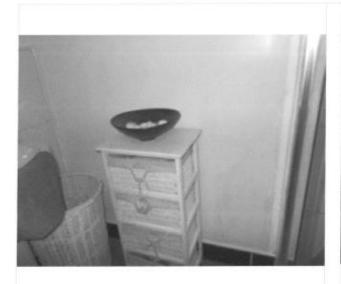
The tribunal, comprising Carol Jones, ordinary member, and Judith Lea, legal member, inspected the house on 17 November 2017. The landlord and the current tenants, Mr and Mrs Baxter, were present. The house was in exactly the same condition as it was when the ordinary member re-inspected on 28 August apart from some work having been carried out to repair the damage caused by the leak in the shower room as shown in the attached photographs.

Front Shower room - wall adjoining front double bedroom (left) re-plastered/painted
