Certificate of Completion of Work under Section 60 of the Housing (Scotland) Act 2006 as amended ("the Act")

Chamber Ref: FTS/HPC/RP/17/0066

178 Perth Road, Dundee, DD1 4JS ("the Property")

### **Re-inspection report**

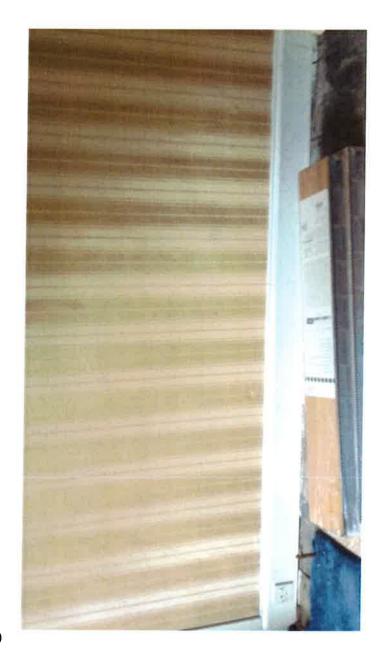
## 1) Condemned sitting room gas fire

As at 19/04/17:
gas fire disconnected
and debris left in fireplace
behind it

As at 5/09/17: gas fire and fire surround removed, fireplace boarded up and wall redecorated

Works in RSEO undertaken: the condemned gas fire has been removed, the fireplace boarded up and the wall redecorated (see photo 1), so works required by b) in the RSEO have been completed

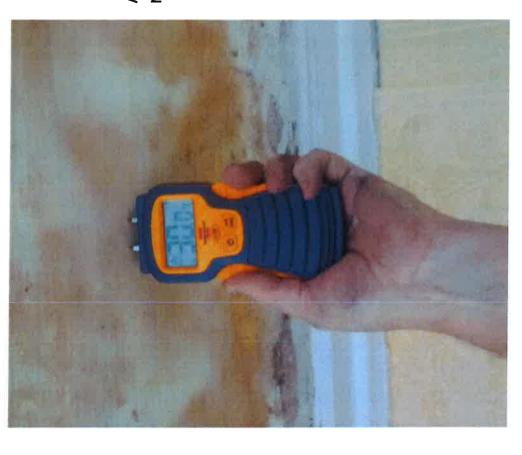
### 2) Damp meter readings in store room: ceiling on party wall side under the chimney

As at 19/04/17 - reading of approx. 20

As at 5/09/17 – reading of 30

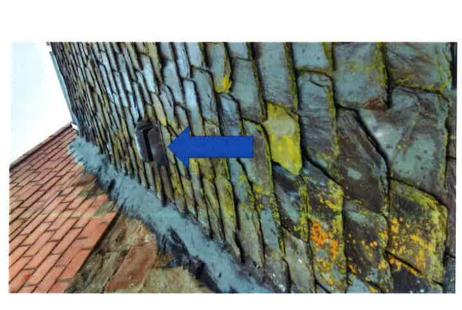
## 5) Condition of roof and ventilator above store room

An access hatch has been cut in the ceiling (see photo 4) and from this the roof ventilator (fitted when the roof was repaired) can be seen (photos 5a and b). It appears that rain is blowing in through the ventilator, causing high levels of damp in the plasterwork beneath it. However, the repair to the concrete filet on the party wall (see photo 5a) seems to have prevented further ingress of water as the brickwork in the attic appears to be drying out (see photo 6).

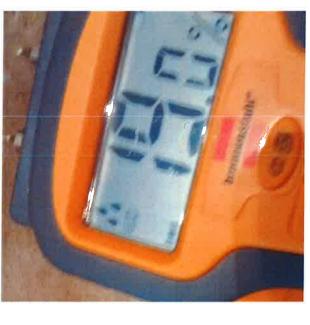
1b) Damp meter readings at 1/12/17

Readings remain high, but indicate that there has been no further water ingress.

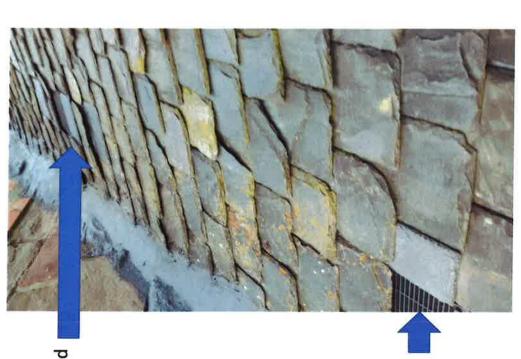
New flush-fitting slate ventilator

Ventilator removed and replaced with slate ventilation system

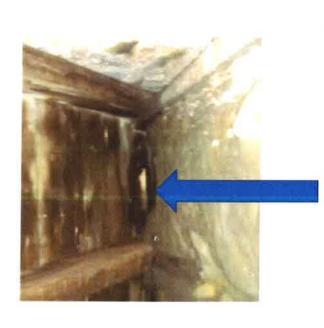
3a) As at 5/09/17: internal view of ventilator from access hatch, showing probable site of water ingress – ventilator is directly open to
