**First-tier Tribunal for Scotland (Housing and Property Chamber)**

**Chamber Ref: PRHP/R/15/0299**

**Reinspection Report 10 JULY 2017**

## **Report on Reinspection on 10 July 2017, following the Repairing Standard Enforcement Order dated 4 May 2016**

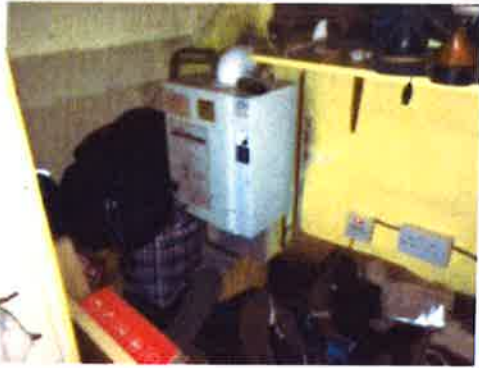
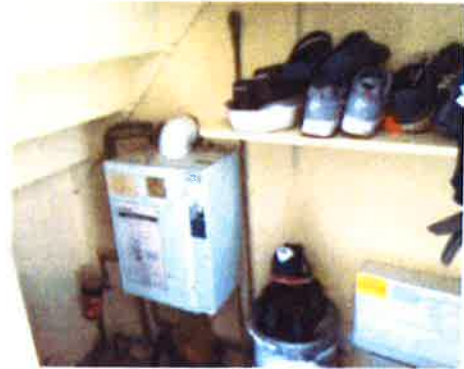
Gas Boiler Installation

- 3.1** A Gas Safety Certificate has been provided by the Landlord dated 1 June 2017 which confirms that the gas installation is satisfactory.

The heating system was switched on and it was noted that the radiators were hot to touch.

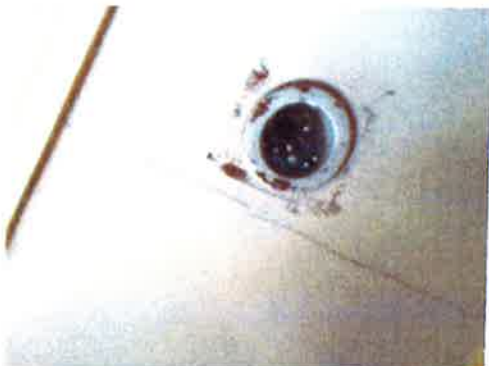
Faulty light fitting on first floor landing

The light fittings which had been previously been faulty were switched on and were noted to be working. The electric socket in the kitchen had been replaced and was working.

Changed and now working

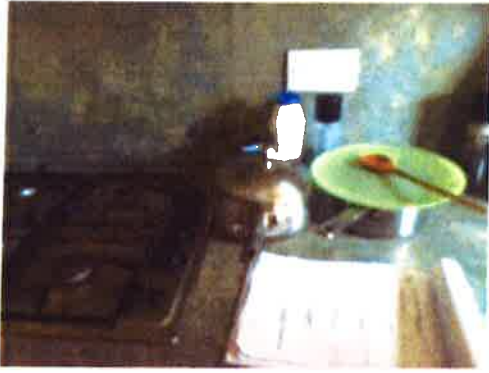
Faulty socket in kitchen next to cooker

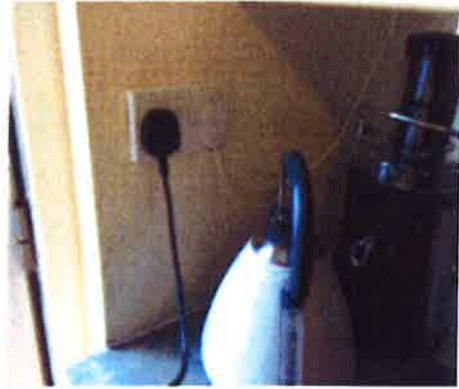
Fixed

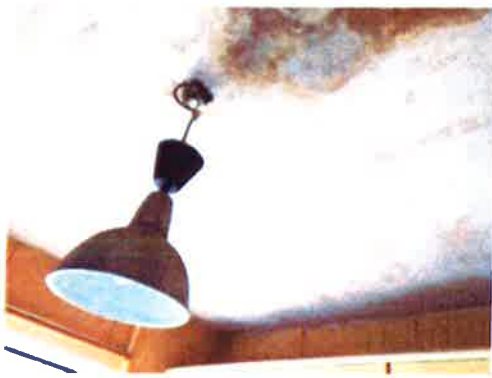
Light fitting in kitchen next to damp patch on ceiling

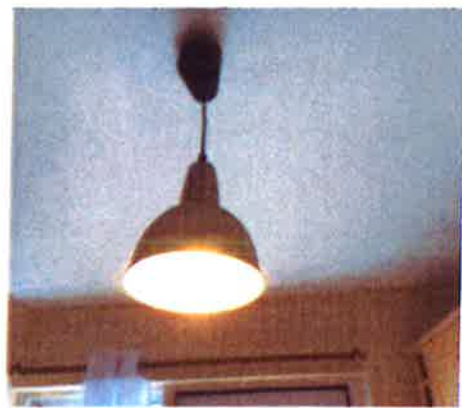
Now working, but cover loose

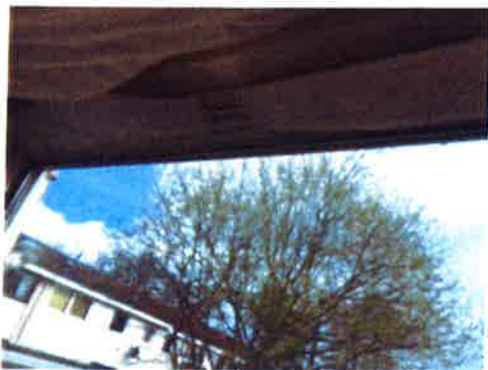
Patio window in Living room - no trickle vents

As before

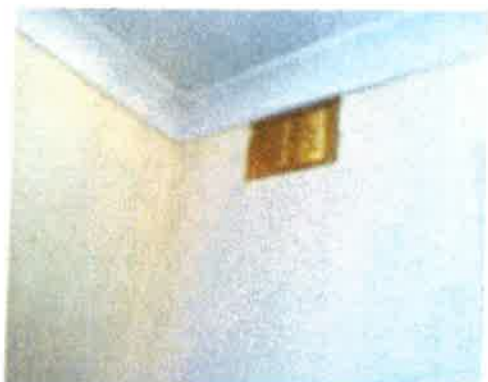
Ventilation grille in Living room - but not on outside wall As before

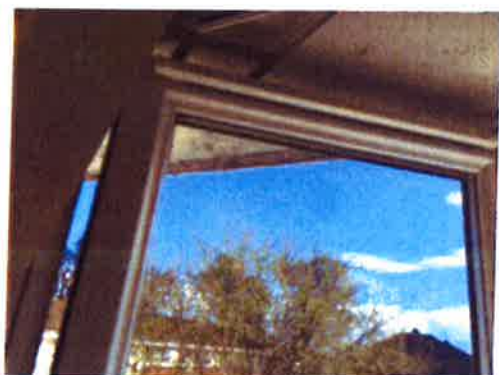
No trickle vents in windows

As before

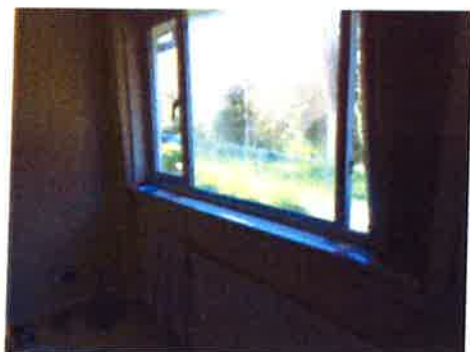
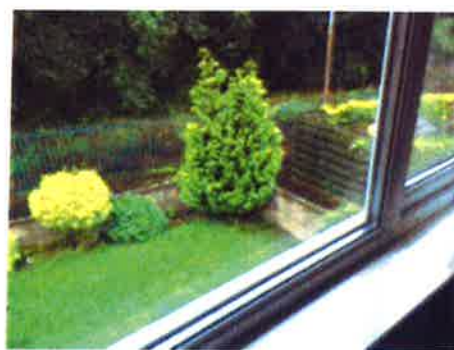
Front bedroom - Double glazing unit failed - moisture trapped between panes

- 3.3** The double glazed unit in the front bedroom has been replaced, and there was no moisture in the new unit.

Window pane changed - now clear

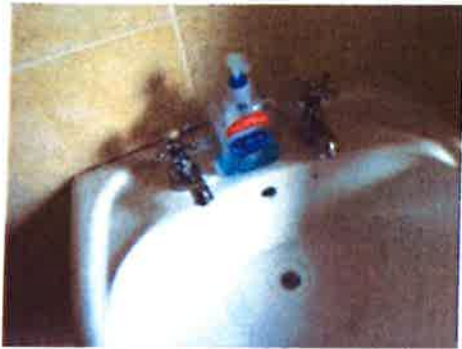
WHB – Cold tap loose and not working, ie no cold water supply

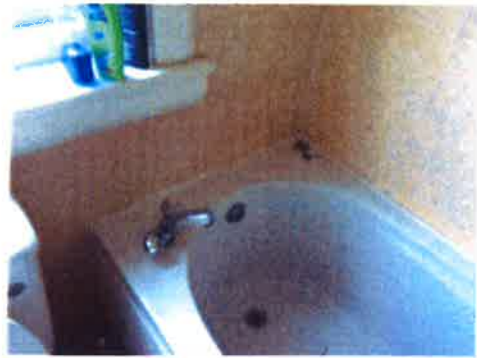
- 3.4.2** The cold taps on the wash hand basin and bath now function properly.

Taps all fixed on WHB and Bath

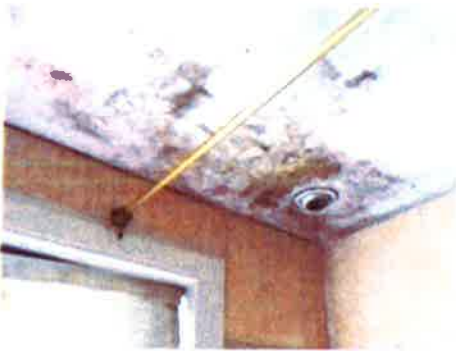
Mould grown on bathroom ceiling – no extract fan, but window opens

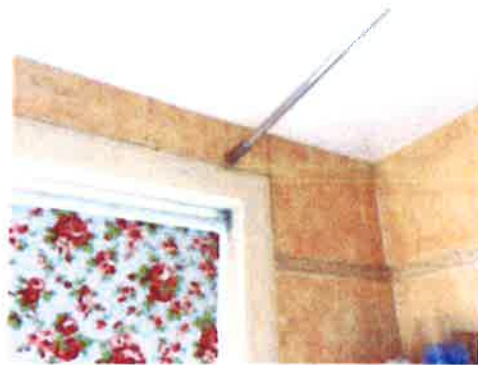
Now fixed and redecorated

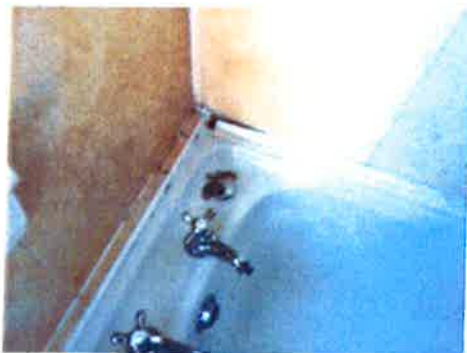
Bath sealant in poor condition

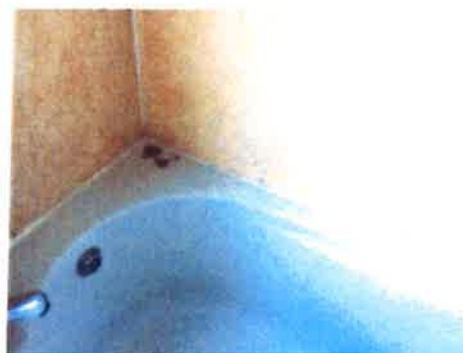
- 3.4.3** The seal round the bath has been repaired.

Now replaced

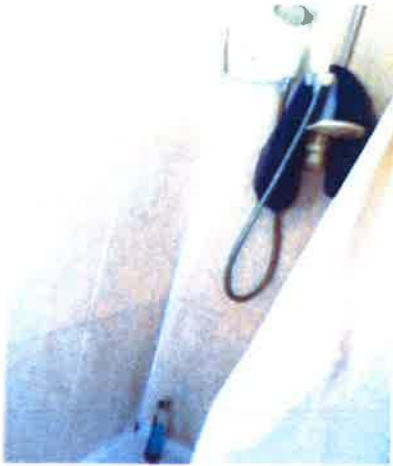
Shower running, water draining into bath drain.

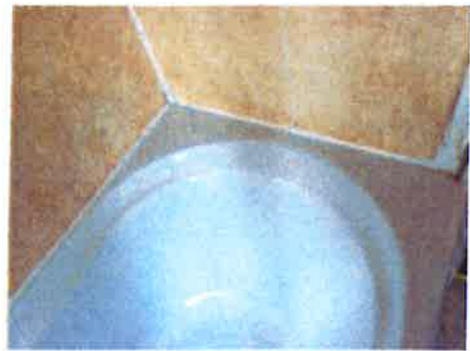
- 3.4.1** The leak in the bathroom has been attended to. At the reinspection the shower did not leak onto the floor, and the floor next to the bath was dry.

Now fixed

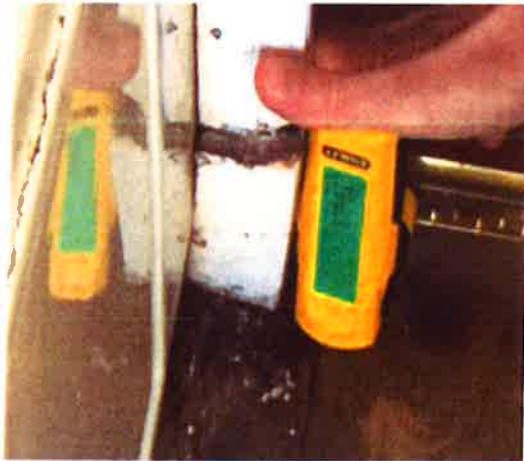
Damp reading taken of floor next to bath indicating damp timber

Floor dry, no signs of dampness

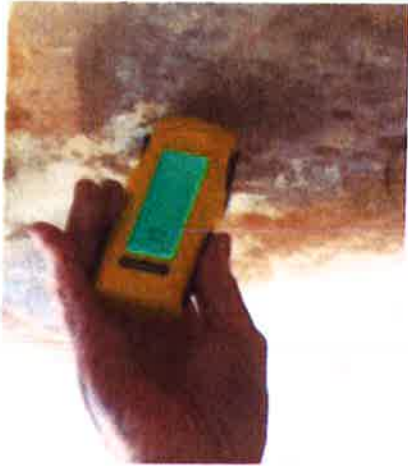
Kitchen ceiling – indicating damp from alleged leak from bathroom

Ceiling dry and redecorated – no signs of dampness

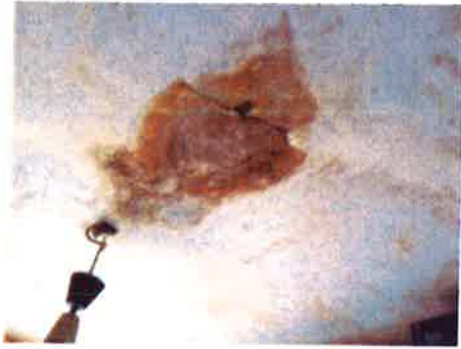
Kitchen ceiling and light fitting

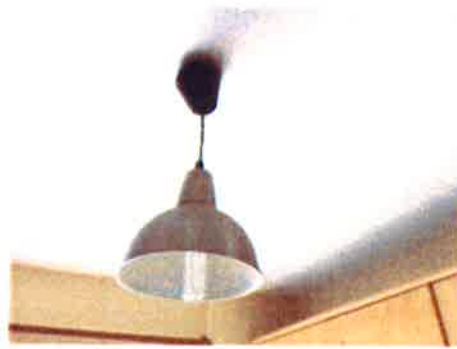
- 3.5** The kitchen ceiling has been replastered and redecorated.

Ceiling replastered and redecorated

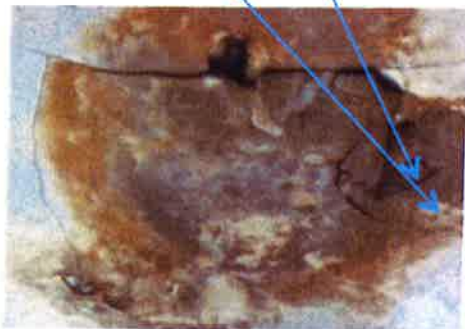
Kitchen ceiling showing drips after shower had been running in bathroom above.

See above – no signs of leak or dampness

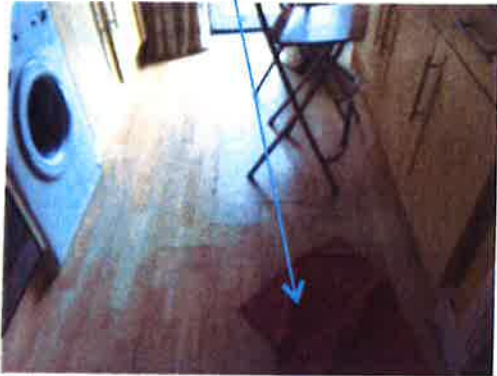
Water on kitchen floor after shower switched on. Water dripping from ceiling.

No water leaking from ceiling
