Certificate of Completion of the First-tier Tribunal for Scotland (Housing and Property Chamber) under section 60(5) of the Housing (Scotland) Act 2006

112 Queen Street, Dumfries, DG1 2JT ('The Property')

Property Re-inspection Report

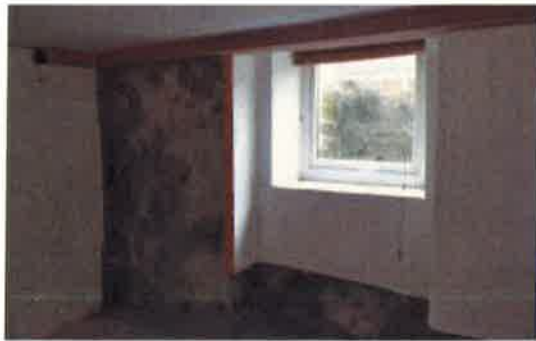
- **The front and rear basement walls were rechecked for dampness throughout, with the readings taken indicating that the basement has continued to dry out since the date of the previous re-inspection. The recorded readings did not give any cause for concern.**
- **When set in radio wave mode, the damp meter detected the presence of significant moisture below the level of the concrete floor slab in the front basement. However, there was no evidence of surface moisture, and the readings were taken at a section of the floor slab where sub-floor dampness would not be a threat to exposed timber.**

Photo 1 – Basement Front elevation

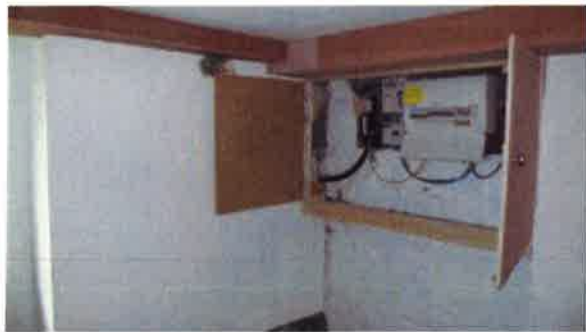
Photo 2 – Electric switchgear in Basement

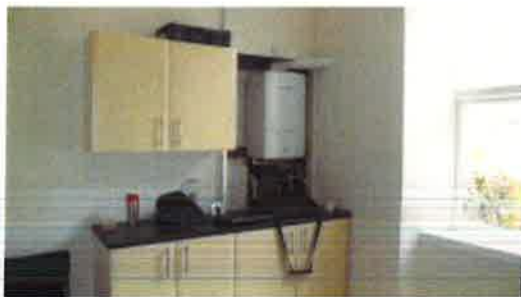
- It was noted that an appropriate electric panel heater has yet to be installed in the bathroom. It was further noted that the Landlord would provide the Tribunal with a copy of an order for a panel heater, together with a copy of the receipt following its installation. The Landlord also stated that a Gas Safety Certificate would be obtained and forwarded to the Tribunal.

Photo 3 – Gas boiler in dining room

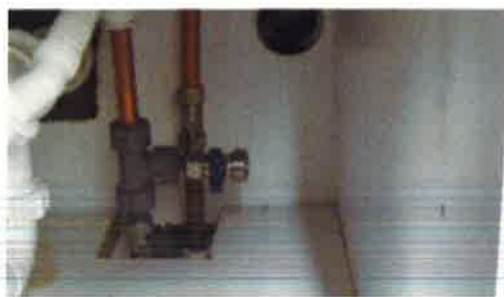
- The washing machine has now been removed from the property because it was broken beyond repair. Should the property be re-let in the future then the pipework is in place to connect a replacement unit.

Photo 4 – Washing machine pipework

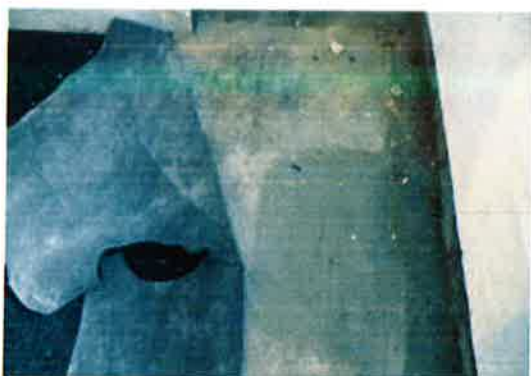
- The Contractor advised that excavation works along the rear elevation had been undertaken by the landlord, the window assembly sealed, the drain hole in the floor, previously used to drain the waste water from the washing machine, sealed (See Photograph 1 below). It was observed that the door steps into the external kitchen door have been reset to ensure that rainwater flows away from the house and basement area (See Photograph 2 below). It was also noted that the window sill (See Photograph 3 below) had been cleared although it was not evident to the Surveyor Member, or the Contractor, where the rainwater would eventually drain away to.

Photo 1 – R/B former drain hole

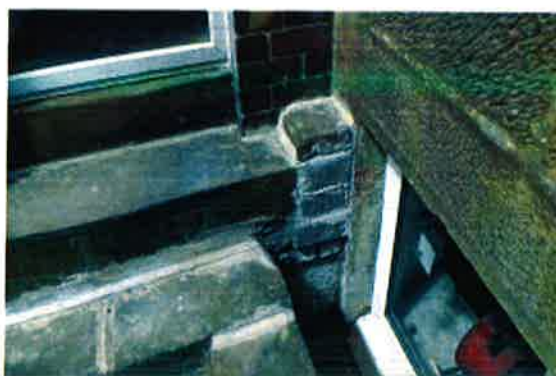
Photo 2 – Re-aligned steps and sealed window

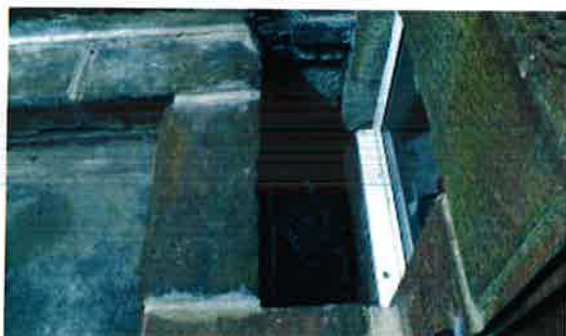
Photo 3 – External sill and soakaway

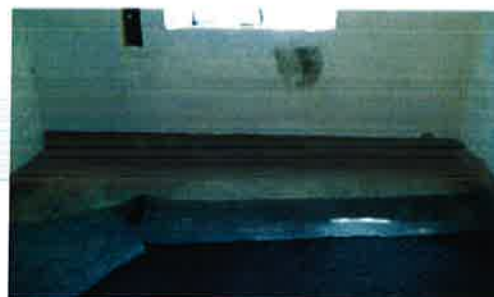
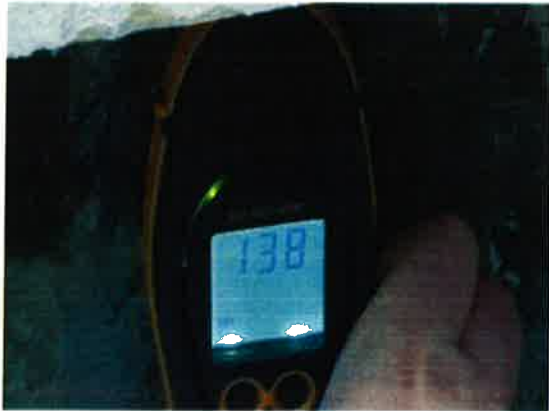
- Improved dampness readings were obtained along the lower sections of the rear elevation using a dual function dampness meter capable of determining levels of moisture below the surface, and deeper within building materials. The readings recorded would suggest that the measures outlined above have been successful. (See Photographs 4 + 5 below)

Photo 4 – Rear wall inner face

Photo 5 – Rear wall reading

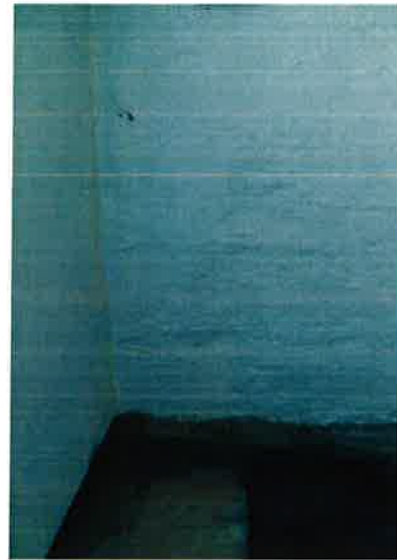
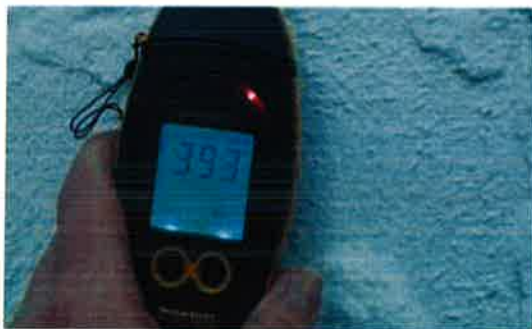
- Meter readings were also obtained once again from the internal wall running perpendicular to the right of the window opening (See Photographs 6 + 7 below). These readings were higher than the ones obtained from the rear elevation and fell within the 22-40% range. They were also concentrated at a height of 4-5ft above the floor level in one small isolated section, and not in the vicinity of any timber. There was no obvious cause for this isolated section of dampness at this location suggesting that this section of wall may still be drying out. Rising damp can also be ruled out.

Photo 6 – Right hand wall

Photo 7 – Right hand wall reading

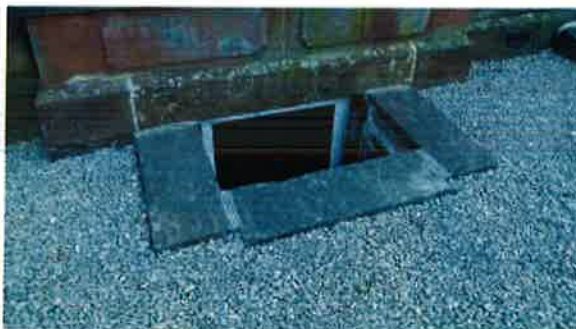
- The sodden earth in the front garden has been removed and replaced by stone chips (See Photograph 9 below);
- The Landlord and the Contractor have undertaken “tanking” work on the interior face of the front elevation and a section of the floor slab.

Photo 9 – Re-surfaced front garden

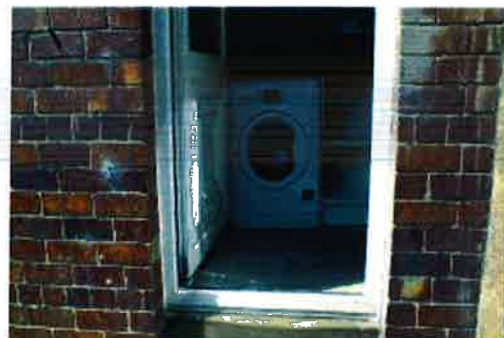
- Install the washing machine in the kitchen and properly connect the outflow pipe to the drains.
- It was noted that the washing machine had been relocated to the kitchen and the relevant pipework was in place to properly connect it to the water supply and drainage outlet (See Photograph 10 below). However, it was noted that the washing machine hoses were still to be fitted to the pipework. It was also noted that the washing machine could be powered up.

Photo 10 – Re-located washing machine

Recommendation: Allow a further period of 1 month for remaining damp areas to hopefully dry out, and for the washing machine hoses to be fitted. Request a Gas Safety certificate. Re-inspect when appropriate.

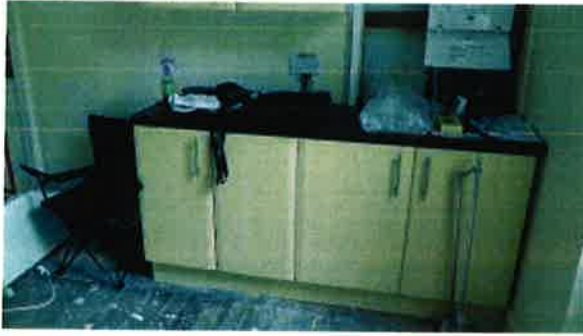
- The Property was installed with a gas central heating system on 26/04/17 by Harness Plumbing and Heating Ltd. Appropriate radiators have been fitted in all the main rooms, the hallway and basement area. There is no radiator in the bathroom, or the rear kitchen area (See Photographs 11 + 12 below). The contractor advised that it is intended to install fixed electric panel heaters in these areas. As the property is now vacant, the central heating system was not in use at the time of the inspection. The Contractor was unaware if a Gas Safety Certificate had been provided to the Landlord.

Photo 11 – Installed gas boiler

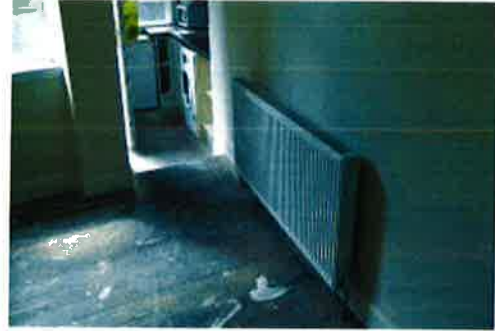
Photo 12 – Recently installed radiator
