STATEMENT OF DECISION: Section 24 (1) of the Housing (Scotland) Act 2006, as amended

Chamber Ref: FTS/HPC/RP/19/2226

36 Craigton Avenue, Milngavie G62 7SX (“The Property”)

Schedule of photographs taken during the inspection of 36 Craighton Avenue, Milngavie
G62 7SX by the First-tier Tribunal for Scotland (Housing and Property Chamber)
on Friday 27 September 2019

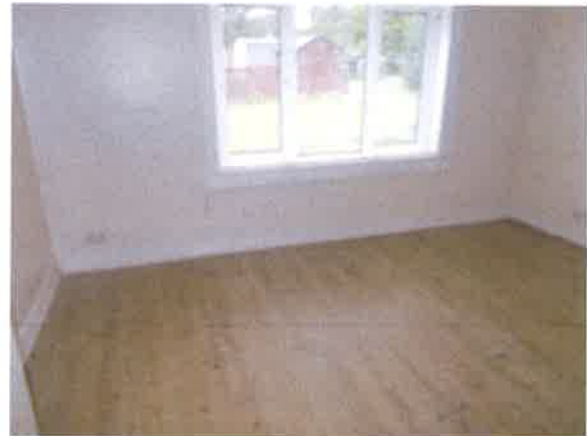
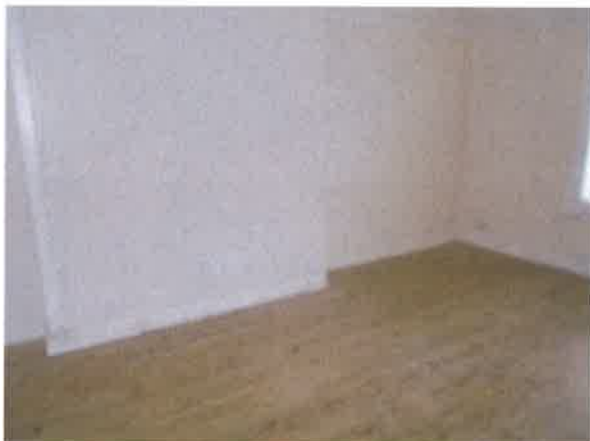
Living Room to rear

- ii. No visible signs of damp was found in the property. The affected areas in the living room and two bedrooms have been treated, re-plastered and freshly decorated. Limited damp meter readings were taken and some moderate levels of moisture were found at the base of the external walls in the above rooms.

13. Reference is made to the Tribunal's earlier Findings in Fact upon which the decision is based.
14. The Tribunal was satisfied that the Property meets the Repairing Standard. The levels of moisture identified at the inspection are considered to be acceptable and reflect a degree of drying out to be expected following the recent re-plastering and decoration.

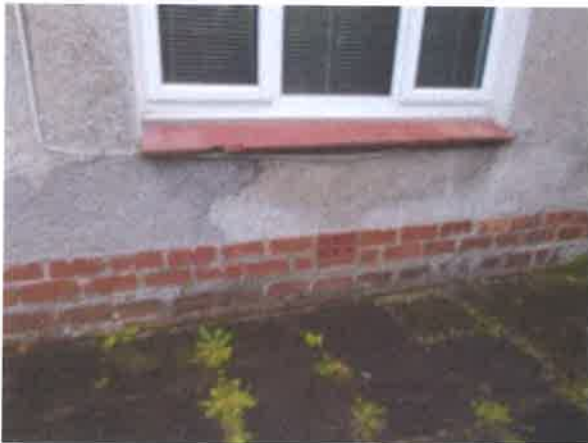
Rear Elevation showing base of external wall

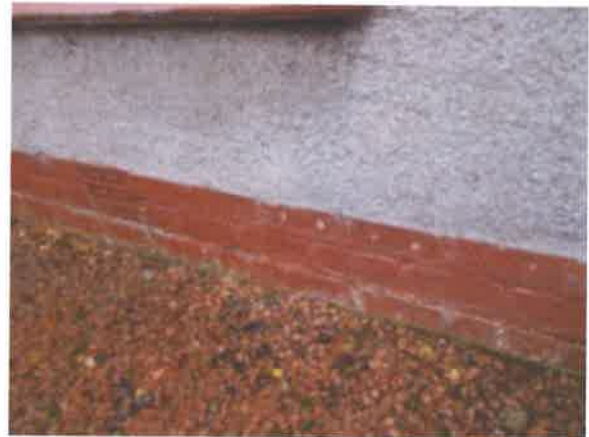
Front Elevation showing base of external wall
