**Statement of Decision of the First-tier Tribunal for Scotland (Housing and Property Chamber) under Section 60 of the Housing (Scotland) Act 2006 (Refusal to Grant a Certificate of Completion)**

**Chamber Ref: PRHP/RP/16/0321**

**141 Braehead, Bonhill, Alexandria, G83 9NB  
("the house")**

First-tier Tribunal for Scotland (Housing and Property Chamber)  
Housing (Scotland) Act 2006  
Re-inspection report

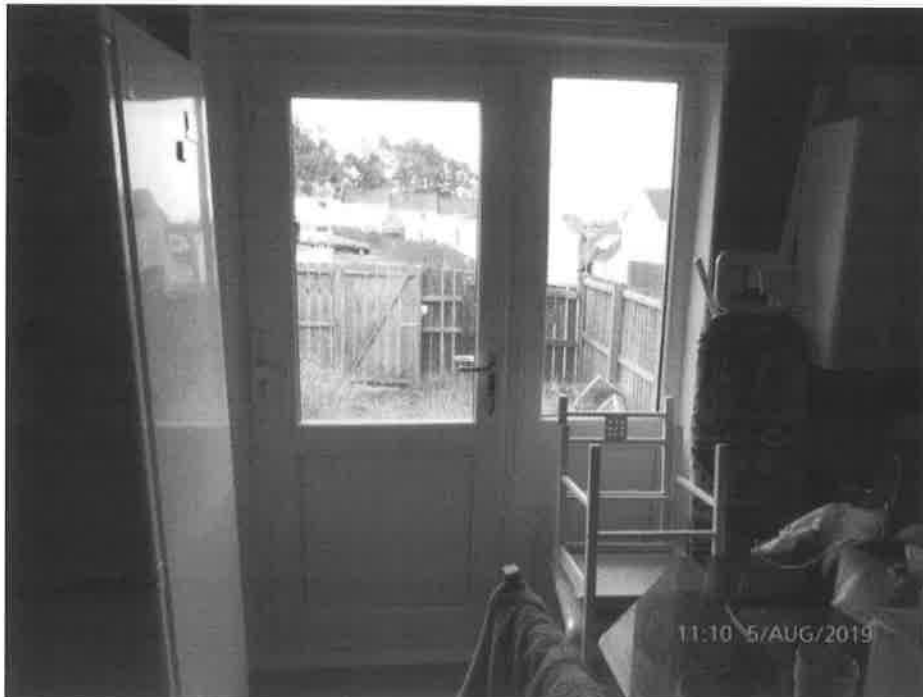
New back door

- (a) To repair, or, as necessary replace, the rear patio door to ensure that it is lockable and otherwise in a reasonable state of repair and proper working order, wind and watertight and in all other respects reasonably fit for human habitation. In particular, the patio door requires to provide a safe means of exit and entry to the house and to conform with building regulations in terms of the width of the door opening, a platform outside the door/the steps down into the rear garden and the handrail. A letter from the local Building Standards section of West Dunbartonshire Council confirming that the patio door conforms to building regulations or is otherwise satisfactory to said Building Standards section requires to be submitted to the Tribunal.

- 1) The patio door has been removed and the previous arrangement of a back door has been re-instated. The top step has been heightened. The loose render has been repaired.
- 2) The render above the living-room window has been repaired.
- 3) A carbon monoxide detector has been fitted in the kitchen.
- 4) The bedroom ceiling has been redecorated. Mr Haughey pointed out that it has not dropped any further.
- 5) The garden fence has been repaired including making the gate capable of being opened and closed safely.

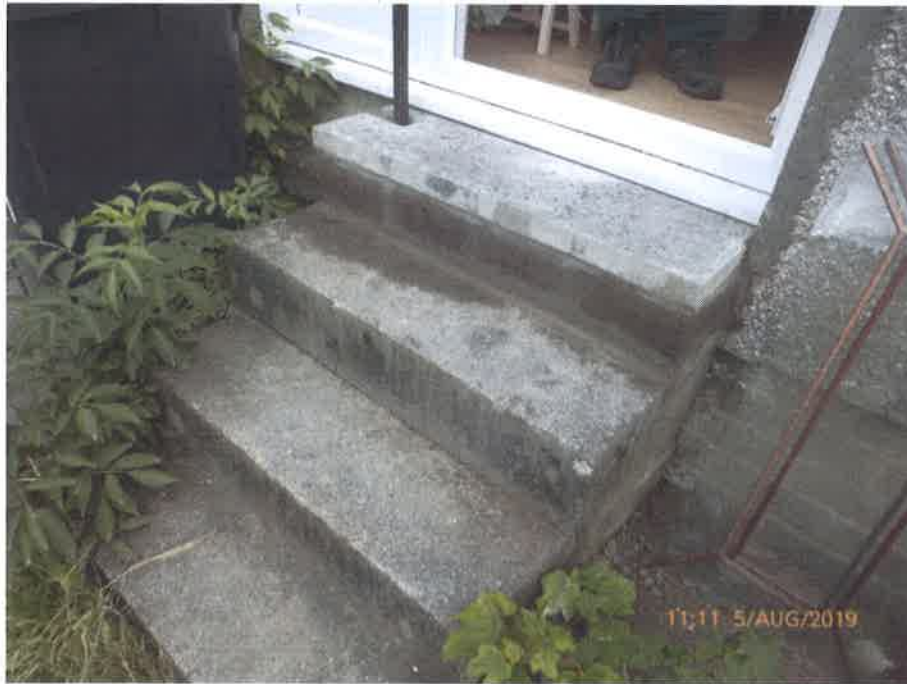
Back door step

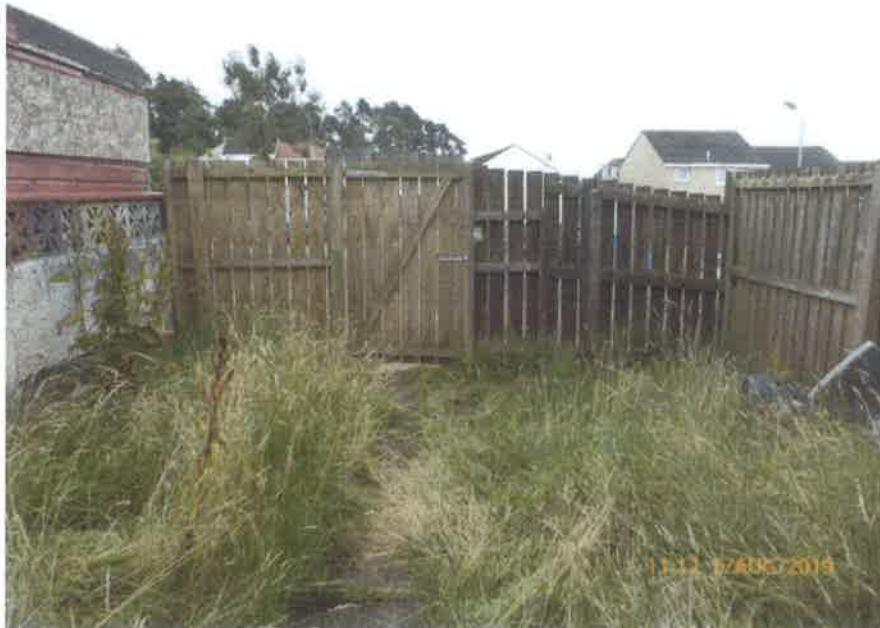
Repaired fence

To repair or replace the rear boundary fence to ensure that it is in a reasonable state of repair and proper working order.
