Certificate of completion of work

Case Reference Number: PRHP/RP/16/0320

Re: 43 Houston Road, Crosslee, Johnstone PA6 7AW ("the house")

Re-Inspection of

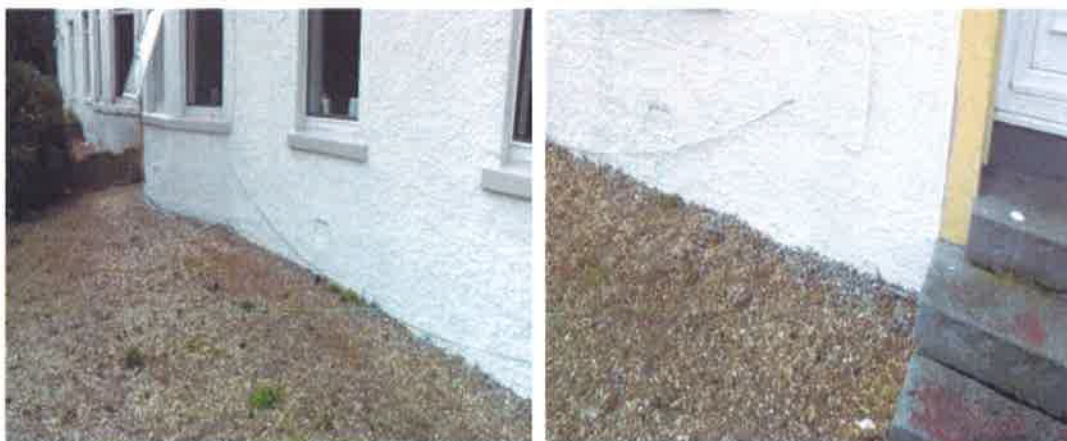
(Ph1) F/E – Roughcast repairs

(Ph2) F/E – Roughcast repair

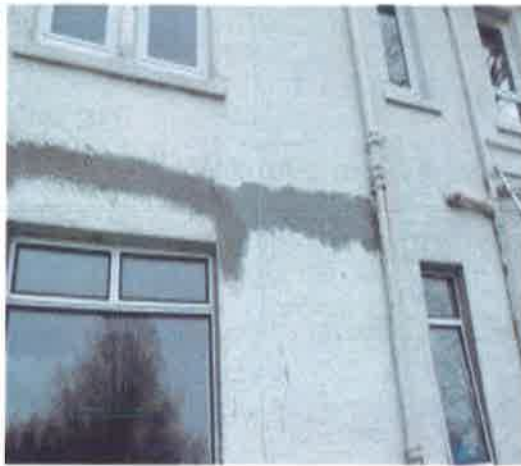
(Ph3) R/E – Roughcast repairs

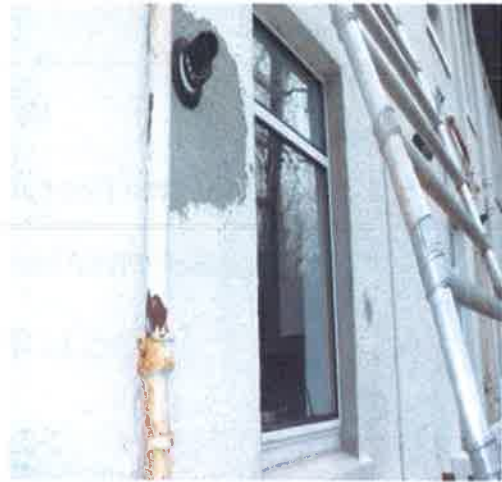
(Ph4) R/E – Roughcast repairs

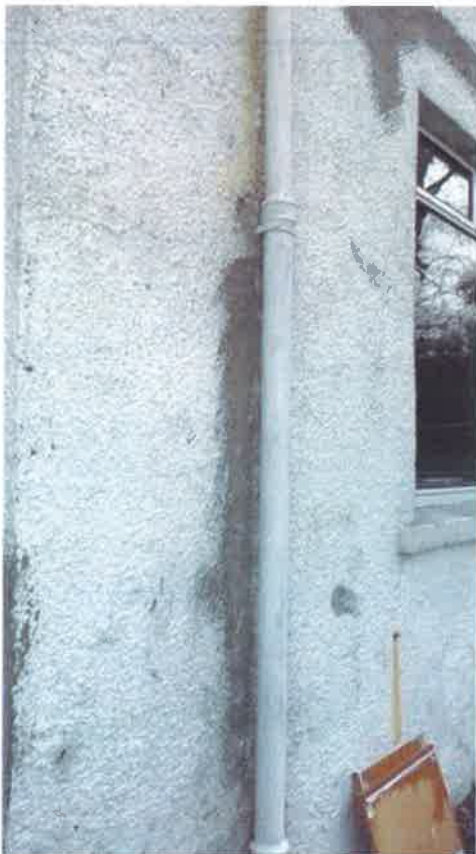
(Ph5) R/E – Roughcast repair

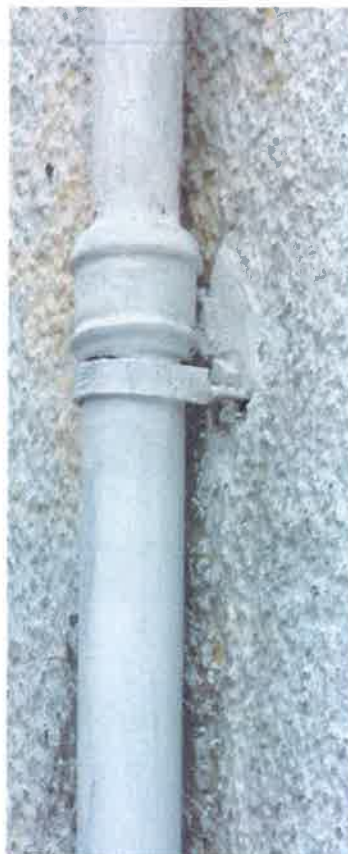
(Ph6) R/E – Roughcast repair

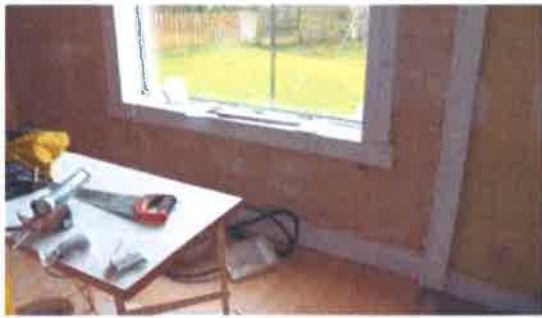
(Ph7) Bed 3 – Redecoration works

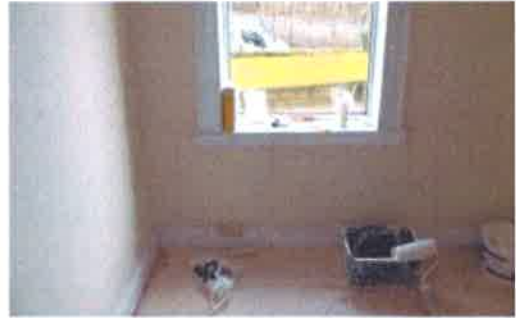
(Ph8) Bed 2 – Redecoration works

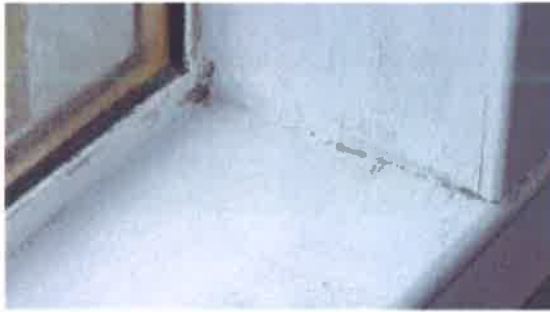
(Ph9) Bed 3 – Window sill primed

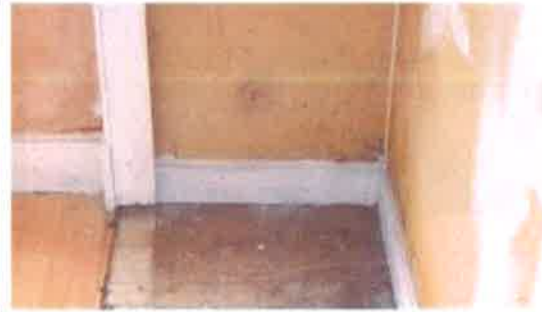
(Ph10) Bed 3 – Wardrobe floor

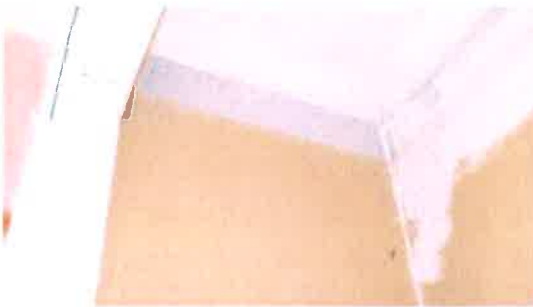
(Ph11) Bed 3 – Wardrobe P/B lined

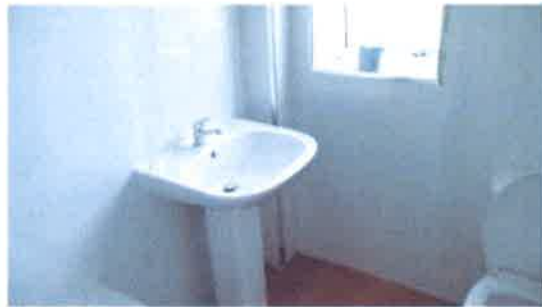
(Ph12) Replacement Bathroom

- *It was observed that internal finishing and decoration works are currently underway. The bathroom has been replaced.*

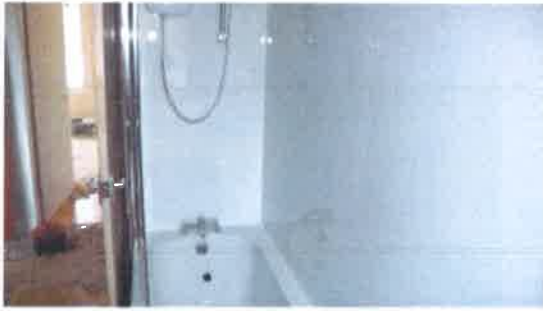
(Ph13) Replacement Bathroom

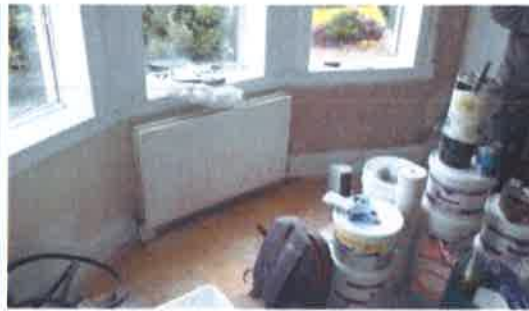
(Ph14) Lounge - Redecoration works

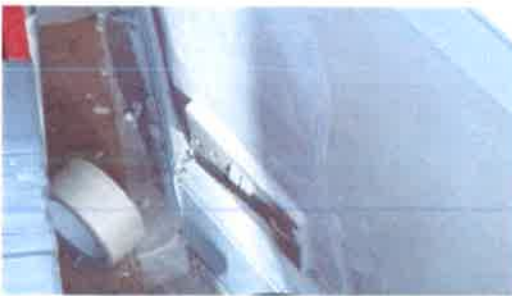
(Ph15) Lounge – Repair to bay wall socket

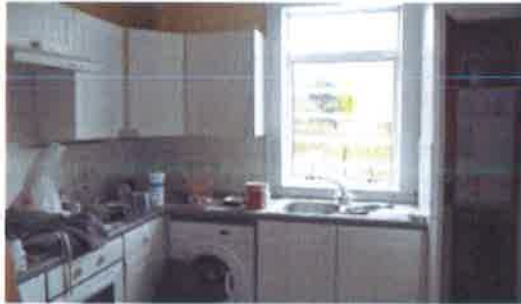
(Ph16) Kitchen works

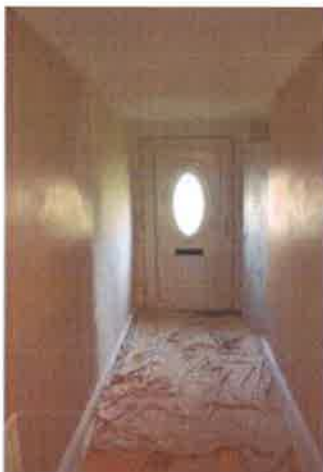
(Ph17) Hallway – Redecoration works

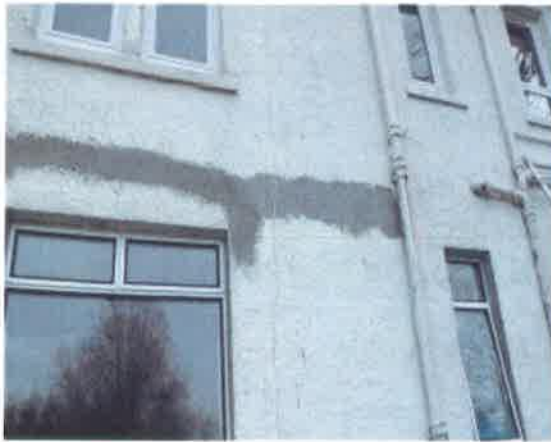
(Ph1) R/E – 1st re-inspection

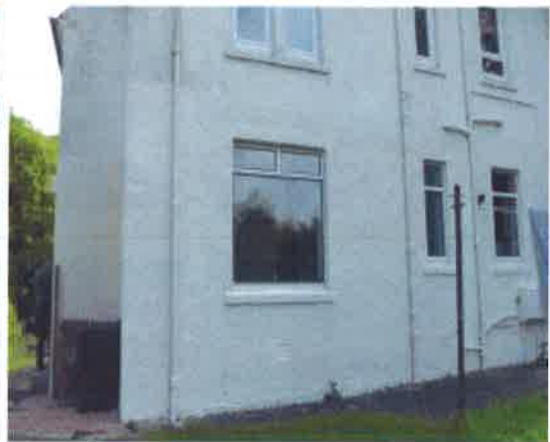
(Ph2) R/E – 2nd re-inspection

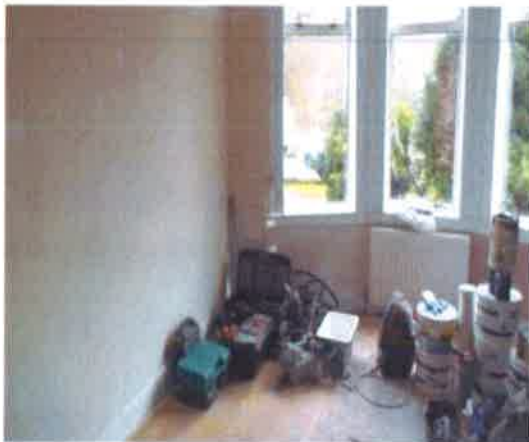
(Ph3) Lounge – 1st re-inspection

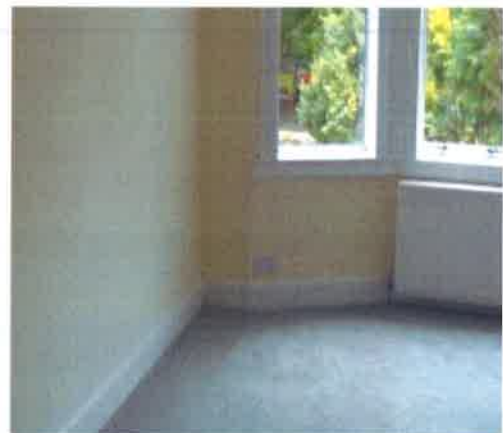
(Ph4) Lounge – 2nd re-inspection

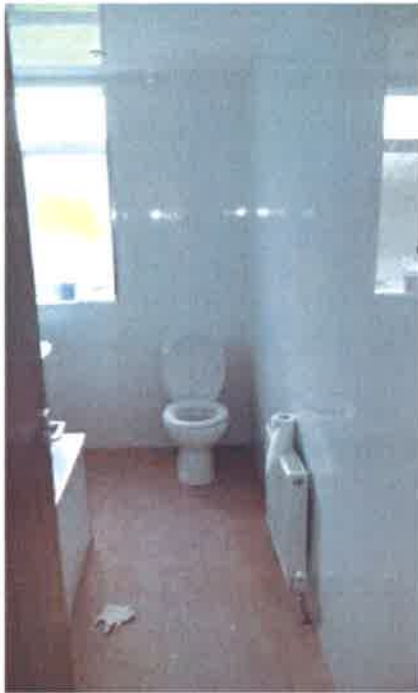
(Ph5) B/R – 1st re-inspection

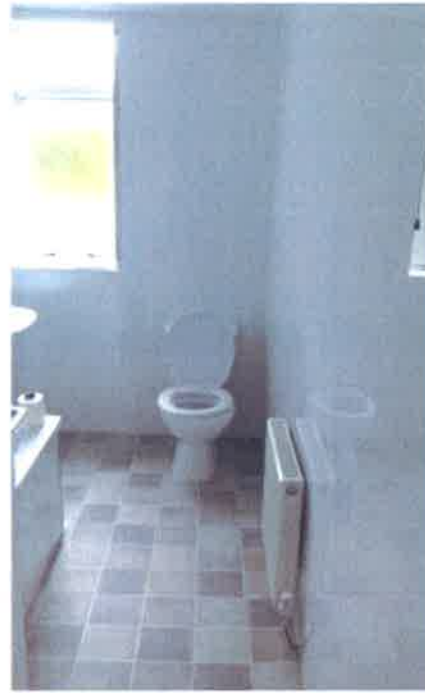
(Ph6) B/R – 2nd re-inspection

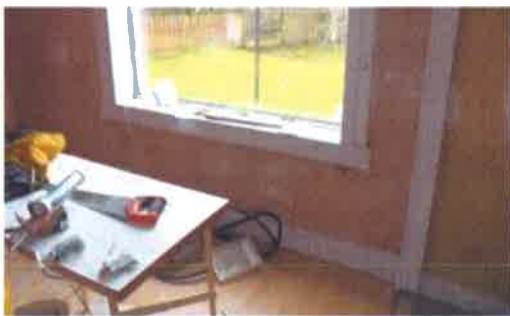
(Ph7) Bed 3 – 1st re-inspection

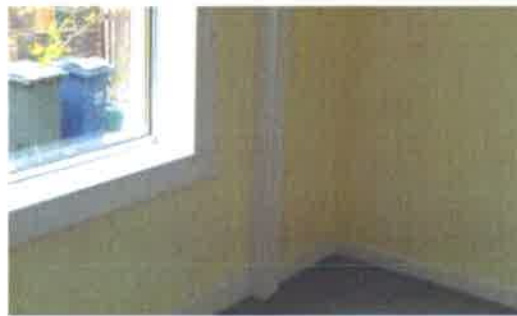
(Ph8) Bed 3 – 2nd re-inspection

c) **Bedroom 3** – No readings of concern were recorded in this room, suggesting that the external repairs undertaken to the adjacent downpipe and rendering have likely proved effective.

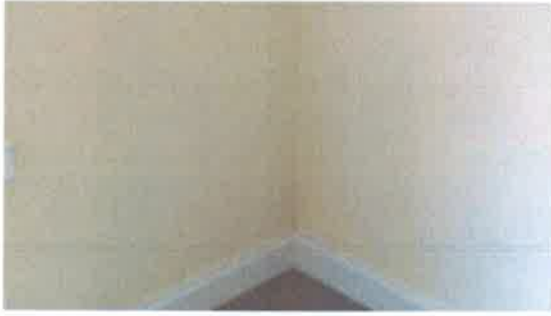
(Ph9) Bed 1 – High damp readings

4. The moisture reading results were as follows: -
 - a) **Bedroom 1** – Readings between 400-600 were obtained at a wall height level of approximately 30-50cm. These readings were obtained close to the external wall, near to its junction with the dividing wall between Bedrooms 1 and 2. These readings indicate a serious level of moisture present below the internal wall surface.

5. The dampness readings obtained in Bedrooms 1 and 2, and those recorded in the Lounge, are consistent with those obtained during the original inspection in December 2016, and the subsequent re-inspection in March 2017. They are also consistent with the damp survey report obtained by the Landlord from Richardson and Starling in November 2015.
6. The property has been well ventilated since the tenant moved out approximately 3-4 months ago, and the central heating system was disconnected during the refurbishment works. This would support the view held by the Ordinary Member, that the principal cause of the significant dampness levels still being recorded within the property is not condensation-based. The root cause of the dampness at the three locations highlighted above remains to be eradicated.

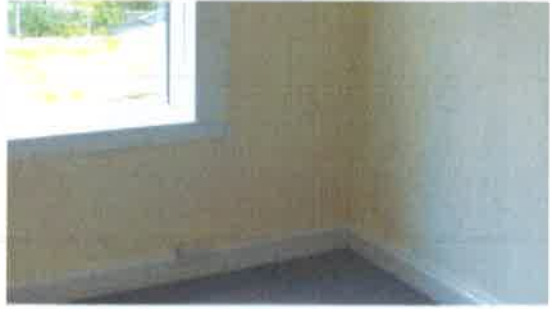
(Ph10) Bed 2 – High damp readings

- b) **Bedroom 2** – Readings between 400-999 were obtained at a wall height level of approximately 30-50cm. These readings were

obtained close to the external wall, near to its junction with the dividing wall between Bedroom 2 and the Lounge. These readings indicate a significant level of moisture present below the internal wall surface.

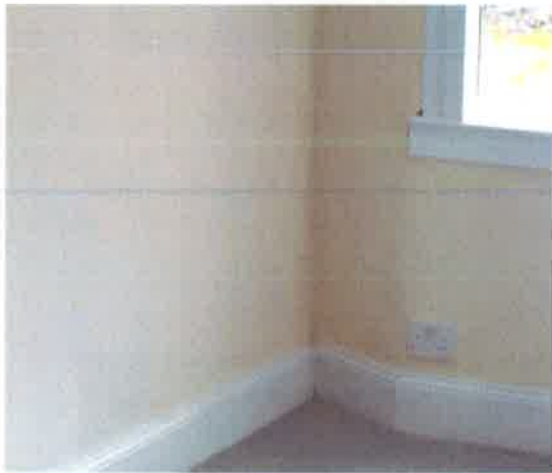
(Ph11) Lounge – High damp readings

d) **Lounge** – A reading of 999 was obtained at a height of 30-50cm from the external wall to the left of the bay window. This reading indicates a significant level of moisture below the internal wall surface.

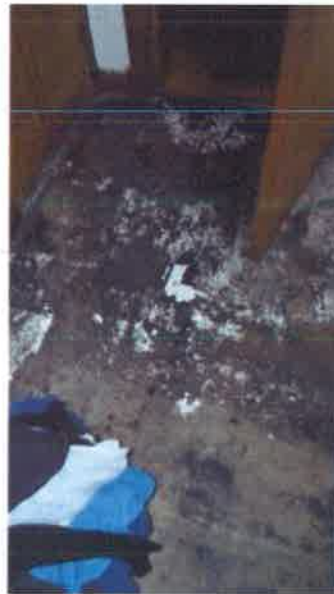
(Ph12) Kitchen – Original inspection

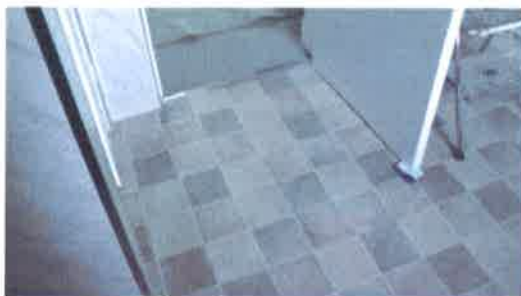
(Ph13) Kitchen – 2nd re-inspection

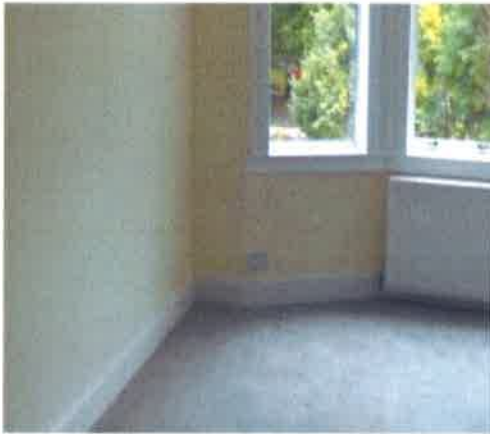
Photo 1 - Lounge

- a) **Bedroom 1** – Readings were comfortably below 200 indicating that there are no current issues relating to moisture in this room.
- b) **Bedroom 2** – Readings were comfortably below 200 indicating that there are no current issues relating to moisture in this room.
- c) **Lounge** – Readings were comfortably below 200 indicating that there are no current issues relating to moisture in this room.
