Statement of Decision of the Housing and Property Chamber of the First-tier Tribunal for Scotland under Section 26 (1) of the Housing (Scotland) Act 2006

**Property: Lion Lodge South (No 2), Coldstream, Berwickshire TD12 4HE
("the Property"/ "the house")**

Chamber Reference: FTS/HPC/RP/18/1918

SCHEDULE OF PHOTOGRAPHS

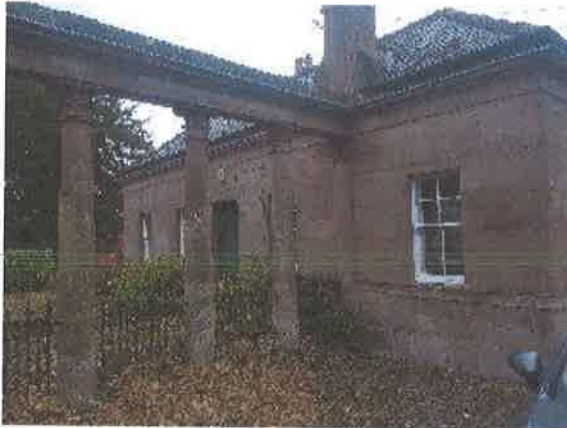
1 External view of House.

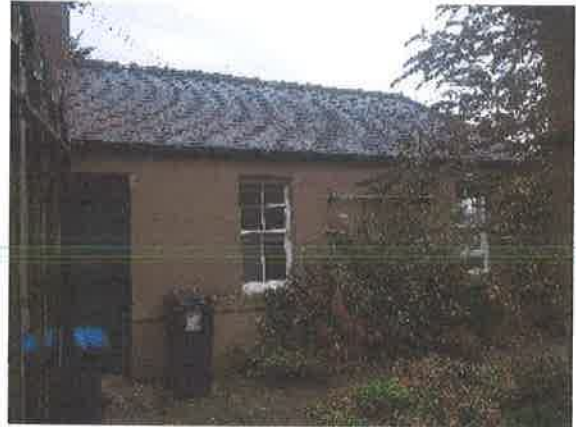
2 External view of House.

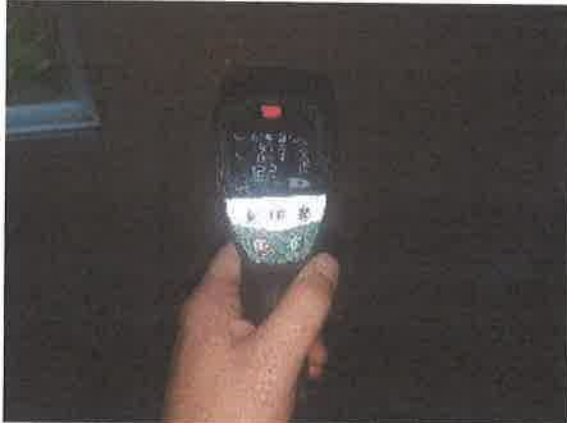
17. There are no visual signs of damp staining apart from those attributable to condensation. The extensive black mould is an indication of condensation rather than penetrating damp. The high relative humidity would be reduced by increasing the heating. The normal acceptable temperature to which the Property should be heated is 20 degrees and, if future occupants would be advised to control the relative humidity down to 50% and reduce water vapour by heating and more ventilation. If the temperature was 20 degrees and the relative humidity was 50%, that would reduce the dew point to 9.3 degrees, which would be below the temperature of the wall and condensation would not occur.

3 Condensation assessment – red light indicates wall temperature below dewpoint.

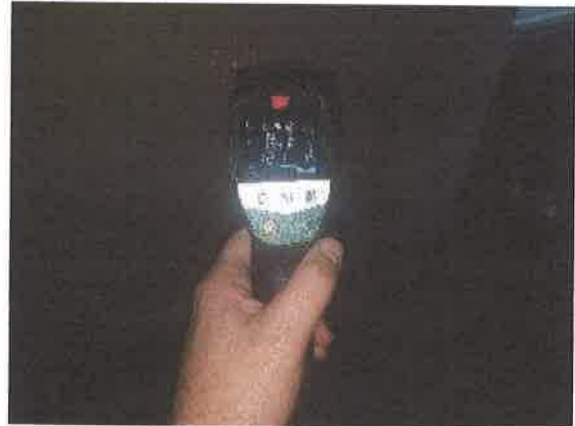
4 Condensation assessment – red light indicates wall temperature below dewpoint.

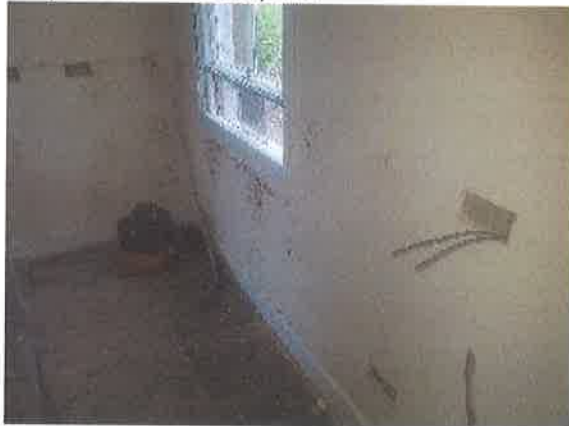
5 Second reception room.

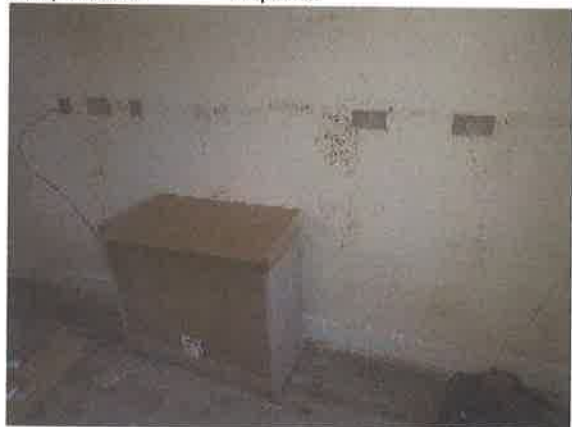
6 Second reception room.

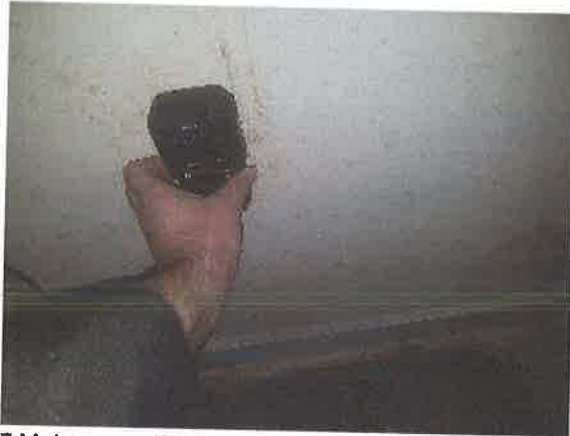
7 Moisture readings.

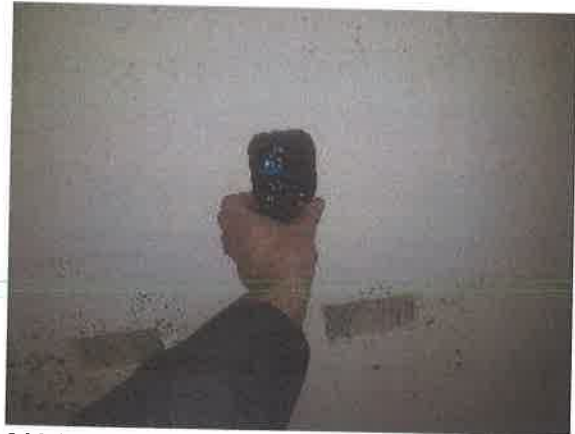
8 Moisture readings.

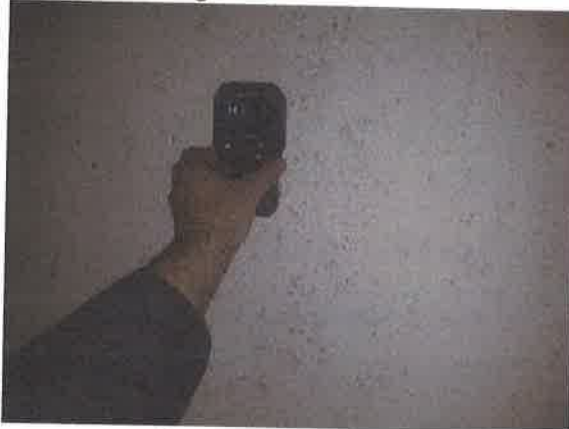
9 Moisture readings.

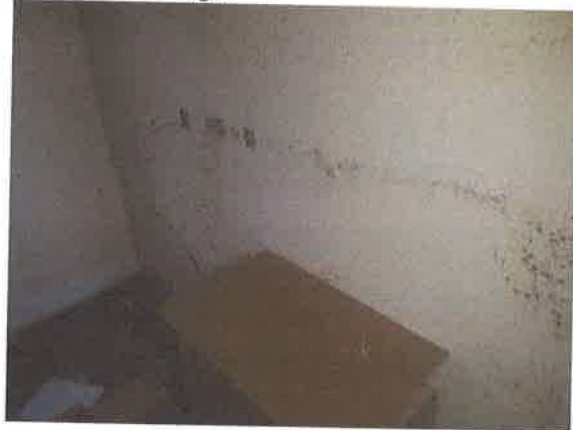
10 Second reception room.

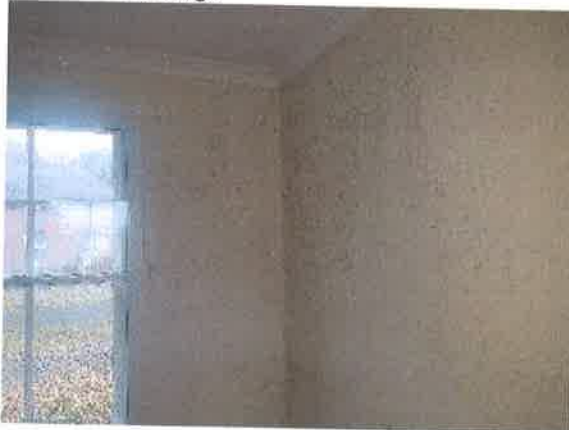
11 Second reception room.

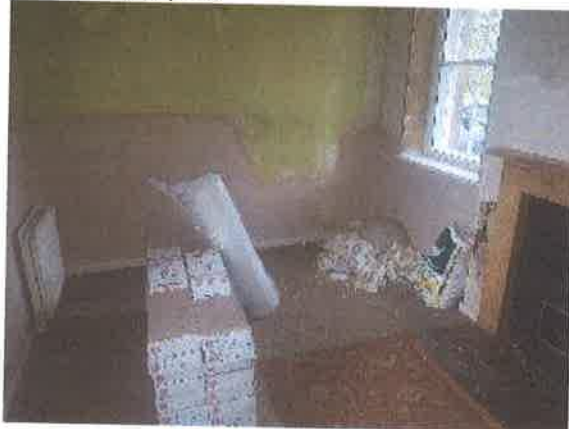
12 Sitting Room – during refurbishment.

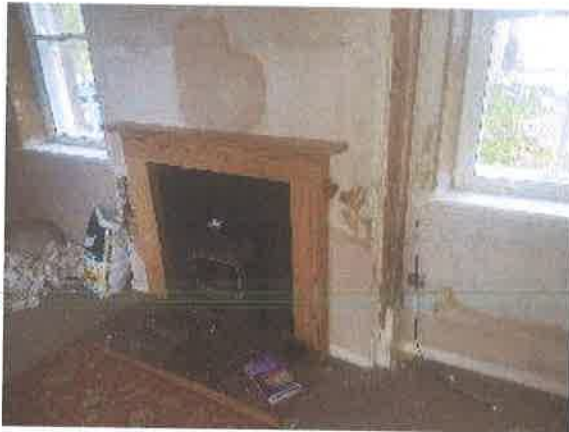
13 Sitting Room – during refurbishment.

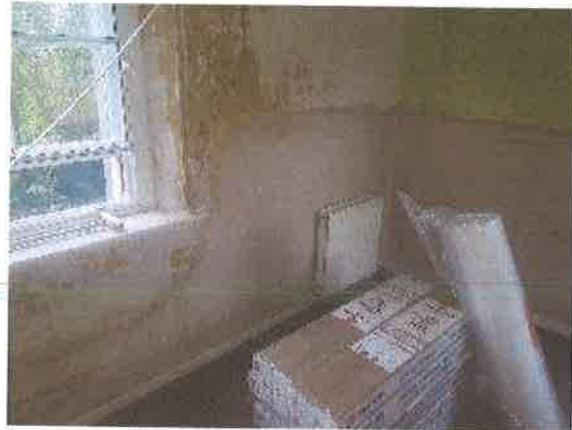
14 Sitting Room – during refurbishment.

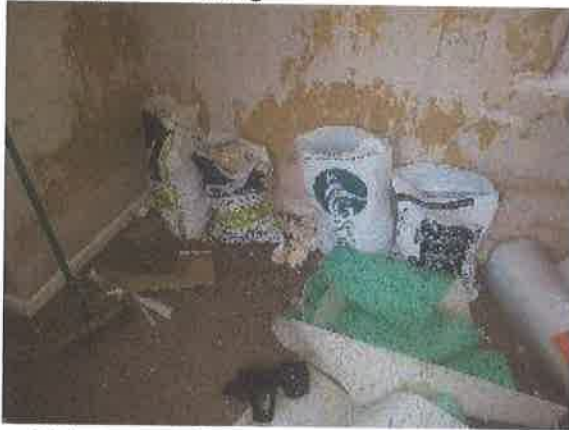
15 Sitting Room – during refurbishment.

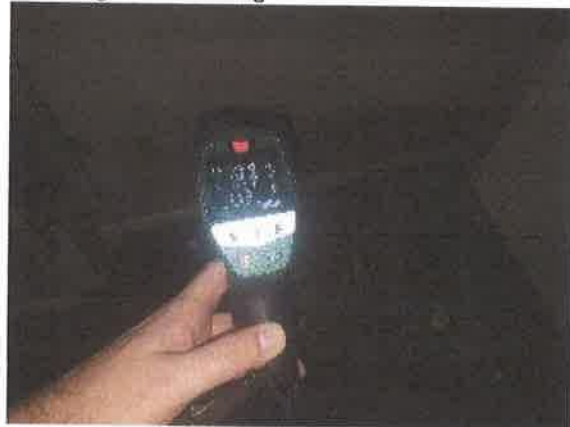
16 Condensation readings.

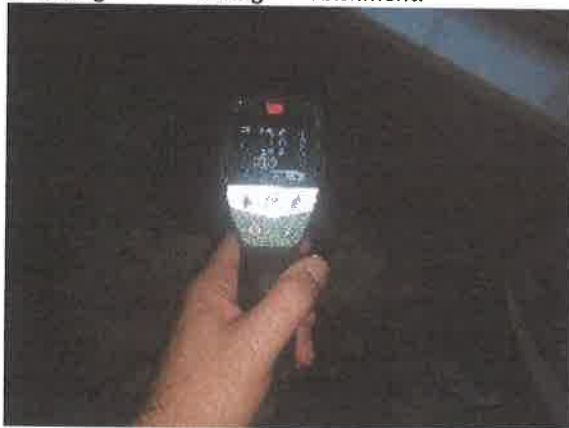
17 Condensation readings.

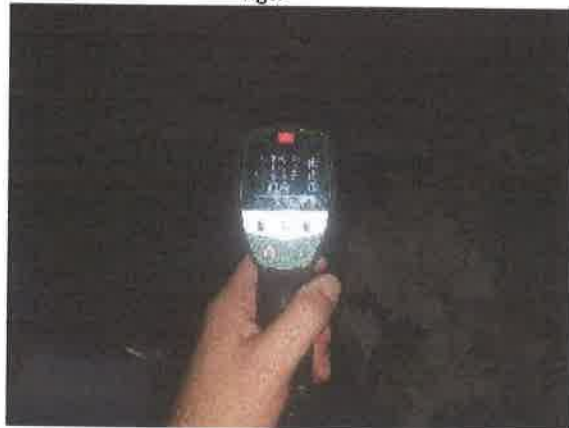
18 Condensation readings.

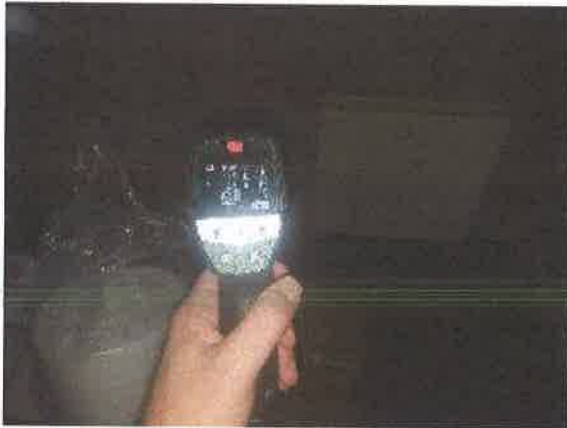
19 Condensation readings.

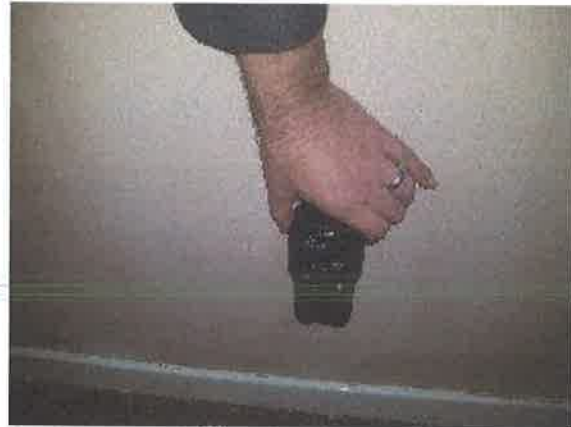
20 Moisture readings.

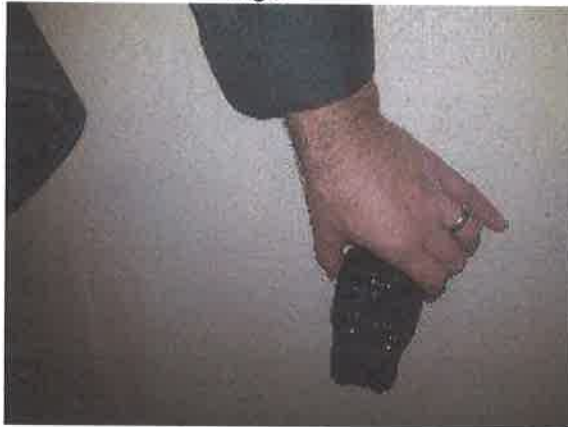
21 Moisture readings.

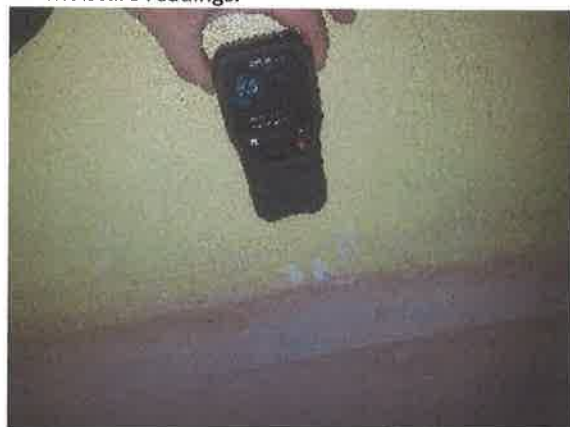
22 Moisture readings.

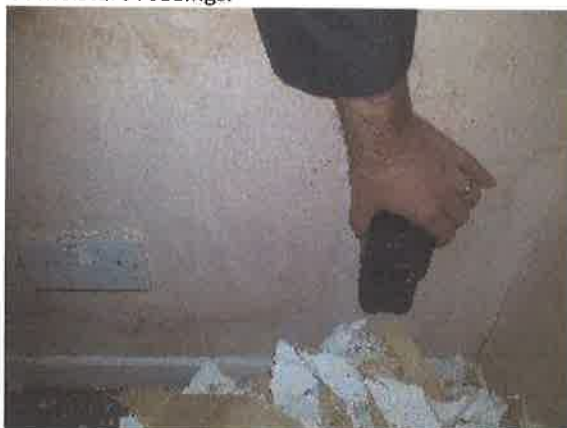
23 Moisture readings.

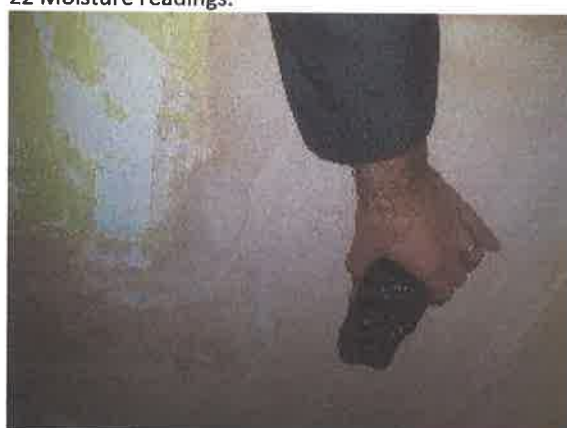
24 Moisture readings.

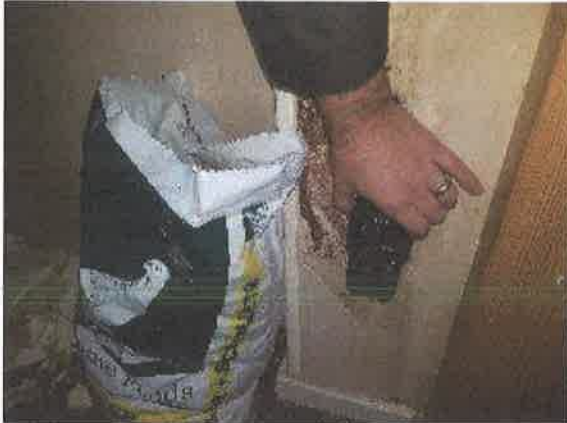
25 Moisture readings.

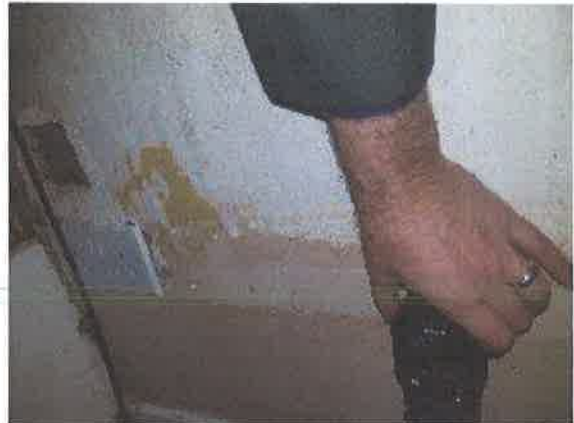
26 Moisture readings.

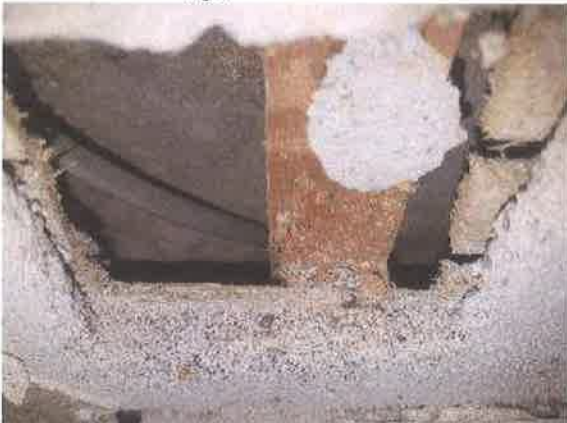
27 Investigation of wall construction.

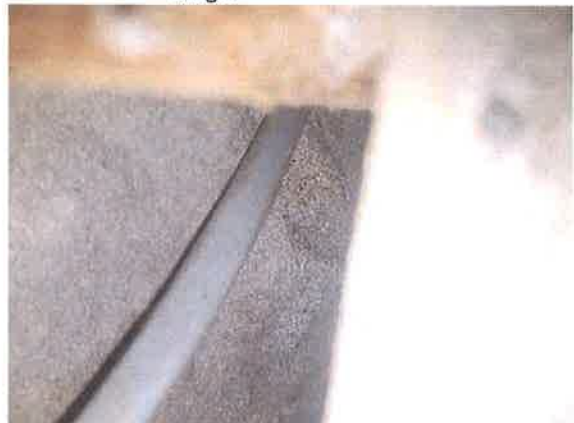
28 Investigation of wall construction.

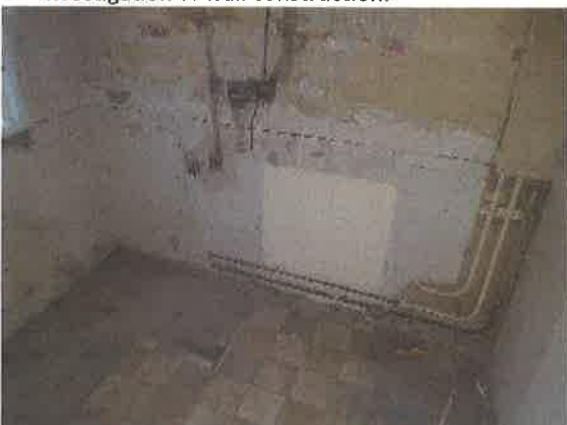
29 Kitchen.

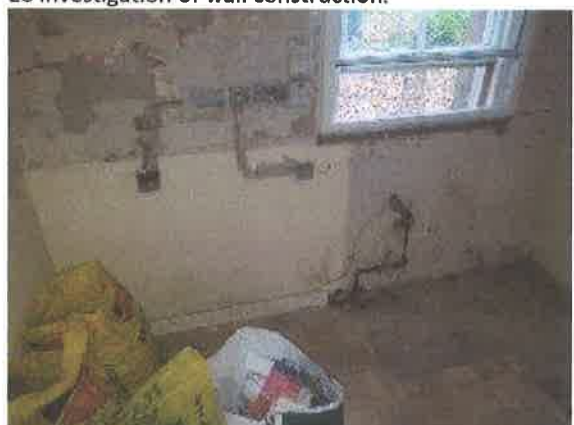
30 Kitchen.

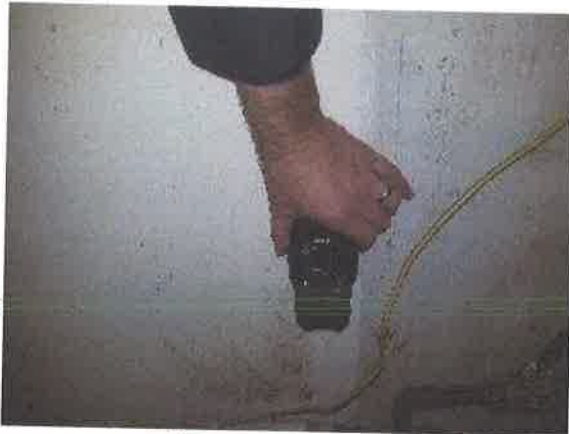
31 Moisture readings in Kitchen.

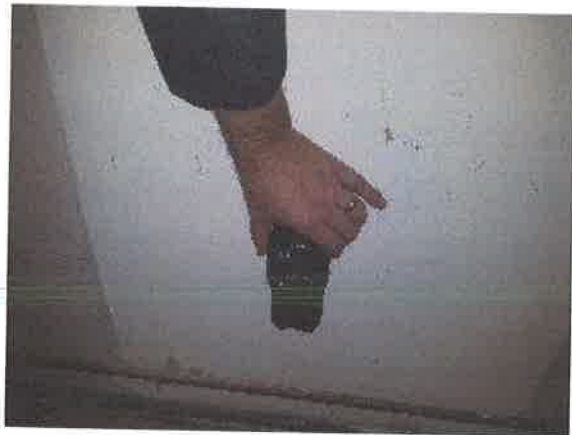
32 Moisture readings in Kitchen.

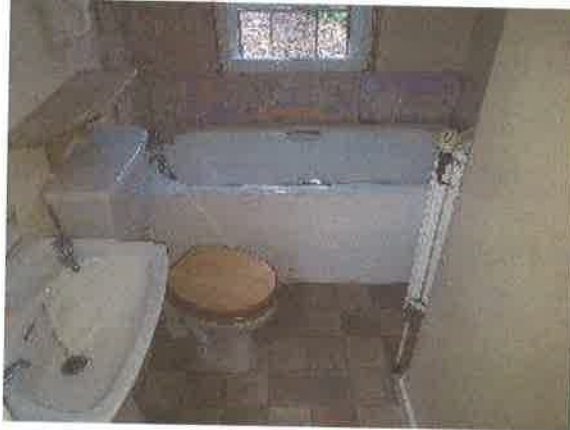
33 Bathroom.

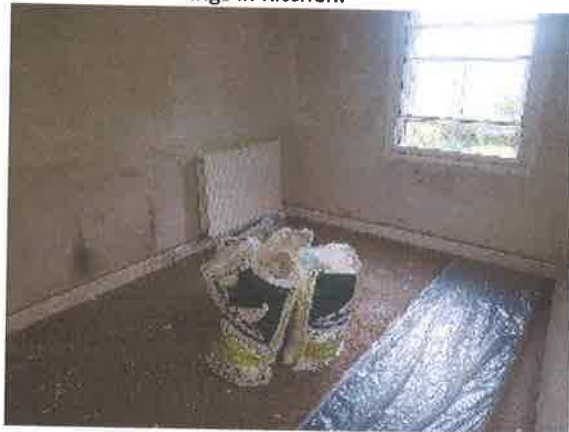
34 Bedroom.

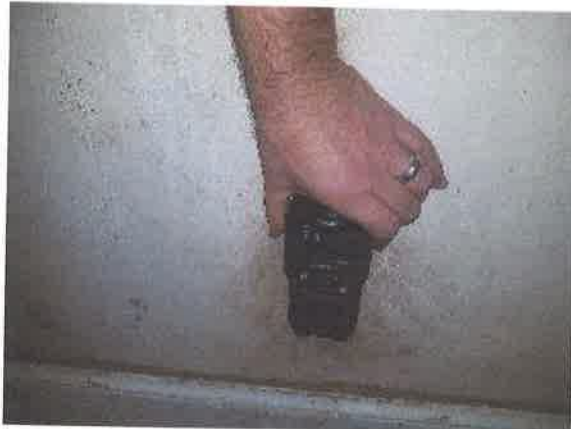
35 Moisture readings in Bedroom.

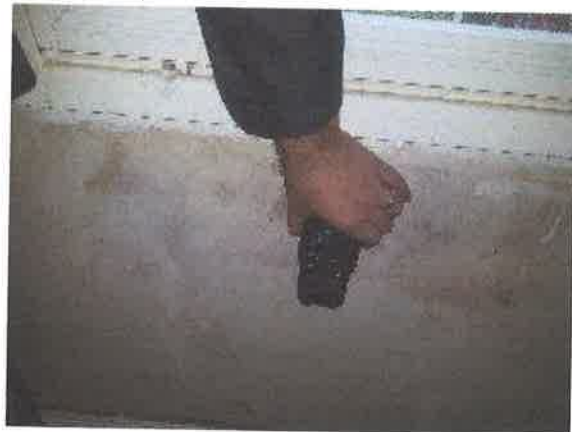
36 Moisture readings in Bedroom.

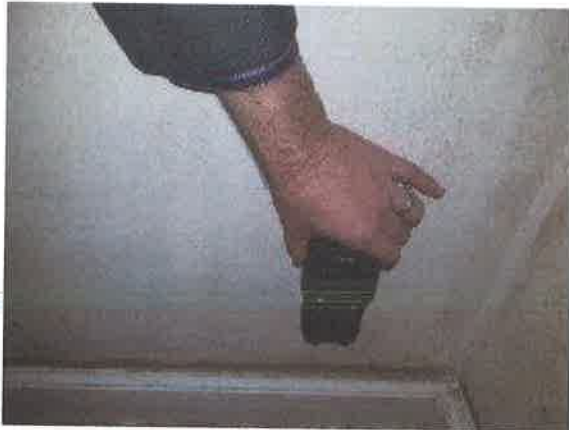
37 Moisture readings in Bedroom.

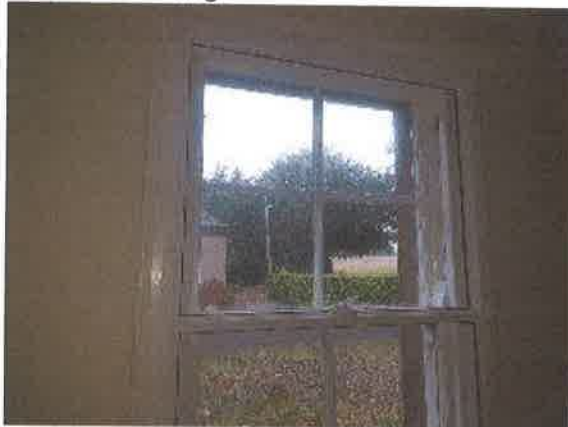
39 Secondary glazing example.

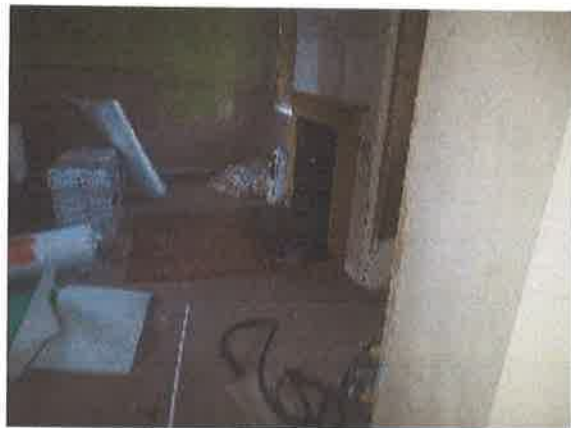
40 Living Room – refurbishment progressing.

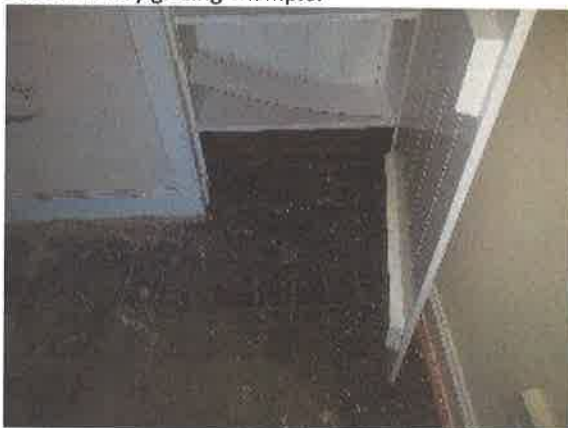
41 Floor covering removed.

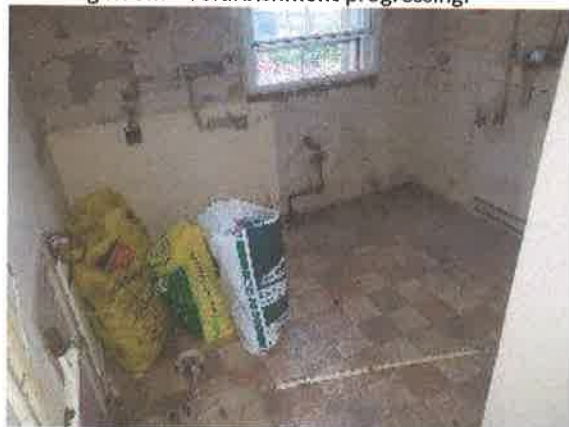
42 Kitchen – refurbishment progressing.
