First-tier Tribunal for Scotland (Housing and Property Chamber)

Chamber Reference: PRHP/RP/16/0357

Property Address: 314 Websters Land, Edinburgh EH1 2RU (“the house”)

Legionella Risk Assessment

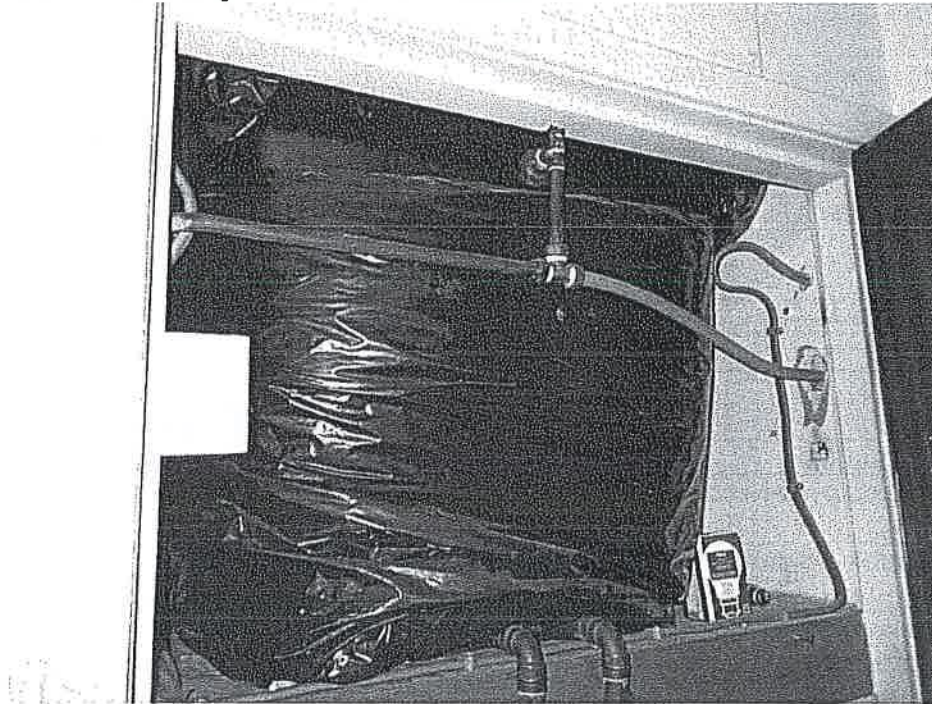
Cold water storage tank – access difficult

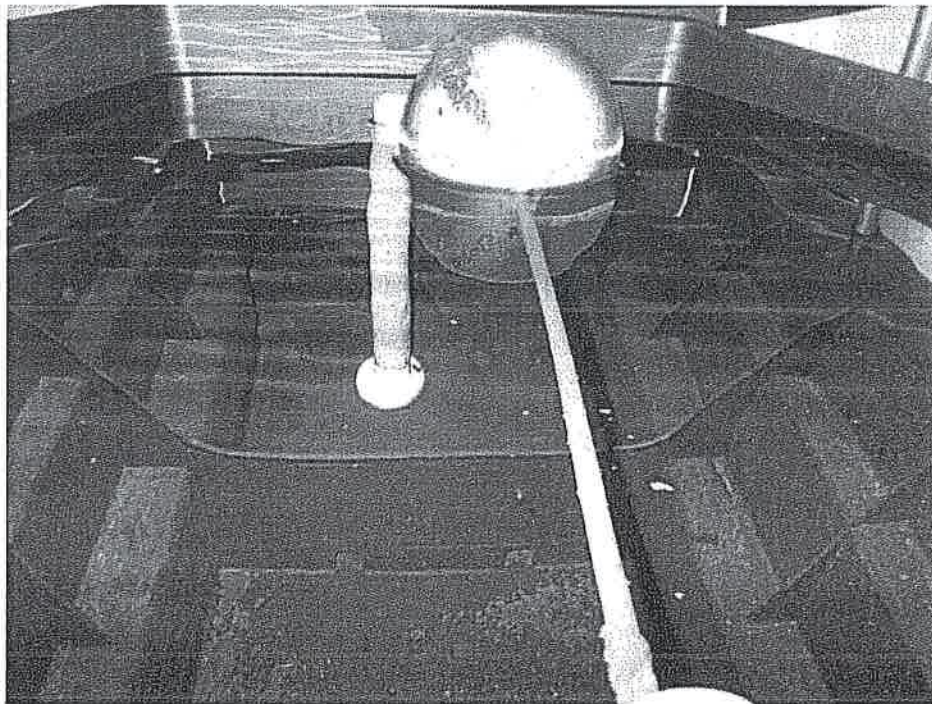
Sediment inside cold water tank

Medium
<p>1. Cold water tank does not meet current regulations; sediment and scale in tank, overflow pipe not screened, no screened air vent, inlet and outlet pipes not on opposite sides of the tank. Recommend remedial works be carried out by a WaterSafe approved plumber to ensure the tank complies with the current Scottish Water Byelaws and that the tank be cleaned and disinfected.</p> <p>2. Temperature of the hot water in the property was very high, and poses a risk of scalding. Recommend a thermostat be fitted to the hot water cylinder and the temperature be set to 60°C.</p>

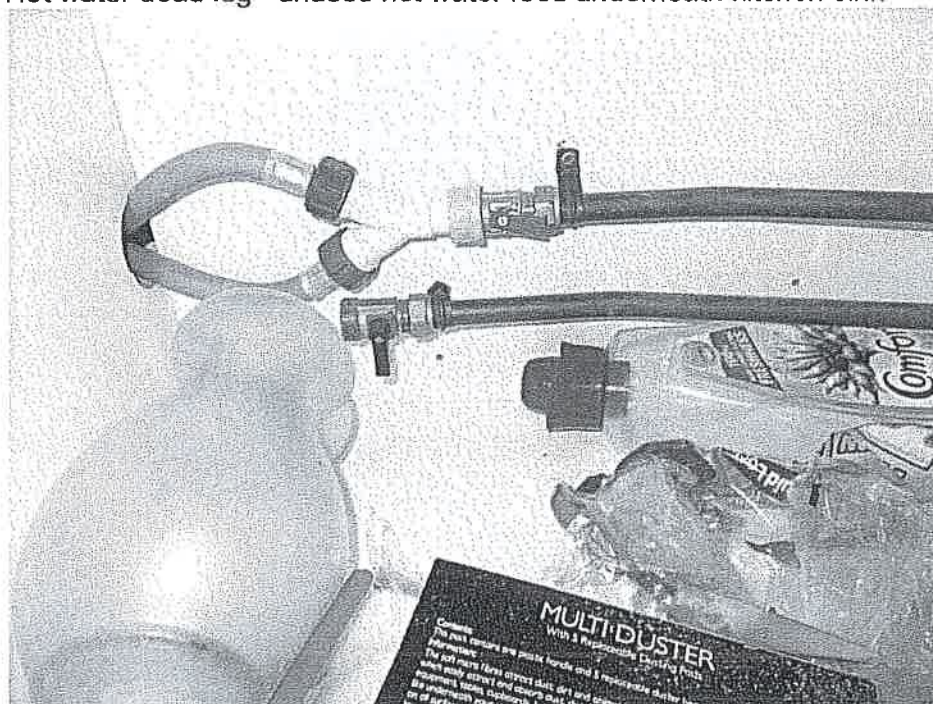
Dead legs were observed in the following areas - unused hot water feed underneath kitchen sink

Hot water dead leg - unused hot water feed underneath kitchen sink

High
Unused hot water feed under the kitchen sink is a dead leg where legionella bacteria could multiply in stagnant hot water. Recommend the dead leg of pipe is removed by a WaterSafe approved plumber in compliance with the current Scottish Water Byelaws.

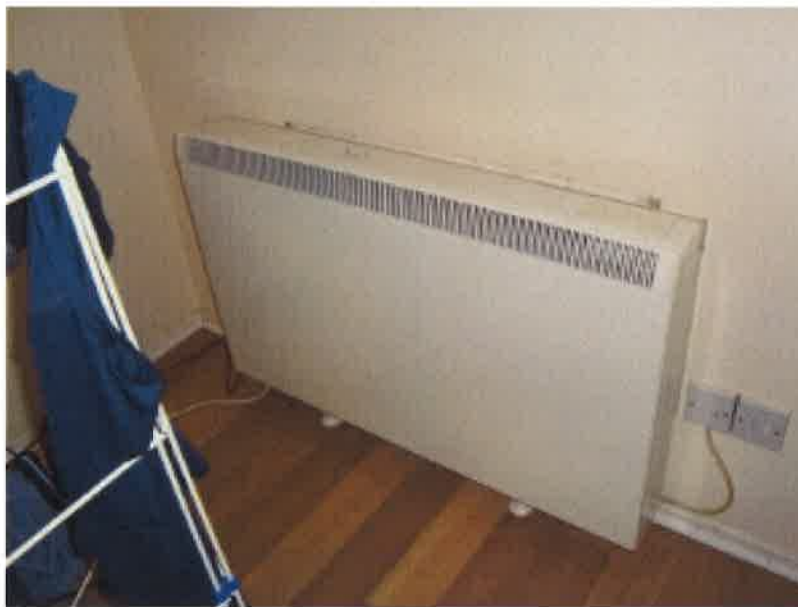
NEW RADIATOR IN STUDIO ROOM

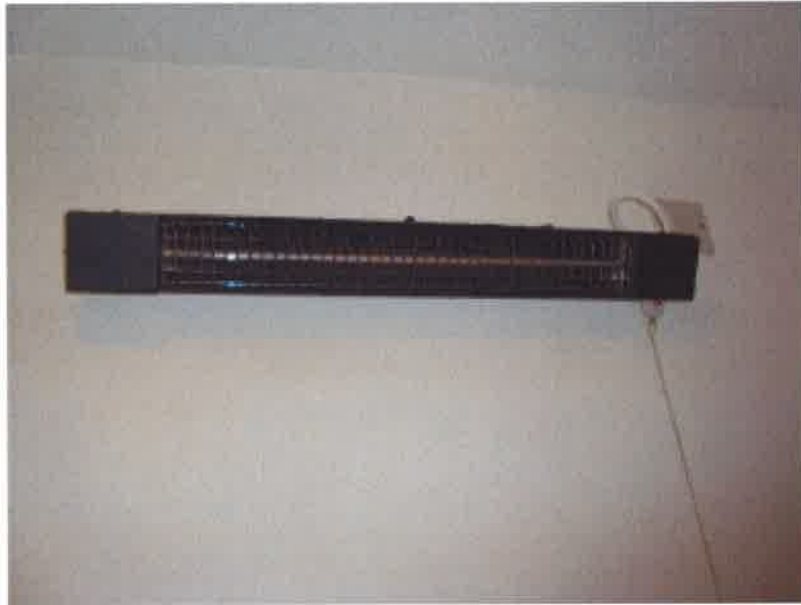
BATHROOM –WALL MOUNTED RADIATOR

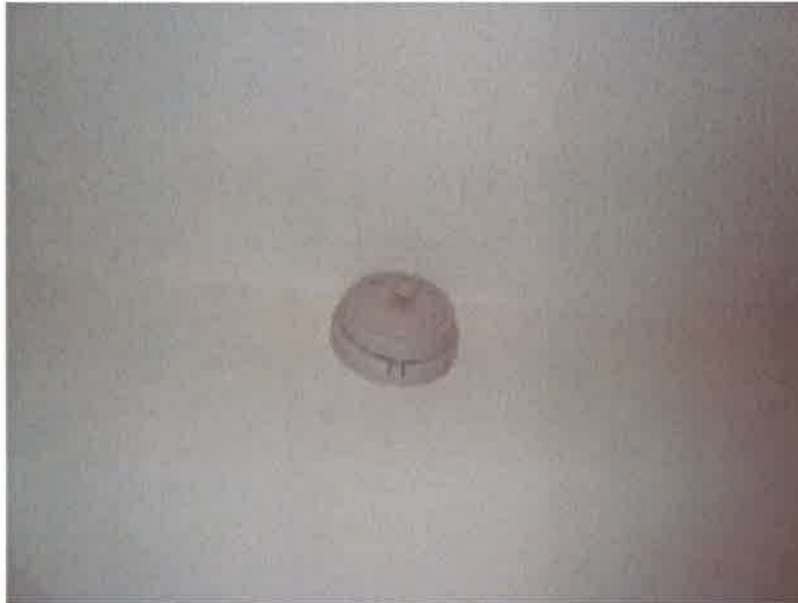
KITCHEN- HEAT DETECTOR

Completed a Pat test. Replaced the faulty kitchen light. Removed the bathroom wall heater. Install and wired a mains wired optical smoke alarm in the hall and living room and a mains wired heat detector in the kitchen. The smoke alarms are interlinked by hard wire

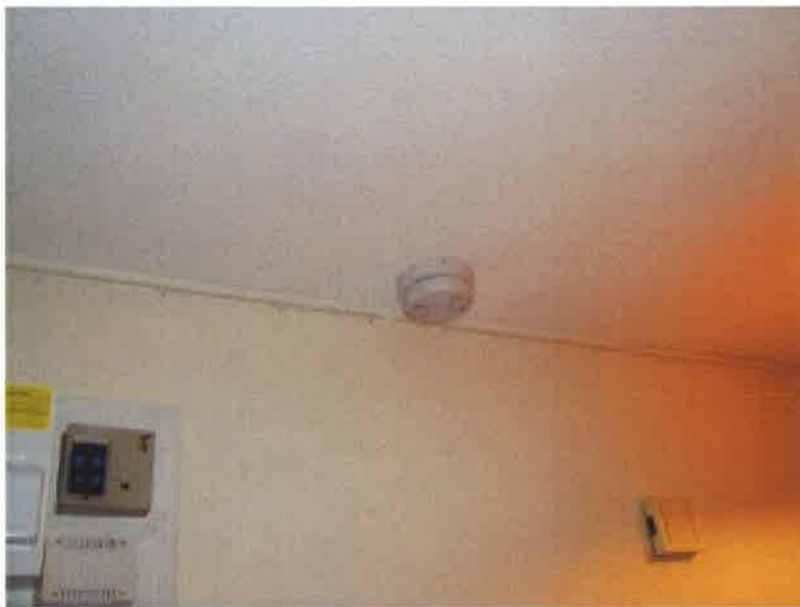
HALL- SMOKE DETCTOR

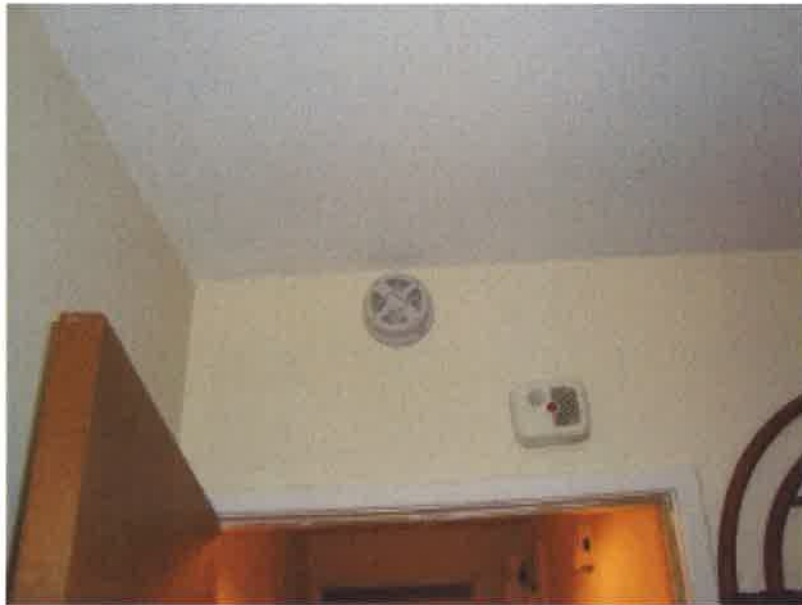
STUDIO-SMOKE DETECTOR

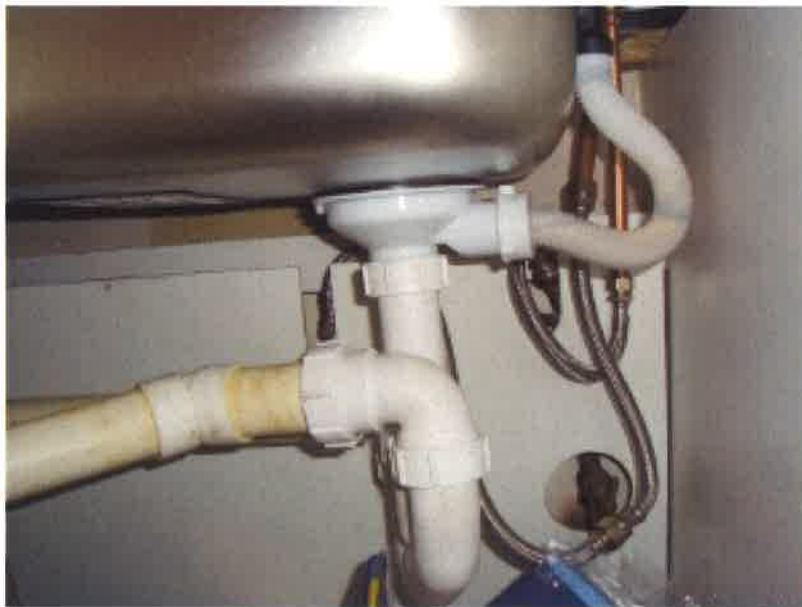
"DEAD LEG" PIPE REMOVED-KITCHEN SINK

Details	Cost
1. Supply and fit new cold water storage tank and associated pipework and fittings. Fit new tank mounting base. 2. Remove hot water pipe dead leg from under kitchen sink. 3. Remove all debris from site and dispose. As per estimate. £671 plus VAT.	
Total	£805.20

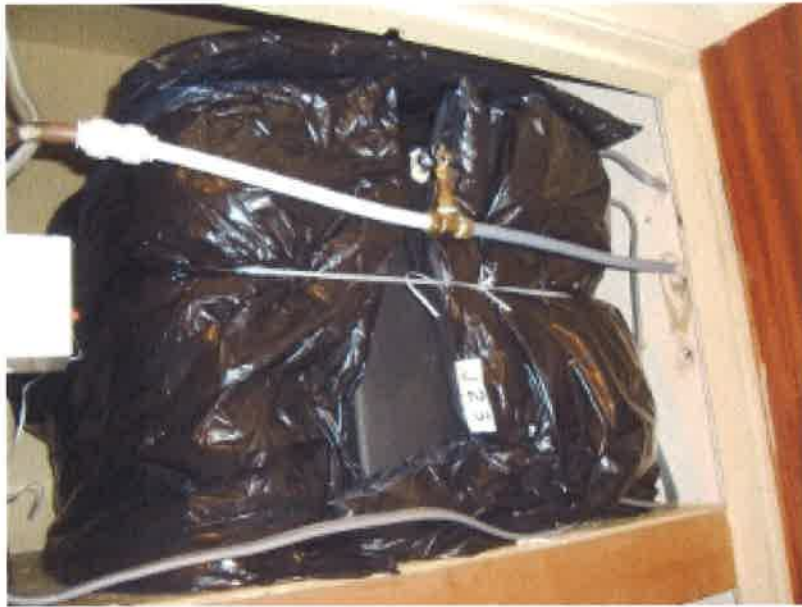
NEW COLD WATER TANK
