**Housing  
(Scotland) Act 2006: Re-inspection Report**

**Property: 1 Institution Street, Macduff, Aberdeenshire AB44 1UT**

**Chamber Reference : FTS/HPC/RT/19/2149**

**Re-inspection Date: 26/10/2021 - 11.30am**

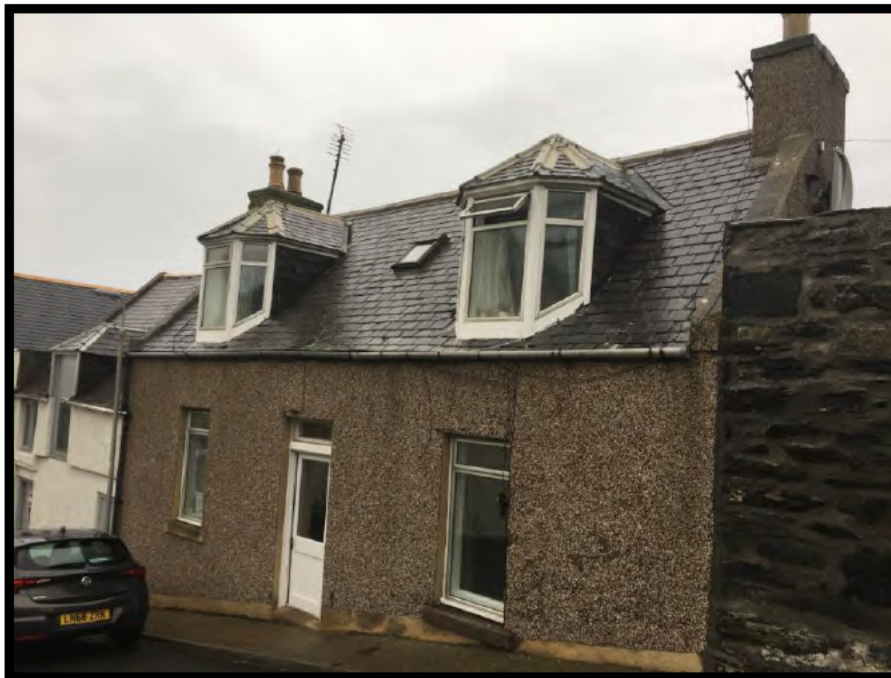
Photograph 1 Front Elevation

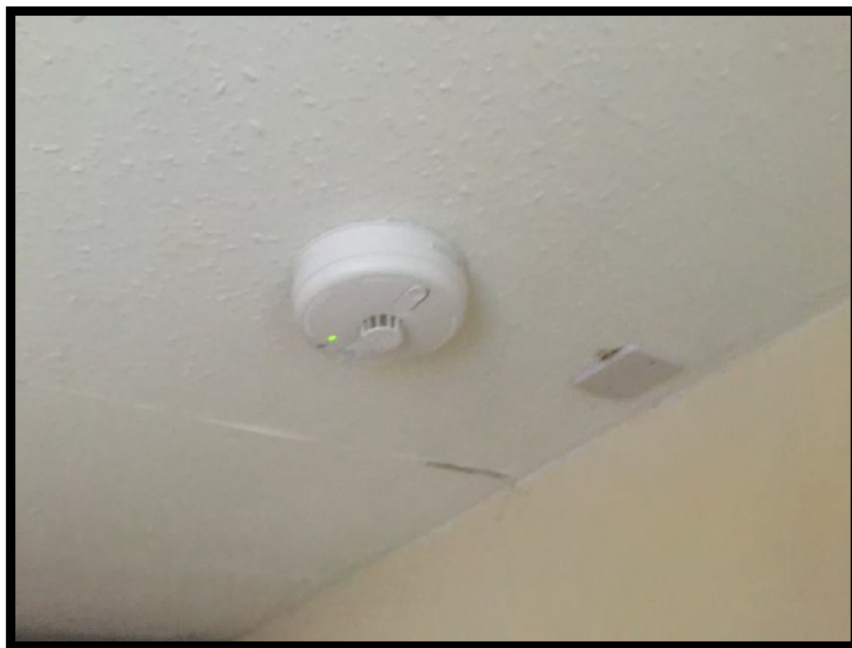
Photograph 2 Ground floor - Kitchen - Example hard wired alarm, alarm system tested at inspection.

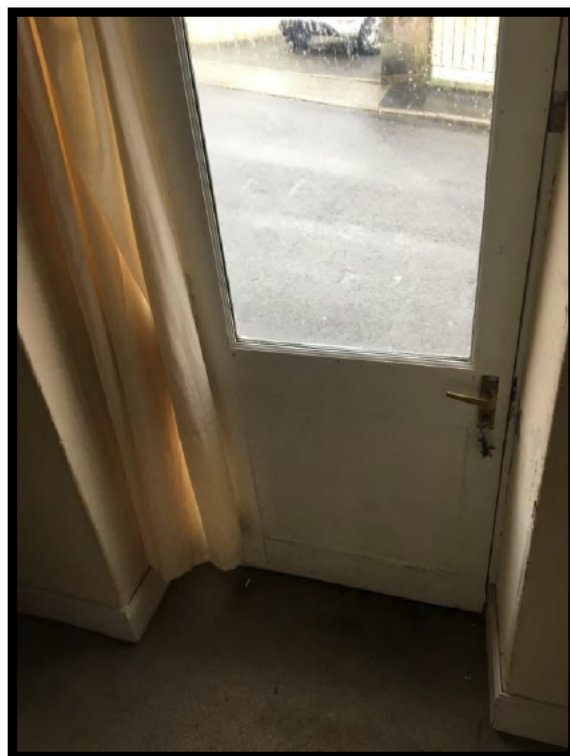
4 The overall state of the front door is the same as at the initial inspection and previous re-inspection. The door latch, lock and keep are damaged. Daylight was visible around the door when it was in the closed position.

Photograph 3 Overview of front door - no significant change.

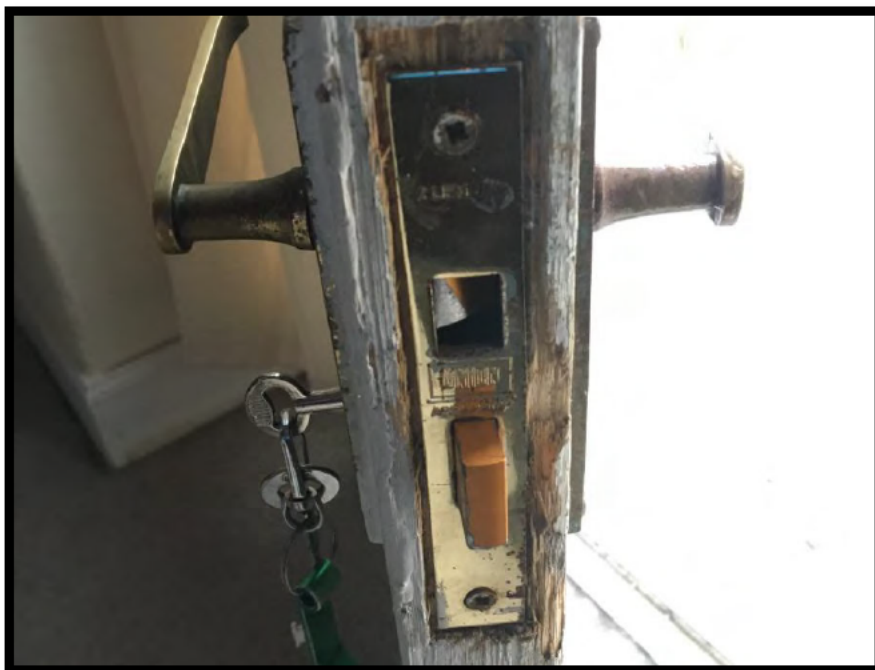
Photograph 4 Damaged sash lock - unchanged.

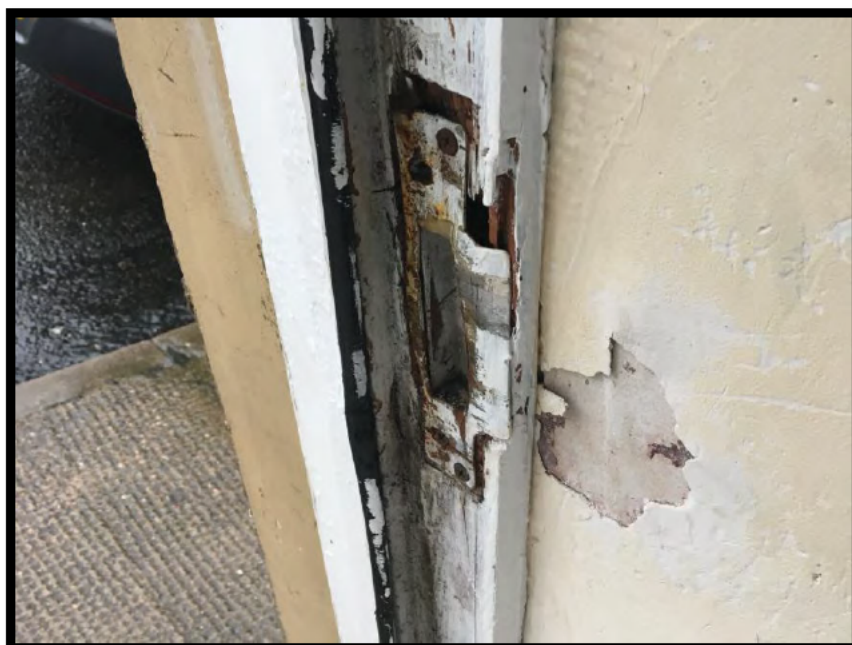
Photograph 5 Damaged lock keep - unchanged.

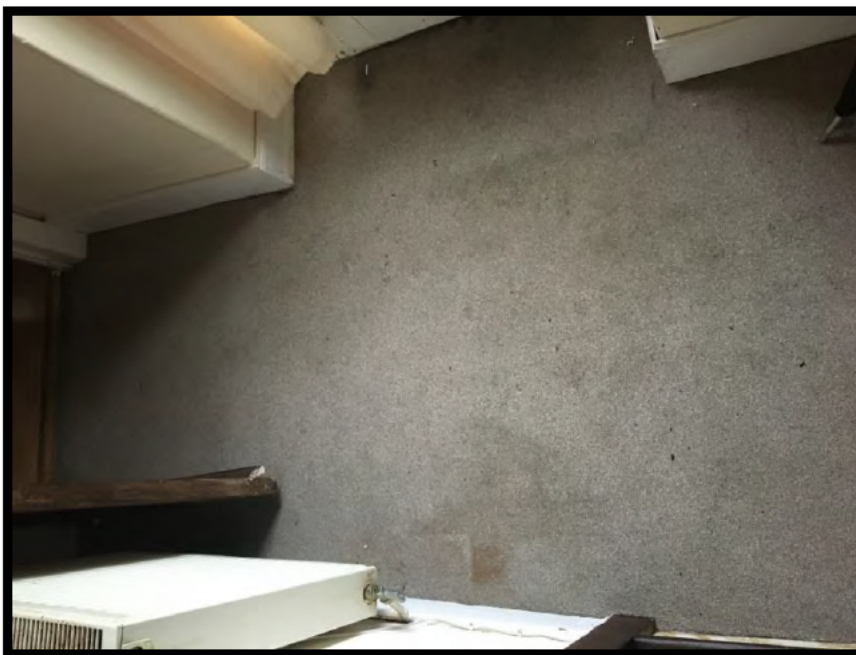
5. The hall carpet has been replaced. At the previous re-inspection, the tenant stated that they had replaced the carpet. The carpet was found to be in a reasonable state of repair.

Photograph 6- Ground floor entrance - new carpet fitted by tenant.

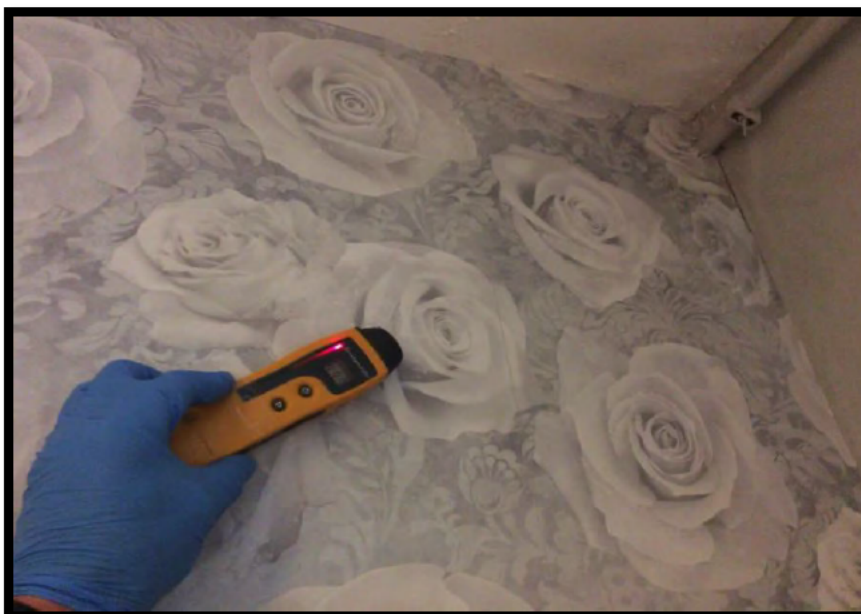
6. Overall, the state of the dampness was very similar to what was found at the initial inspection. The exceptions were the rear wall of the bathroom, where the meter readings showed normal moisture content. It was not clear from the inspection what, if any repairs had been taken to the exterior. Further dampness was noted to the gable wall of the right hand bedroom.

Photograph 7 Meter reading red (99%) to gable wall in sitting room, near ceiling - no significant change.

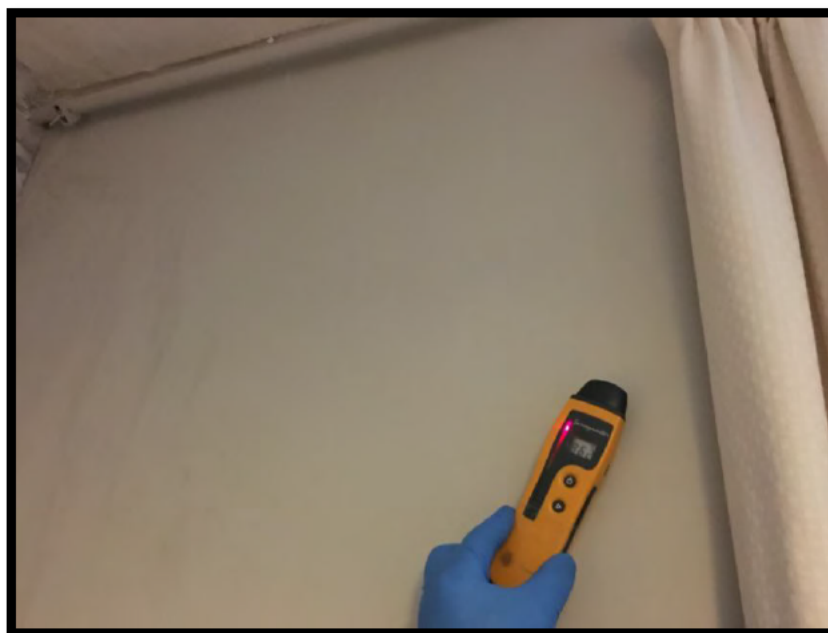
Photograph 8 Moisture meter reading red (96% localised spot) to front wall of sitting room - unchanged.

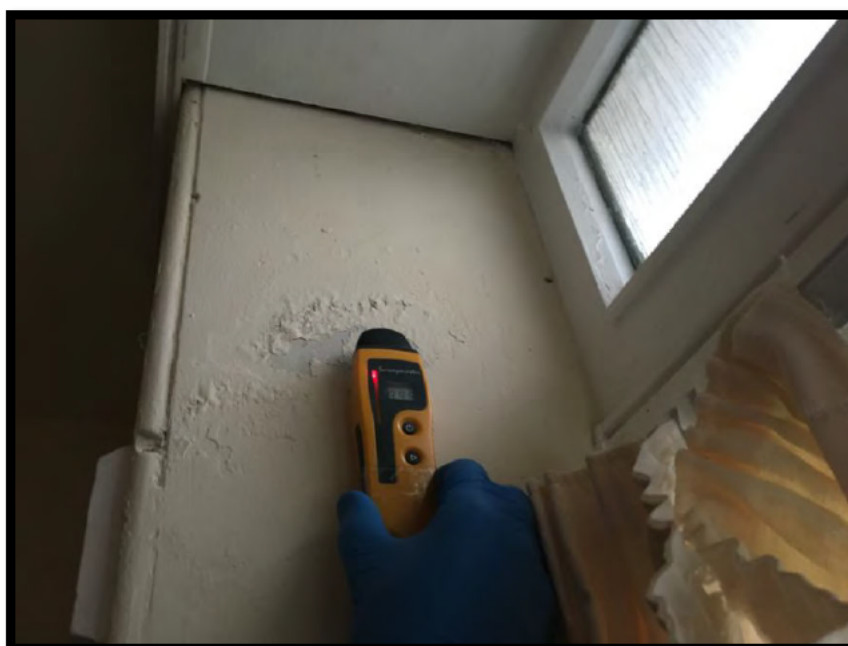
Photograph 9 - Moisture meter reading red (99%) to front wall at ground floor entrance. Both sides of door affected - unchanged.

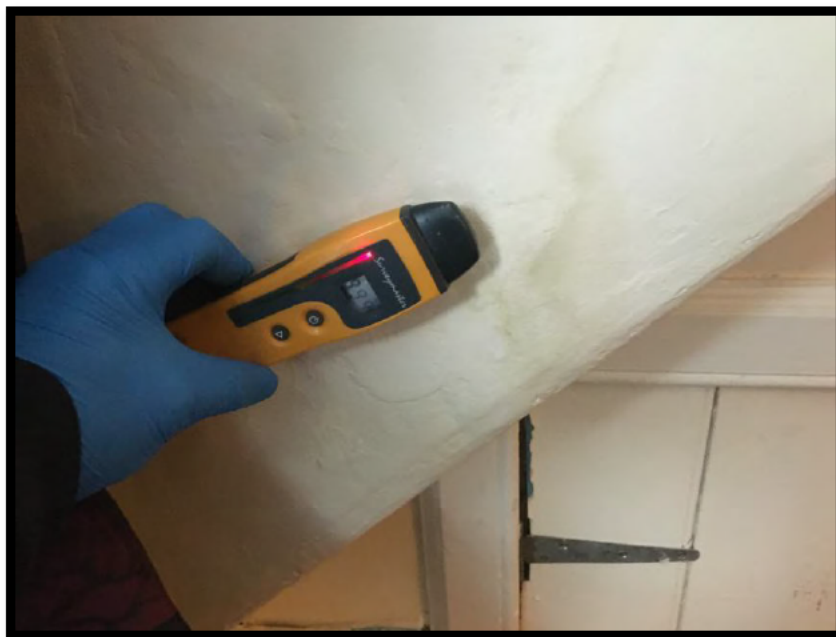
Photograph 10 - Moisture meter reading red (99%) to side of window dormer, right hand bedroom - unchanged.

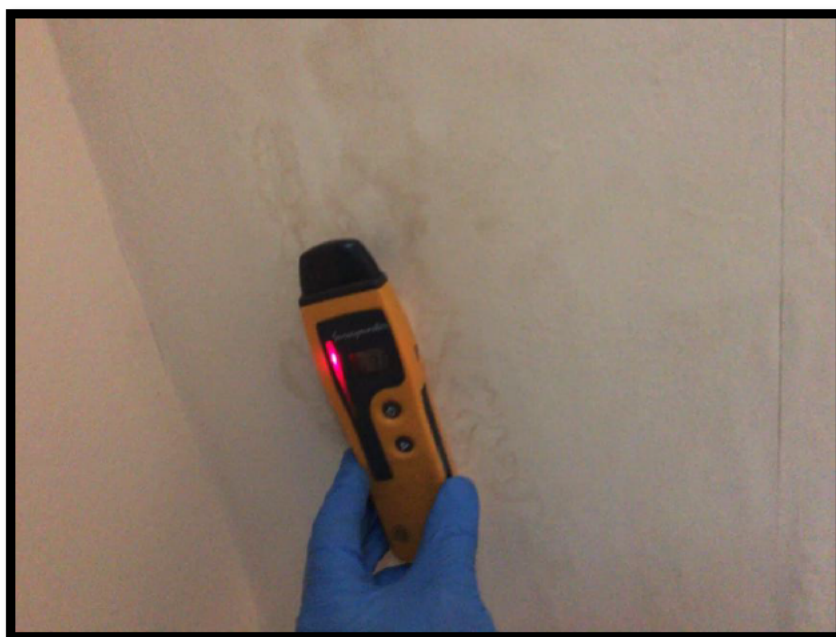
Photograph 11 - Moisture meter reading red (89%) to rear roof slope, right hand bedroom, previously green, 9%.

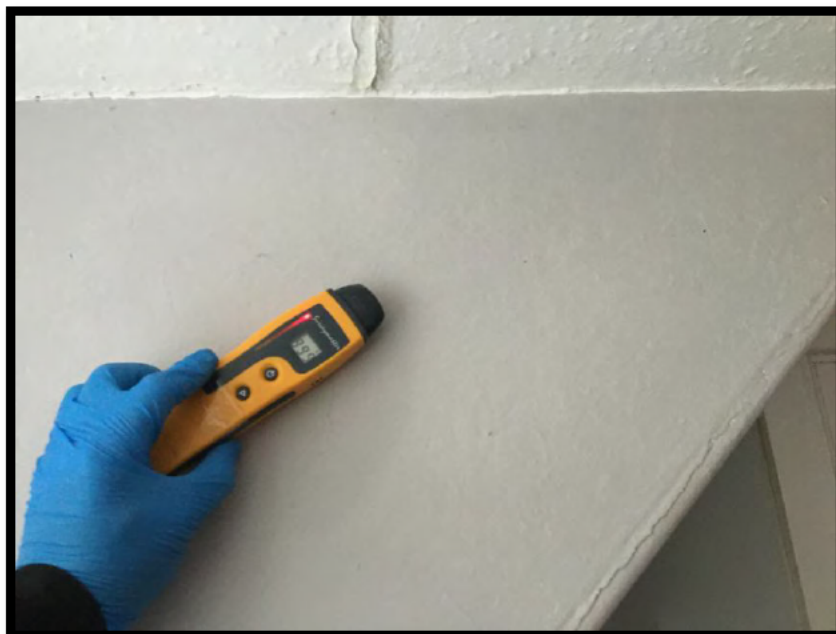
Photograph 12 - Moisture meter reading red (99%, three areas) to side of window dormer, left hand bedroom, unchanged

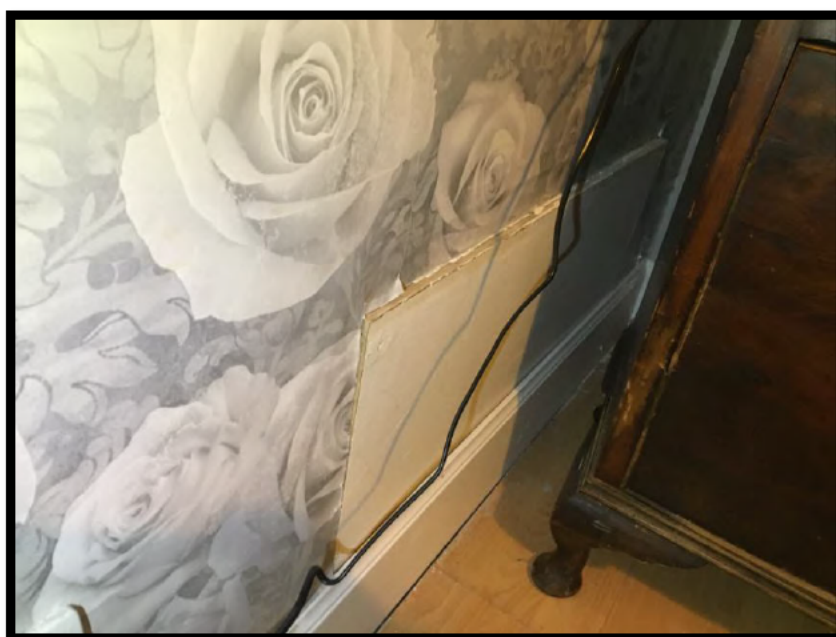
7. The gas meter cupboard door is unchanged from the initial inspection.

Photograph 11 - Gas meter cover, sitting room - unchanged.

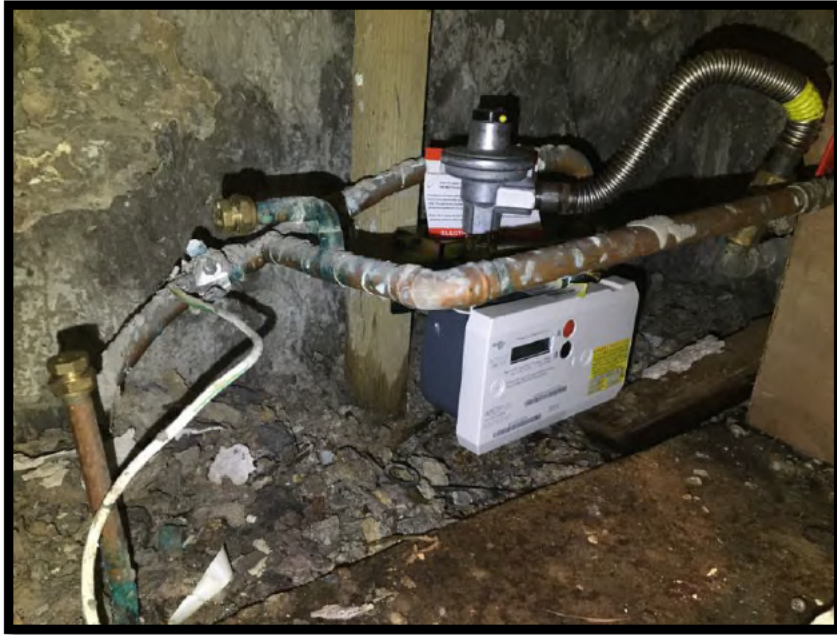
Photograph 12 - Gas meter cupboard - internal - unchanged.

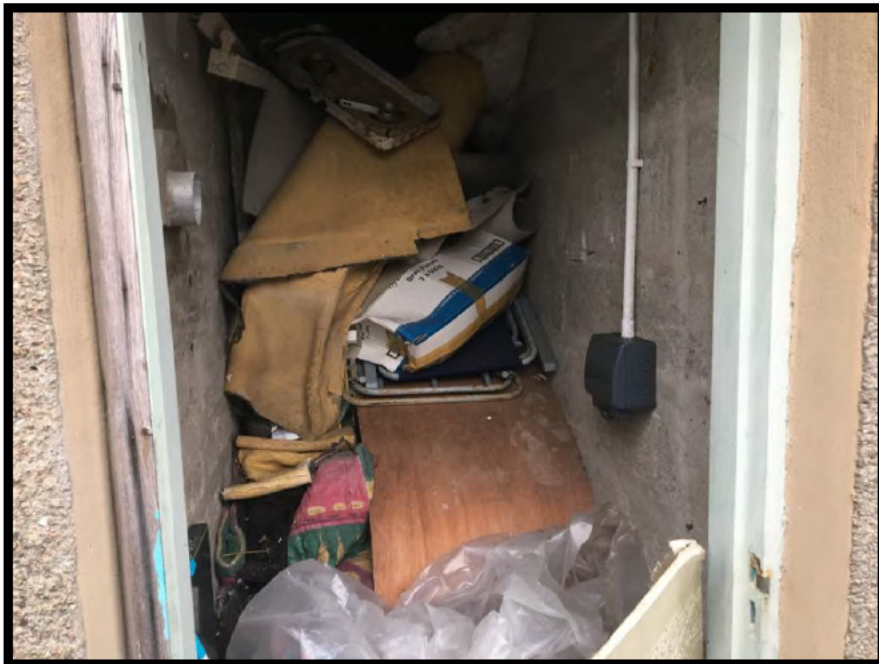
1. The outlet in the external store has been replaced with an external type fitting and the wiring to the cooker hood has been altered to utilise a normal socket outlet. There were no exposed wires seen. No EICR was exhibited.

Photograph 13 External store attached to kitchen. Door missing, as before. Exposed electrical switch replaced with exterior style fitting.

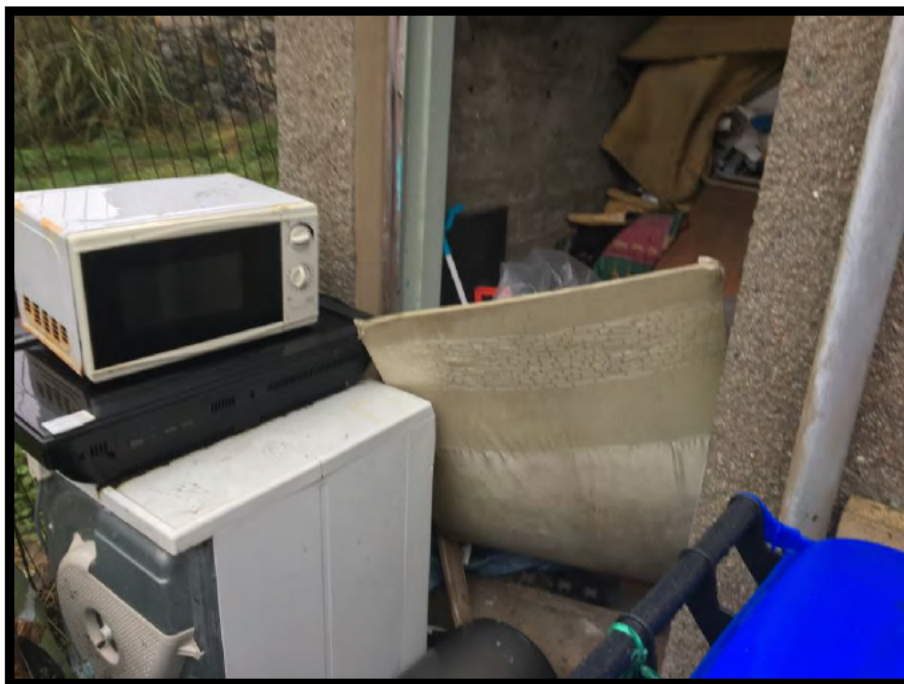
Photograph 14 External store outside view.

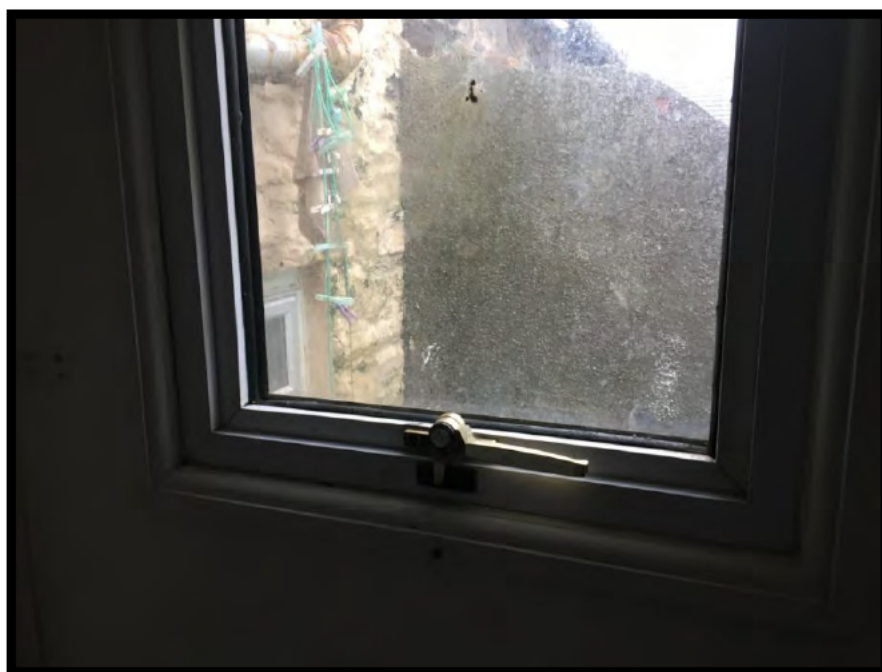
Photograph 15 Rear door window - catch replaced, glazing inner panel broken/missing.

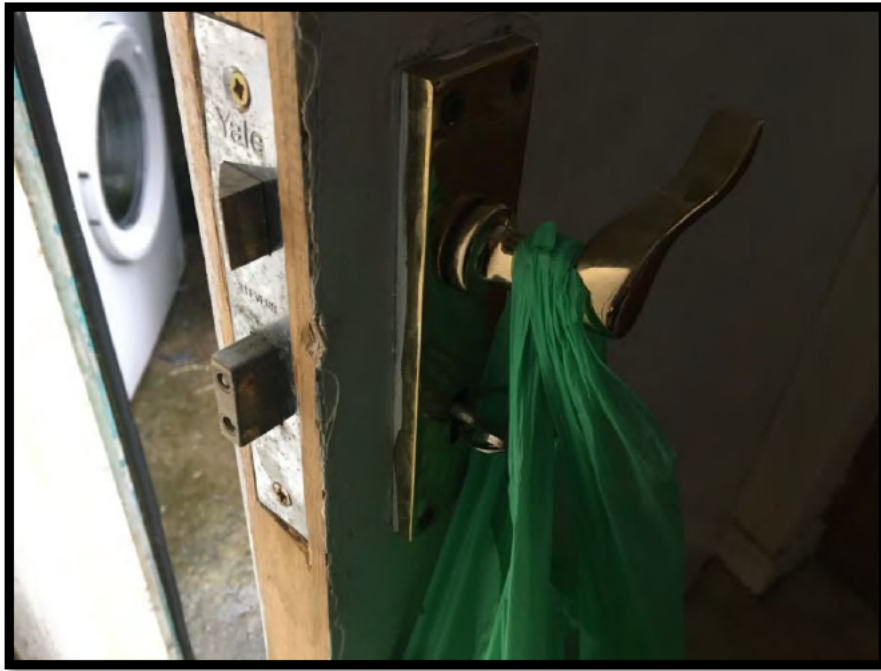
Photograph 16 Rear door latch serviceable at re-inspection.

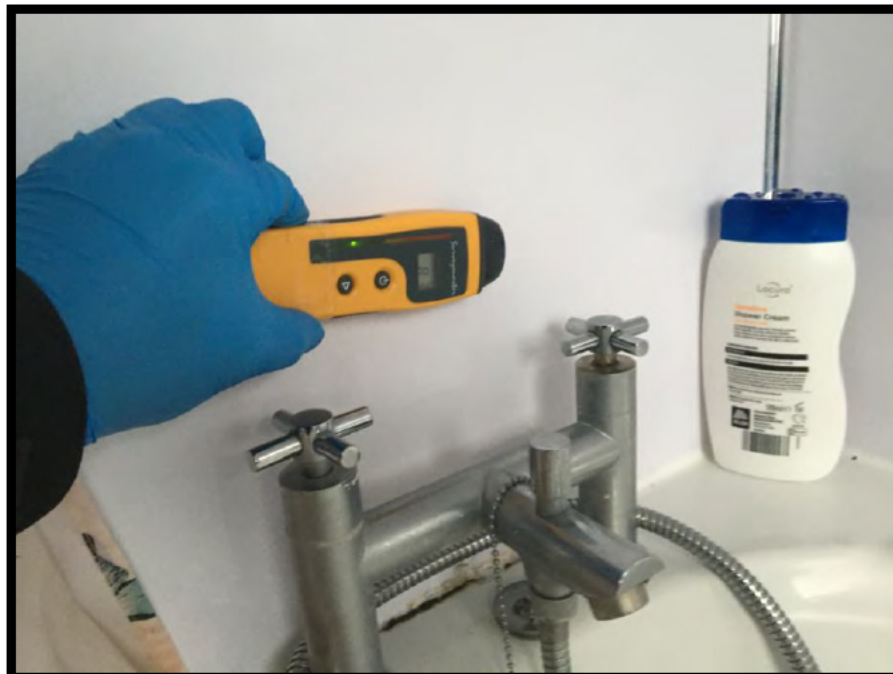
Photograph 17 - Moisture meter reading green (8%) to tiling at bath - was 99%.

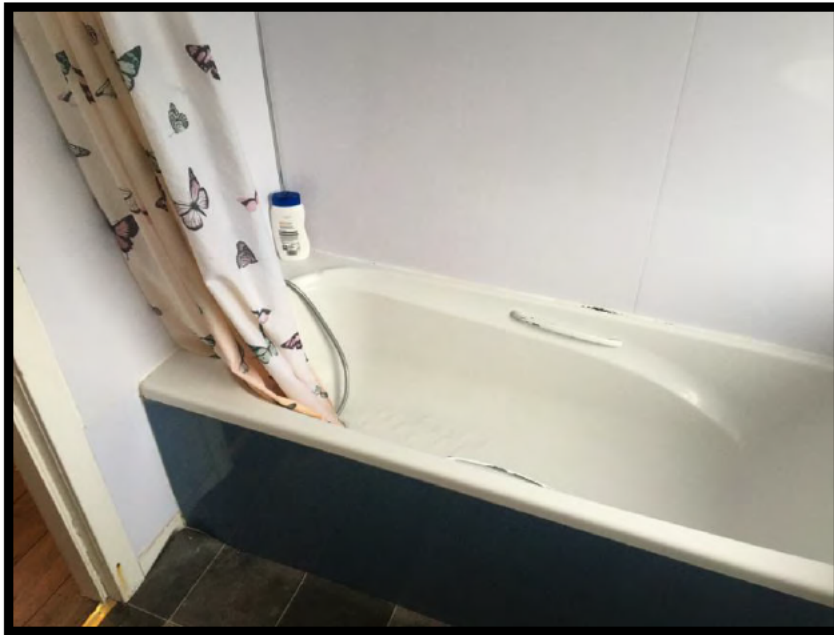
9. The walls around the bath have been re-lined with "Aquapanel", proprietary waterproof linings. Moisture meter readings around the bath areas showed amber or green, normal levels of moisture.

Photograph 18 - Bathroom - new waterproof linings around bath.

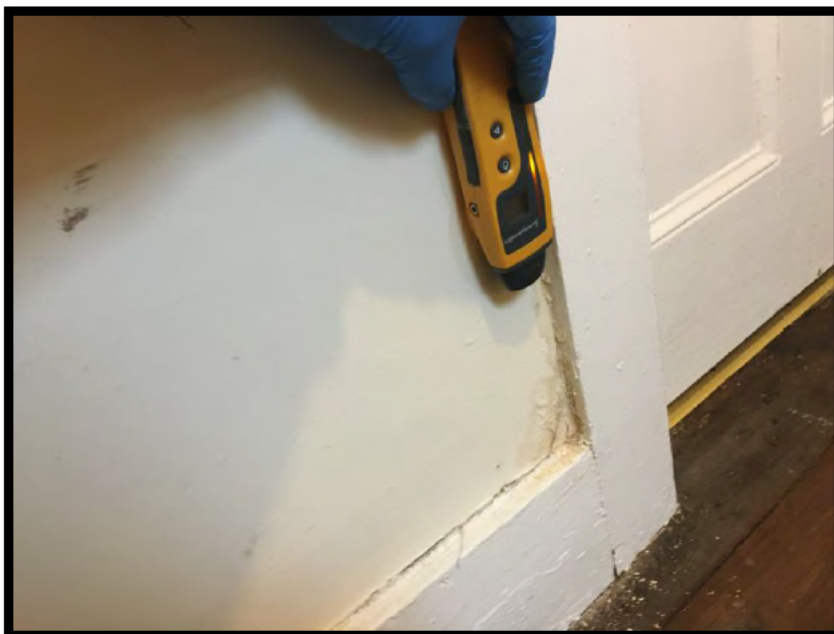
Photograph 19 - Moisture meter reading amber (21%) to landing wall left side of bathroom door, was 99%.

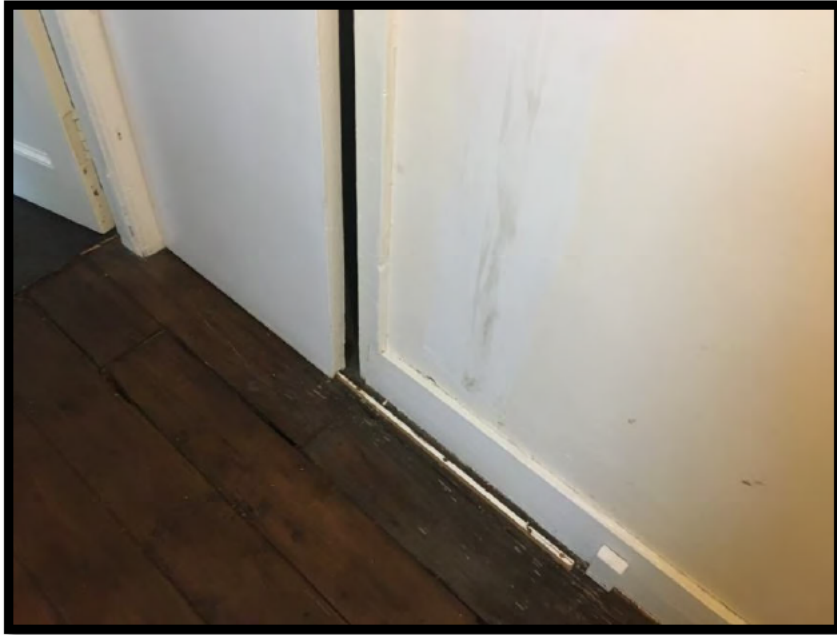
Photograph 20 - Sliding door to boiler cupboard at first floor landing - strip affixed to floor as guide rail.

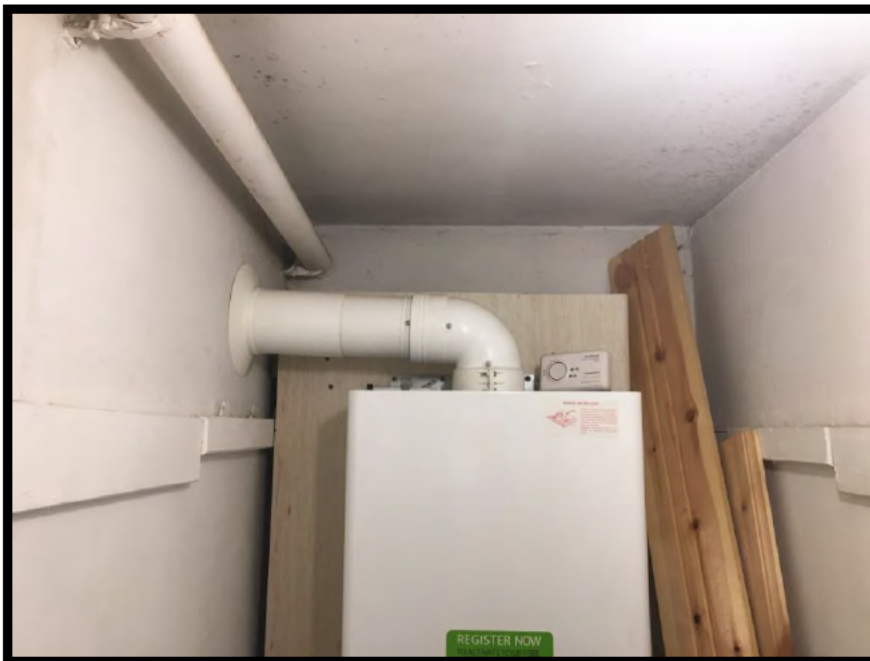
3 A "First Alert" carbon monoxide alarm was found resting on top of the boiler. The position of the alarm does not comply with the manufacturer's guidance. The position was such that the alarm could easily be knocked to the floor. The alarm had no installation date in the space left for this information.

Photograph 21 - Central heating boiler with CO alarm resting on edge, unchanged.
