First-tier Tribunal for Scotland (Housing and Property Chamber)

STATEMENT OF DECISION: Housing (Scotland) Act 2006 Section 24 (1)
Title No: LAN94337

13 George Mann Terrace, Blairbeth, Rutherglen, Glasgow G73 4NN ("The House")

13 George Mann Terrace
Blairbeth, Rutherglen, G73 4NN
FTS/HPC/RP17/0033
Inspection 16/05/17 at 10.00
Weather dry/overcast

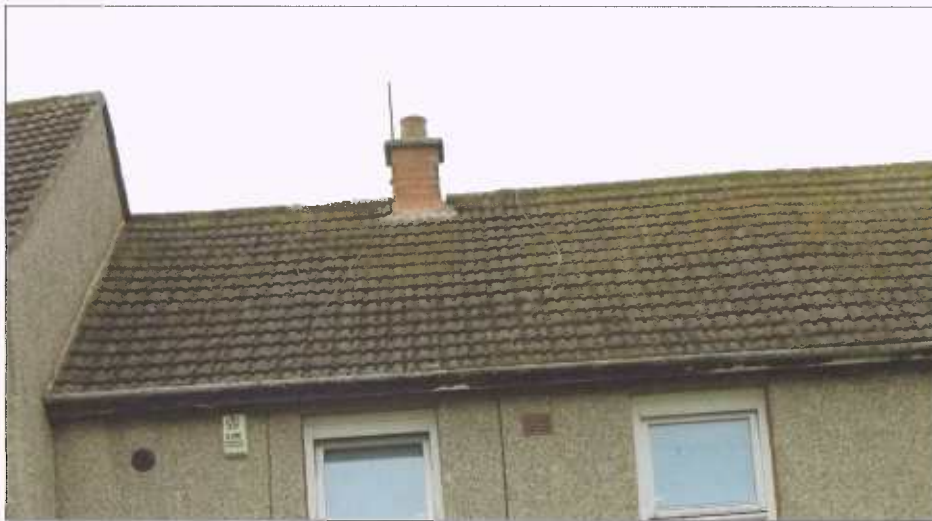
Front elevation

Externally the property has the original rosemary tiled roof with a brick chimney only serving the property. The roof has a covering of moss front and back, however there is no evidence of missing tiles or any replacements tiles at the front elevation.

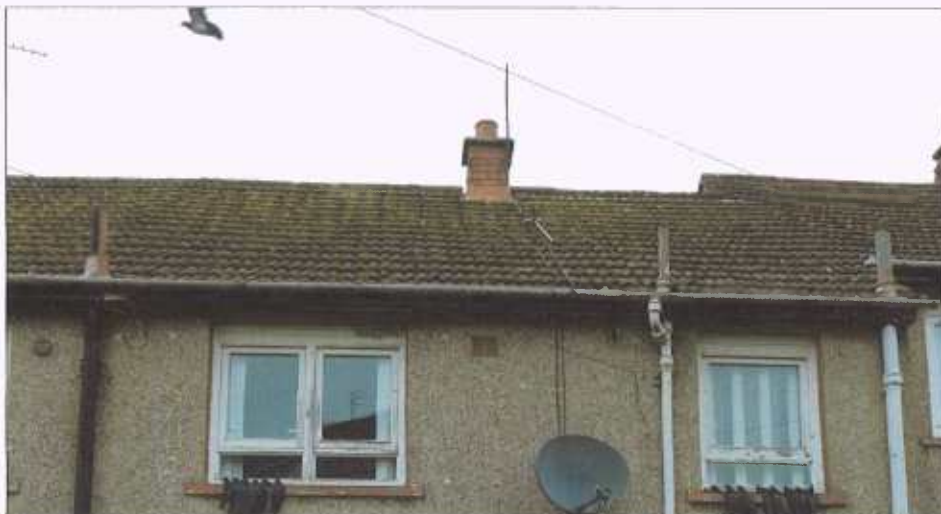
Rear elevation

- i) From an external visual inspection some work appeared to have been carried out to lead flashing around the chimney head of the roof. There were no tiles missing and a tile appeared to have been replaced at the top right hand corner of the rear elevation.

Lead flashing at chimney head appears to have had works carried out and a tile appears to have been replaced at the top righthand corner.

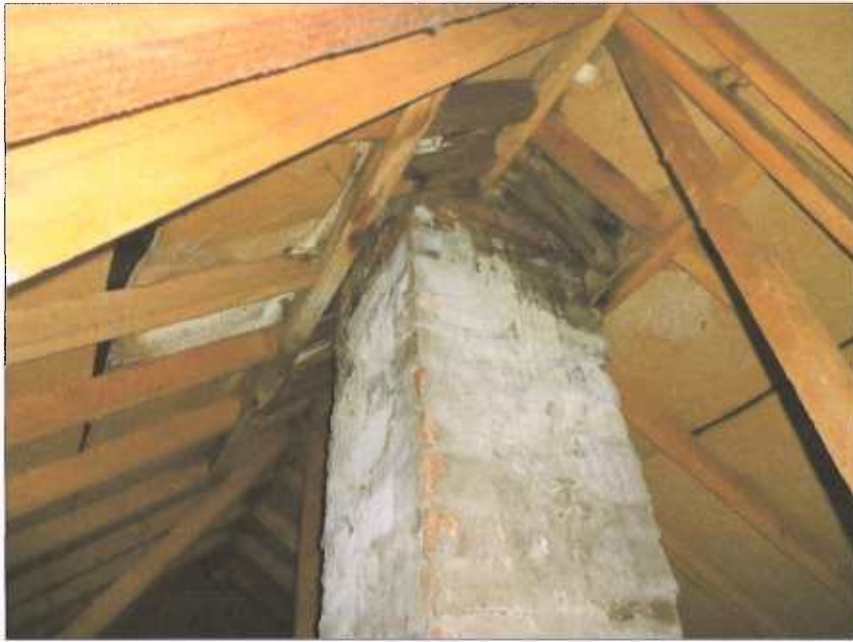
- ii) In the loft space, the timbers around the chimney head showed evidence of water ingress. However the readings on the damp meter were all within the amber range showing no current evidence of dampness. Historic water staining was noted on the roofing boards. A large wasps' nest at the back of the loft space had been treated but another two small nests were noted nearer the chimney. The Landlord's representative's attention was drawn to the nests and a recommendation to have these treated also.

The timbers around the chimney showed evidence of water ingress however the readings on the protimeter (damp metre) were all within the amber range.

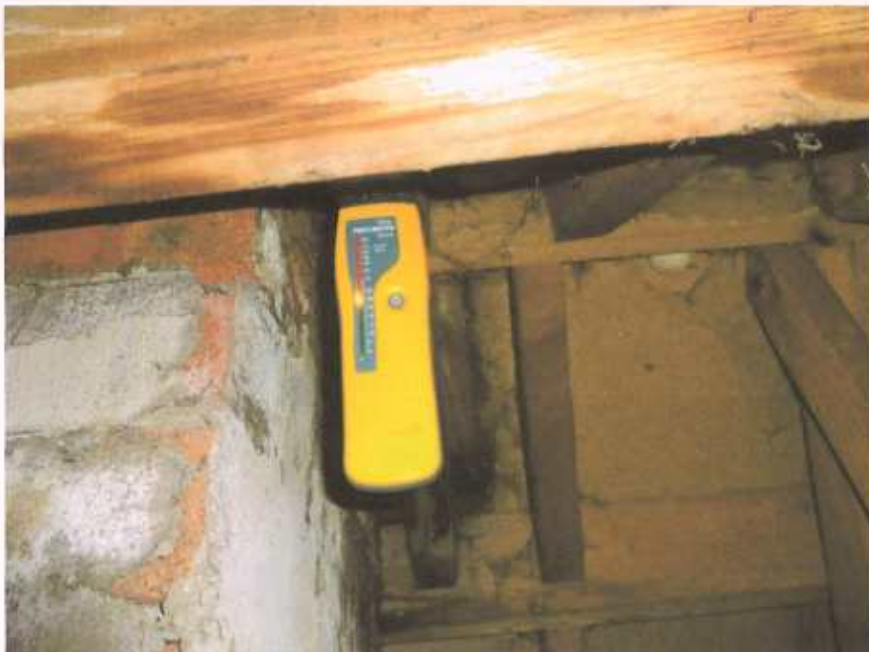
No evidence of recent dampness within loft space - historic water staining was noted.

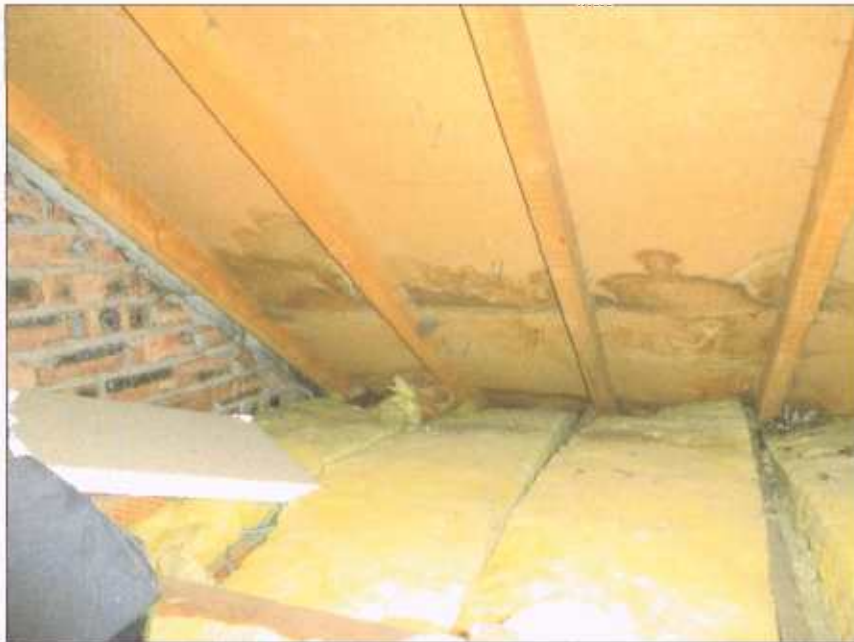
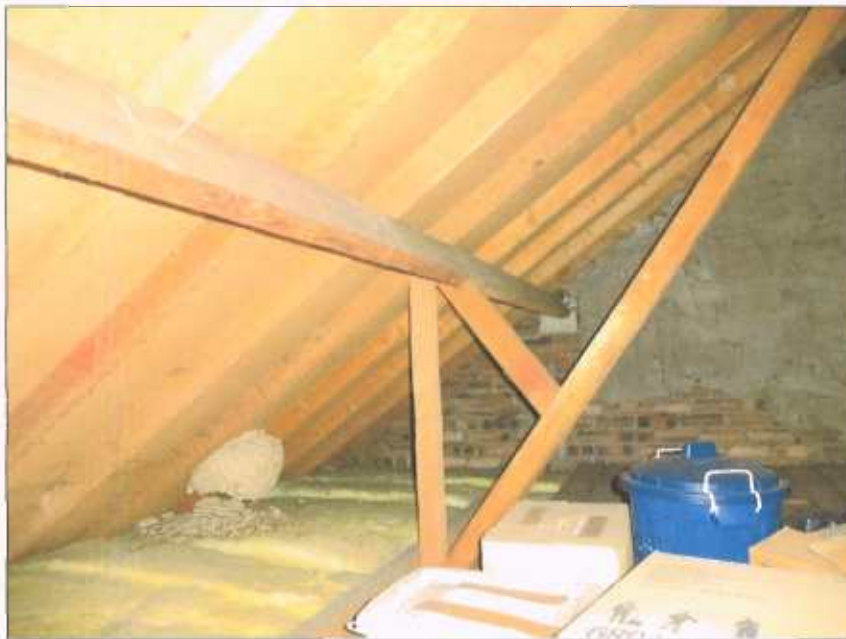
A large wasps nest was noted during the inspection, this appears to have been successfully treated. Two small wasp's nests were noted and highlighted during the inspection to the landlord's agent.

16. A large wasps' nest had been treated in the loft space. Two other small nests were observed and it is suggested that these are also treated.

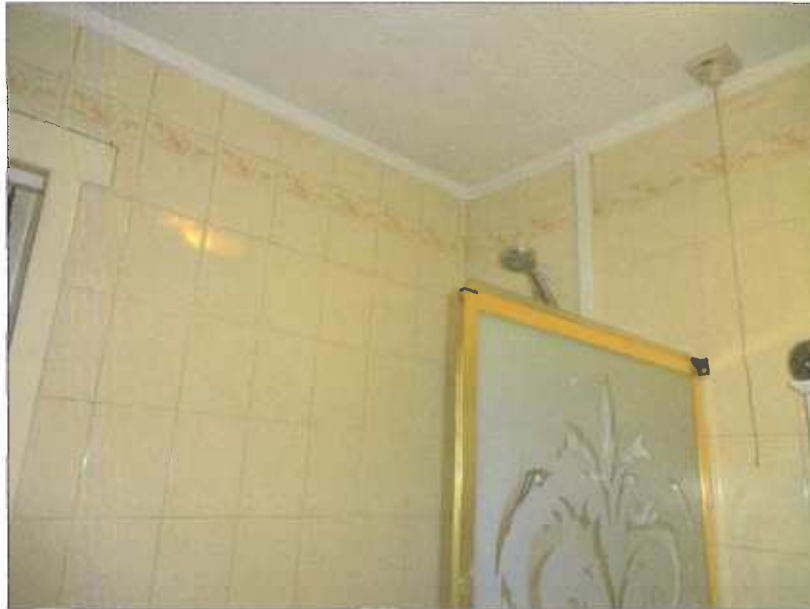
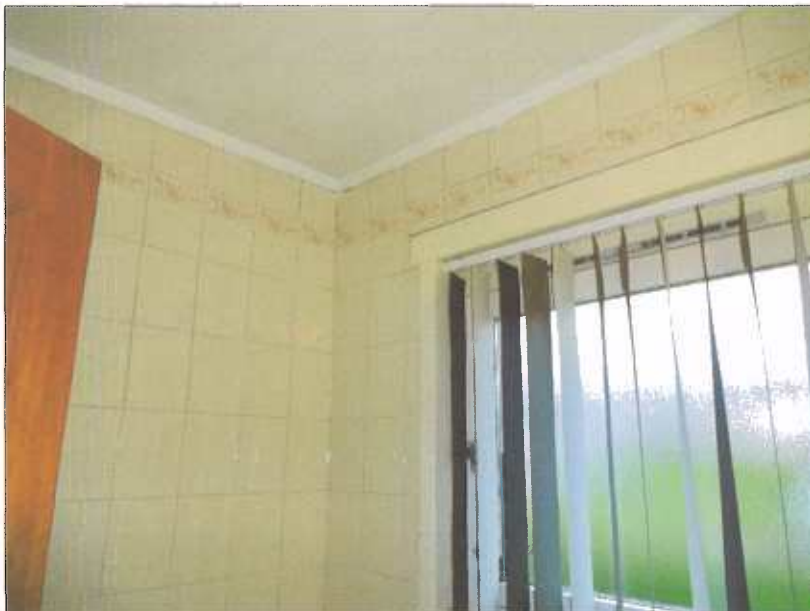
- iii) The bathroom had no evidence of damp or mould. The window was timber framed double glazing with trickle ventilation. Damp meter readings at the window and in the corner beside the bath were green showing there was no dampness present.

No evidence of mould noted, the window cill and timbers at the bath were tested with the protimeter and all were found to be within normal range and the ceiling was clear of mould.

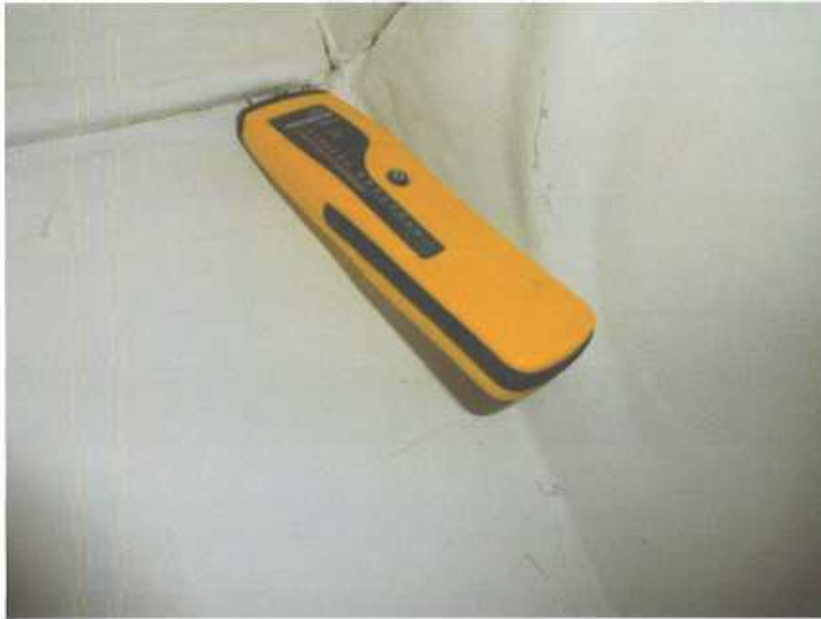
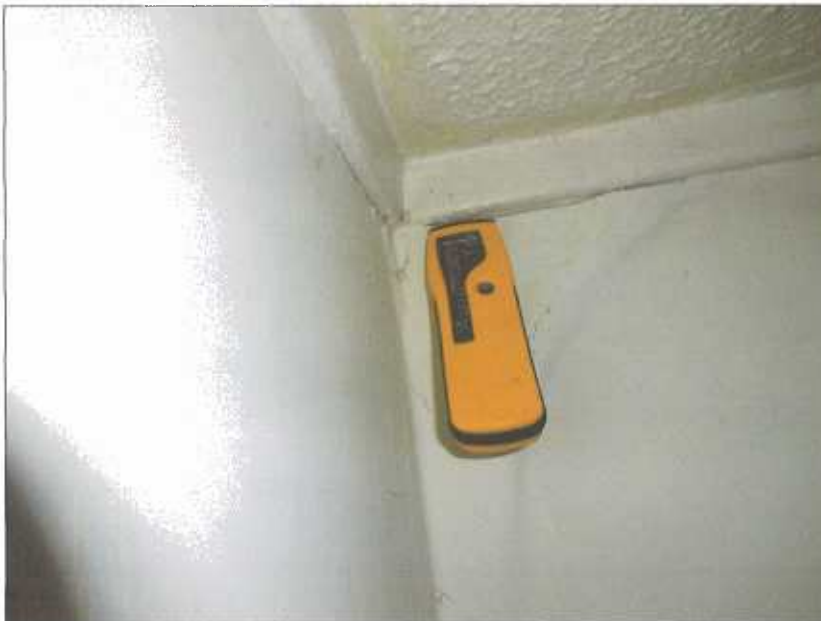
Back bedroom

- 4) Dampness in bedrooms and windows soaking. The front and back bedroom ceilings and window cills were tested for dampness. No evidence of dampness recorded. Window and window cills dry.

All readings are within the normal range no evidences of dampness or mould was recorded within the bedrooms. The gas fired combi boiler is housed in the bedroom cupboard and a battery-operated carbon monoxide monitor was fitted, this meets with the current repairing standards.

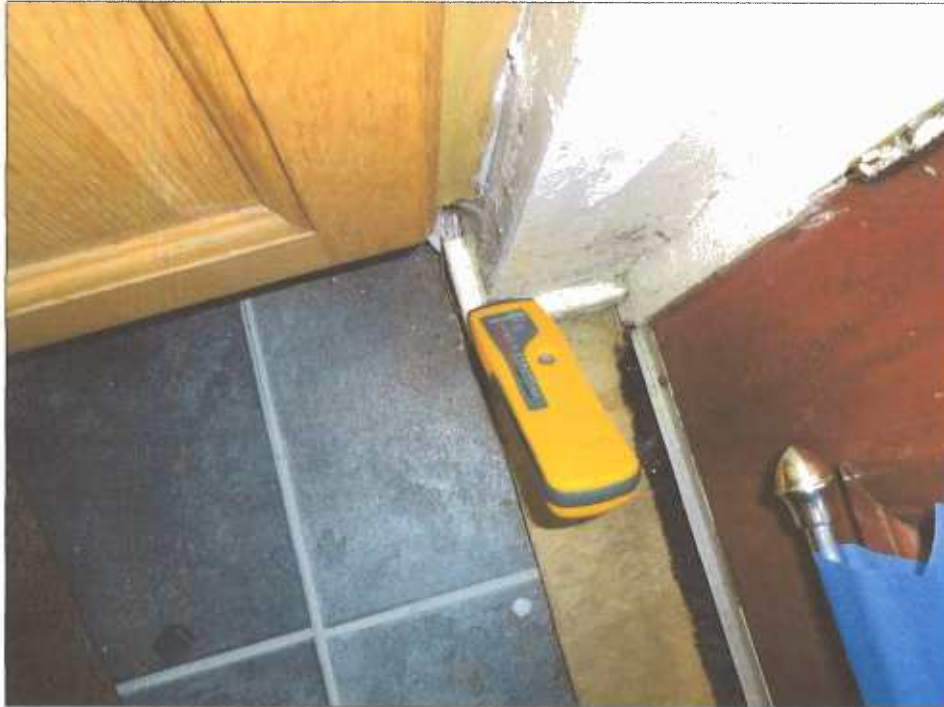
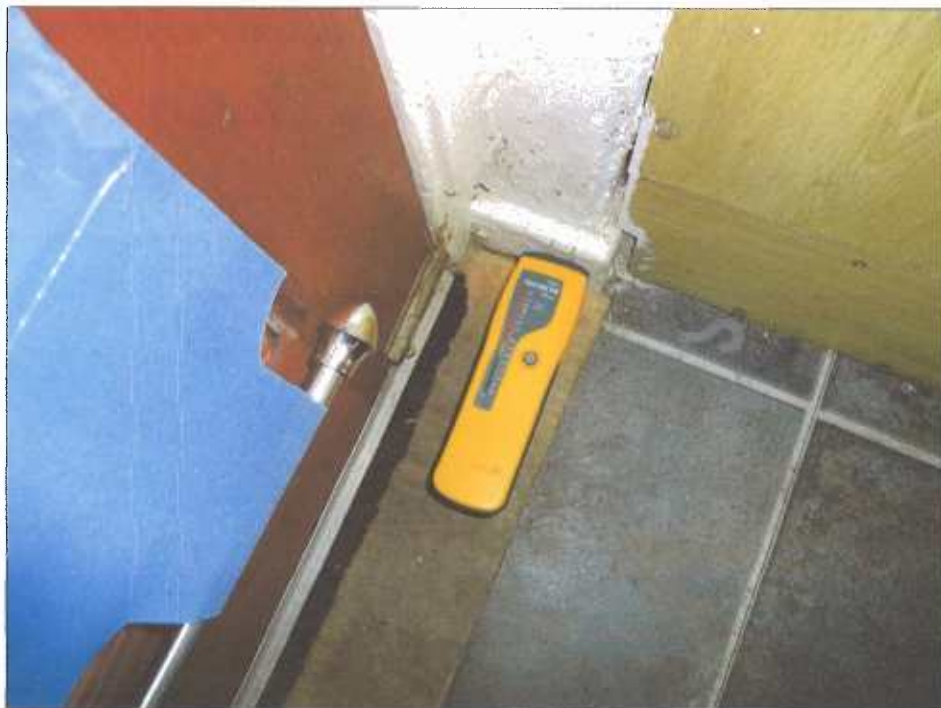
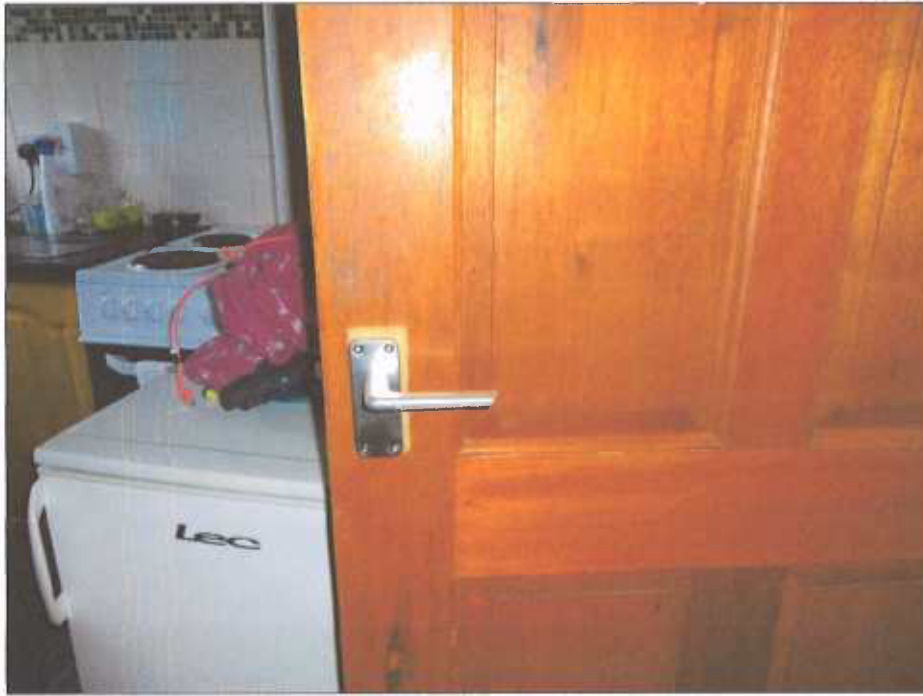
All cupboards checked no evidence of dampness was found. The walls were tested and all were within normal range. Moisture readings were also taken at the back door and all reading are within the normal range.

The kitchen door handle has been replaced and works accordingly.
