### **Statement of Decision**

**1 Middlefield Cottage, Hawklaw, Cupar, Fife, KU15 4PL  
("The Property")**

### Re-inspection report

**Property:** 1 Middlefield Cottage, Hawkhill, Cupar KY15 4PL

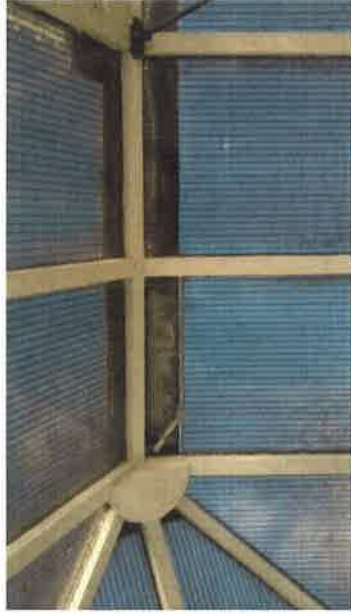
As at 13/03/17 – double pitched roof showing slipped glazing panels exposing the flashing and open to water and wind penetration

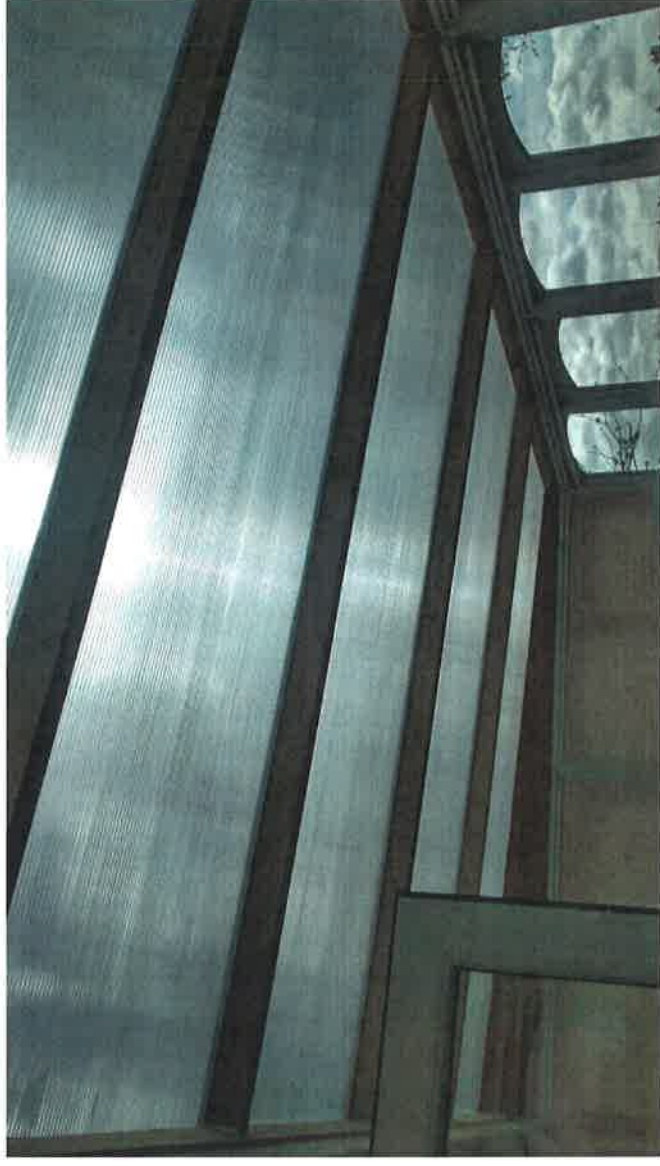
- The double-pitched conservatory roof has been replaced with a single pitched roof which appears to be wind and watertight (see photos pg 1)
- The conservatory door appears to be reasonably well-fitted (see photo pg 4)
- As at the reinspection of 13/03/17, all smoke alarms are appropriately located (see photos pg 2). However, it should be noted that the appliance in the rear lobby is an old model and may need replacement.
- There are heat alarms in both the kitchen and sitting room. However, on testing they still did not appear to be interconnected with the smoke alarm system (see photos pg 2)

As at 24/04/18 – replaced by single pitched roof – now wind and watertight

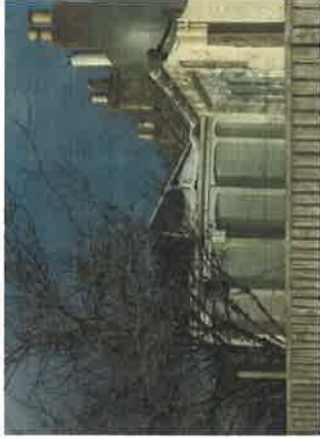
As at 13/01/17 – side elevation showing double pitched conservatory roof

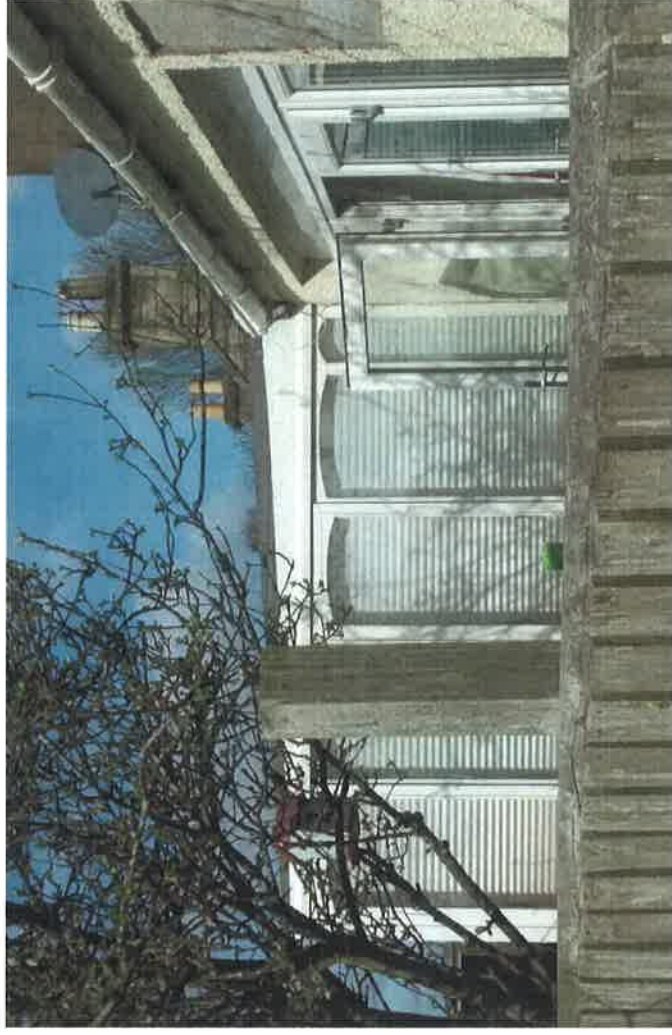
As at 24/04/18 – side elevation showing new single pitched roof

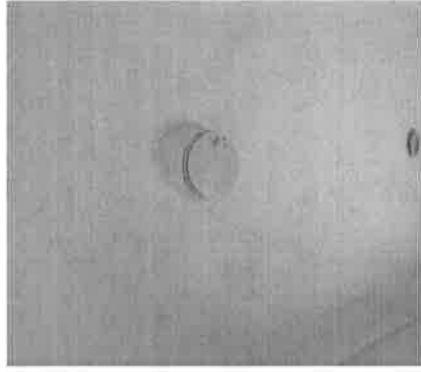
Front lobby – new fitting (note damaged light fitting)

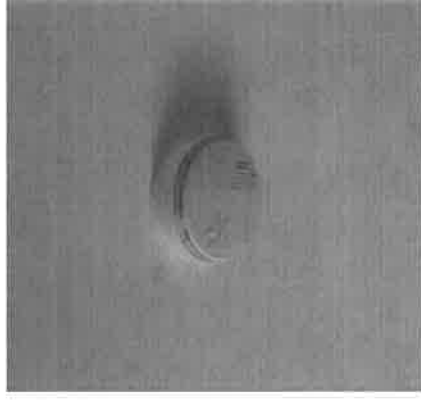
Bedroom at end of front lobby – new fitting

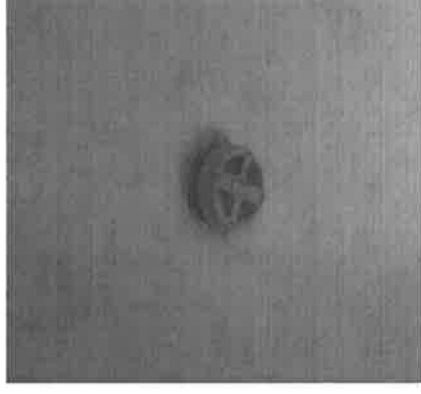
Rear lobby – old fitting that may need replacing

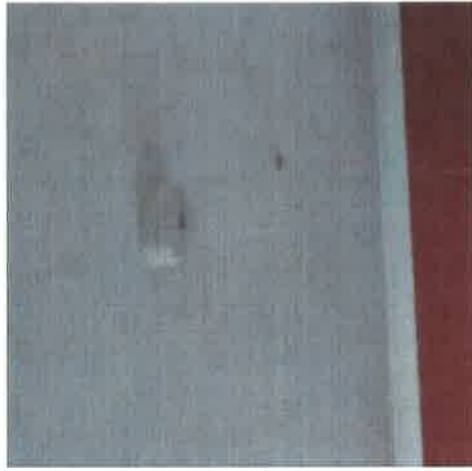
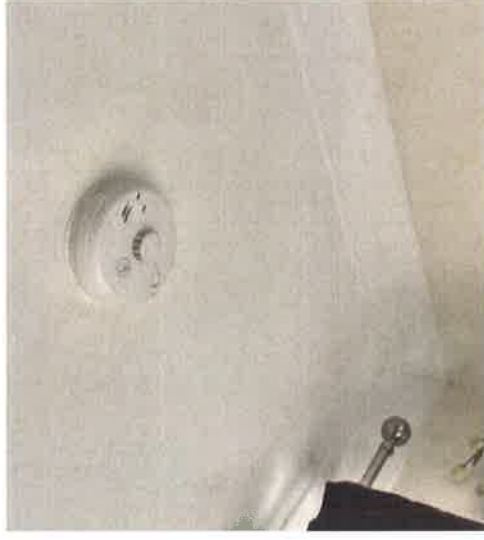
Sitting room – heat detector

Kitchen – heat detector

Heat and smoke detectors do not appear to be interconnected

- The floor tiles in the conservatory still need to be repaired (see photo pg 3)
- A qualified electrician should be asked to test the fire alarm system and provide a written report showing that smoke and heat alarms are interconnected, meet the current standard and are in working order.

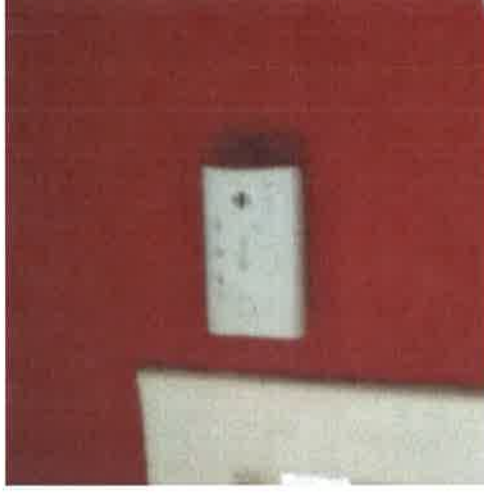
Sitting room – CO alarm

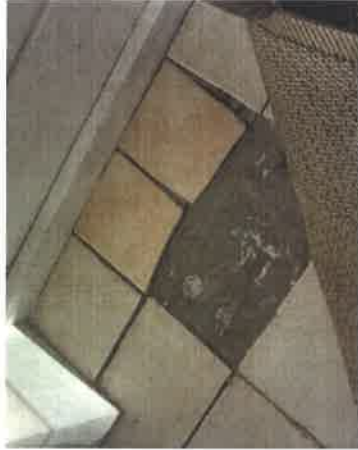
As at 13/03/17

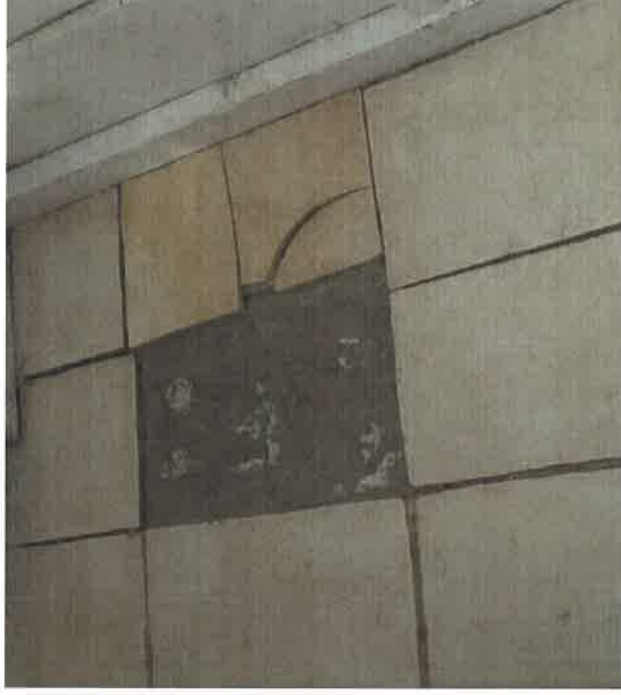
As at 24/04/18 – further cracking to tiles

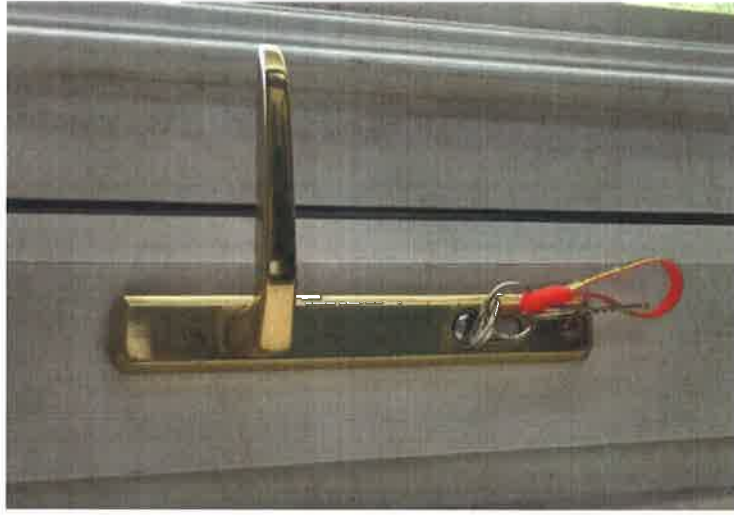
Rear door with functioning  
key
