First-tier Tribunal for Scotland (Housing and Property Chamber)

STATEMENT OF DECISION: section 24(1) Housing (Scotland) Act 2006 ('the Act')

Chamber Ref: FTS/HPC/RP/17/0053

Property: First floor left flat, 125 High Street, Fort William, PH33 6DG ('the House')

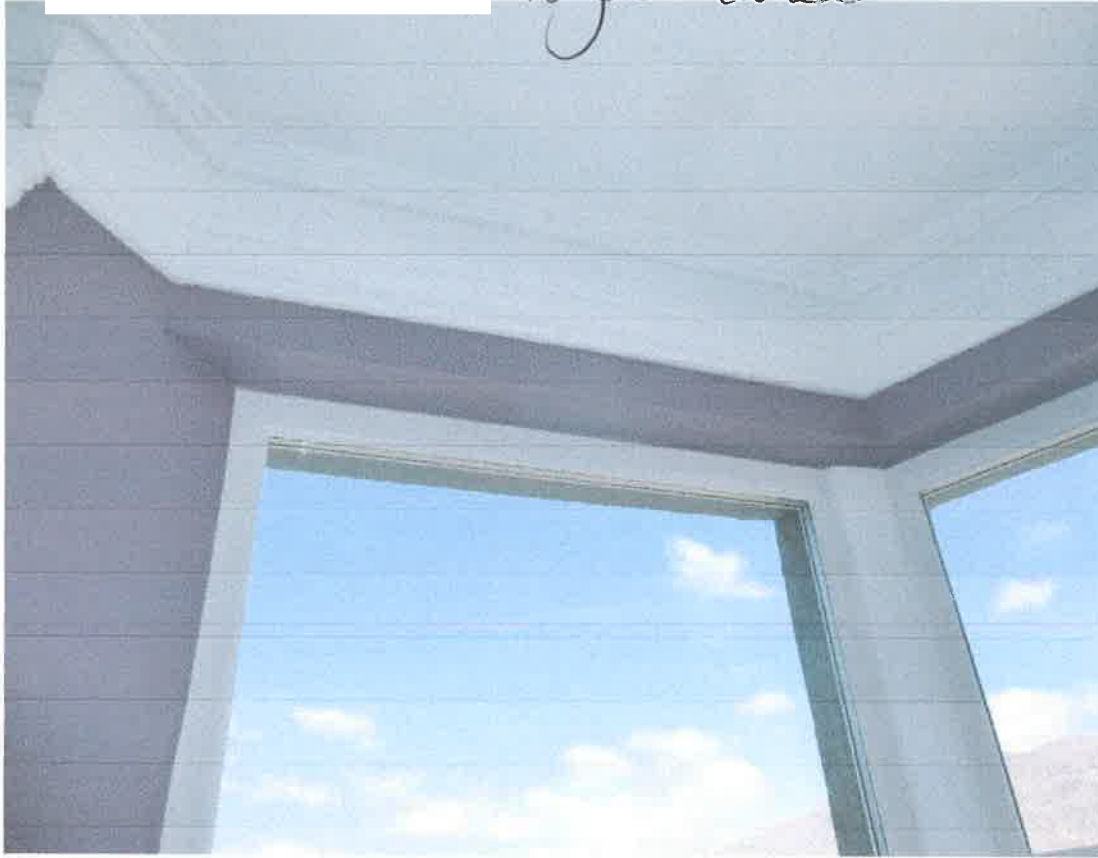
The living room has a bay formed of four adjoining windows. The windows have recently been replaced, consequently, there was no longer a problem with a broken window handle. The Tenant said that the windows did not now let in wind and there was no longer any black mould on the windows. However, the Tenant indicated smear stains on the left-most window, where there had been water ingress from the top of the new window on 3rd April 2017. The weather has been dry since that date so there has been no further ingress of water. The Tenant had reported matters to the local authority and there has been an inspection of the property. She did not have a report from the local authority.

The House is not watertight, given the recent ingress of water through the living room window. It was observed from the Landlords' representations that they have not disputed that there is a problem with water ingress and that they are currently in discussion with the other owners within the tenement building to try to find a solution. It was impossible to determine the cause of the water ingress, but the Tribunal noted that investigations are ongoing, including investigating the rhones and gutters. It was noted that the Landlords stated that the external wall had been painted with silicone paint and that the mastic had been replaced on the living room windows; however, water ingress had continued.

Lounge bay window – no evidence of current water ingress

2. Ensure that the leaking living room window is fully sealed to prevent water ingress;
3. Install a vent in the living room wall where the chimney stack was removed;
4. Repair or replace the storage heater in the second bedroom;
5. Install a heater within the bathroom.

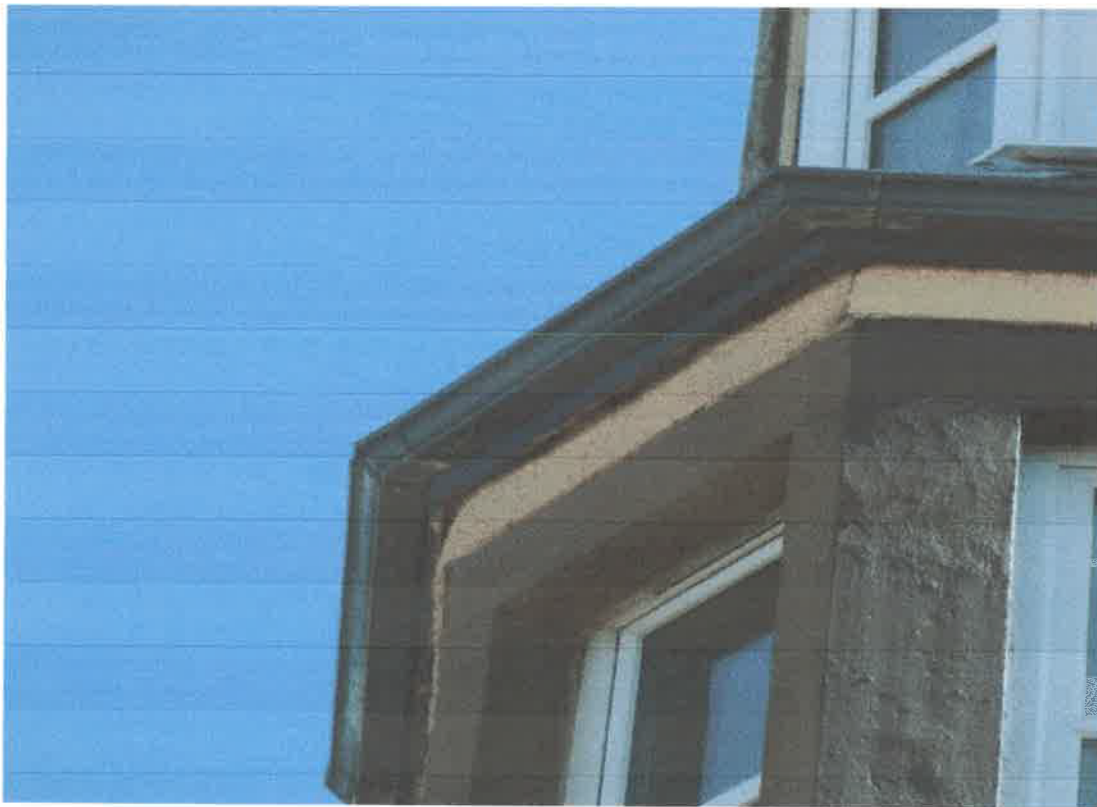
8.7 The Tribunal members inspected the building from the outside. The outer walls appeared to be in good condition. There were no areas of peeling paint and the fascia boards were not rotted. There was no green staining or water staining on the walls; however, the wall on which the windows are situated in the living room, showed signs of becoming increasingly dirtier closer to the ground. The gutters and downpipes appeared to be in good condition; however, the building is high and it was impossible to observe the gutters and downpipes closely.

Rainwater goods – one floor above flat. Some refurbishment required, but fascias good

1. Ensure that the rhones and gutters are in a reasonable state of repair and in proper working order, and are not contributing to the water ingress within the House. In the event that the rhones and gutters are contributing to the water ingress, repair or replace the rhones and gutters to ensure that they are in a reasonable state of repair and proper working order;

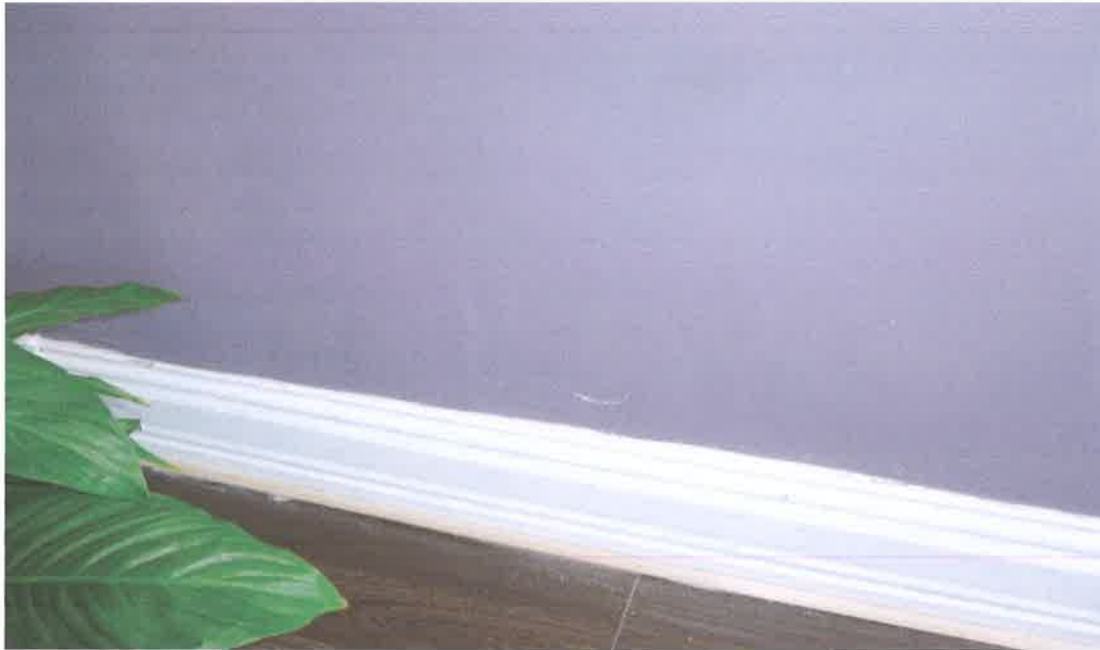
The House is not watertight or reasonably fit for human habitation given the existence of damp within the wall from which the chimney stack was removed, and the lack of ventilation in the wall.

Ex- position of wall vent to lounge wall. Previously chimney breast.

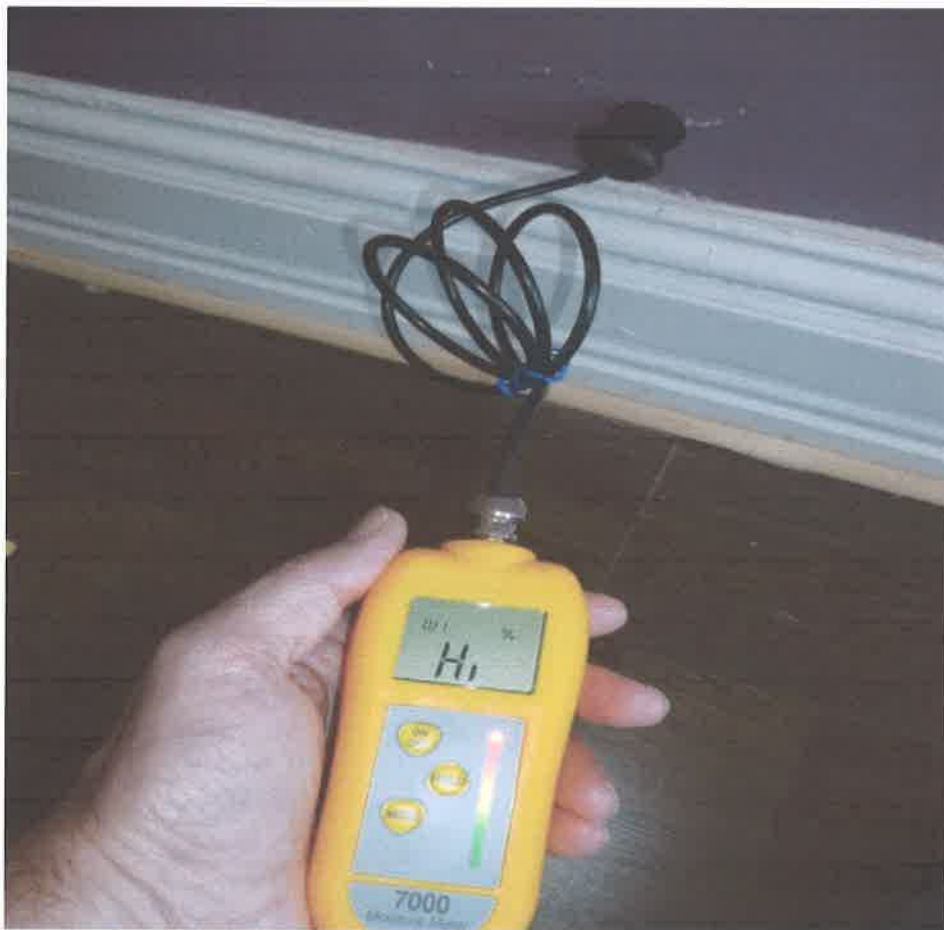
The Ordinary Member took moisture meter readings at various points on the wall. The meter readings from the area where the fireplace had been

sealed and the chimney stack removed indicated a significant level of moisture. This appeared to be due to removal of the chimney vent. Otherwise, the meter readings were normal within the living room.

High moisture reading to ex-vent position

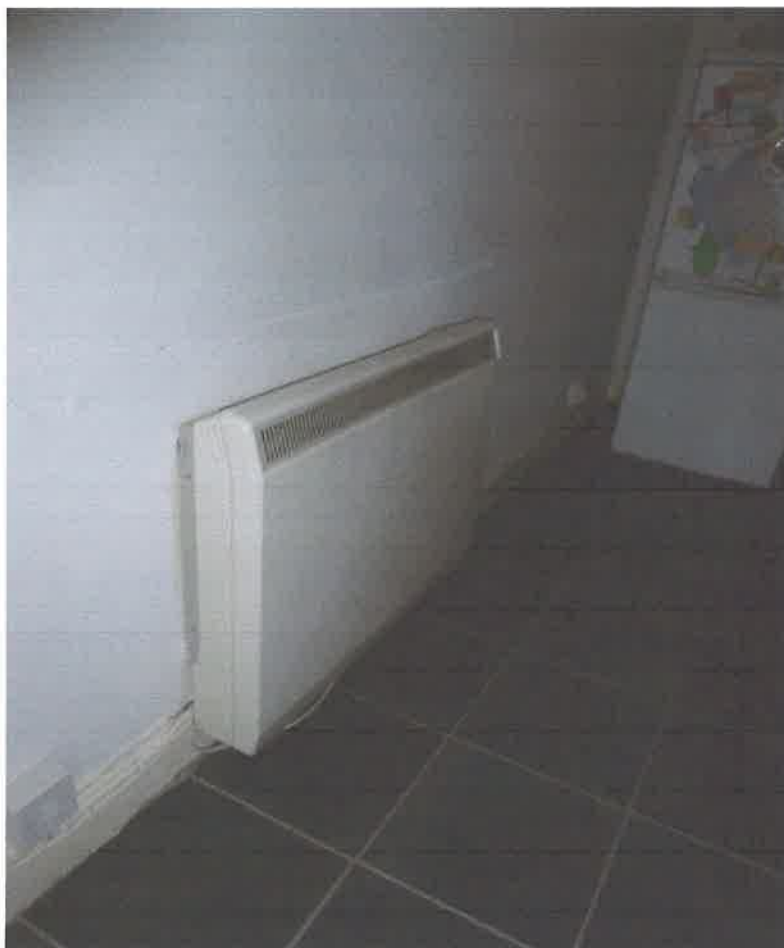
Storage heater to kitchen wall

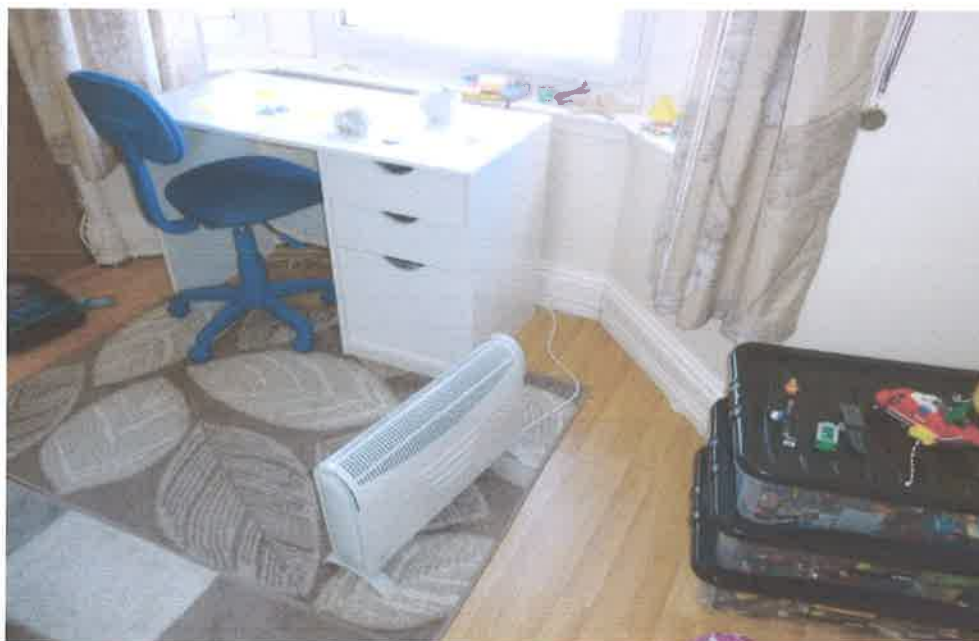
The storage heater in the second bedroom had been disconnected and removed from the wall. The Tenant said it did not work at the start of the tenancy, and this caused the bedroom to be cold. She was using a portable electric heater in the bedroom; the heater belonged to her.

The House is not reasonably fit for human habitation given that the second bedroom and the bathroom do not have heaters, and both rooms are cold.

Bedroom 2 – only form of heating is tenants plug in heater

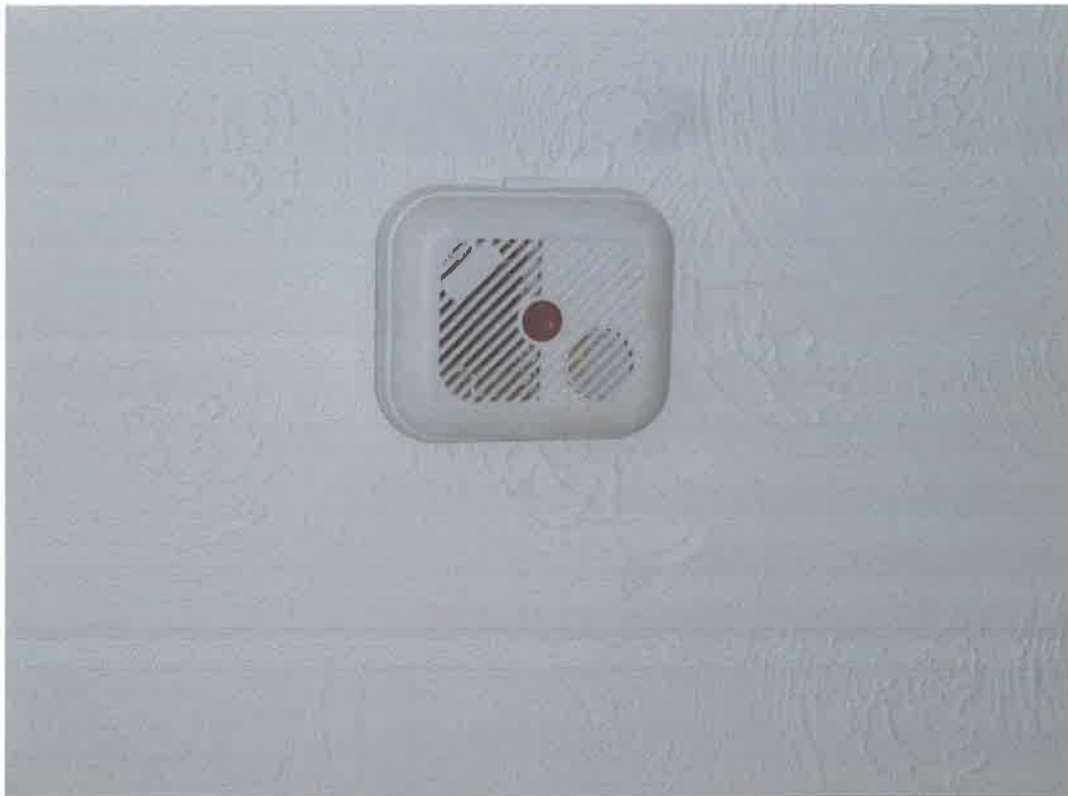
The Tribunal members observed that there were two smoke detectors in the House: one in the hallway and one in the living room. It was not clear if the smoke detectors were mains-wired or in working order. There was no heat detector in the kitchen. This issue had not been included in the application or intimated to the Landlords.

The Tribunal made a further observation that the House does not have satisfactory provision for detecting fires and for giving warning in the event of fire or suspected fire, in terms of s13(1)(f) of the Housing (Scotland) Act 2006. The Landlords are recommended to install a mains-wired heat alarm in the kitchen. In the event that the existing smoke detectors are not mains-wired and in working order, the Landlords are recommended to install interlinked mains-wired smoke detectors. The Landlords should ensure that the provision for detecting fires and for giving warning in the event of fire or suspected fire complies with the revised Domestic Technical Handbook and the Scottish Government's guidance on the requirements for smoke alarms.

Smoke detectors to hallway and lounge ceilings

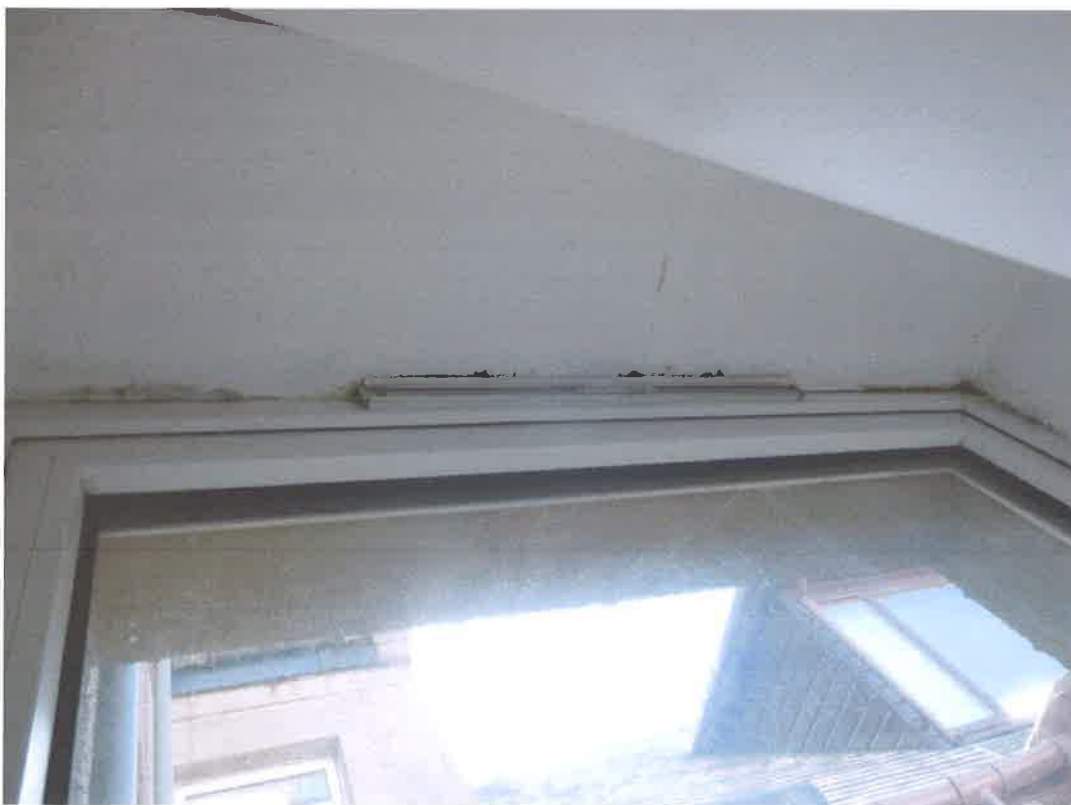
Moisture meter readings were taken throughout the House. There was a mildly elevated reading (within normal levels) from the right hand side of the window frame in the first bedroom. With the exception of the aforementioned area within the living room, the moisture meter readings throughout were within the normal range. The Tenant had placed small granule-filled moisture traps in both bedrooms. In the second bedroom, there was water within the trap. The Tenant said that she had been using the traps for approximately 6 weeks and had previously discarded a trap full of water from each bedroom. Although the windows throughout the flat had trickle vents, only one vent in the living room was open. The Ordinary Member showed the Tenant how to open the vents and suggested they were kept open to allow the flat to ventilate.

Trickle vents to windows – many closed. Some opened during visit.

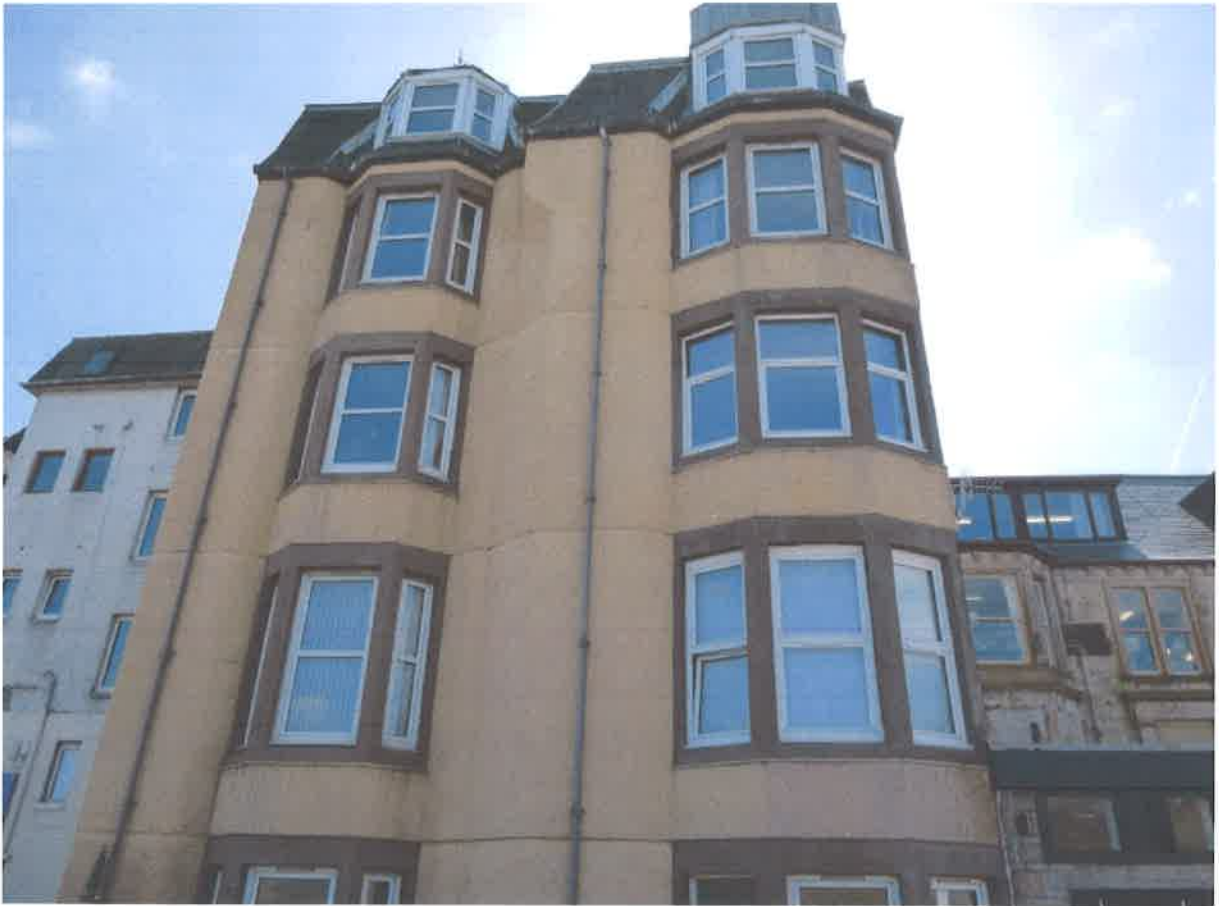
Front main elevation. Flat is 3rd level down.
