**Repairing Standard Enforcement Order (RSEO): Housing (Scotland) Act 2006
Section 24**

Chamber Ref: FTS/HPC/RP/18/0231

STATEMENT OF DECISION FOR REPAIRING STANDARD ENFORCEMENT ORDER ("RSEO") UNDER SECTION 24 HOUSING (SCOTLAND) ACT 2006 ("the Act").

Schedule of Photographs taken at the inspection on 28th March 2018

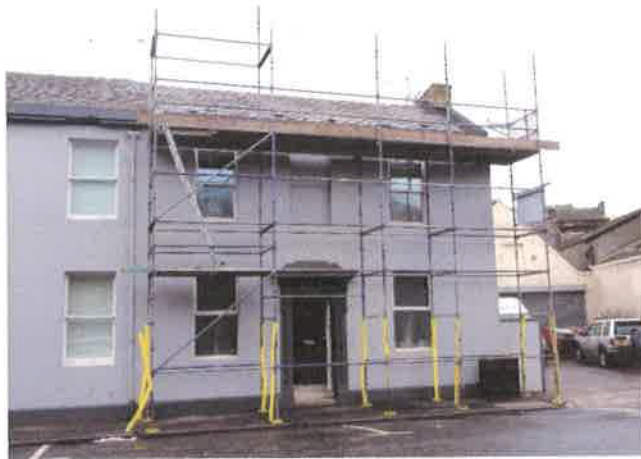
1:- Entrance & External View

10. At the time of inspection scaffolding had been erected on the pavement immediately in front of the building as part of ongoing repairs to the building. This restricted the tribunal's observations particularly in respect of the stonework and parapet style gutters on the front elevation. (Photograph 1)

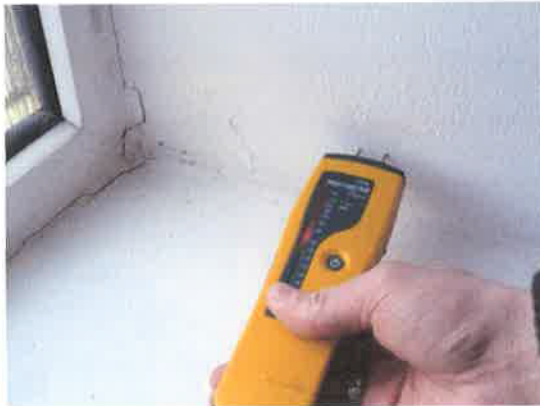
2:- Living room Window

The windows are of translucent double glazed design and there is evidence of condensation between the panes indicating a failure of the seals. Residual damp staining was evident at the timber sill of the south window although this was dry at the time of the inspection.

30. The defective double glazed units in the living room / lounge and the front bedroom should be repaired or renewed as necessary to ensure that they are in a reasonable state of repair and full working order.

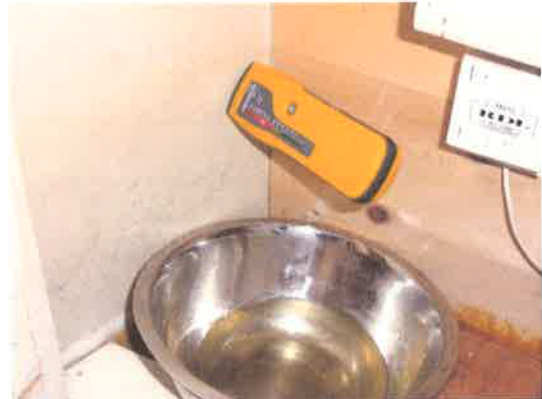
3:- Electrical Cupboard

The electrical consumer unit was not, at the time of the inspection, directly affected by damp although the relatively high moisture content affecting the wall lining in close proximity may be considered a potential health and safety issue. It would also appear that the levels of dampness in the wall and cupboard may vary intermittently, depending on weather conditions.

On the floor within the cupboard housing the electrical consumer unit there was a stainless steel bowl partially filled with water although the exact source of the water could not be identified.

29. In view of the 'trailing wire' issue identified in respect of the washing machine power supply and the potential for dampness and water penetration in the vicinity of the mains consumer unit, the landlord should instruct a SELECT or NICEIC electrician to carry out a full inspection of the electrical installation and apparatus throughout the Property and to repair or renew any parts which require to be renewed or repaired, to ensure the installation is fully functioning and meets current regulatory standards. A satisfactory Electrical Installation should be lodged with the offices of the Tribunal.

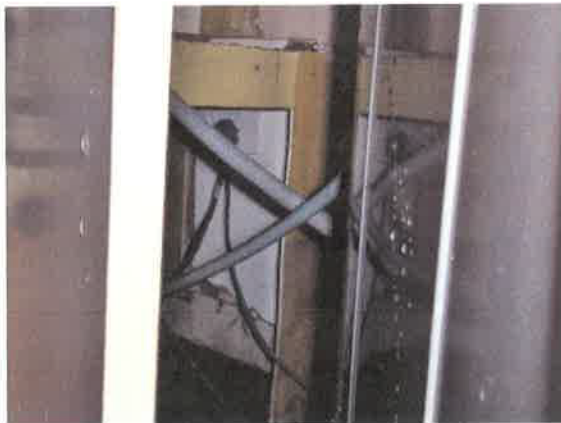
4:- Washing machine electrical connection

power point is lying loose and not encased in any form of conduit (Photograph 4) resulting in a 'trailing wire' power source.

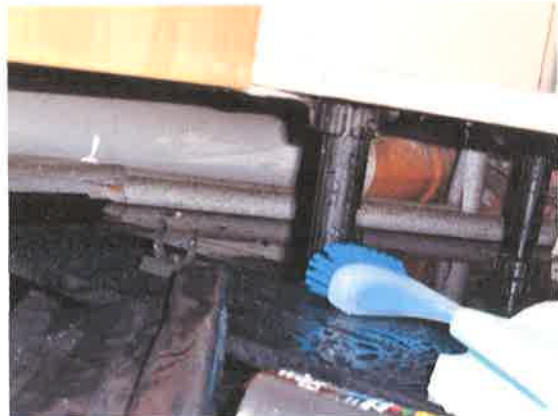
5:-Waste disposal pipe

Prior to the inspection the tenant had removed the kick boards below the kitchen units which are situated between the mutual wall with the ground floor cloakroom / wc and the rear external wall. Located below the units is what appears to be a waste disposal pipe leading from the wc to an external foul sewer. Access to the pipe was very restricted due to the presence of the units although, from a limited inspection there was no evidence of a leak or nauseous smell from the waste pipe. (Photograph 5)

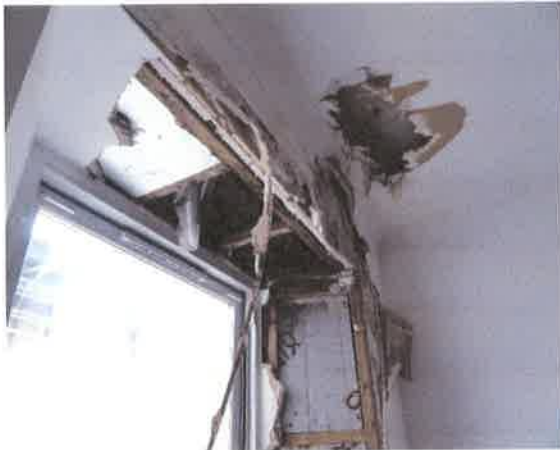
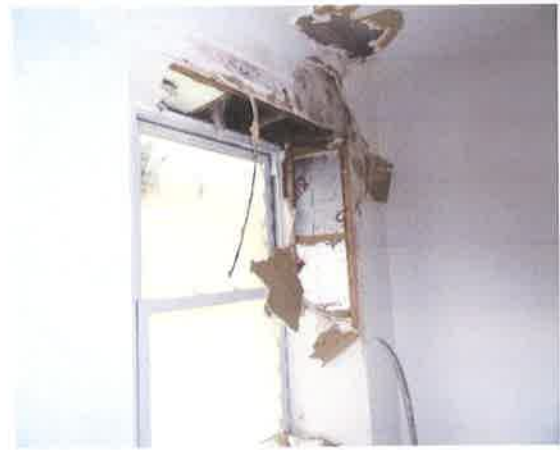
There are areas of missing ceiling and wall plaster specifically around the front window (Photograph 6 & 7). Adjacent to the window there is a hole in the plasterboard ceiling lining exposing a void between the original lathe and plaster ceiling and the more modern plasterboard replacement. Residual damp staining, dry at the time of inspection, was noted at the ceiling and surrounding area. A section of bitumen was lying on the floor. The tenant stated this had been part of a damp proof course (DPC) previously located above or around the window opening prior to the plaster collapse.

The window pane was covered in a "whitewash" restricting the observations of the tribunal, although evidence of condensation was noted between the double glazed panes suggesting that the "seal" was defective.

6 :- Bedroom Window

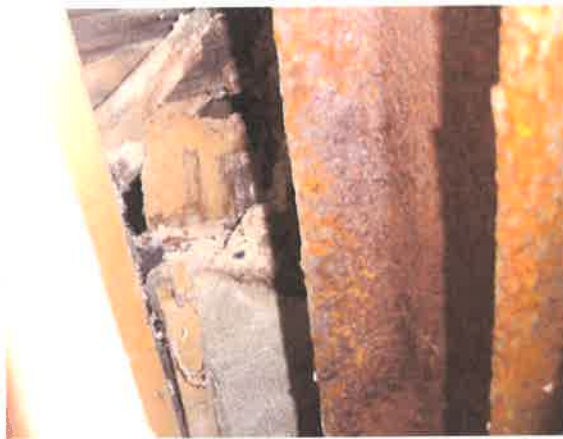
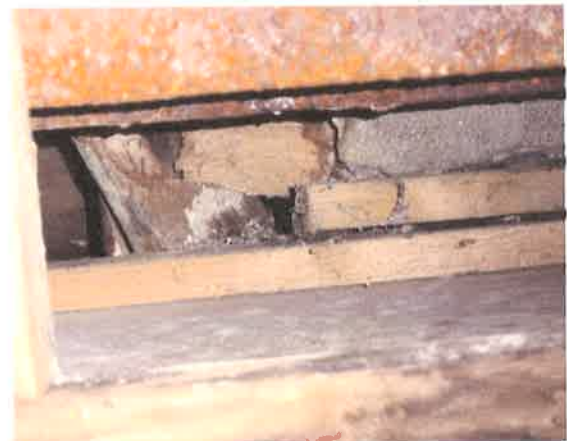
Following the collapse or removal of the plasterboard lining above the window, this has exposed a number of roof timbers which have been affected by decay, a badly corroded steel joist and some deterioration to the internal face of exposed stonework (Photograph 8 & 9). This coincides with the positioning of the external "parapet gutters" on the front elevation which appeared to be the subject of an ongoing repair by the landlord.

21. The tribunal was satisfied from its inspection that the area around the front bedroom window where the plaster and plasterboard were missing which gave sight of the rotted timber and corroded joists meant that the property was not wind and watertight and reasonably fit for human habitation. The tenant had temporarily moved his bedroom to the ground floor as a result.

Photographs 8 &9:- Corroded beam & rotted timbers above bedroom window

23. The tribunal considered that the report by J & E Shepherd dated 9 February 2018 addressed the majority of issues apart from the areas of rotten wood seen by the tribunal at the inspection and considers that a more detailed report, prepared by a suitably qualified timber and damp specialist contractor, should be obtained in order to identify the extent of the damp, decay and recommended remedial action. The tribunal did not consider that the corroded steel joist in that area was a matter of concern in relation to the repairing standard.

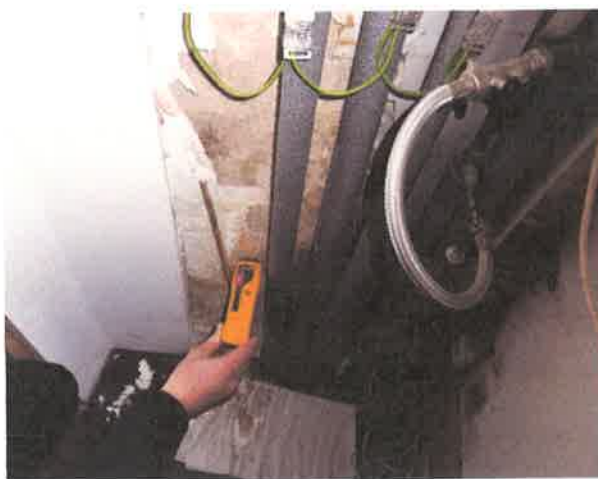
Moisture readings taken on the rear wall of the cupboard containing the gas fired boiler in the bathroom identified a moisture content of 40% and the readings were witnessed by the parties present during the inspection. (Photograph 10) Repairs are necessary to the surrounding wall plaster.

10:- Damp wall below boiler

24. The report should also address the other areas of damp and / or water ingress identified by the tribunal at the inspection in the living room / lounge and boiler cupboard, including the area on the rear wall surrounding the boiler flue, in order to identify the extent of all necessary remedial action. The landlord should address those repairs or renewals as recommended.

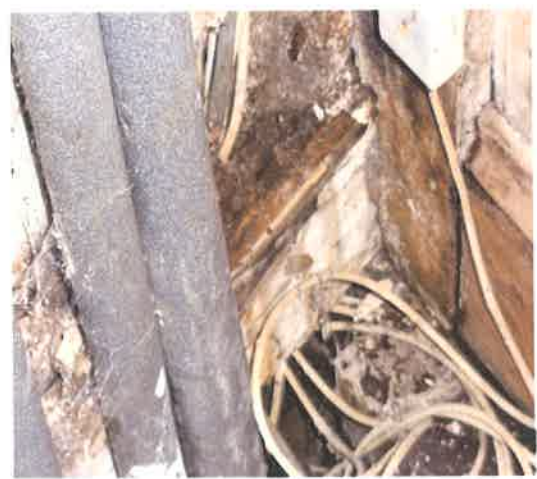
There is evidence of rot affecting the timber skirting board, adjacent to the boiler on the outer wall. (Photograph 11) Damp conditions are at a level which may cause future decay and further deterioration of the surrounding wall plaster and adjoining timbers if left untreated.

11:- Rotted skirting below boiler

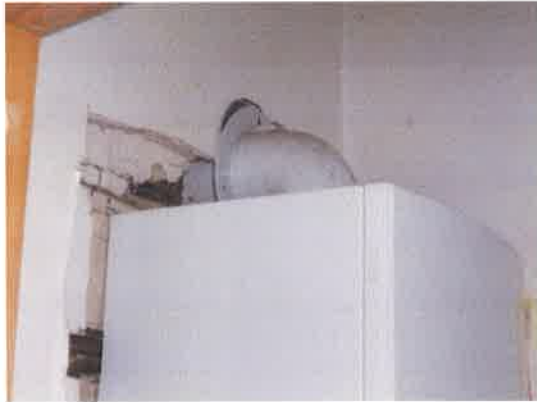
12:- Internal gap at boiler flue

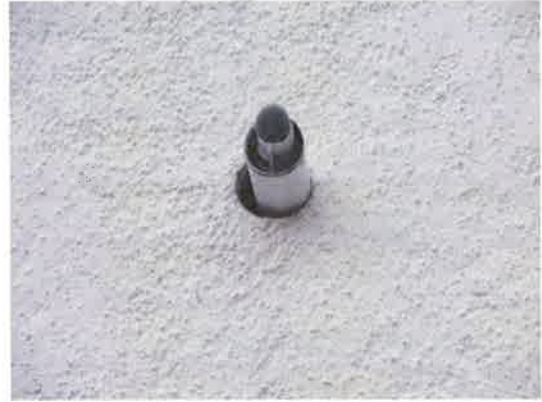
There is a visible gap between the surrounding masonry and the boiler flue projection on the rear elevation (Photograph 13) which may be a contributory factor in relation to the prevailing damp conditions affecting the plasterwork in the boiler cupboard.

13:- External gap at boiler flue

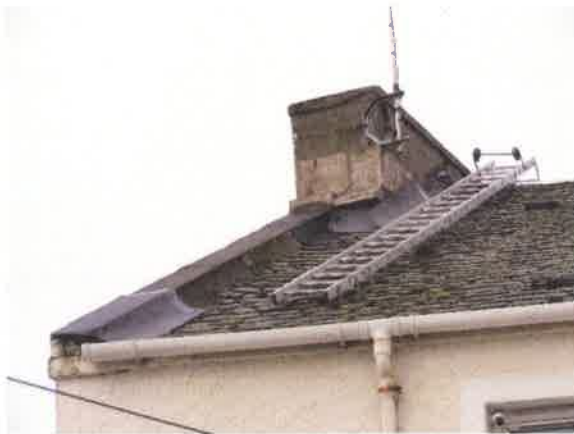
The skew stones (gable wall projection above roof level) most notably on the rear roof pitch, together with areas of the south chimney are in need of repair and re-felting to avoid water ingress (Photograph 14)

14:- Rear roof, south chimney & skew

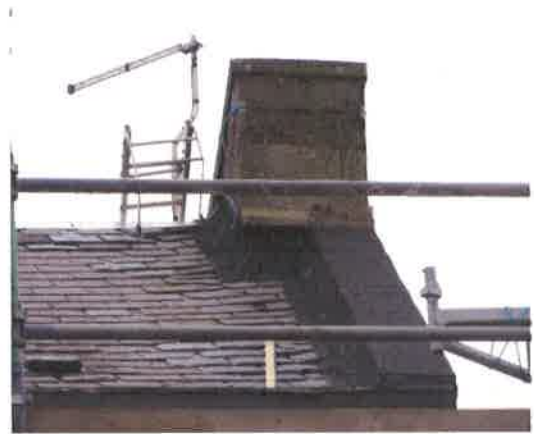
The area around the base of the gable (south) chimney and the projecting skew stone on the front roof pitch have been overlaid with felt as protection against water ingress. Several slates appear to have been renewed although a number of repairs to the roof covering and associated flashing remain outstanding. (Photograph 15 & 16)

15:- Front roof, south chimney & skew

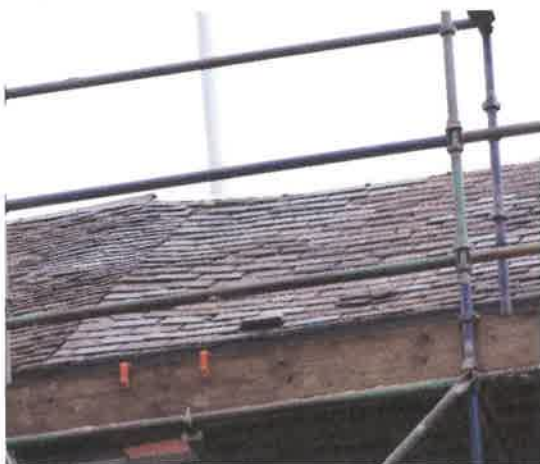
Roof slating appears old, possibly the original. Some recent repairs have been completed although there are a number of loose chipped and missing slates and further repairs are necessary.

16:- Missing roof slates

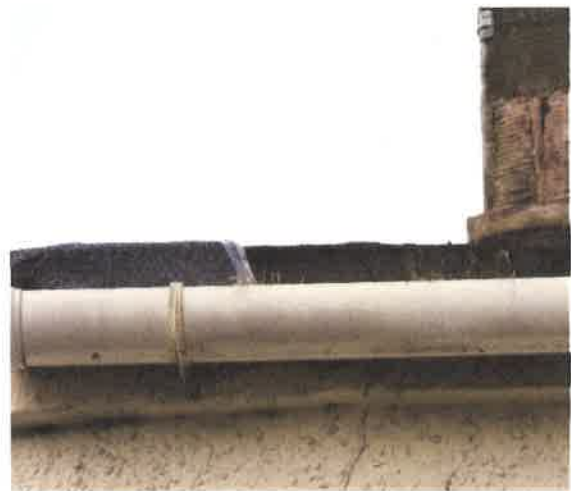
There is some vegetation affecting a localised area of the rear PVC gutter (Photograph 17) although no evidence of any significant staining affecting the surrounding rendering / masonry was noted. There is no guttering immediately below the curved / angled roof above the internal stair projection on the rear elevation (Photograph 18). At a height slightly above that of the remaining PVC rear eaves gutters, a low level diversionary structure predominantly of lead or some similar material, has been constructed to divert the majority of the rainwater, which would otherwise cascade over the stair projection, into the existing gutters. (Photograph 19) In buildings, particularly those of this age and construction, this is not an uncommon design.

17:- Remnants of vegetation in gutter

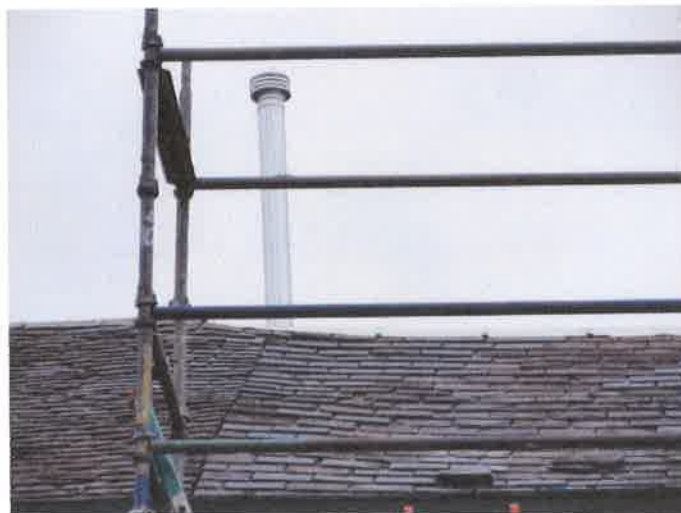
20:- Replacement mutual flue

The former mutual chimney-head which was previously shared with 44 Fort Street has been removed and replaced with a stainless steel flue projecting above roof level. This flue serves a gas appliance in the adjoining property. (Photograph 20)
