Statement of decision of the First-tier Tribunal for Scotland (Housing and Property Chamber) under Section 24 (1) of the Housing (Scotland) Act 2006.

Chamber Ref: FTS/HPC/RP/18/3495

28 Craigton Avenue, Milngavie, Glasgow, G62 7SX being the subjects registered in the Land Register of Scotland under Title Number DMB74837 ('The Property')

Schedule of Photographs taken during the
inspection by tribunal members on 28
February 2019

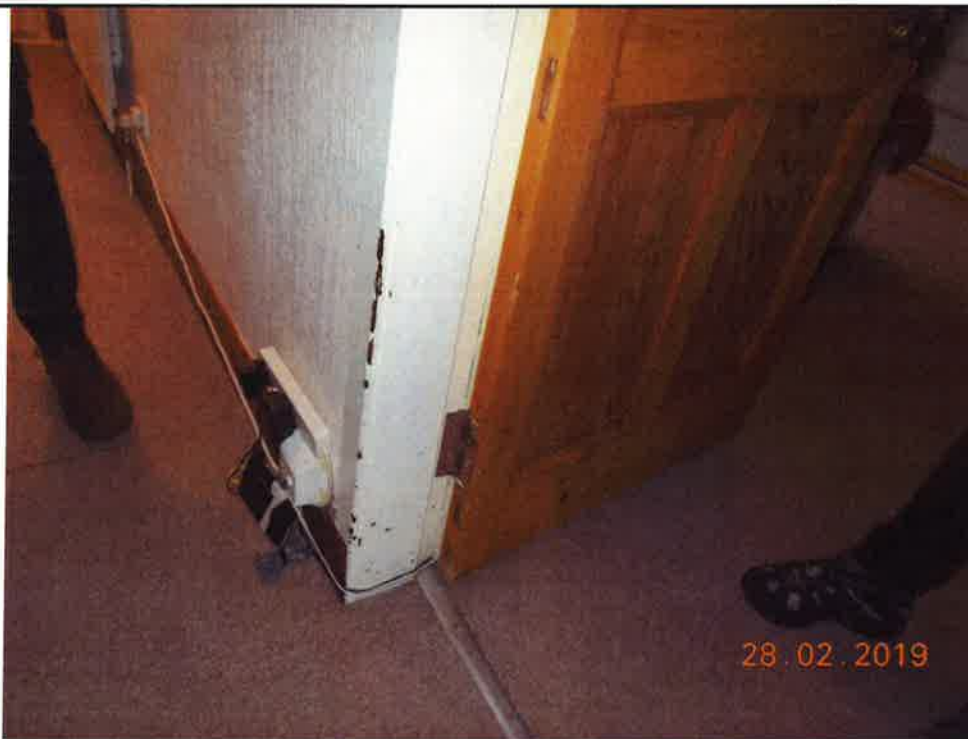
2. Decor damage to door surround in Hall (Typical)

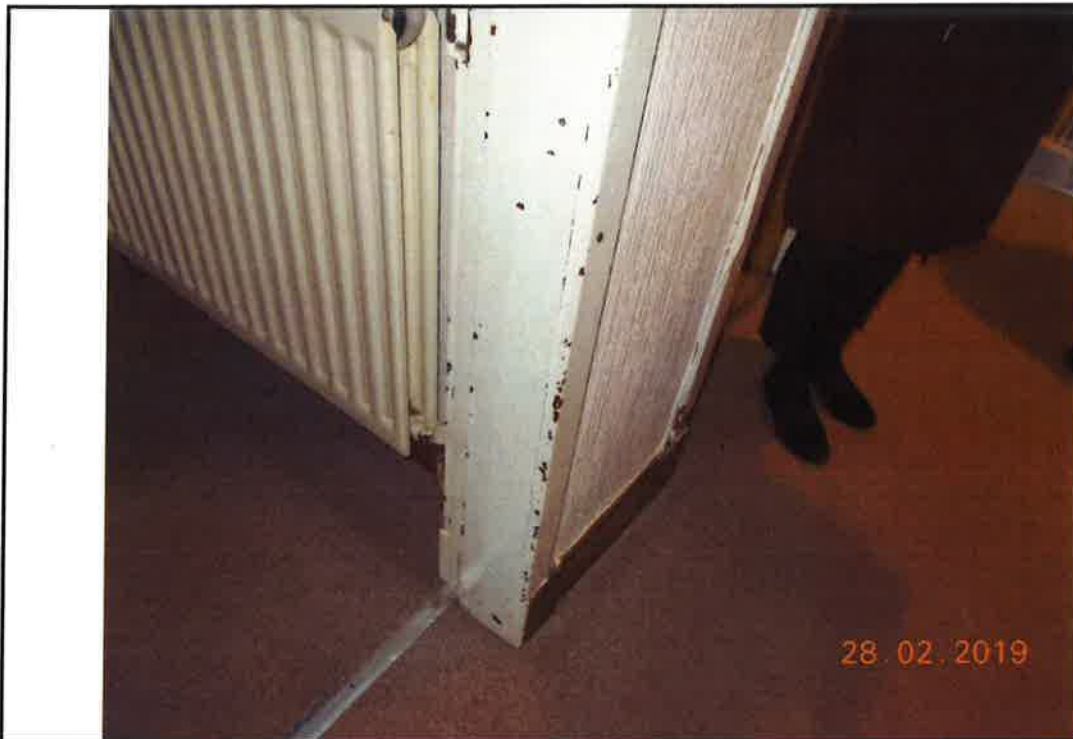
3. Decor damage to door surround in Hall (Typical)

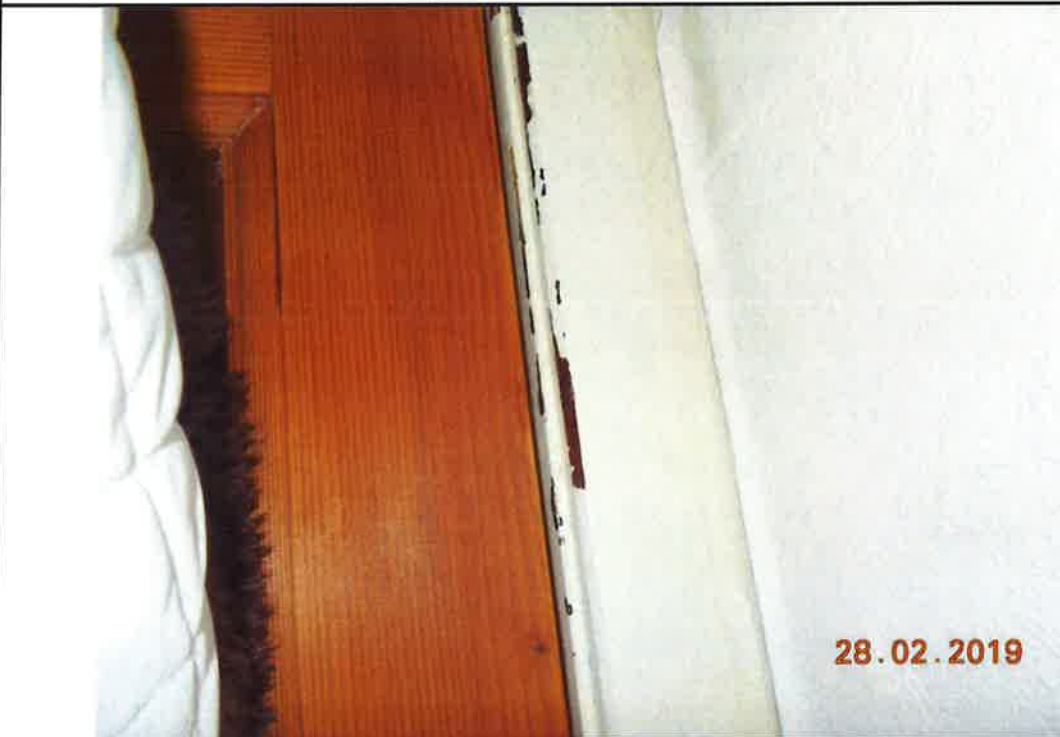
4. Decor damage to door surround in second Front Bedroom (right on entering)

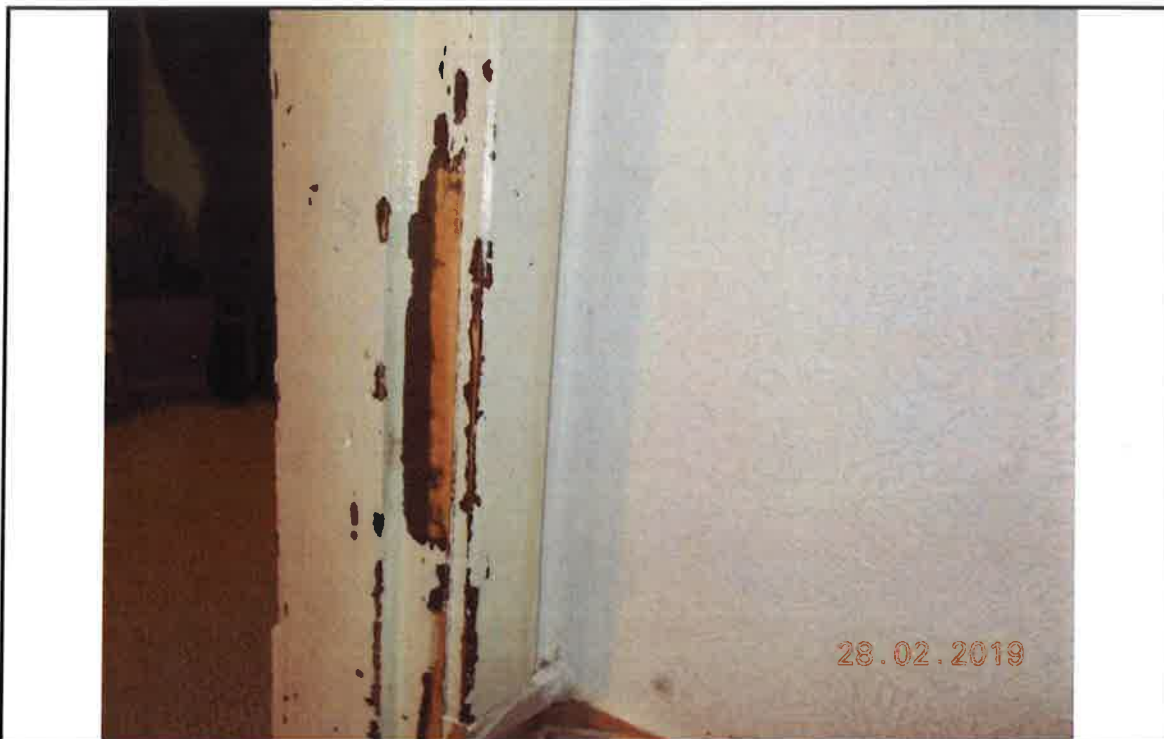
5. Decor damage to door surround in second Front Bedroom (right on entering)

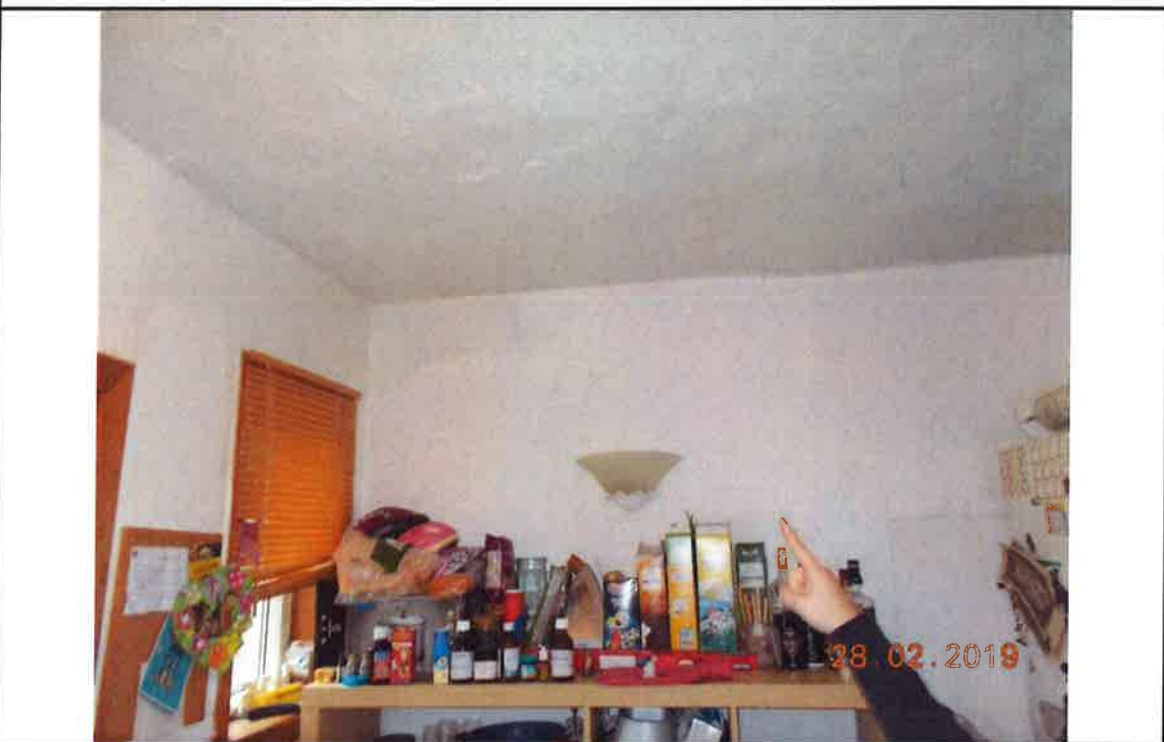
6. Patched decor in Kitchen

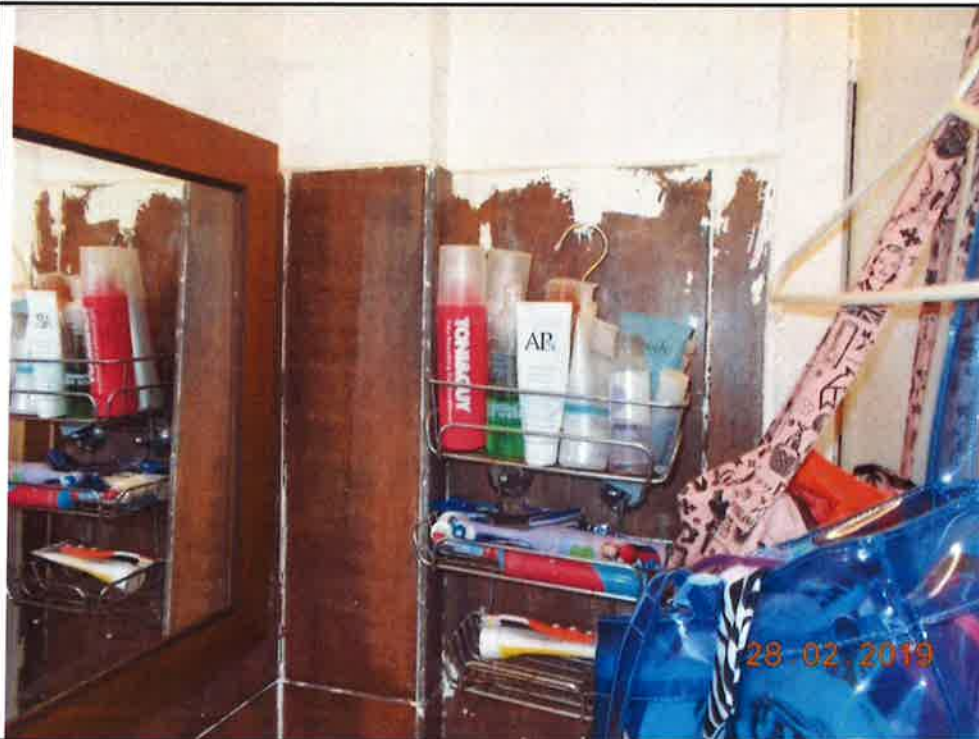
8. Stripped decor from tiles in Bathroom

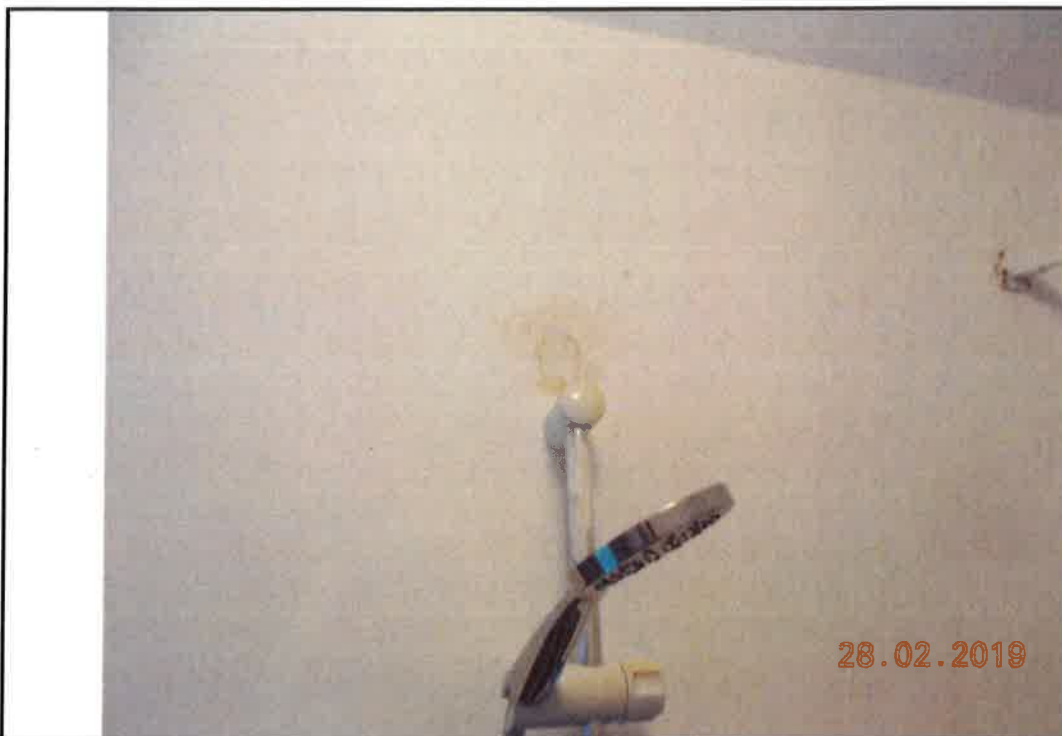
9. Patched plaster/decor at shower fixing in Bathroom

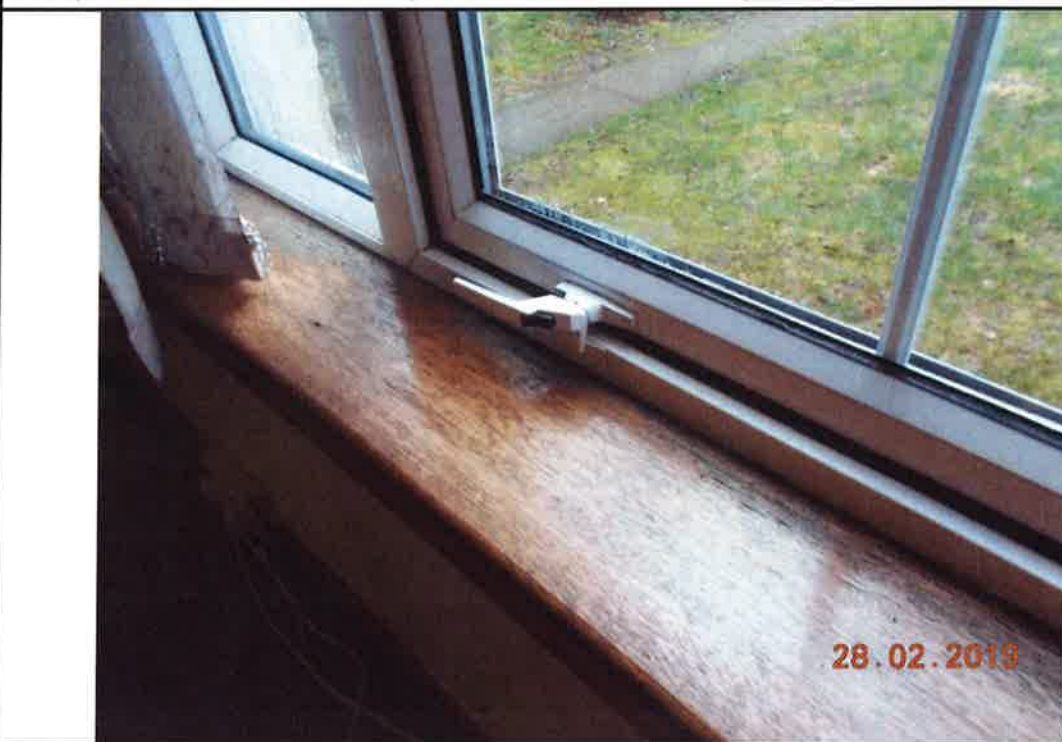
The main bedroom to the front of the Property: The window surrounds and sill was made of veneered wood which was discoloured in place and had been affected by moisture/ dampness and in consequence was stained.

10. Damp/mould at window in main Front Bedroom (left on entering)

1.2 To Main Bedroom; in external wall 100mm wall mounted passive ventilator PV100 or equal.

1.3 To areas affected by mould growth; apply 2 coats of sterilising solution and finish with 2 coats of anti-mould paint extending 500mm beyond affected area.

1.4 Strip and replace window surrounds affected by mould growth.

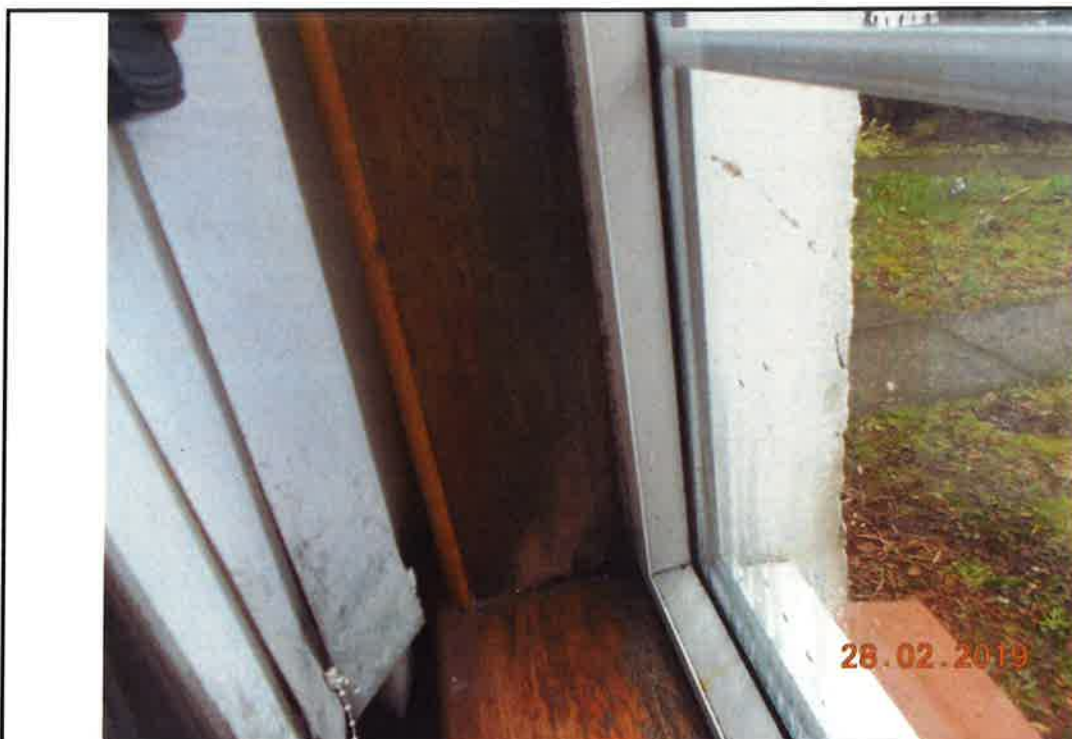
11. Damp/mould at window in main Front Bedroom (left on entering)

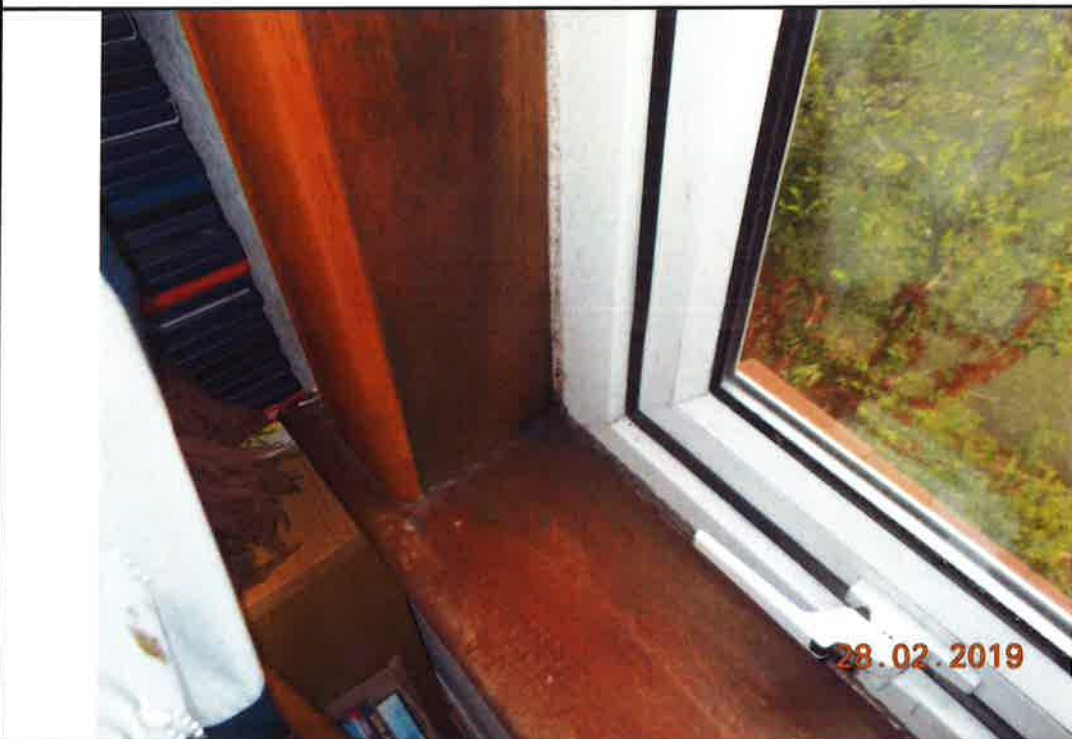
12. Damp/mould at window in other Front Bedroom (right on entering)

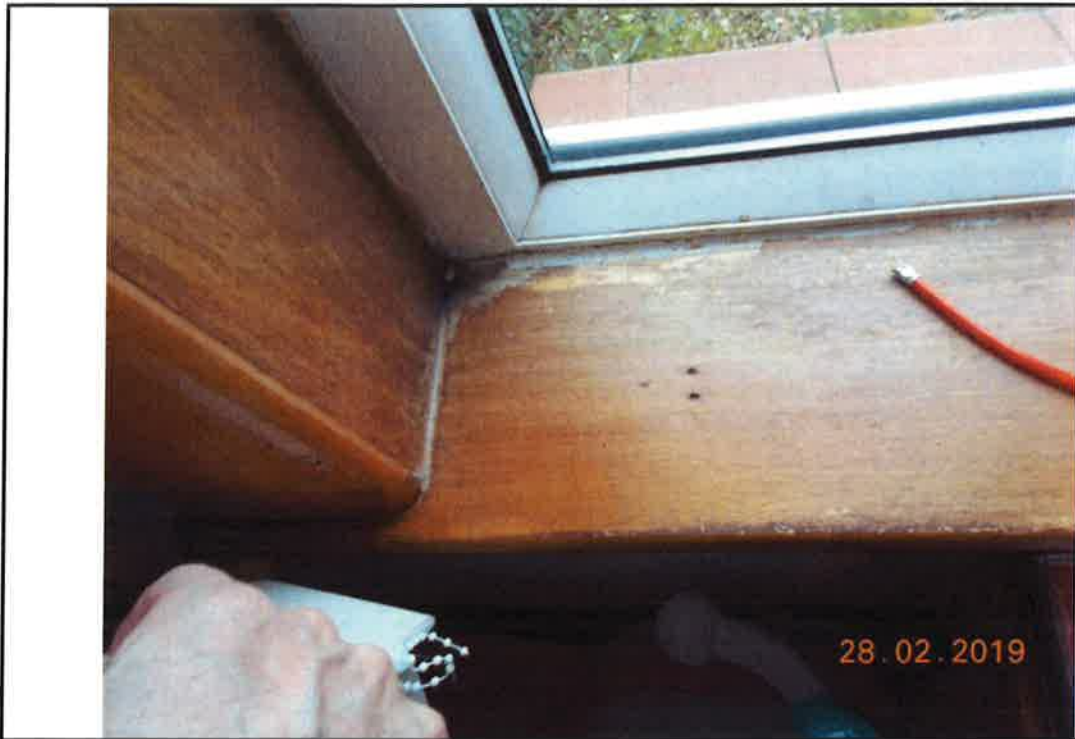
13. Damp/mould at window in Living Room

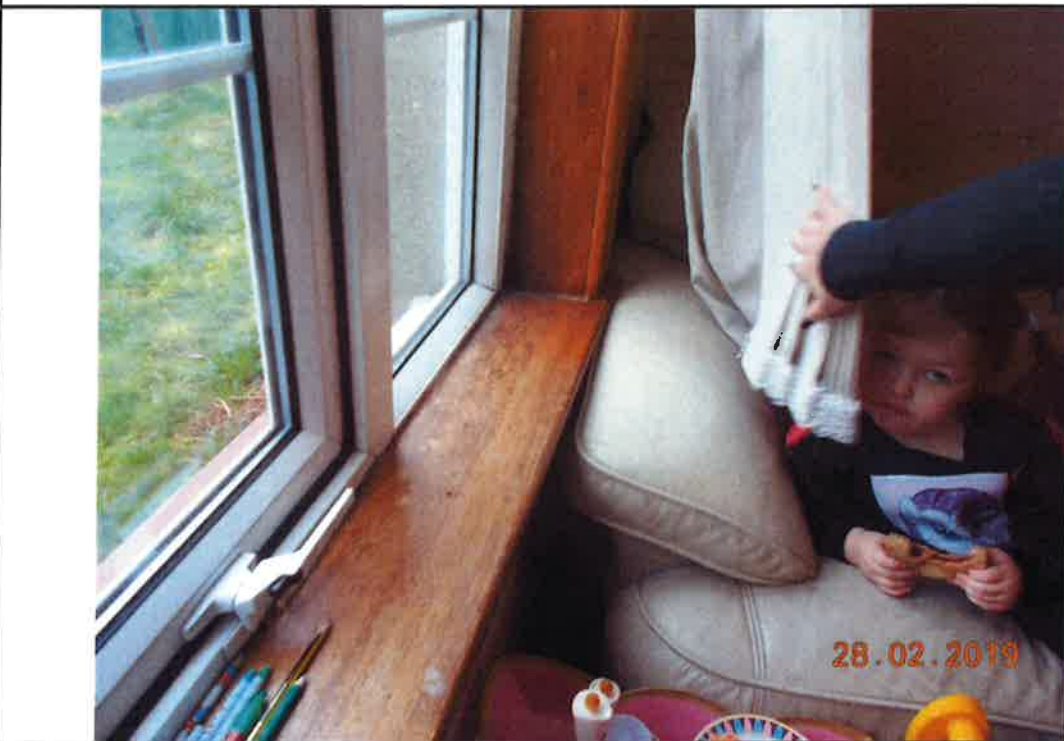
14. Damp/mould at window in Living Room

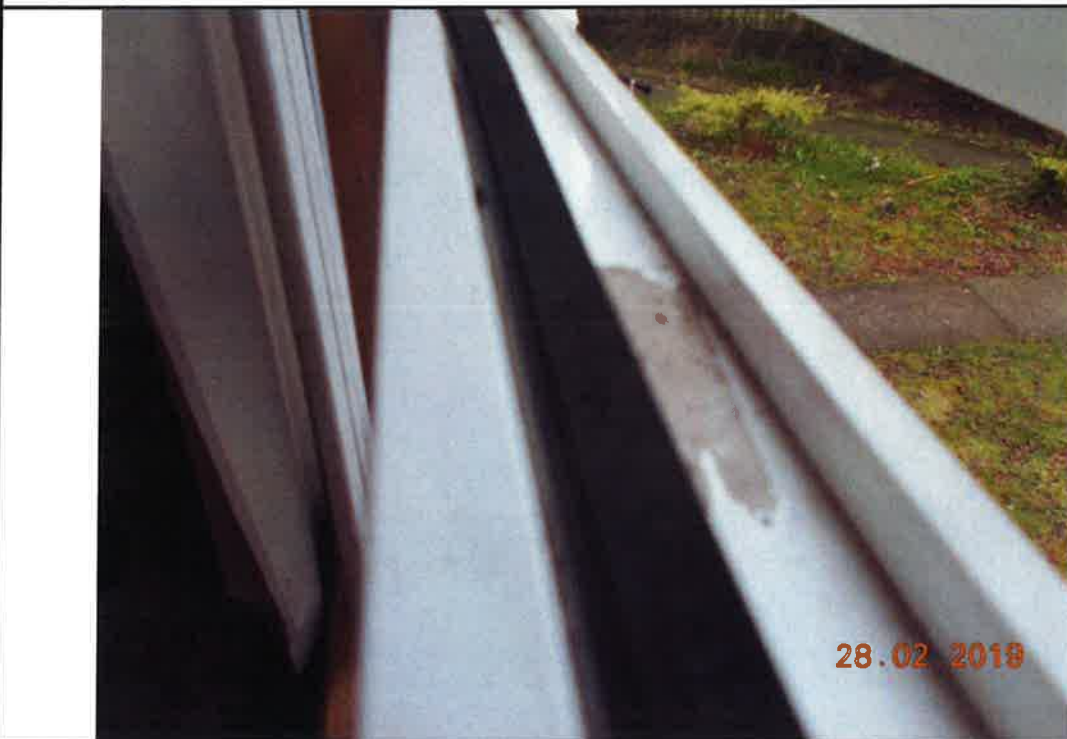
The windows throughout the Property are UPVC framed with sealed double glazed units. There were no holes in the window at the inspection. The handles had been replaced and were secure at the inspection. The condition of the window seals vary throughout the Property. When the sash of the windows are closed shut they close against neoprene seals. On a number of occasions the seals have become loose with the result that when the sash is closed the seal is not compressed.

16. Seal to opening section of window in main Front Bedroom (left on entering)

2. Overhaul all opening sashes to windows to ensure neoprene sealing gaskets between sash and frame are intact and secured in place sufficient to ensure they seal properly without either requiring to be held in place or adjusted following closure.

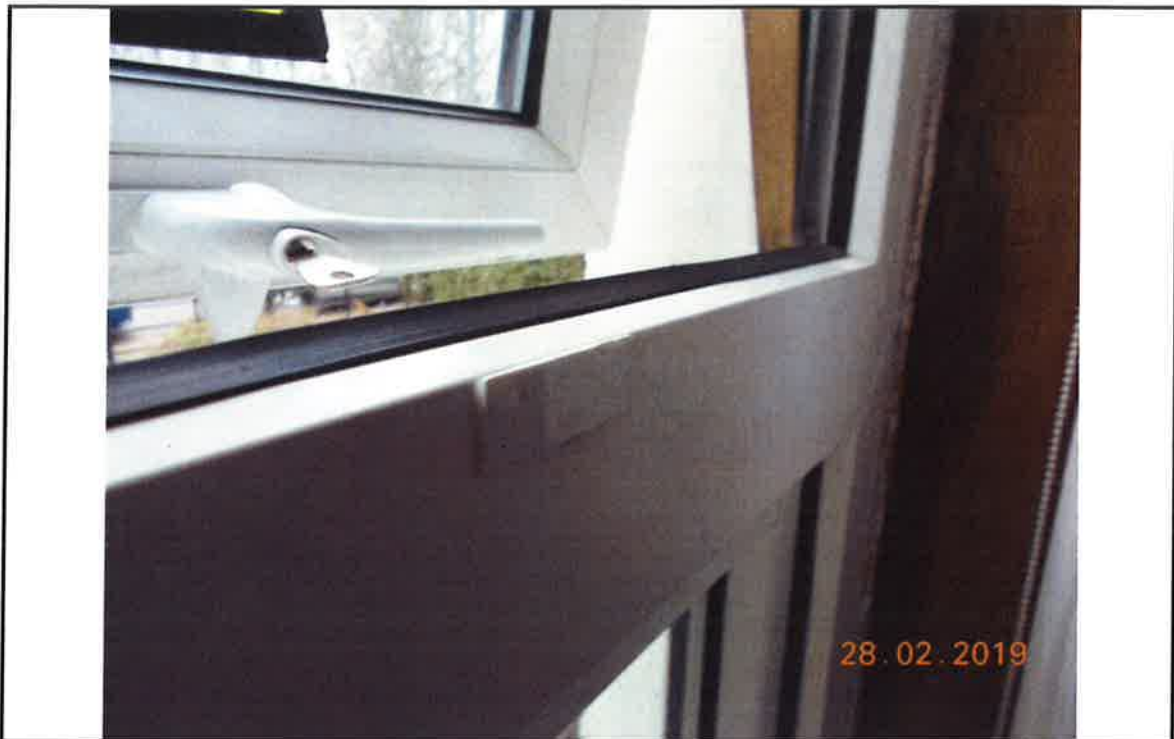
17. Seal to opening section of window in other Front Bedroom (right on entering)

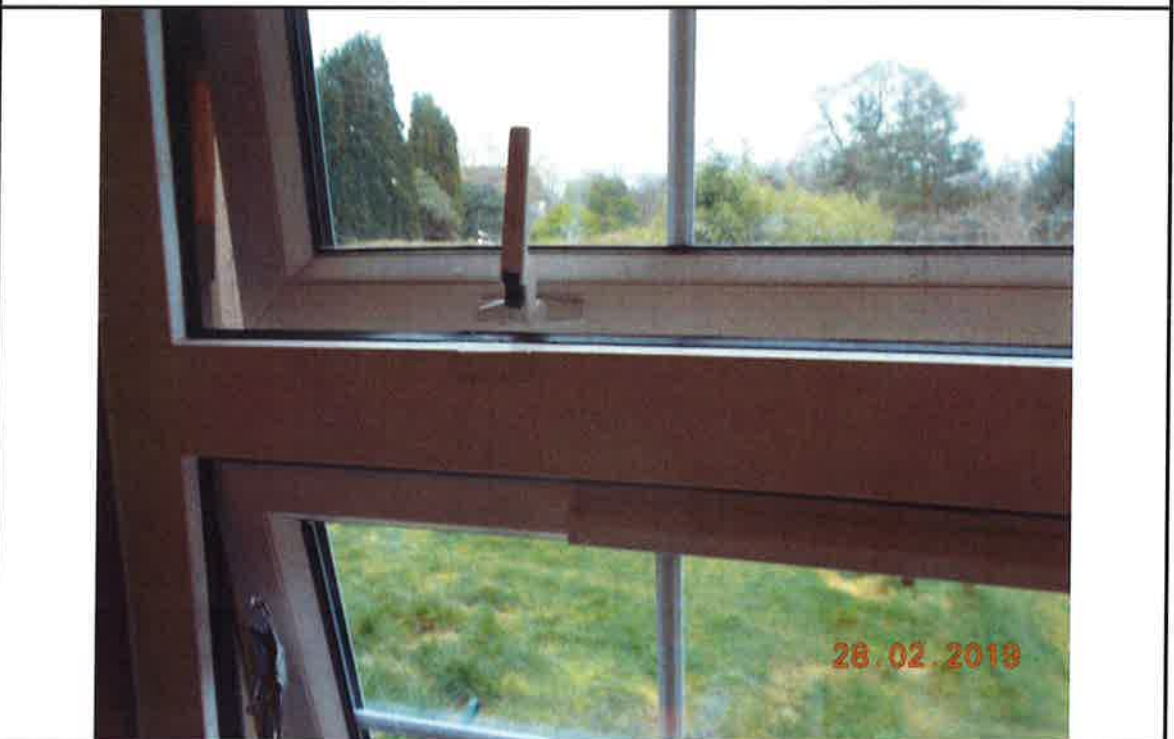
18. Seal to opening section of window in Kitchen

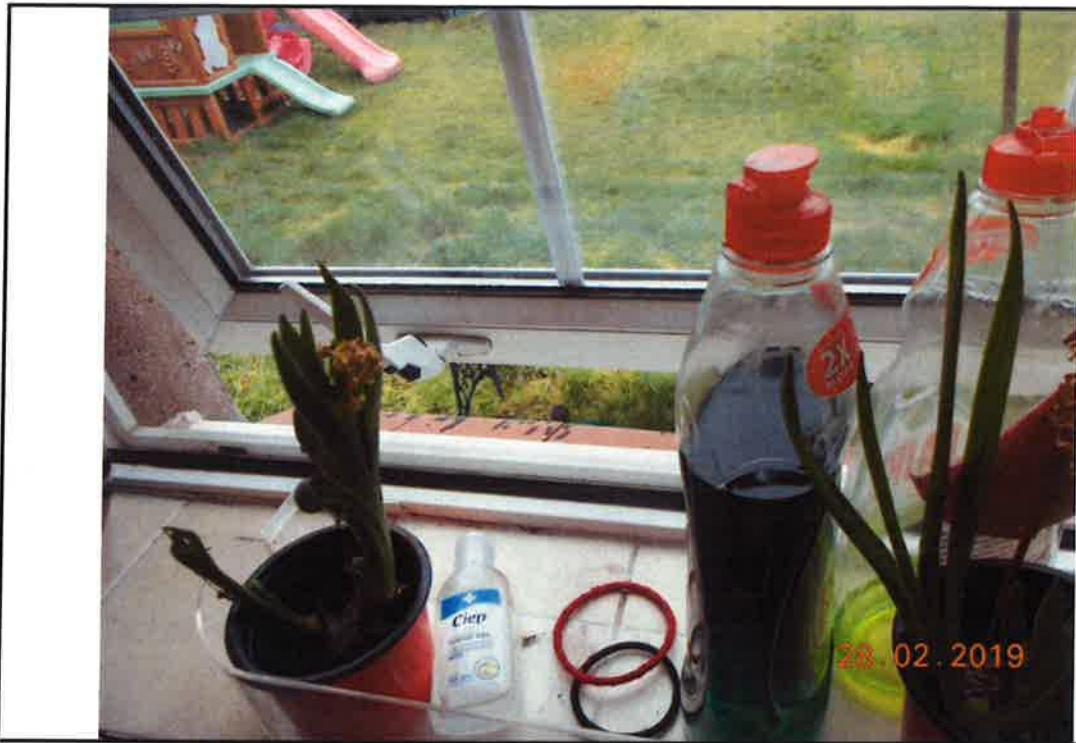
19. Seal to opening section of window in Kitchen

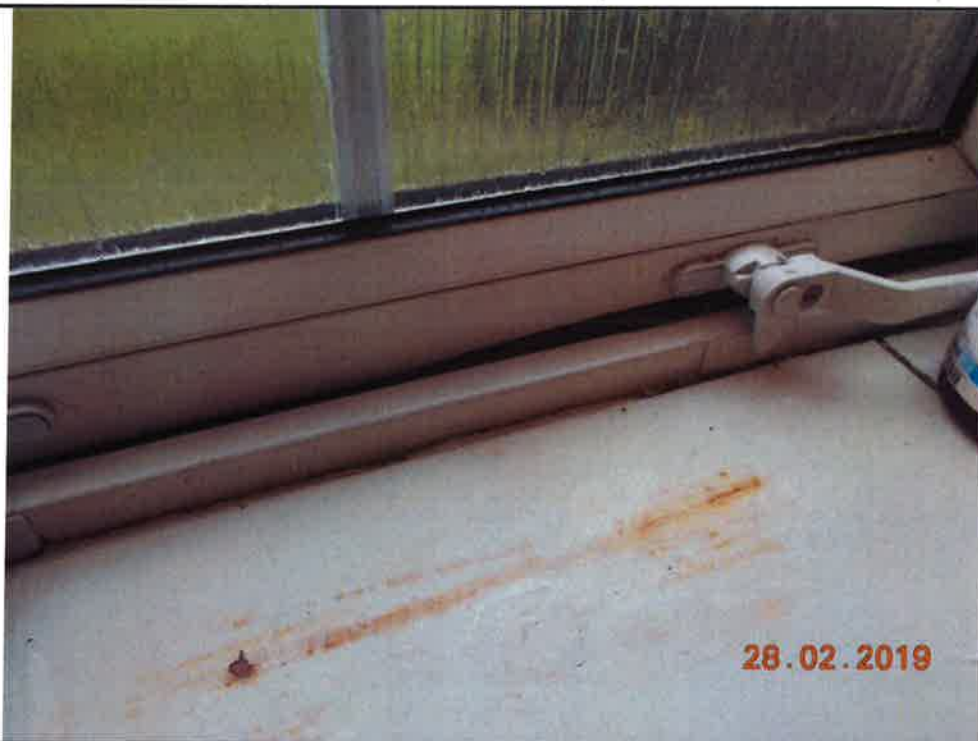
20. Seal to opening section of window in Bathroom

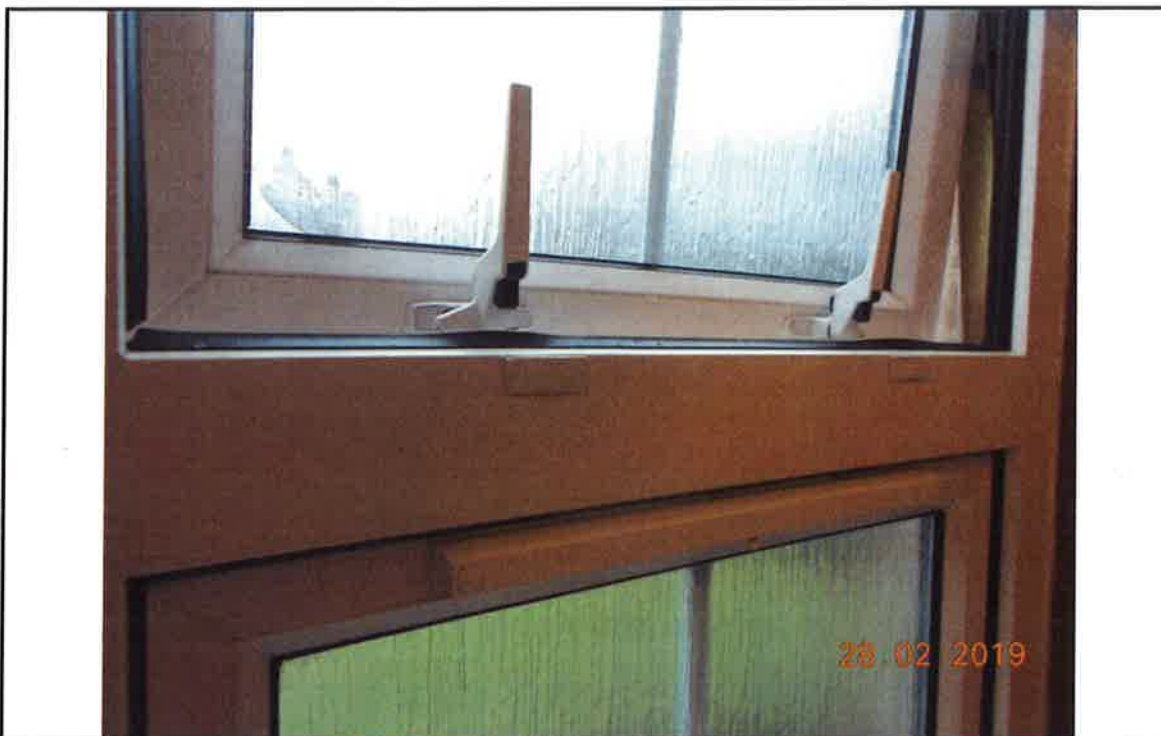
21. Seal to opening section of window in Bathroom

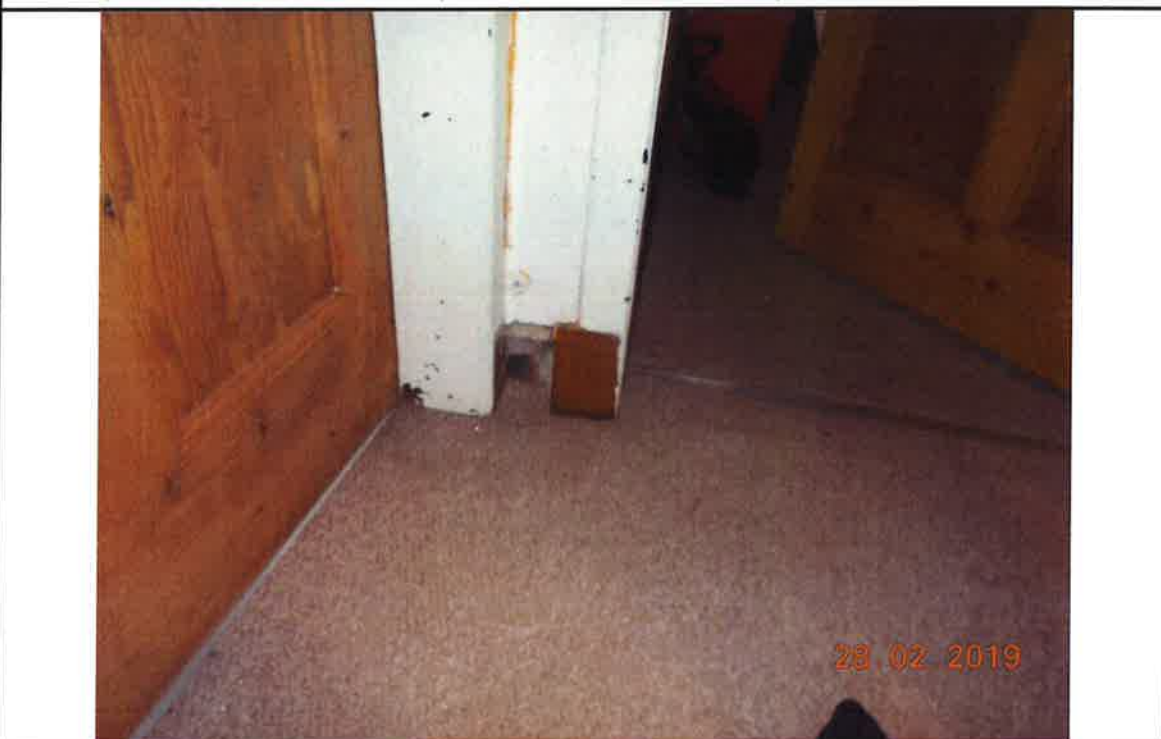
22. Missing section of skirting board in Hall (hole in wall)

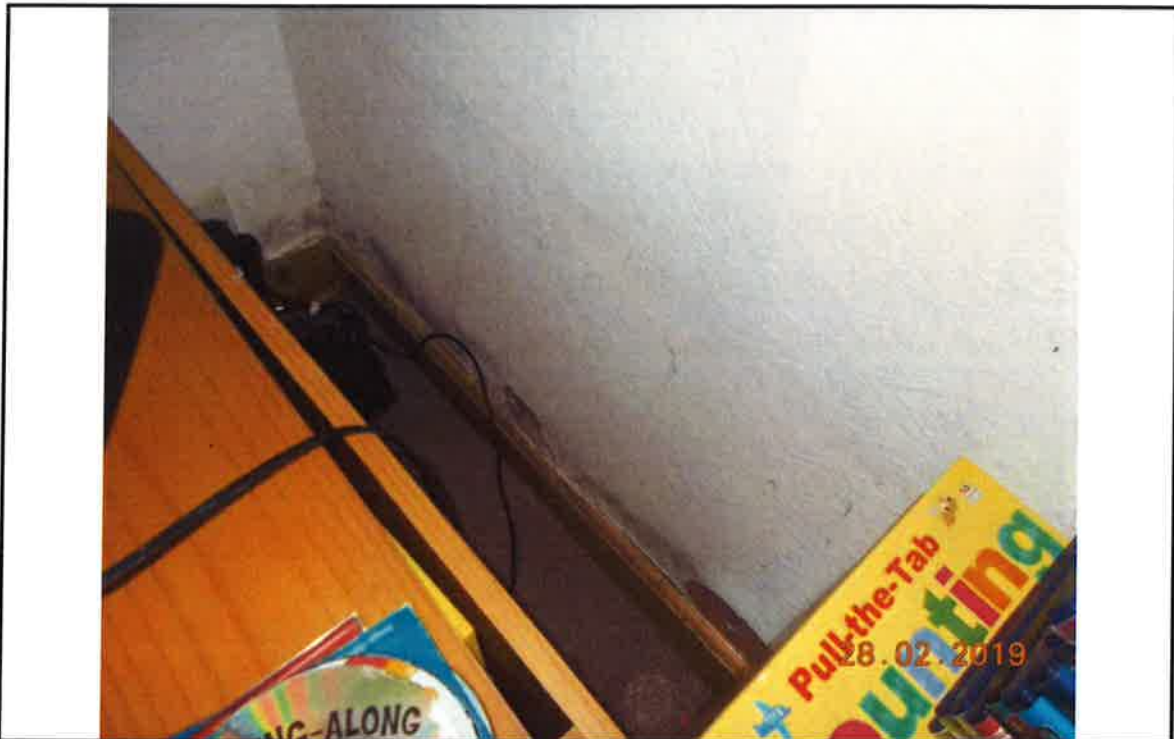
23. Hole in plaster work on inner surface of front wall in other Front Bedroom (right on entering)

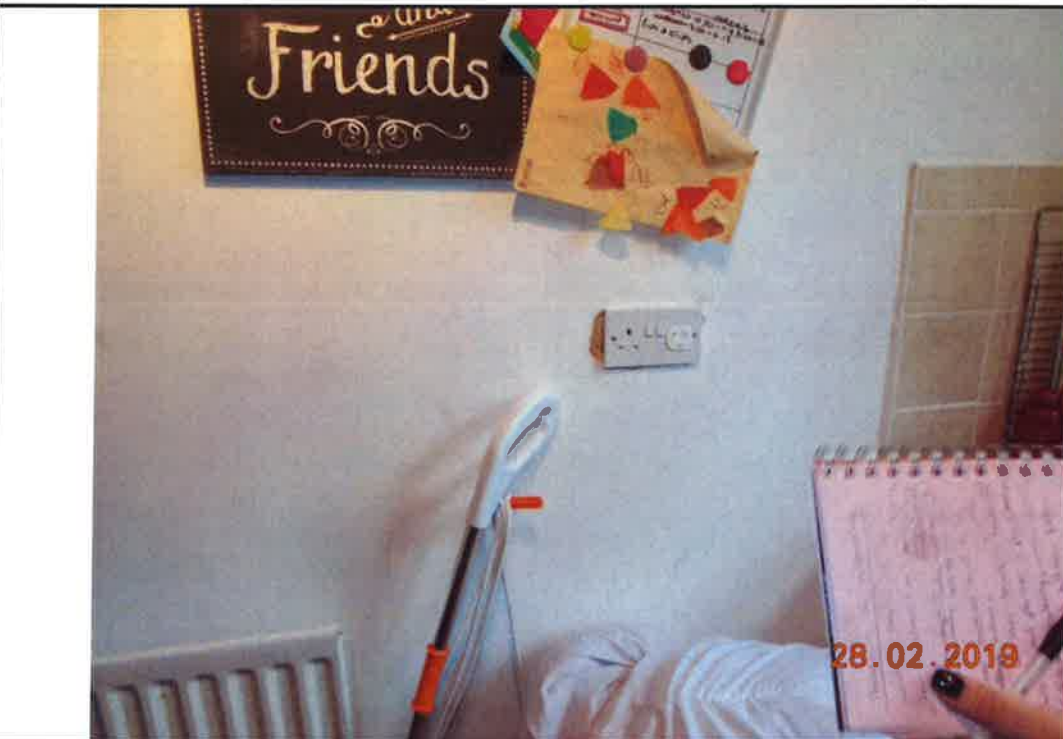
24. Hole in plasterwork around electrical socket outlet in Kitchen

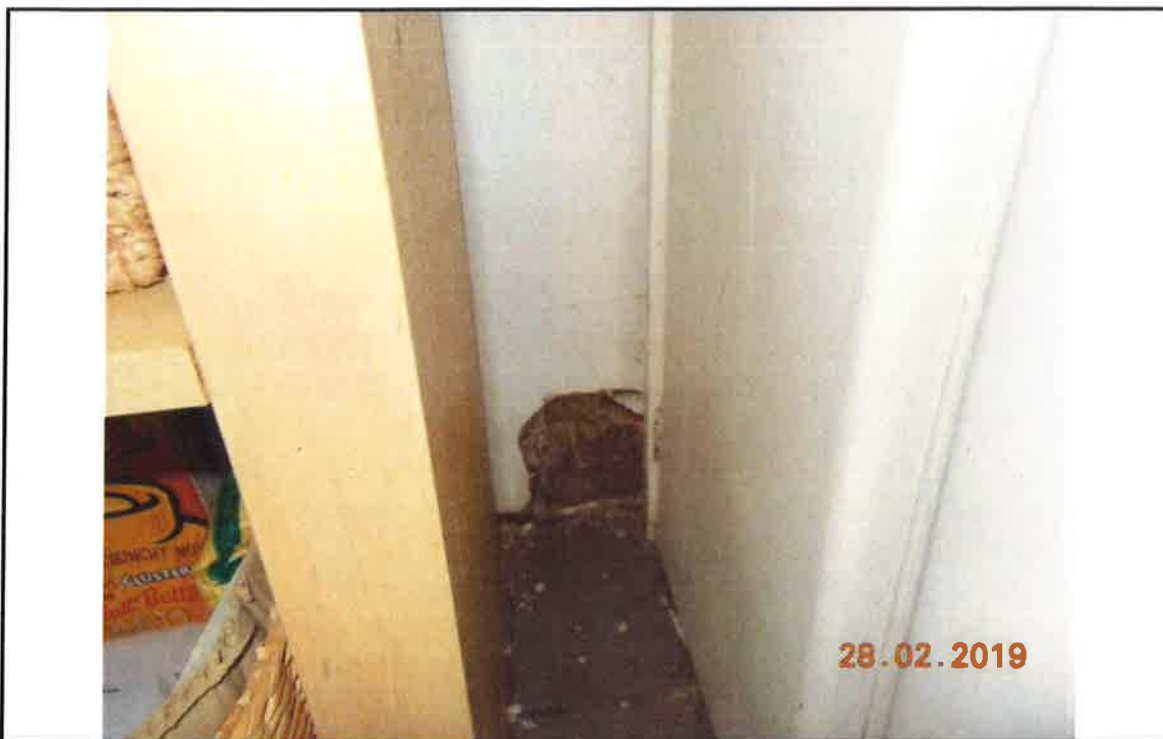
25. Hole in plaster work on inner surface of gable wall in Kitchen

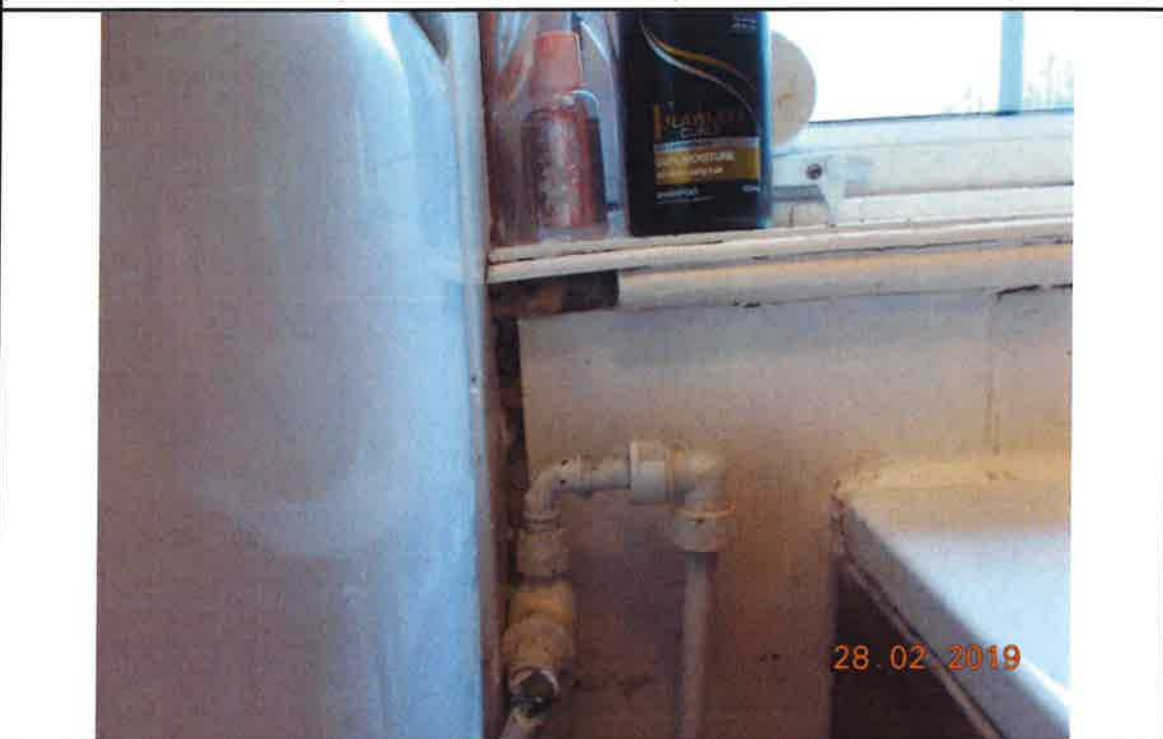
26. Hole in wall below window in Bathroom

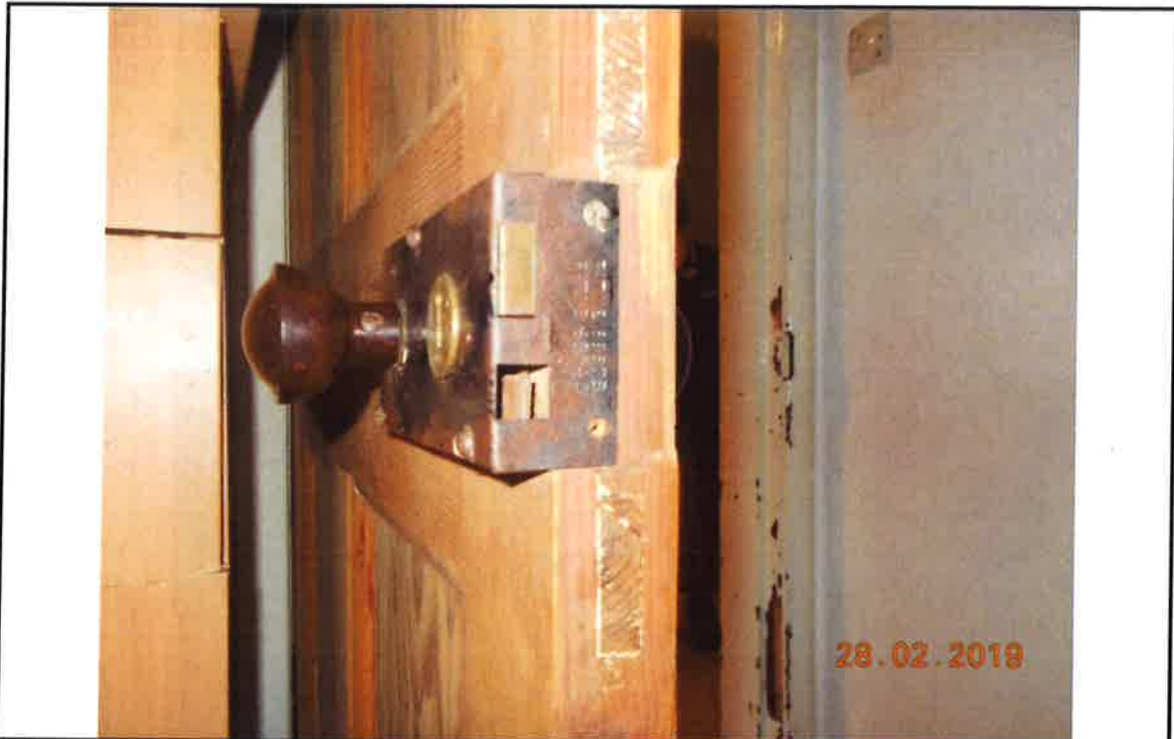
The internal doors were the original doors of the Property. The lock mechanism had two parts. One part is the locking mechanism. The other part is the mechanism to ensure that the doors remain closed. The catches are missing from the closing mechanisms of the smaller front bedroom, the living room and the kitchen.

27. Door lock with missing catch in other Front Bedroom (typical)

3. Overhaul latch locks of the internal doors to ensure when door is closed the door leaf is secured against the facings. (If latch locks cannot be overhauled fit another form of restraint such as a ball catch.)

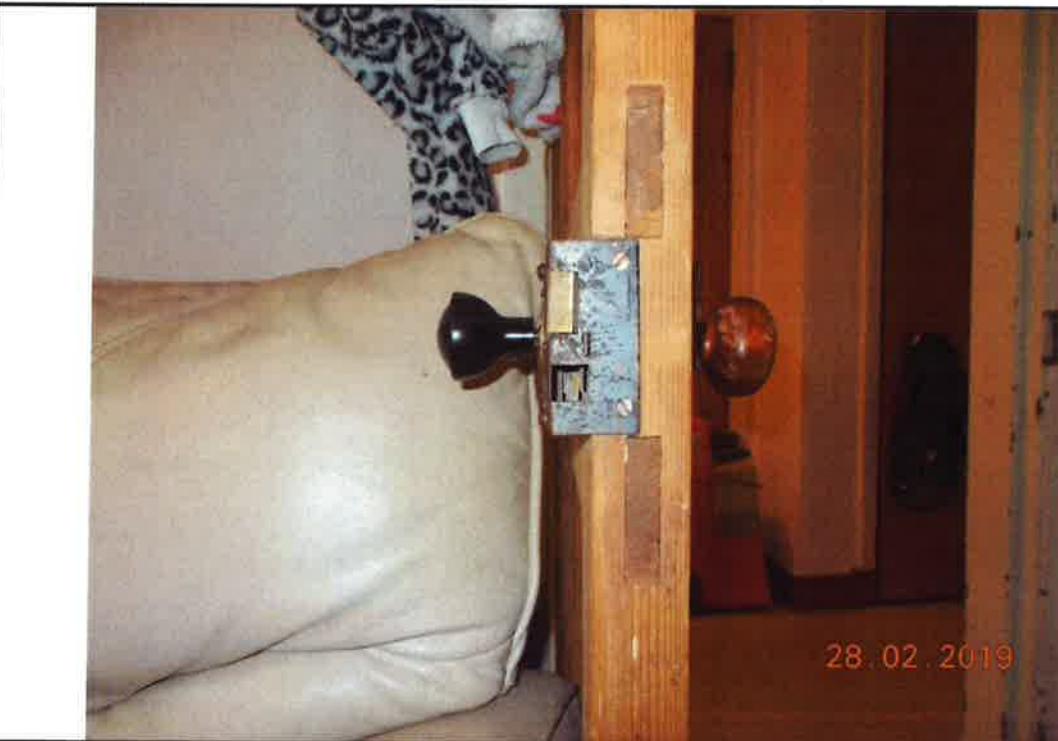
28. Door lock with missing catch in Living Room (typical)

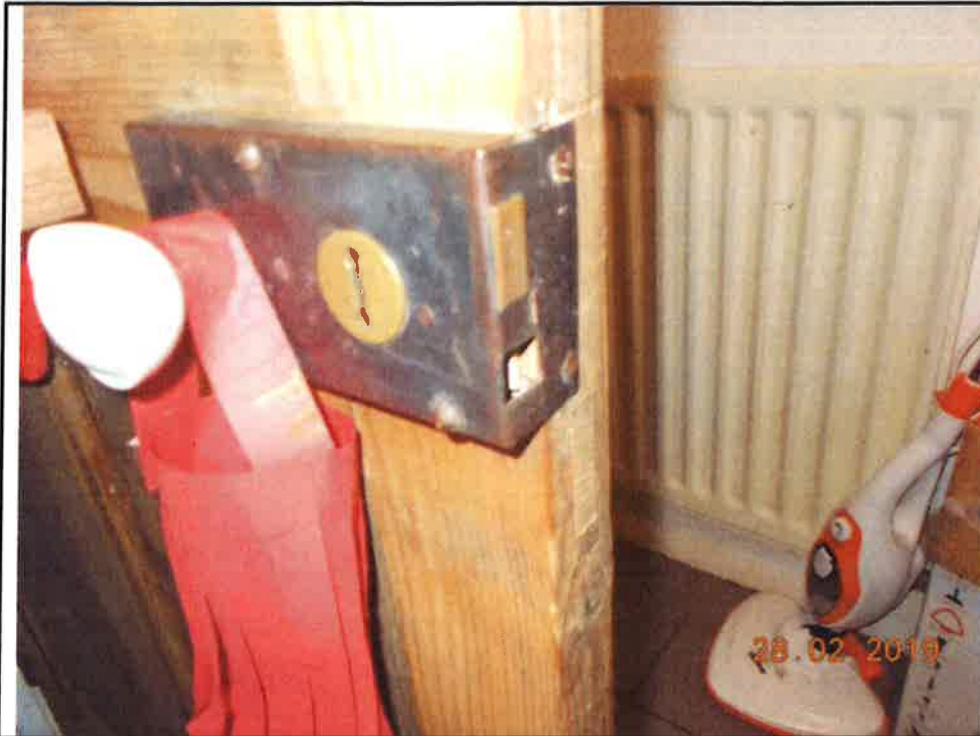
29. Door lock with missing catch in other Kitchen (typical)

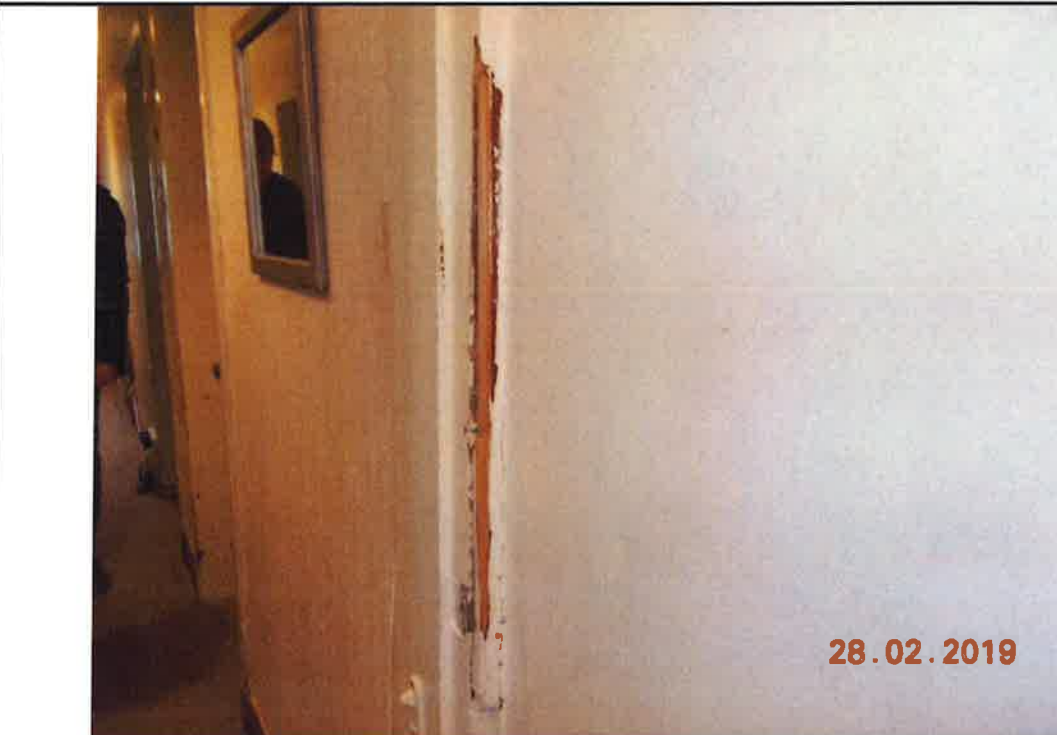
30. Damaged timber surround to door to Bathroom
