Statement of decision of the First-tier Tribunal for Scotland (Housing and Property Chamber) under Section 24 (1) of the Housing (Scotland) Act 2006.

Chamber Ref: FTS/HPC/RP/18/3495

28 Craigton Avenue, Milngavie, Glasgow, G62 7SX being the subjects registered in the Land Register of Scotland under Title Number DMB74837 ('The Property')

Schedule of Photographs taken during the
inspection by tribunal members on 28
February 2019

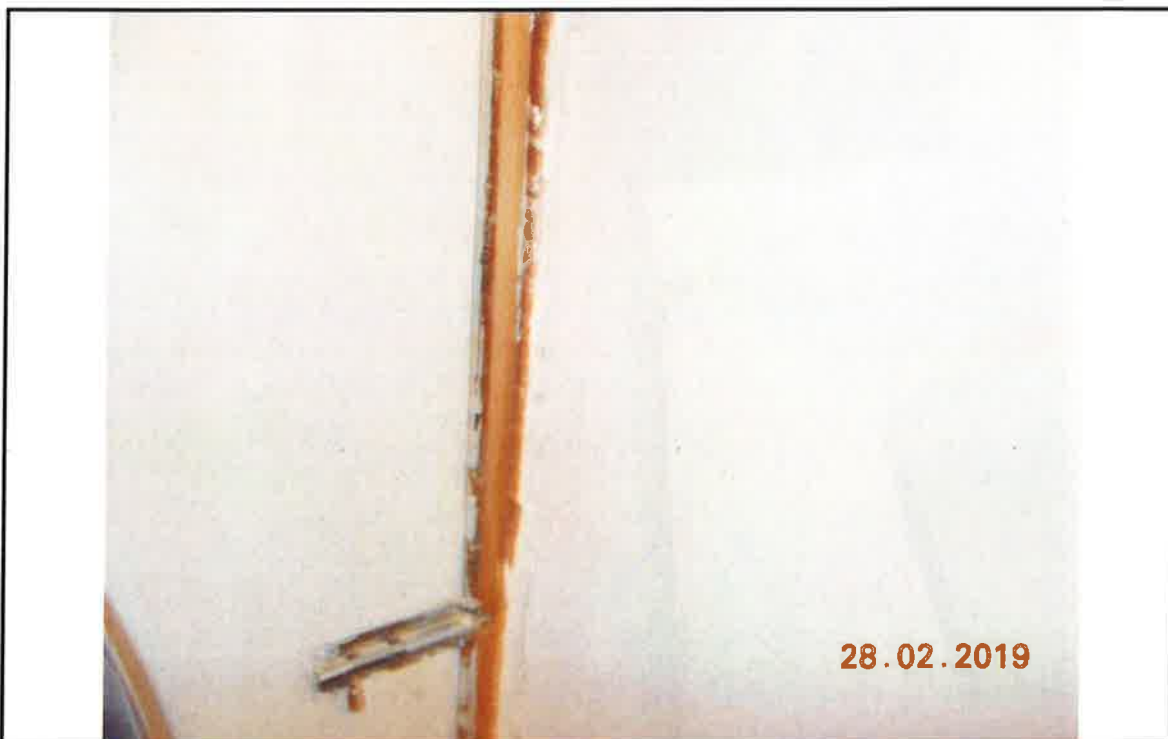
31. Damaged timber surround to door to Bathroom

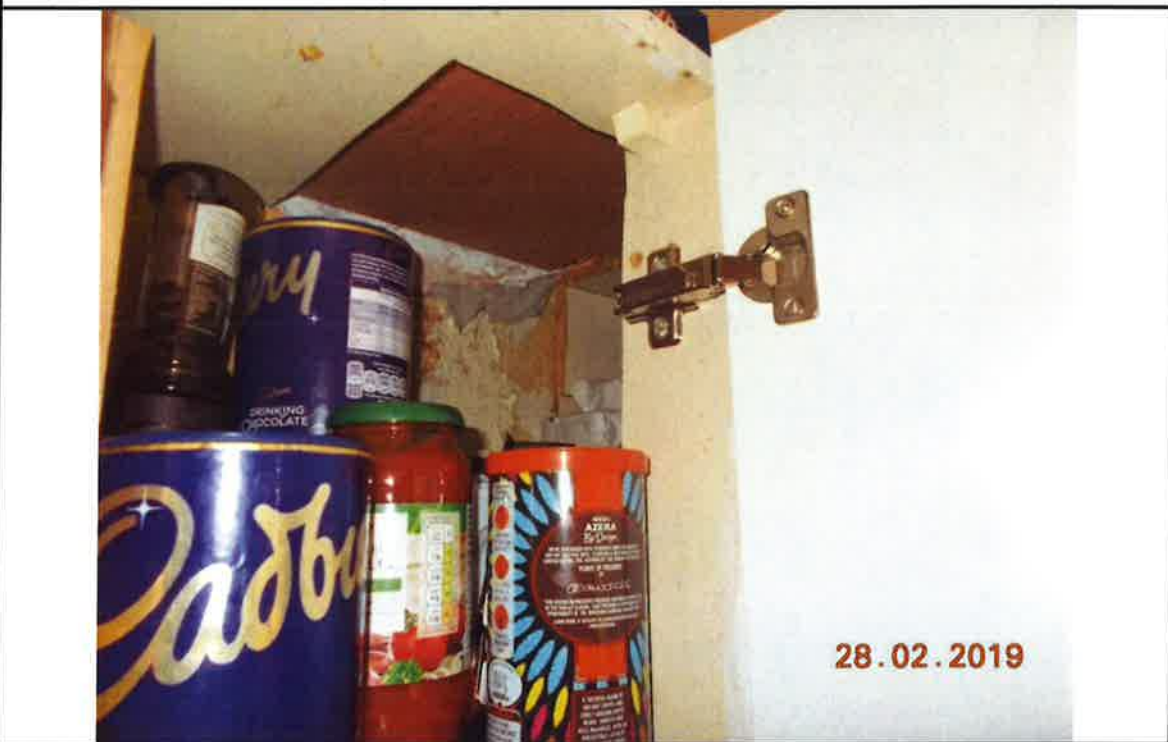
32. Interior of kitchen wall units

4. Repair or replace kitchen sink base unit to ensure there is an intact, properly supported base, intermediate shelf and back panel. Properly form holes for the passage of water supply and drainage pipes and seal around as required. Repair or replace the kitchen drawer unit and kitchen wall unit to render it in proper working order.

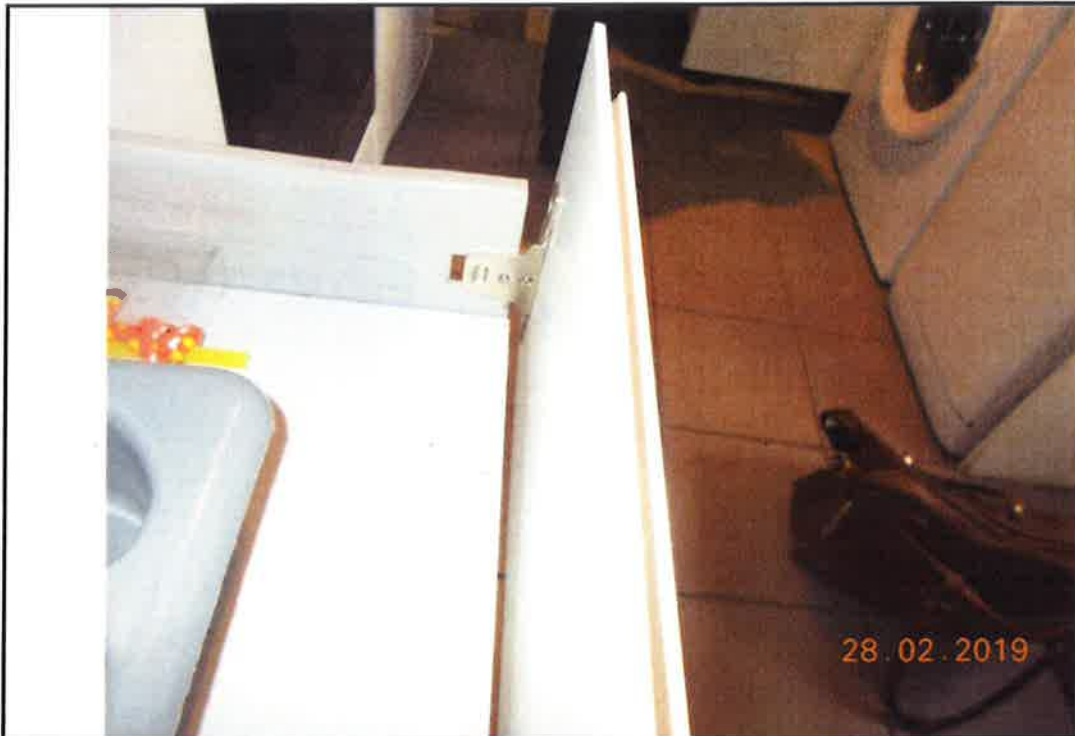
The kitchen cupboards and drawers had been partly upgraded. However the drawer unit to the left of the cooker did not operate properly as the top drawer does not run well on the runners and the bottom of the drawer has parted from the front. . The back plate is missing from the kitchen wall unit. The base section of the sink unit is also partly missing. The mid shelf in the unit below the kitchen sink is poorly supported.

33. Interior of kitchen drawer unit

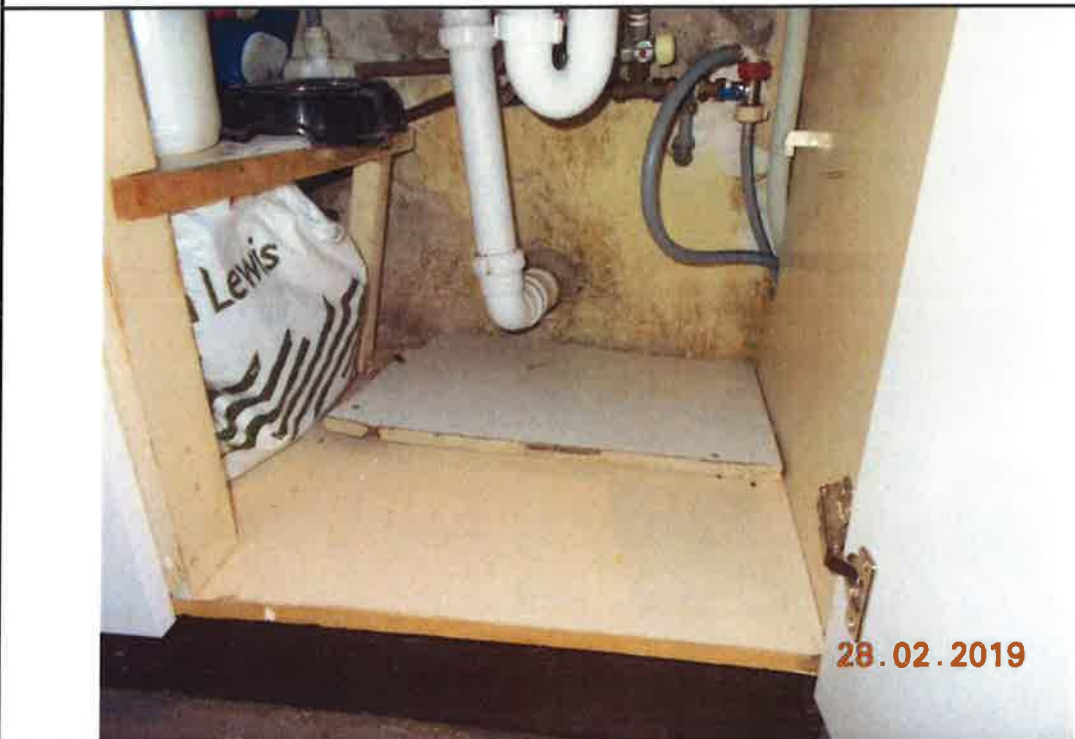
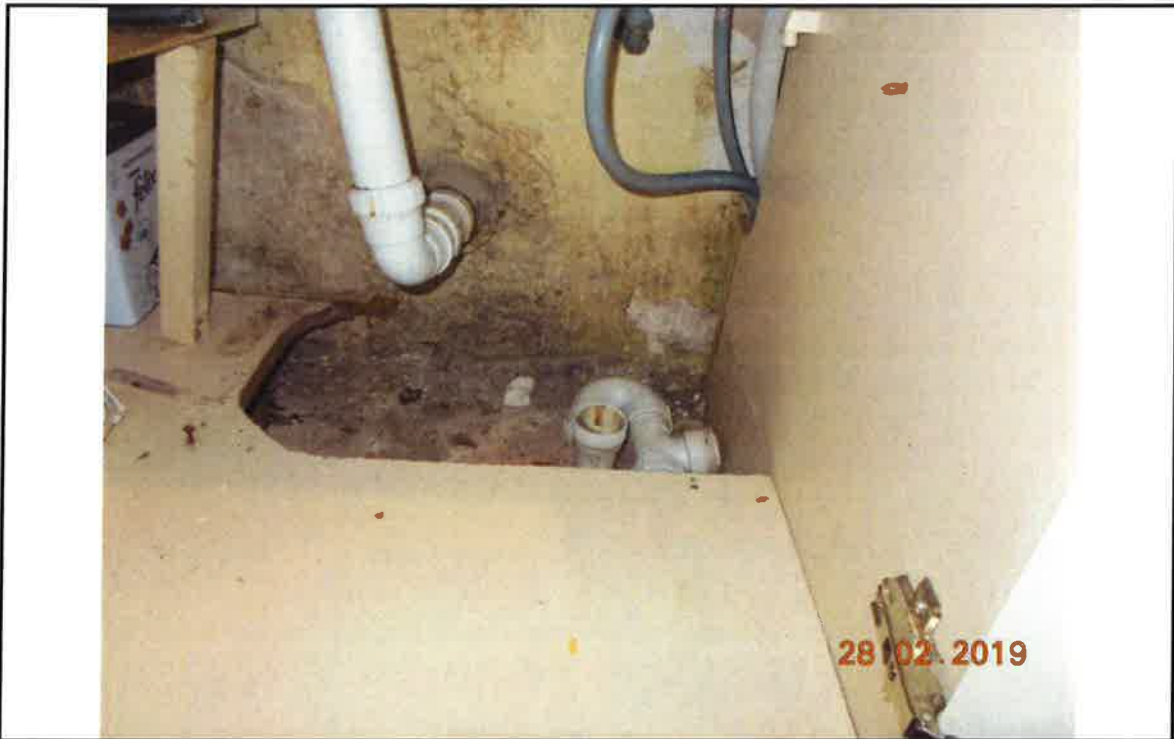
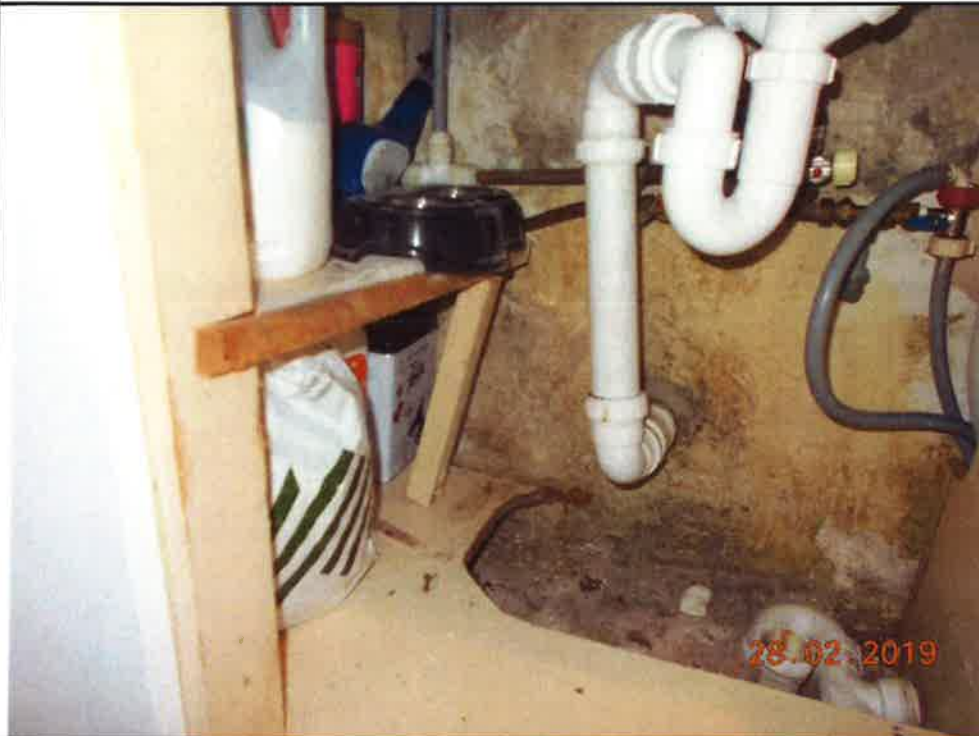
34. Interior of kitchen sink base unit

35. Interior of kitchen sink base unit

36. Interior of kitchen sink base unit

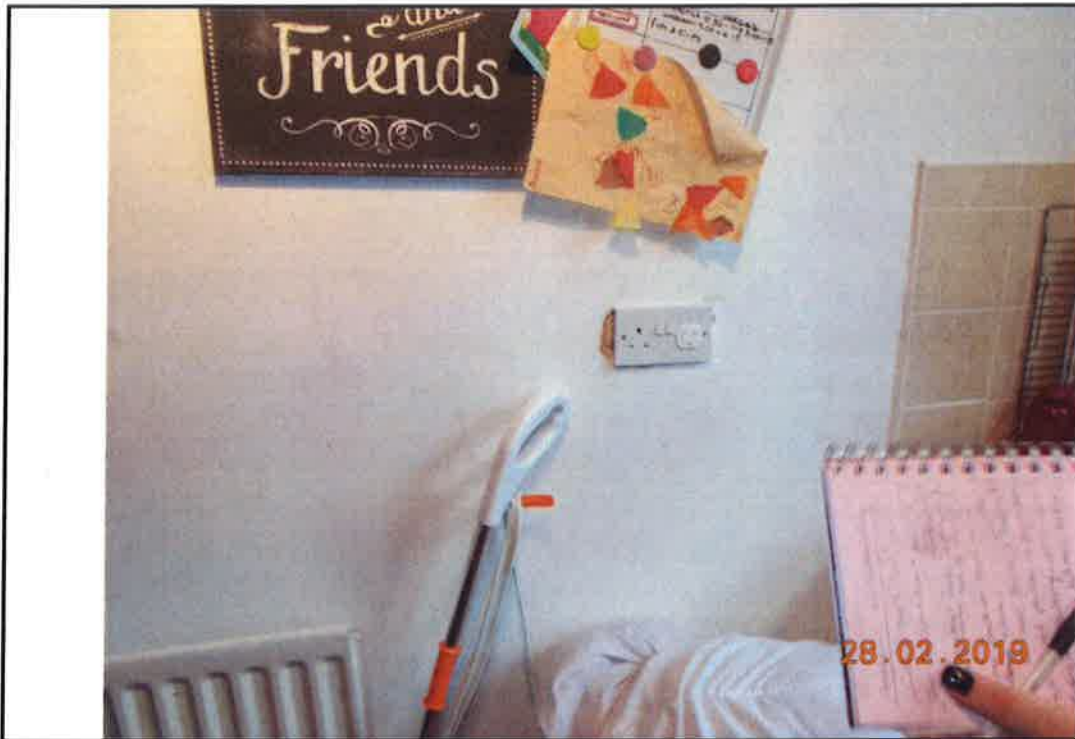
37. Gap at side of electrical socket outlet in Kitchen

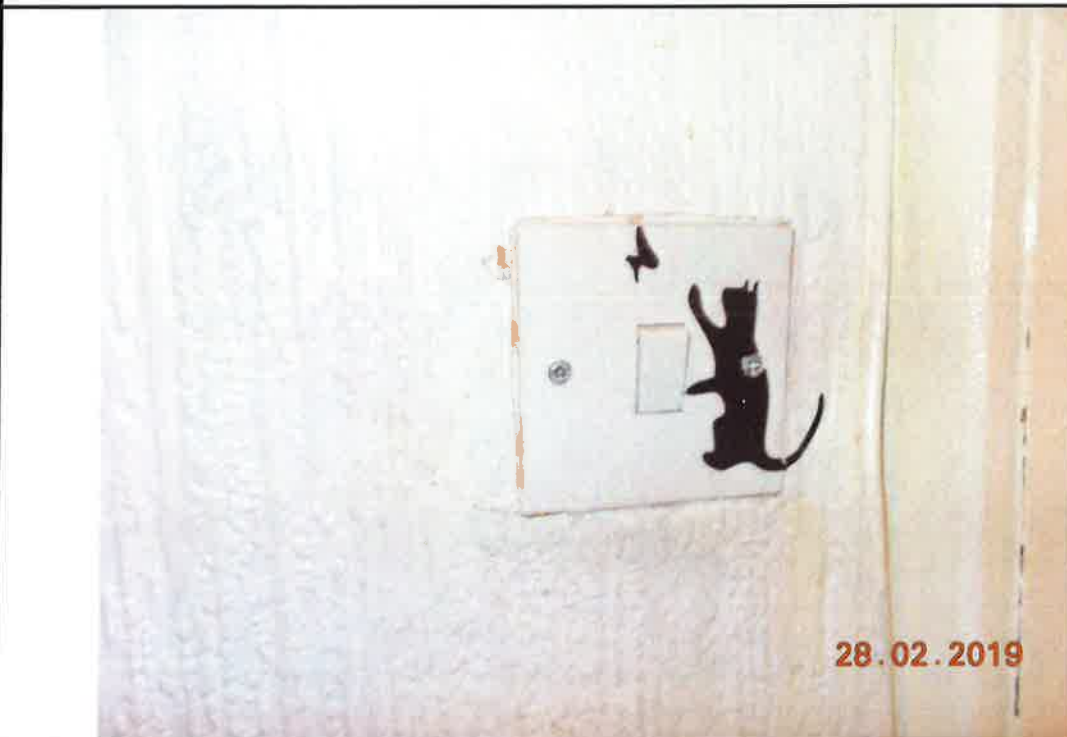
The kitchen light fitting and the bathroom light switch are both loose.

38. Loose light switch in Hall serving Bathroom light

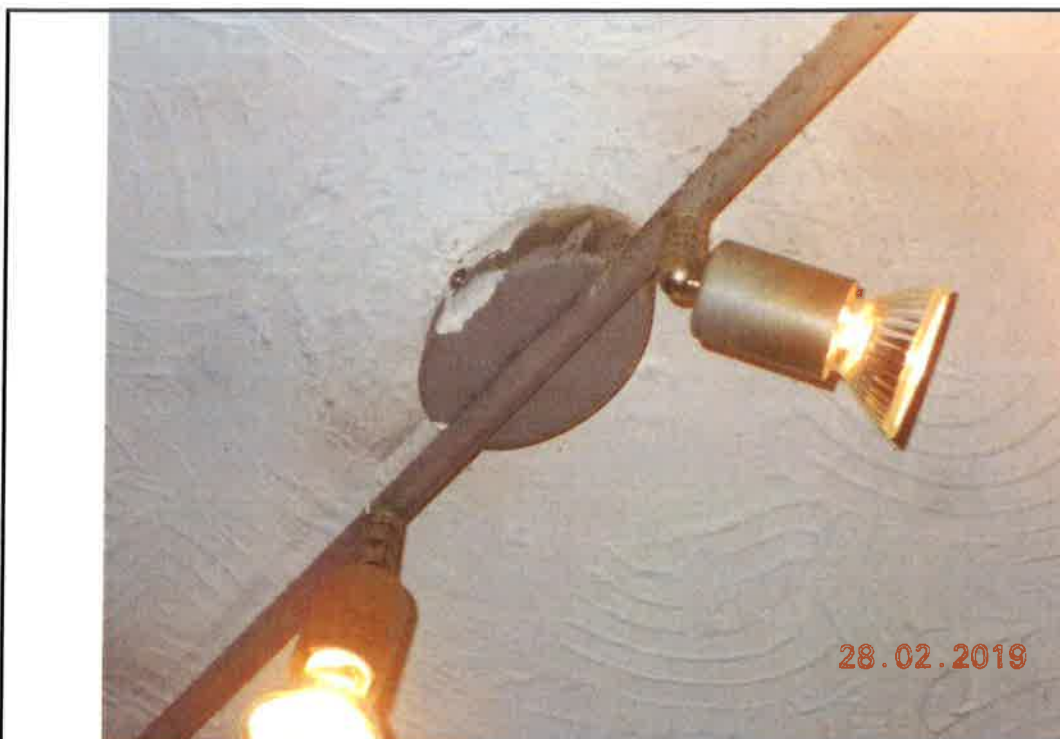
41. Loose light fitting in Kitchen

6. Exhibit a valid current and compliant Gas Safety Certificate for the Property by a suitably qualified Gas Safe registered engineer to address the state of repair and working order of all gas appliances and installations in the Property.
7. Fill holes around socket outlet on Kitchen wall to secure compliance with regulations relating to electrical installations.
8. Fill the hole in the external wall of the bathroom below the window sill.
9. Fill the hole in the plaster in the smaller front bedroom.
10. Repair or replace the missing section of skirting between the doors to the Kitchen and third Bedroom.
11. Secure or replace light switch for Bathroom light located in Hall.
12. Secure or replace ceiling mounted light fitting in Kitchen.
