**Repairing Standard Enforcement Order (RSEO): Housing (Scotland) Act 2006
Section 24(1)**

West Roucan Farmhouse, Torthorwald, Dumfries, DG1 3QG ("the property")

Statement of Decision: Housing (Scotland) Act 2006 Section 24(1)

PHOTOGRAPH SCHEDULE

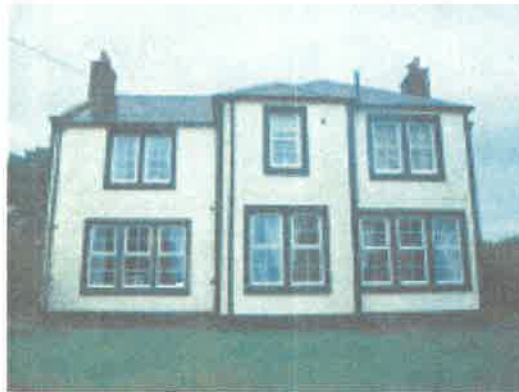
FRONT ELEVATION

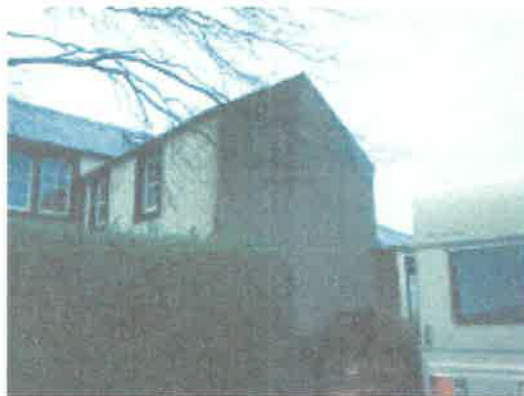
8. **East Gable.** The Tribunal noted that there are no cracks in the roughcast on the east gable wall. Mr Black advised that the wall has been re-rendered since his first inspection of the property, prior to submission of the application. He also advised that the damaged chimney stack previously located at the top of this wall has been removed. The Tribunal noted the absence of a chimney stack on the roof above the east gable wall.

14. **East Gable wall and dampness.** Mr Black advised the Tribunal that the east gable wall has been completely re-rendered since his first inspection in November 2017 and the damaged chimney head has been removed. In November the wall had been badly cracked from ground to chimney and he and Mr Rome thought that this was likely to be the cause of dampness within the property on the same

- 22. The Tribunal considered the issues of disrepair set out in the Application and noted at the inspection.
- 23. **Exterior of east gable wall.** The Tribunal is satisfied from its inspection of the property and the evidence presented to it by the Third Party that defects affecting the exterior of the wall have been rectified and that no breach of the repairing standard exists in relation to same. It also notes that the damaged chimney head referred to in the application has been removed.

GABLE WALL – NEW RENDER

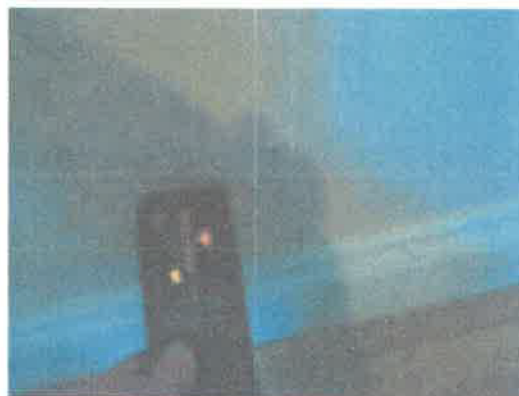
9. **Dampness.** On entering the utility room Mr Black directed the Tribunal to an area of wall next to the door. He advised that when previously inspected, this had been covered by black mould, but since then the wall appears to have been framed/strapped and plastered over. The Tribunal noted that part of the wall looks as though it has been recently plastered. Meter readings taken indicated the absence of damp. The Tribunal noted an extractor fan in the room and were advised that this is a new fan, recently installed. In the kitchen the Tribunal inspected the inside of the east gable wall. Meter readings were taken at various locations which confirmed the presence of damp. Some evidence of re-plastering was evident. An extractor fan was noted. On the half landing the Tribunal noted an area of wall which showed signs of damp. Meter readings however indicated that the wall is dry. No dampness was detected in the bathroom, although condensation stains were noted on the ceiling. In the east bedroom on the upper floor, located

UTILITY ROOM – “DRY” READING

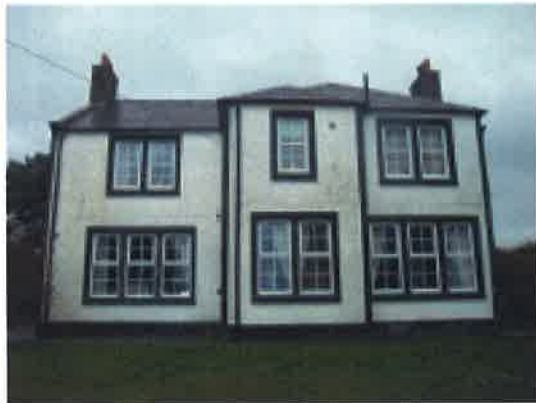
FRONT ELEVATION

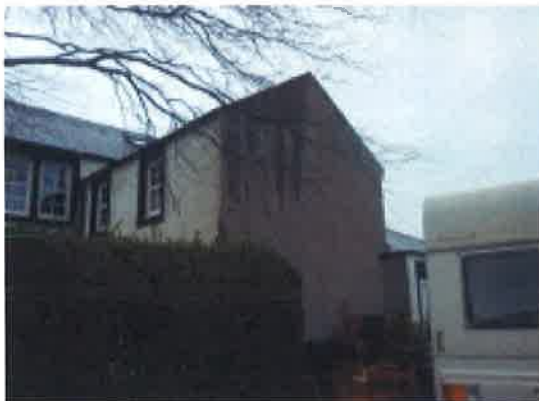
GABLE WALL – NEW RENDER

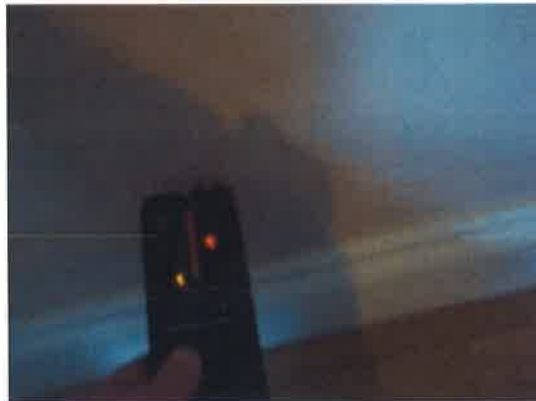
UTILITY ROOM – “DRY” READING

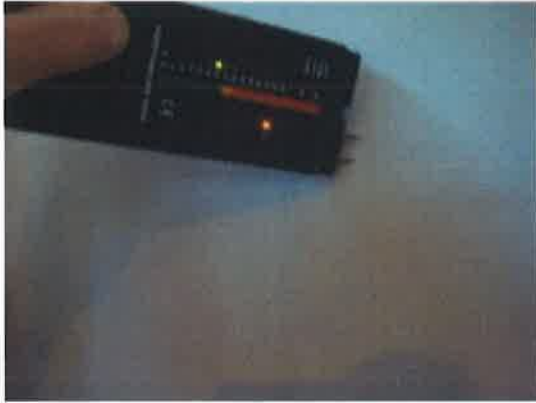
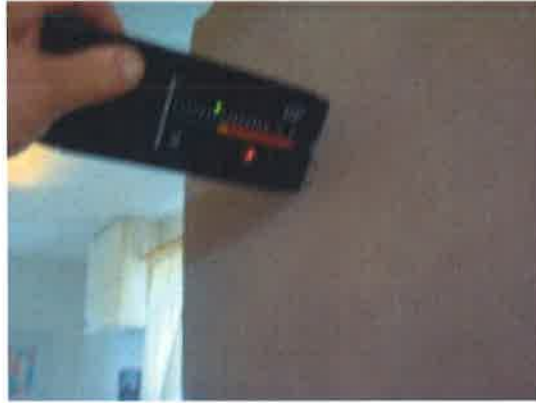
UTILITY ROOM - "DRY" READINGS

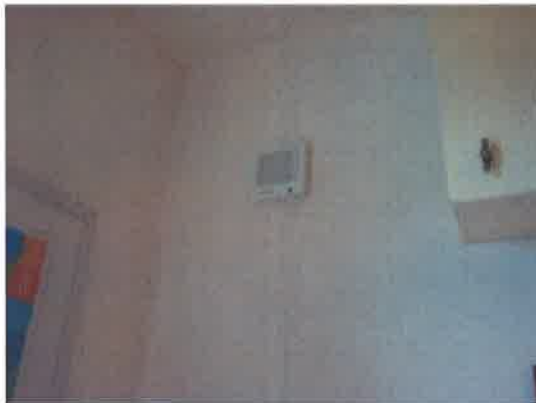
UTILITY ROOM - VENT

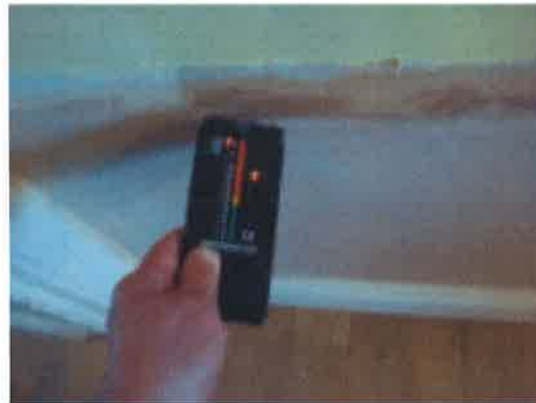
- 18. The property is a five bedroom detached dwellinghouse in Torthorwald, Dumfries.
- 19. The interior of the east gable wall in the kitchen and the east bedroom on the upper floor is affected by damp.
- 20. Windows within the property do not exclude draughts.
- 21. There is no heat detector in the kitchen or smoke detector in the living room.

- 24. **Dampness.** In its application the Third party complains of dampness in various rooms within the property – utility room, kitchen, bathroom, mid stair and upper east bedroom. At the hearing Mr Black, on behalf of the Third party, confirmed that work appears to have been carried out within the property and no dampness is now evident in the utility room, bathroom and mid stair. This is supported by the meter readings taken at the property during the Tribunal's inspection of same. However, the Third party maintains that the interior of the east gable wall in the kitchen and east bedroom are still affected by dampness and that any work carried out has not rectified this. The Tribunal notes that meter readings taken in both rooms show moderate to high levels of damp. The Tribunal also notes that the Landlord's written representations indicate only that the work carried out involved the removal of

plaster, installation of a damp proof course and re-plastering. During its inspection the Tribunal noted that some recent re-plastering has been carried out in the kitchen, although not in the east bedroom. No report from the contractor was provided with the written representations to establish the precise nature of the work carried out. Furthermore, no detailed information about the alleged upgrade of extractor fans has been provided. The Tribunal therefore concluded that while some work has certainly been carried out at the property, it has not fully eradicated the dampness and a breach of the repairing standard has been established in relation to same. The Tribunal notes that the report from Richardson and Starling is dated September 2016 which establishes that the Landlord has had some knowledge of the dampness for approximately 18 months, although only the utility room, kitchen and bathroom appear to have been inspected at that time. Some works recommended in this report now appear to have been completed, but not until 18 months after the report was issued. No updated inspection report by Richardson and Starling has been produced.

KITCHEN - "DAMP" READING

- (1) To instruct a suitably qualified timber damp specialist and building contractor to prepare a detailed survey of the property, with specific reference to the east gable wall, to identify the cause and full extent of the dampness and any remedial action. The report should include both the internal and external fabric of the building, specifically around the affected areas. Thereafter to carry out all recommended repairs to remedy the dampness and any associated defects, and any resultant decoration made good.

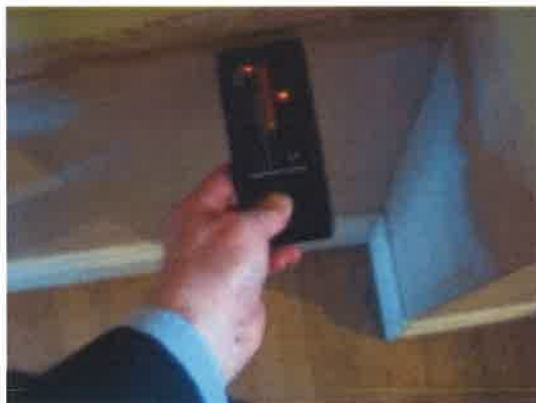
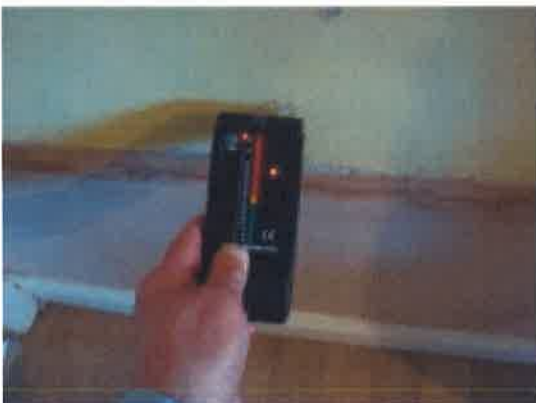
KITCHEN - "DAMP" READINGS

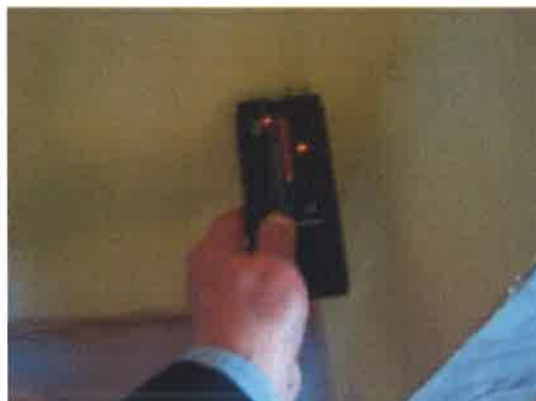
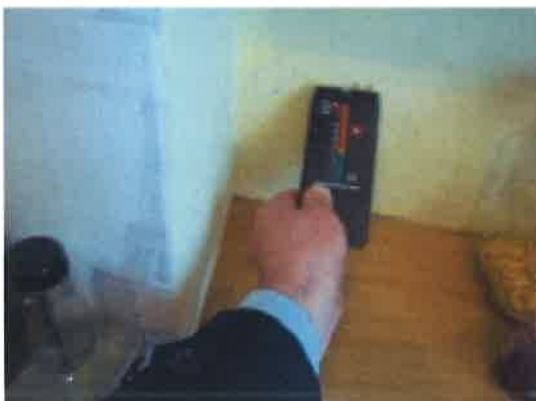
KITCHEN - "DAMP" READINGS

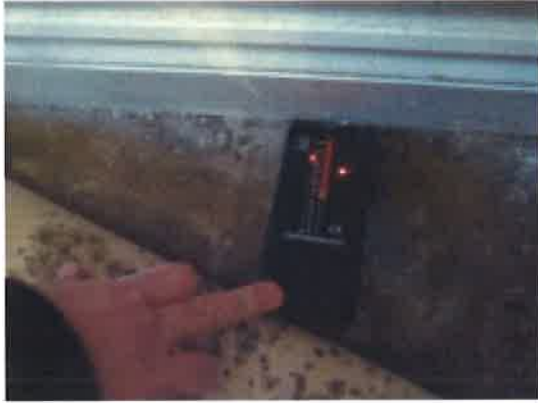
KITCHEN "DAMP" READING

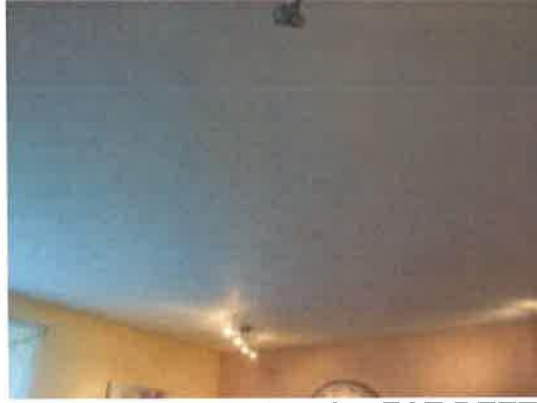
10. **Smoke and carbon monoxide detectors.** The Tribunal noted the absence of a heat detector in the kitchen. The Tribunal inspected the living room and dining room, both of which have open fires. Carbon monoxide detectors were noted in both rooms. There are no smoke detectors in either room. In the hall and landing the Tribunal noted the presence of hard wired smoke detectors.

15. Smoke and heat detectors. Mr Black advised the Tribunal that the lack of a smoke detector in the living room and heat detector in the kitchen have not been addressed by the landlord. A smoke detector is not needed in the dining room in terms of current guidelines.

25. Smoke, heat and carbon monoxide detectors. The Tribunal is satisfied from its inspection and the evidence presented at the hearing that functioning carbon monoxide detectors have been installed at the property. Hard wired smoke detectors were also noted in the hall and upper landing. However, there is no heat detector in the kitchen or smoke detector in the living room. The Landlord has therefore failed to comply with the repairing standard in relation to same

KITCHEN CEILING-NO HEAT DETECTOR

- (3) To install hard wired interlinked smoke and heat detectors in the living room and kitchen to comply with the statutory guidance.
- (4) To instruct a suitably qualified SELECT, NAPIT OR NICEIC registered electrician to carry out a certified electrical condition check of the entire electrical installation of the property and exhibit a copy of the electrical installation condition report (EICR) to the Tribunal.

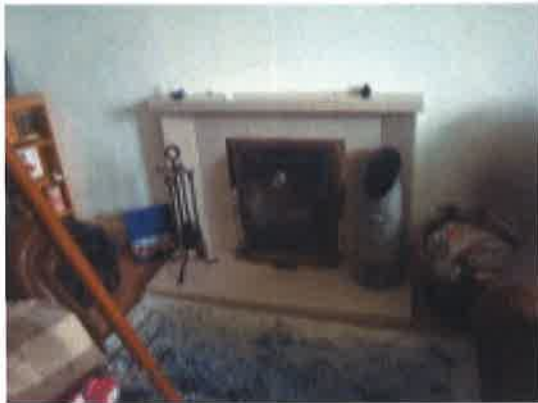
LIVING ROOM – OPEN FIREPLACE

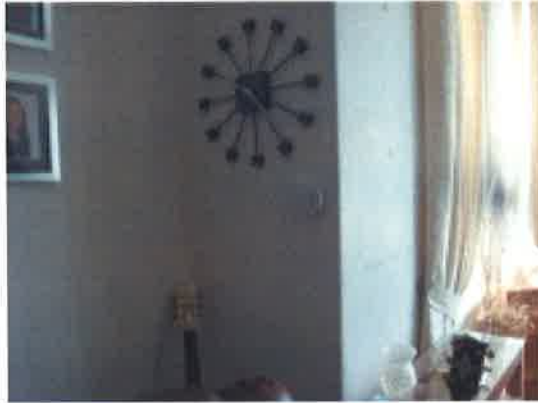
LIVING ROOM – CO MONITOR

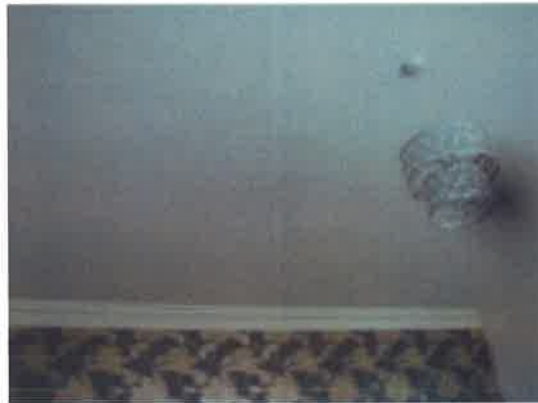
LIVING ROOM – NO SMOKE DETECTOR

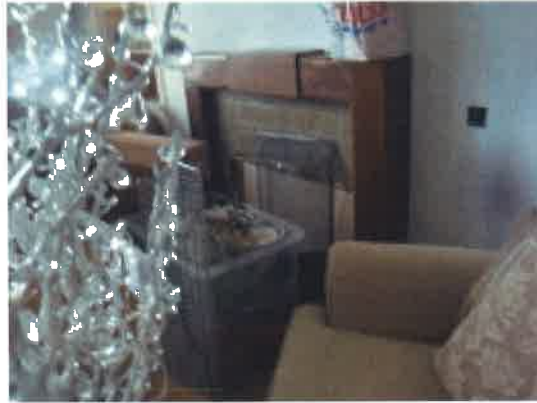
DINING ROOM – OPEN FIREPLACE

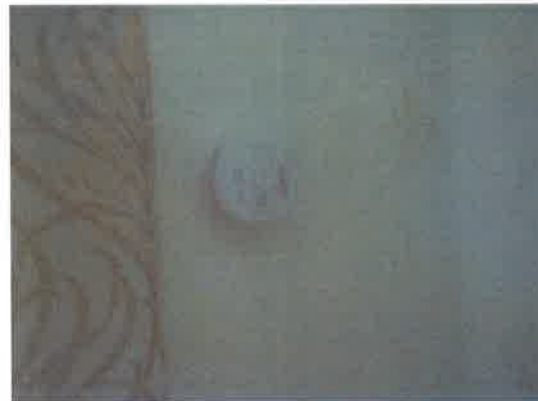
DINING ROOM – CO MONITOR

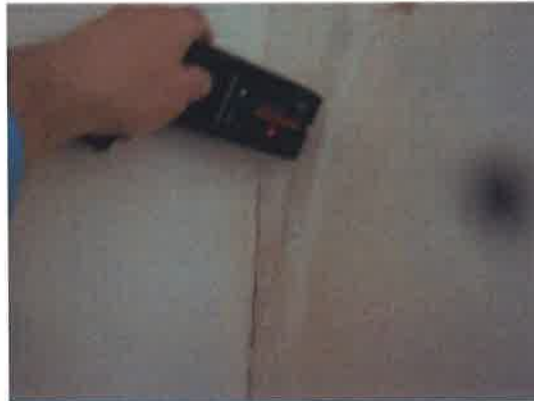
HALF LANDING-"DRY" READING AT STAIN

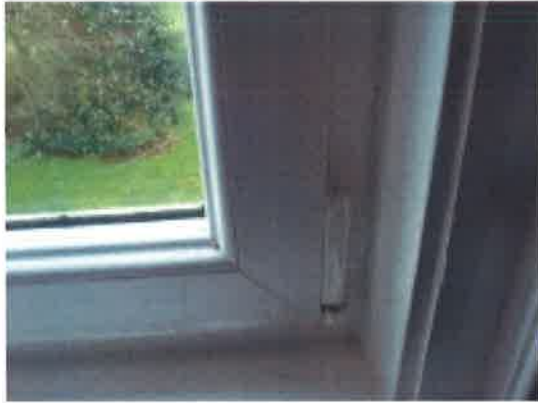
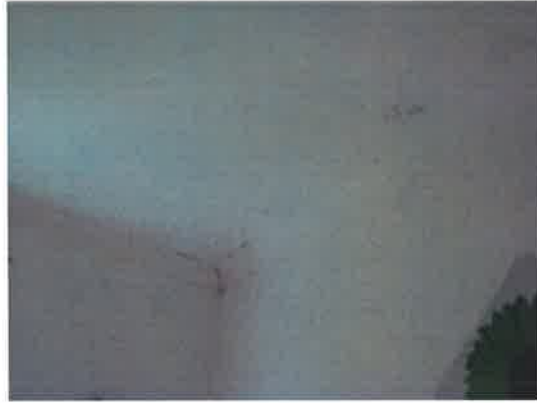
11. **Windows.** The Tribunal inspected the window in the half landing. This was capable of being opened and closed and otherwise appeared to be in working order. The Tribunal inspected windows in the main bathroom and two of the bedrooms. They noted that tape has been applied to the frames, covering the space between the frames and the windows. Mr Black advised that this tape has been applied by the Tenants in an effort to exclude draughts. On inspection the Tribunal noted that draughts can be detected from the windows, despite the presence of the tape.

16. Windows. Mr Black advised the Tribunal that when he first inspected the property, the window in the half landing could not be opened. He is satisfied that it now appears to be in proper working order. With regards the bathroom and bedroom windows, which have tape round them, Mr Black advised that the Tenants were very vocal in their complaints about the windows, saying that they are cheap and badly fitted. He was advised that the Tenant's wife fell off a stool when she was putting the tape round the windows, injuring herself. Mr Black stated that he understood this to be the last straw for the tenants, who gave notice to the landlord after this incident and are due to move out on 4 May 2018. Mr Black further advised the Tribunal that the main complaint about the windows is the draughts and that he understands the Tenants were promised new seals for these some time ago.

26. Windows. The Tribunal considered the condition of the windows at the inspection and the evidence of Third Party at the hearing. The Tribunal notes that the Tenant has attempted to deal with the draughty windows by applying tape over the areas most affected. The Tribunal further notes that, despite the presence of this tape, draughts can still be detected. The Landlord does not appear to dispute the claim that the windows are defective. In the agents written representations the Landlord advises that new window seals are being sourced and will be fitted in due course. However, the Tribunal is satisfied that this matter was brought to the attention of the Landlord on 13 November 2018, and perhaps even before then by the Tenant. The windows are not currently wind and watertight and therefore a breach of the repairing standard has been established in relation to same. The defective window in the mid stair has, however, been repaired, and now appears to be in working order.

MAIN BATHROOM-WINDOW SEALED AND CONDENSATION STAINS ON CEIL.

- (2) To instruct a suitably qualified window contractor to inspect the windows in the property and carry out such repairs as are necessary to ensure that the windows are wind and watertight, or to replace the windows.

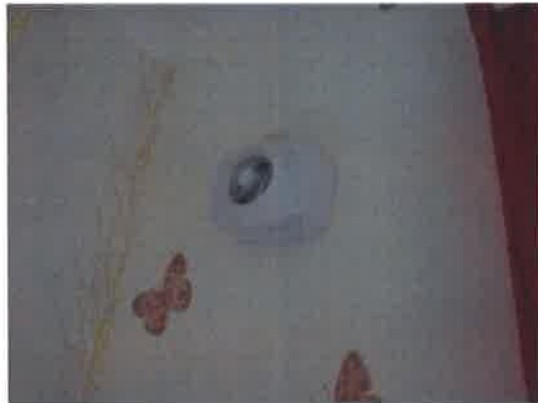
BATHROOM – VENT

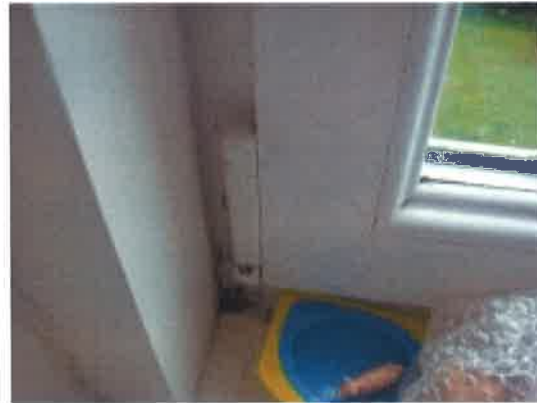
FRONT BED – WINDOW SEALED

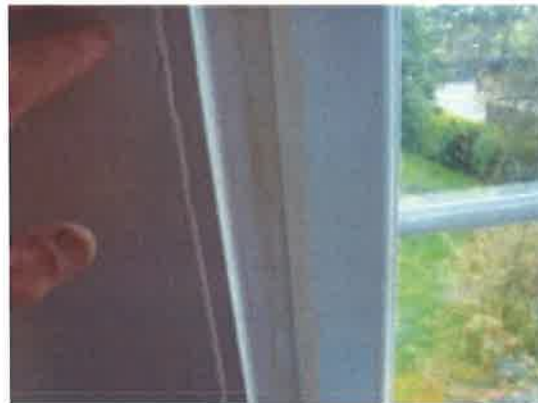
FRONT BED – WINDOW SEALED

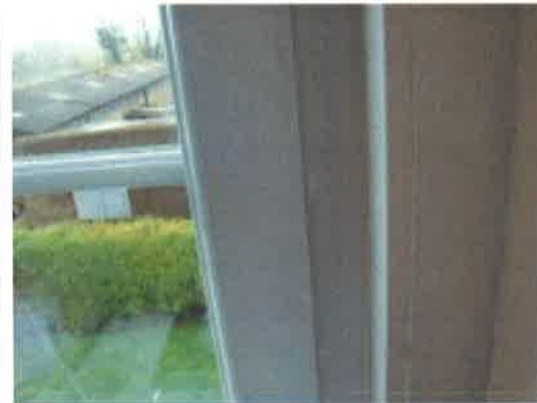
REAR BED – WINDOW SEALED

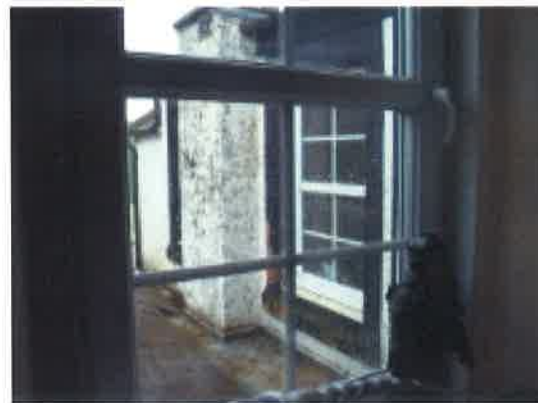
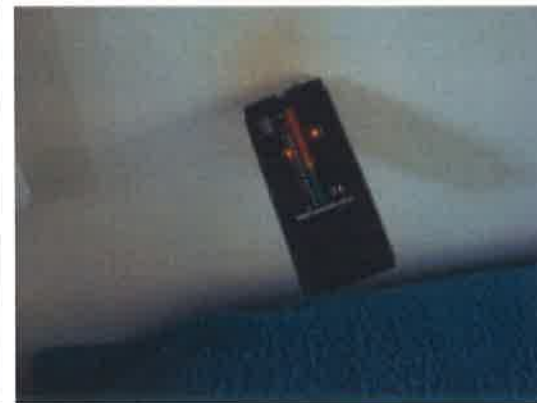
above the kitchen, the Tribunal noted marks on the gable wall and meter readings taken indicated high levels of damp.

REAR BED AND HALF LANDING WINDOW. BED OFF HALF LANDING-“DAMP”
