**First-tier Tribunal for Scotland (Housing and Property Chamber)**

Determination: Housing (Scotland) Act 2006: Section 24

**Case Reference FTS/HPC/RT/18/1192**

**7 Spinney Court, Locharbriggs, Heathhall, Dumfries, DG1 1XN registered under Title Number DMF4865 (“the Property”).**

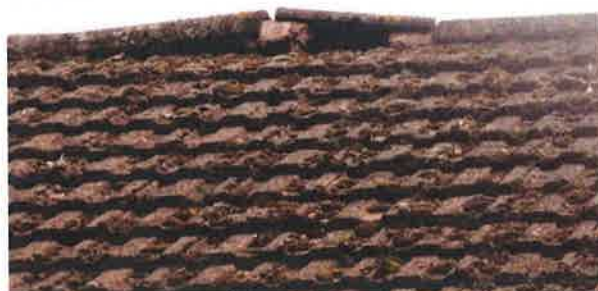
8.1 As viewed from the front, the ridge tiles of the roof appear slightly uneven (Photograph 3). From the rear there is clear evidence that two of the ridge tiles have become raised and appear to be supported from below by a "block" of stonework / concrete. (Photograph 2). When viewed from within the attic there is visible daylight at this area, signs of "windblown" debris and damp staining although was dry at the date of inspection. (Photograph 9). It is possible that the configuration of the ridge tiles in this format may have been deliberate rather than storm damage, possibly to increase ventilation to the roof void. If so it is an unsatisfactory arrangement and additional ventilation, should, if necessary be provided by specific ventilation tiles or other appropriate means.

**2:- Ridge tiles from rear**

- (1) Instruct a suitably qualified contractor to inspect the ridge tiles and chimney head, in order to identify and report on the cause of the damp staining within the roof void and detail the extent of any necessary remedial action. Thereafter the contractor should complete all necessary repairs to remedy the dampness and any associated defects. (Sections 13 (1) (a) and 13 (1) (b) of the 2006 Act).**
- (2) Renew or repair all sections of decayed timber fascia boarding at the front porch projection and redecorate as necessary. (Section 13 (1) (b) of the 2006 Act).**
- (3) Remove all debris and vegetation from the rain water goods and ensure that they are returned to good working order and free from defects. (Section 13 (1) (b) of the 2006 Act).**

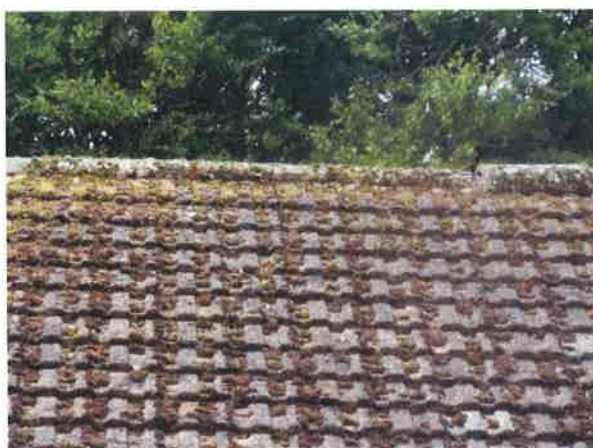
**3:- Front roof pitch and ridge tiles**

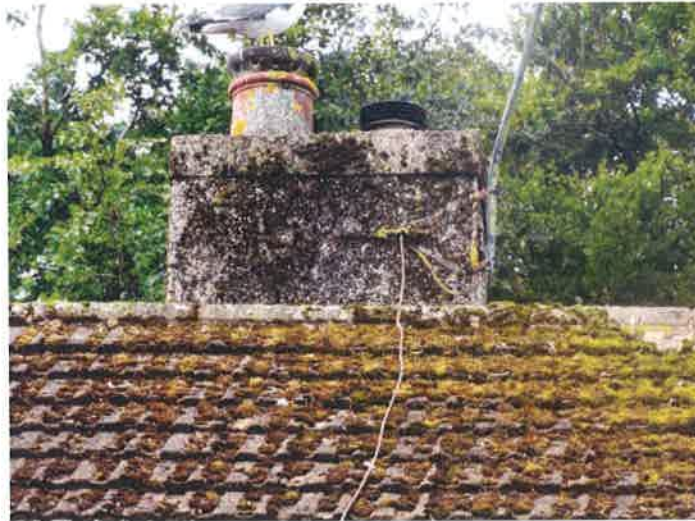
8.2 Viewed from ground level the chimney head shows signs of general wear commensurate with a building of this age and design (photograph 4). There is, particularly on the front elevation of the chimney, a visible covering of moss. Within the roof space there are, surrounding the chimney head and on the sarking panels, areas of damp staining. These were randomly tested and established to be dry at the date of inspection. (Photographs 10 – 14).

**4:- Chimney head & front roof pitch**

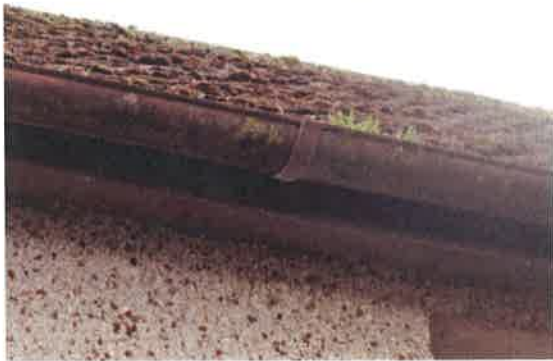
8.4 eaves gutters are of cast iron construction, almost certainly the original, and are corroded. Vegetation is evident in the guttering on both the front and rear roof pitches and at the front porch projection. (Photographs 5-7)

**5:- Eaves gutters front**

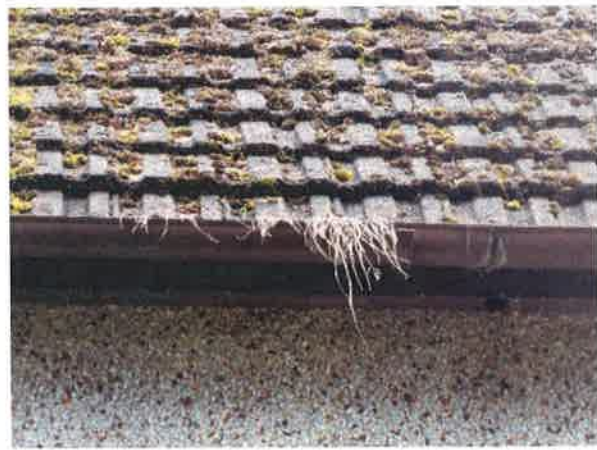
**6:- Eaves gutters Rear**

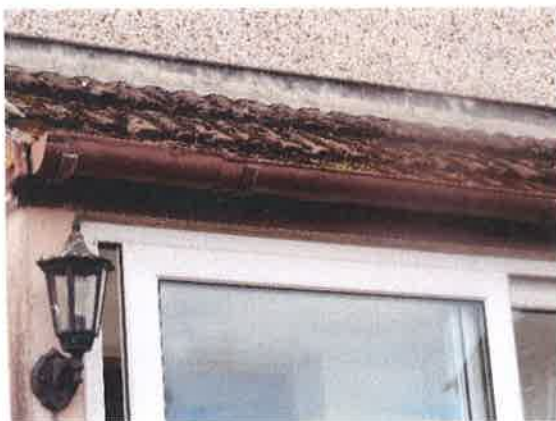
**7:- eaves gutters front porch**

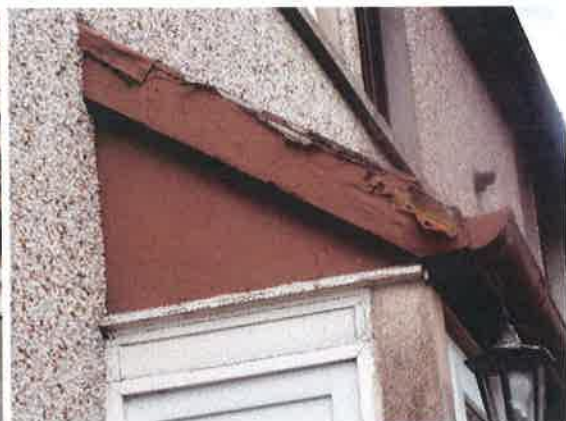
8.3 The timber fascia boarding at the front porch projection displays evidence of decay and blistered paintwork. (Photograph 8)

13.2 The tribunal found that the timber fascia boarding at the front porch was rotten and was not in a reasonable state of repair.

**8:- Timber fascia at porch projection**

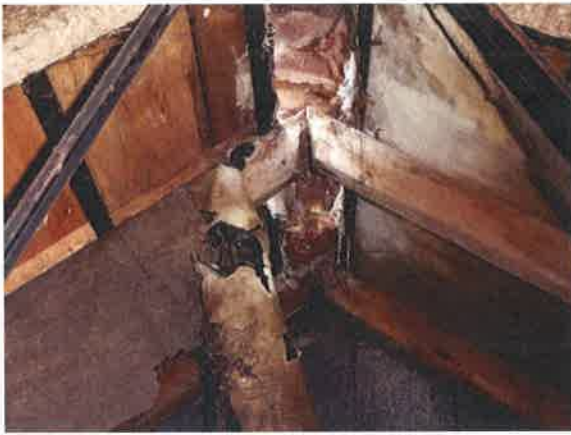
**9:- Below raised ridge tile in attic**

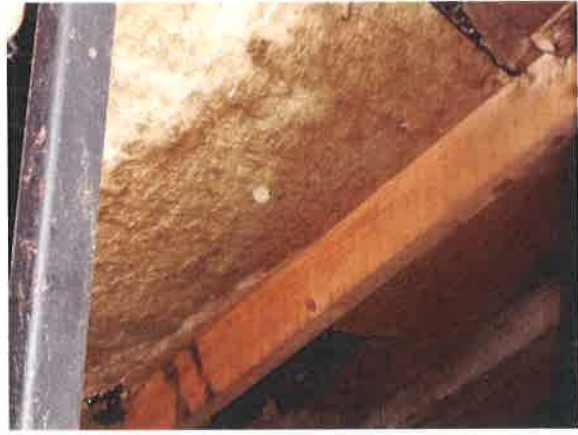
**10:- Sarking & insulation in attic**

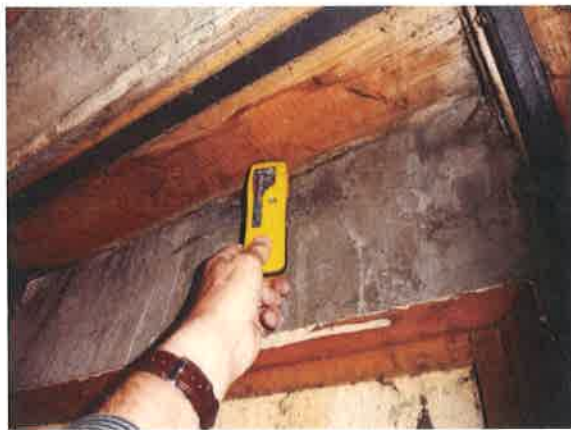
Having regard to the recent hot dry weather the tribunal were unable to confirm if the damp staining around the chimney head, completely dry at the time of inspection, was entirely historic or as a result of general wear and tear at the chimney head flashing / rendering.

**11:- Staining by chimney - dry**

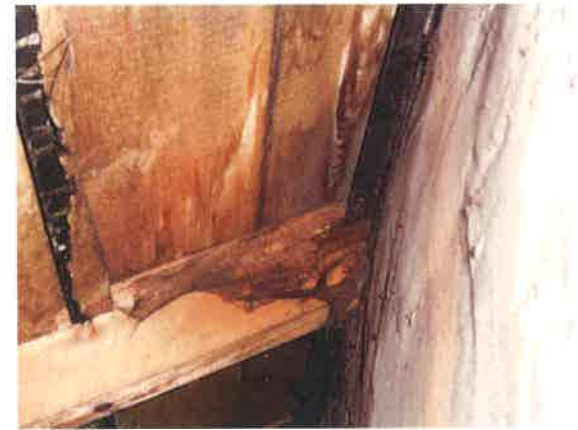
**12:- Staining at sarking – dry**

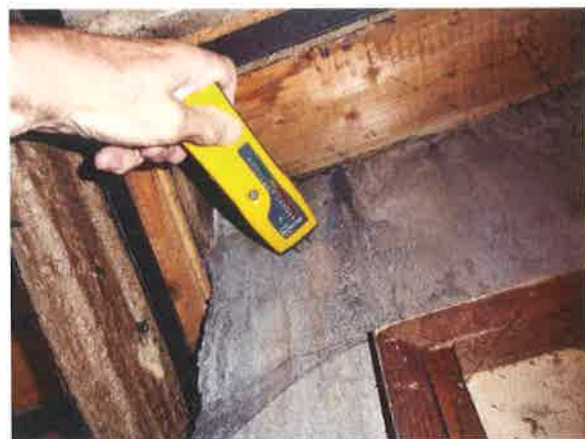
**13:- Staining chimney plaster – dry**

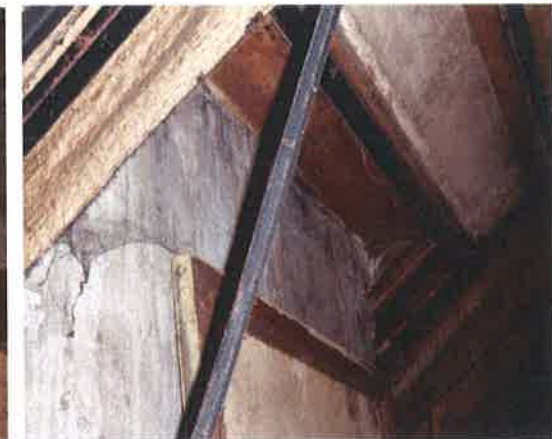
**14:- Staining at sarking - dry**
