**First-tier Tribunal for Scotland (Housing and Property Chamber)**

**STATEMENT OF DECISION: Housing (Scotland) Act 2006, section 22(1A)**

**Reference number: FTS/HPC/RT/18/2234**

**Re: Mid Cottage, Warmanbie House (Warmanbie Cottage), Annan, DG12 5LL  
("the House")**

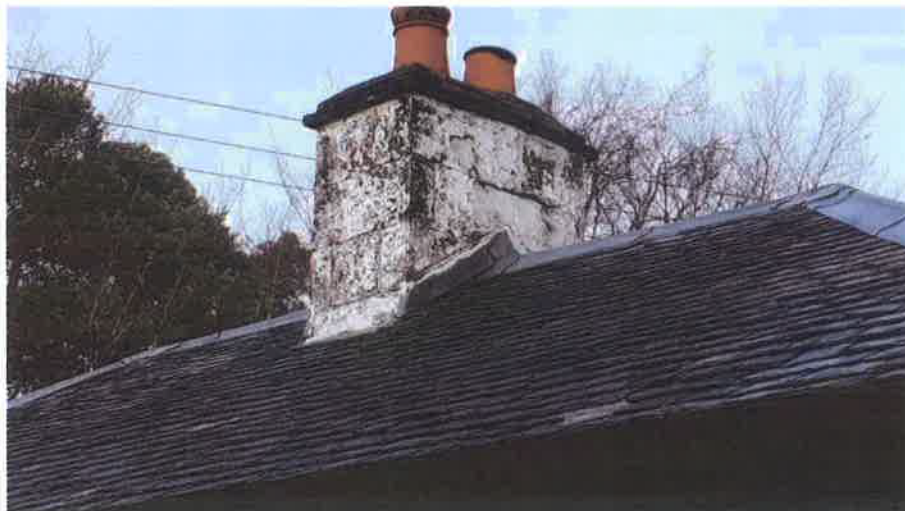
51. The chimneys were inspected from ground level. It appeared that the front chimney was haunched and required general repairs to both the mortar bedding and cope. The rear chimney similarly required general repairs to the mortar which appeared to have cracks. Accordingly, the repairing standard has not been met (section 13 (1) (a) and (b) of the Act.)

2 The front chimney (stonework, pointing and pot haunching defective)

- (h) To repair and seal the holes in the stonework on the East elevation of the House at ground level and repair or replace the air vent cover there;
- (i) To repair the mortar bedding around the chimney haunch, pots and copes, to ensure the House is wind and watertight and in all other respects reasonably for human habitation;

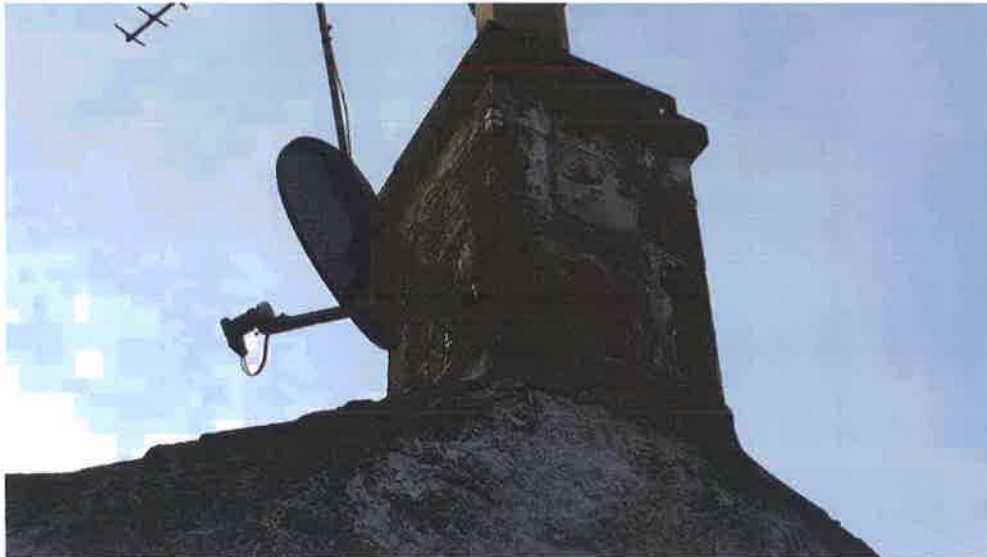
3 The rear chimney (stonework and pointing defective)

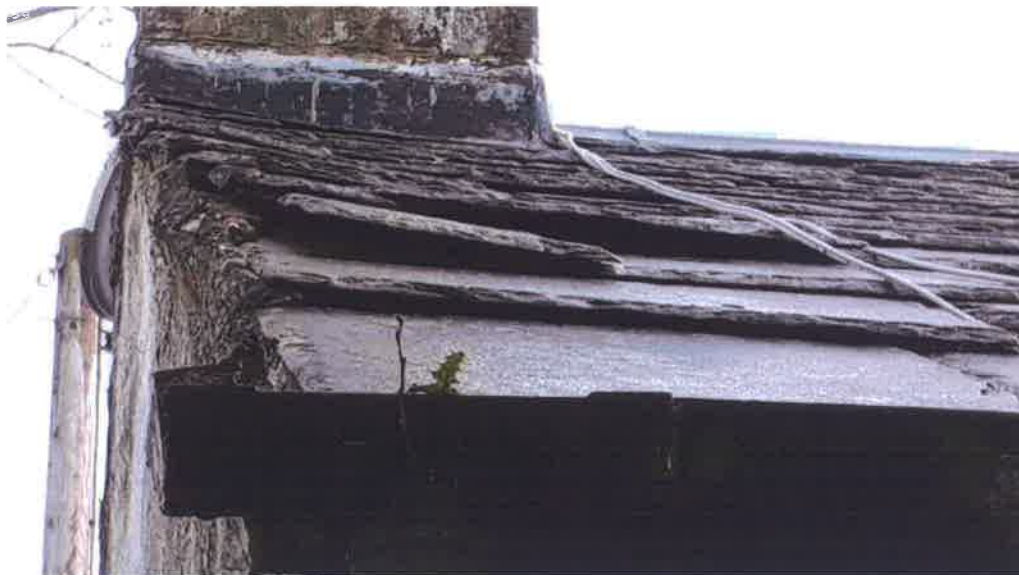
43. The wall head gable to the rear of the House was consistent in design with the style of the build. However, the mortar appeared on visual inspection to have deteriorated and required to be removed and replaced. Accordingly,

4 The rear roof gable end (defective cement mortar pointing)

- (d) To insulate the Southern area of the attic space;
- (e) To remove the defective mortar pointing on the rear wall head gable and renew it, to ensure the House is wind and watertight and in all other respects reasonably for human habitation;

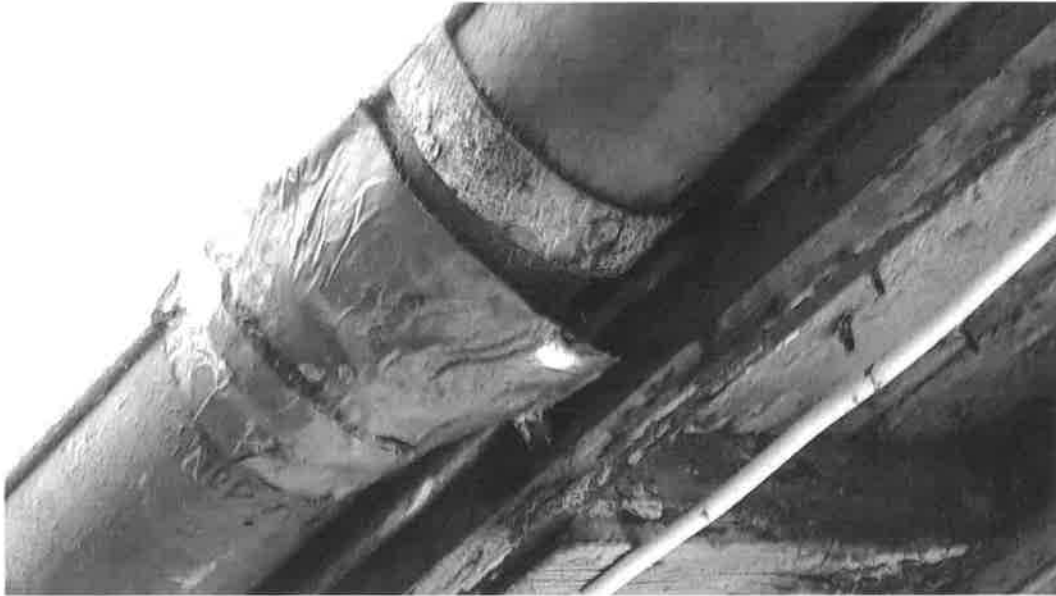
- the repairing standard has not been met (section 13 (1) (a) and (b) of the Act.)
44. The guttering had a defective joint which had been temporarily repaired at the front elevation. There was evidence of corrosion and it was noted that the corner section had corroded at the front East elevation. A downpipe was missing. Accordingly, the repairing standard has not been met (section 13 (1) (b) of the Act.)

5 The front elevation (patched cast iron gutter joint)

- (f) To repair or renew all defective sections of guttering, joints and corner joints and to replace the missing downpipe on the West elevation;
- (g) To repair or replace all decayed sections of the timber fascia below the guttering and securely re-fix the gutter;

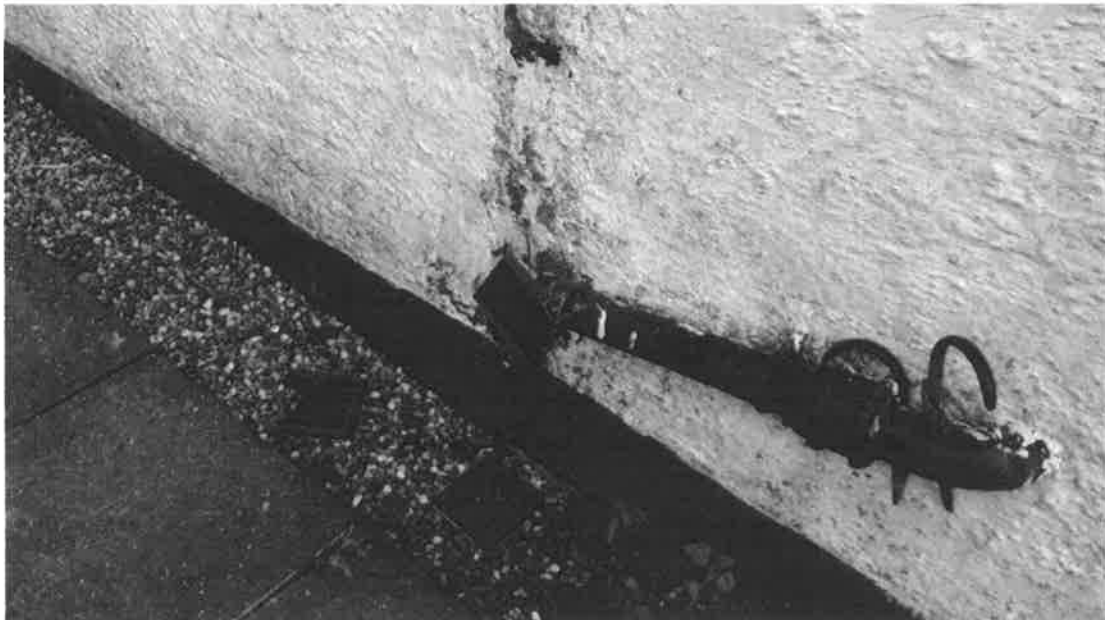
6 The side elevation west – missing downpipe)

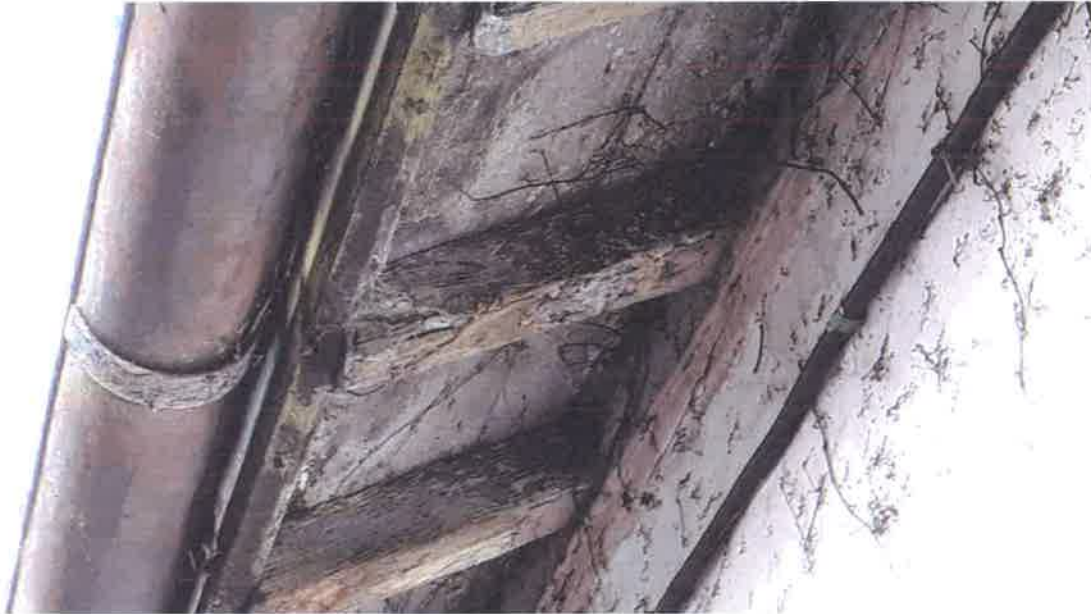
45. The fascia boards behind the guttering were decayed at parts and needed repaired or replaced. Accordingly, the repairing standard has not been met (section 13 (1) (b) of the Act.)

7 An example of a defective section of the timber soffit at eaves

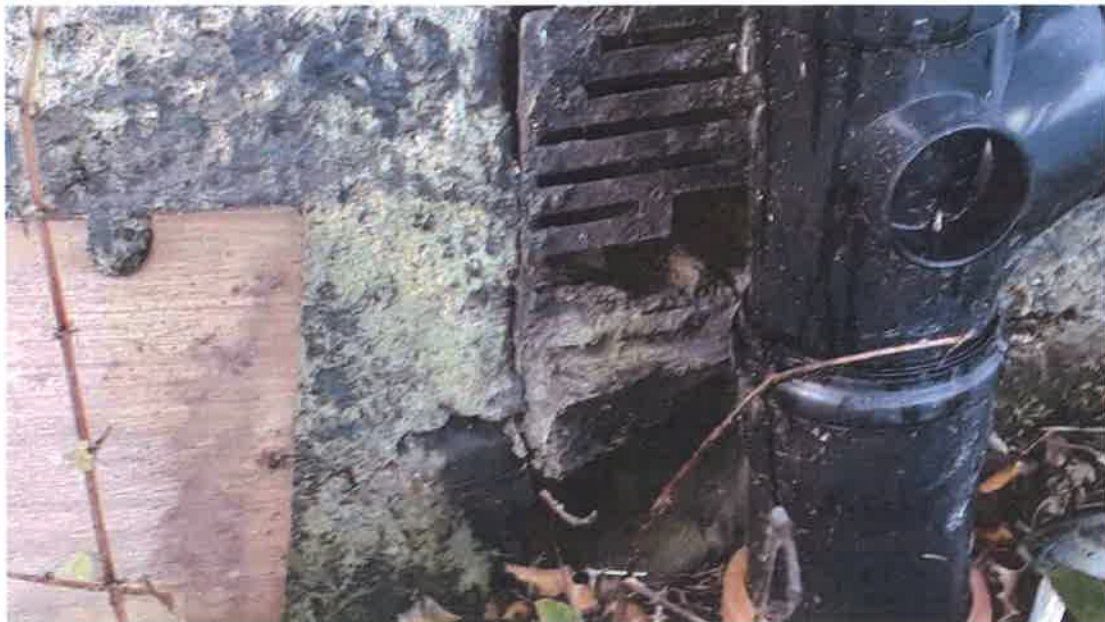
46. At the East elevation wall there were holes in the stonework at ground level and there was a broken air vent cover. Accordingly, the repairing standard has not been met (section 13 (1) (a) and (b) of the Act.)

8 The side elevation east (hole in stonework and defective air vent)

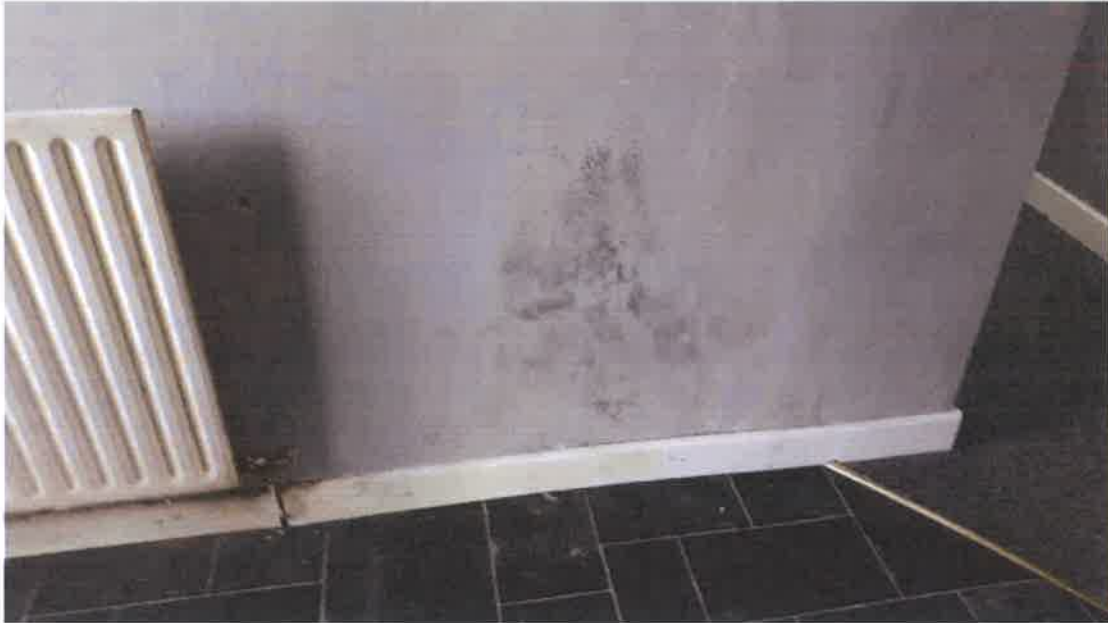
39. There was evidence of dampness on the interior wall between the kitchen and back habitable room and on the external wall of the back habitable room including visible black mould. The Damp Meter readings at those locations were showing red and at the higher end of the scale. Accordingly, the repairing standard has not been met (section 13 (1) (a) of the Act.)

9 Dampness in kitchen wall (separating wall from rear bedroom 2)

- (a) To instruct a suitably qualified damp proof contractor to carry out a full inspection of the House to identify the source of the penetrating or rising dampness and thereafter to carry out such repairs as are necessary to eradicate the dampness evident in the kitchen, rear habitable room and bathroom;

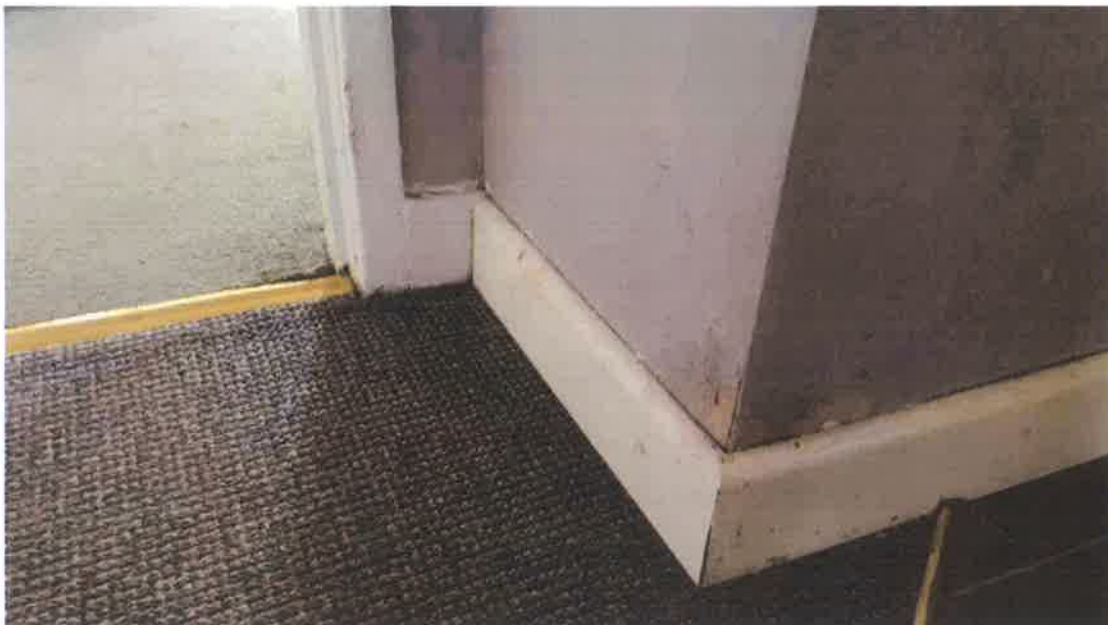
10 Dampness in kitchen wall (at entrance from front lounge)

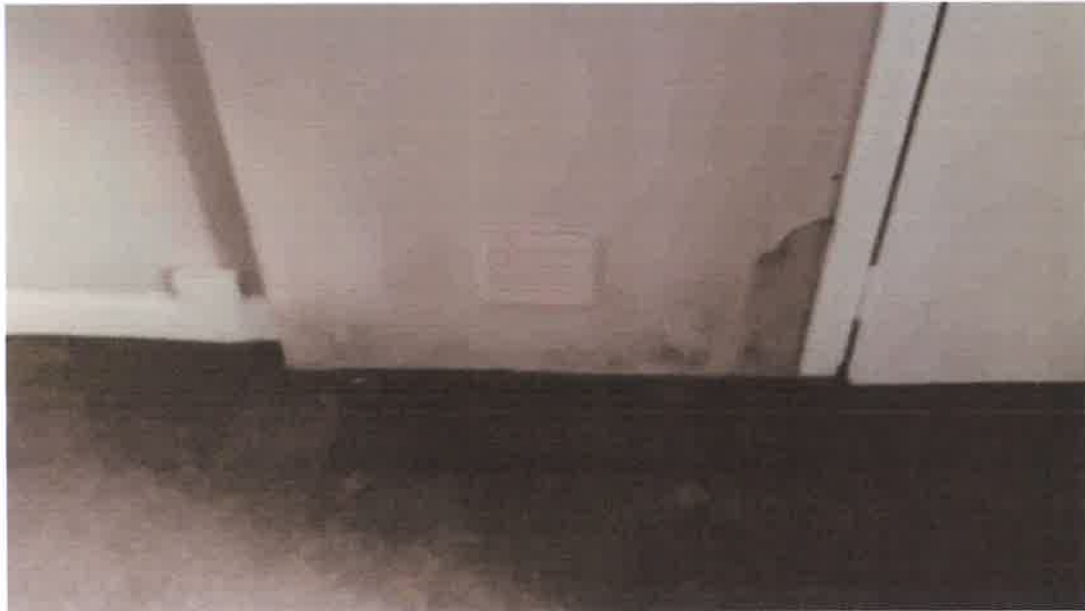
11 Dampness at rear chimney breast in bedroom 2

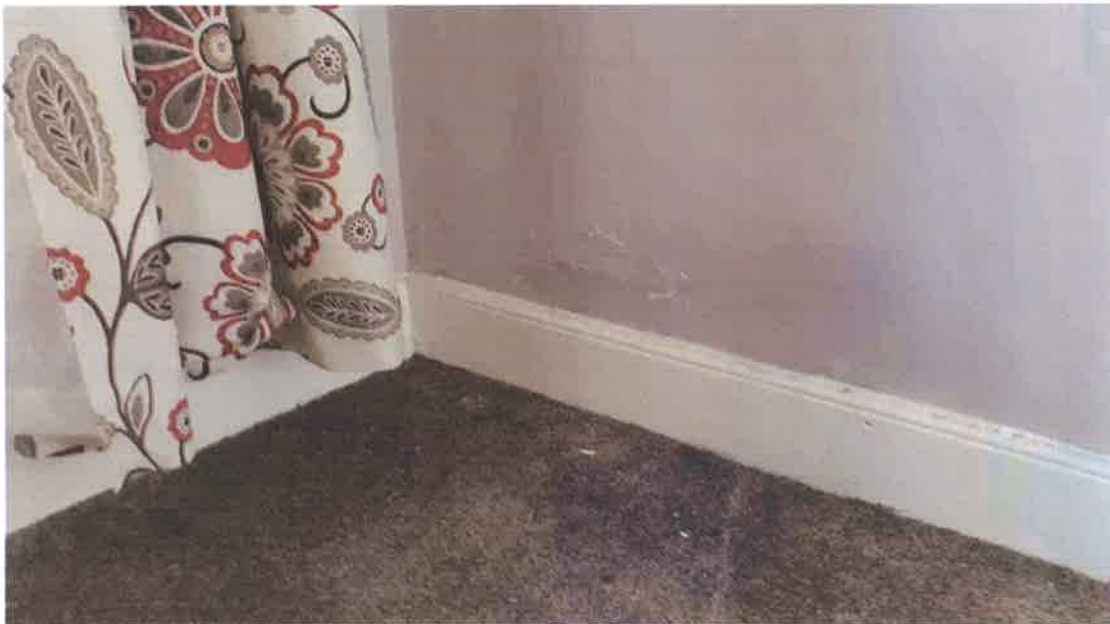
12 Dampness at south east corner at base of wall in bedroom 2

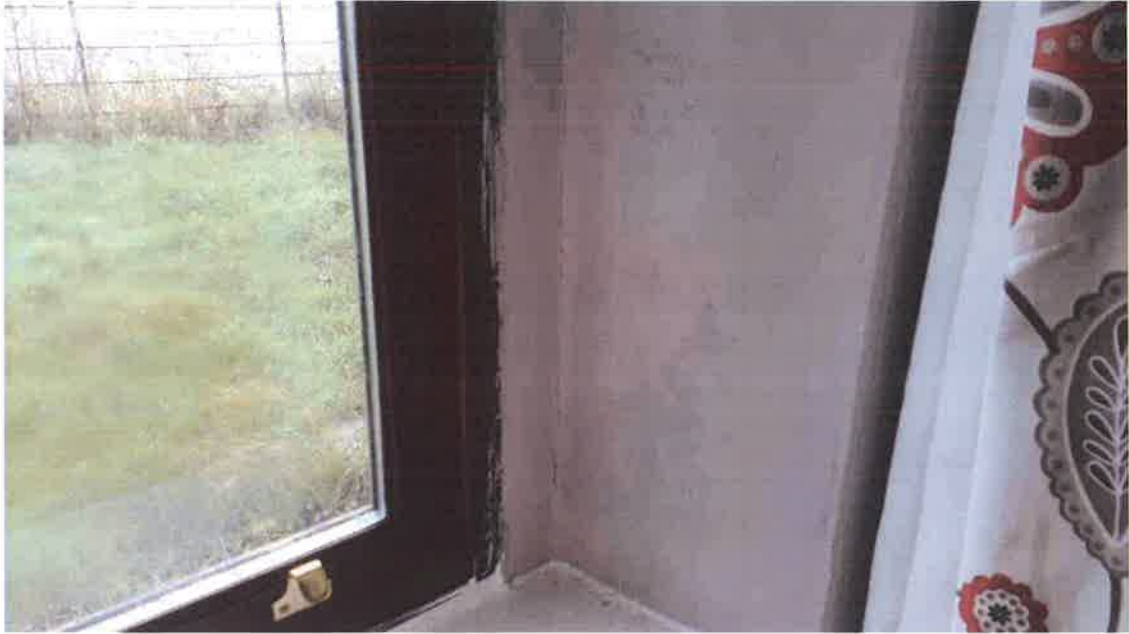
13 Dampness at the window reveal in bedroom 2

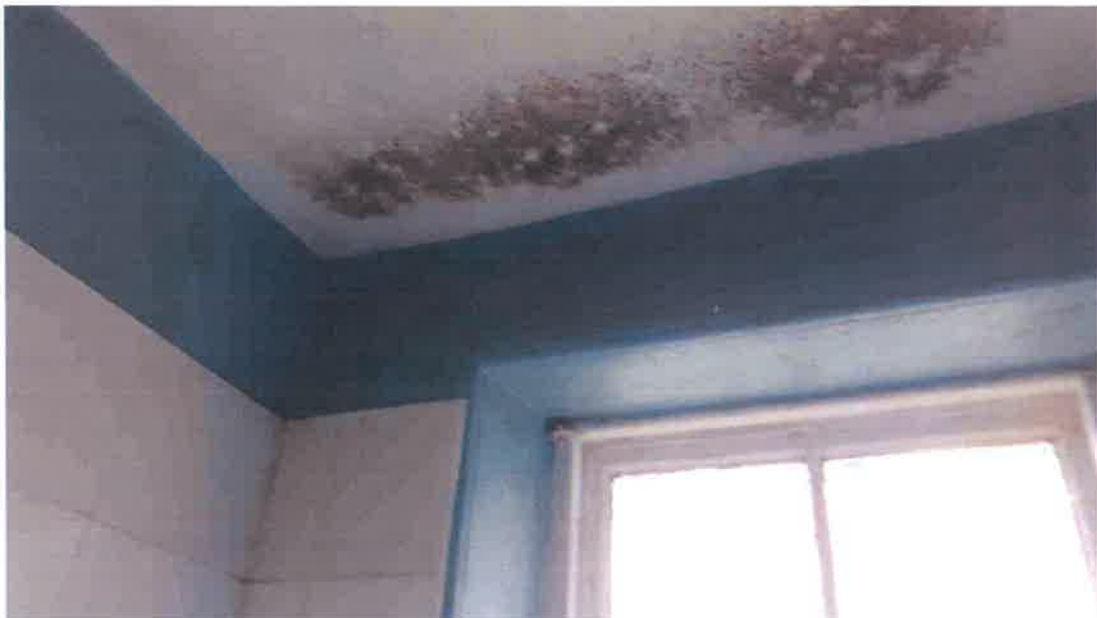
40. There was evidence of black mould on a section of the ceiling of the bathroom near to the window area. Investigation and repair of the dampness issue is needed by the landlord to meet the repairing standard (section 13 (1) (a) of the Act).

14 Dampness on ceiling in bathroom

- (b) To eradicate the dampness and black mould evident on the ceiling in the bathroom of the House, treat same with a fungicide and re-paint;
- (c) Install mechanical extractor fans in the kitchen and bathroom to ensure adequate ventilation;

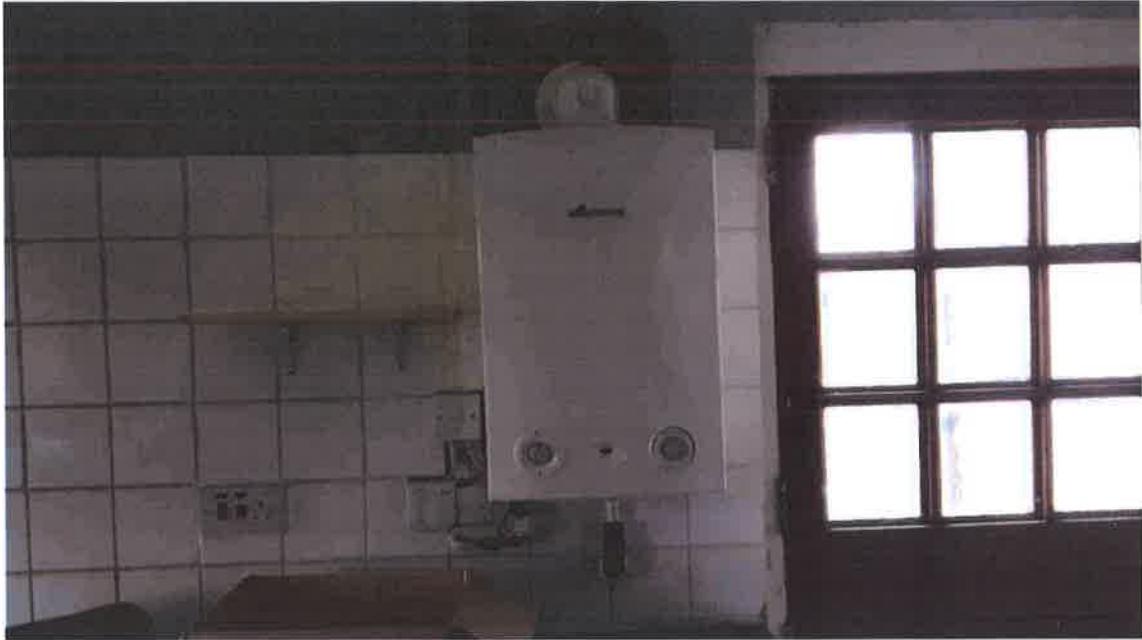
50. There was one Carbon Monoxide detector at the open fire in the Livingroom. There was no Carbon Monoxide detector in the kitchen which is required to provide satisfactory provision for giving warning if carbon monoxide is present in a concentration that is hazardous to health. Accordingly, the repairing standard has not been met (section 13 (1) (g) of the Act.)

15 The kitchen boiler (no CO detector)

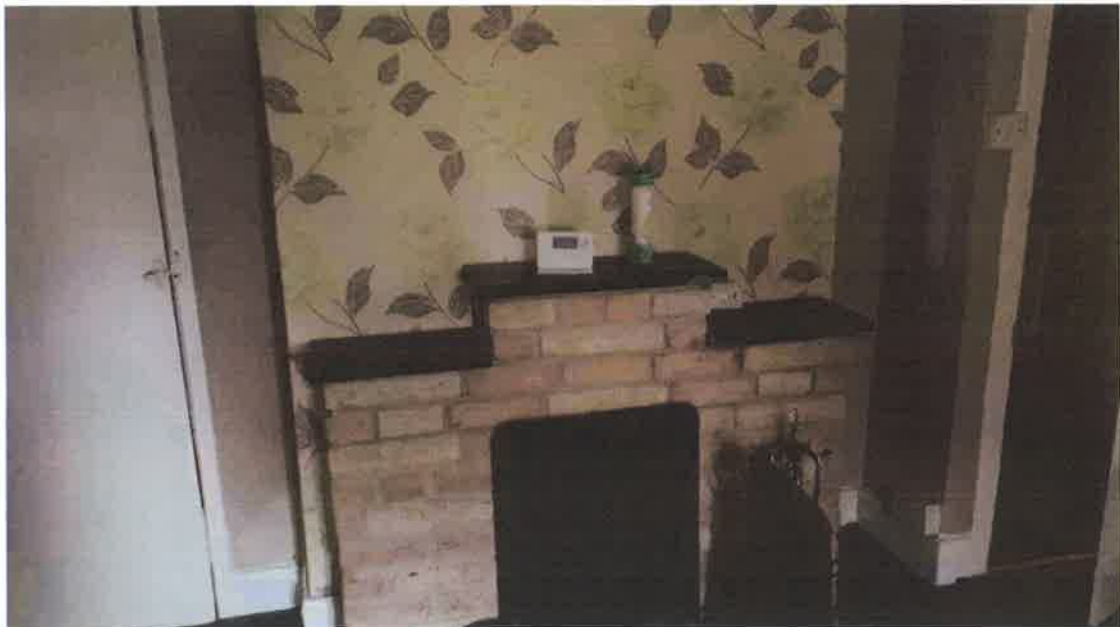
16 The lounge open fire (CO detector visible)

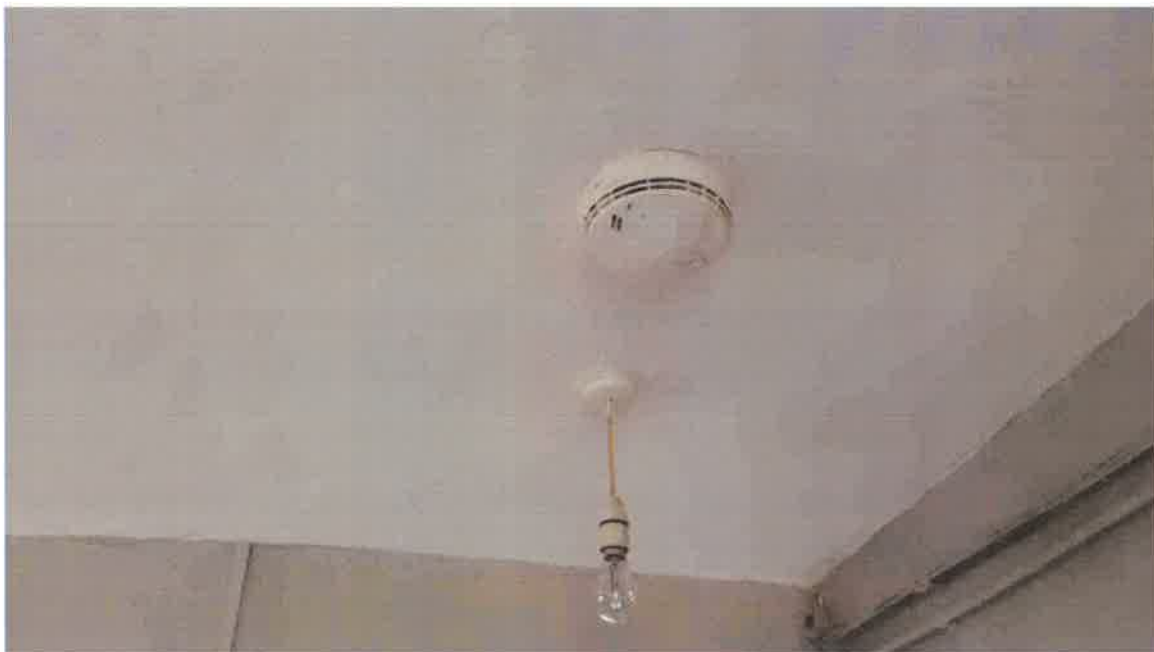
49. There were functioning interlinked and hardwired smoke detectors within the entrance hall and kitchen. The revised Domestic Technical Handbook guidance issued by Building Standards Division (Technical Handbooks 2013: – Domestic – Fire), states there should be at least: one functioning smoke alarm in the room which is frequently used by the occupants for general daytime living purposes, one functioning smoke alarm in every circulation space, such as hallways and landings, one heat alarm in every kitchen, and all alarms should be interlinked. In this House, no smoke alarm had been fitted in the main living area, the room which is frequently used by the Tenant for general daytime purposes. Accordingly, the repairing standard has not been met (section 13 (1) (f) of the Act.)

17 Smoke detector in entrance hallway

- (j) To install sufficient smoke alarms and a heat detector that are mains wired and interlinked, all to comply with the relevant fire legislation;
- (k) To instruct a suitably competent qualified electrician (such as NICEIC, SELECT or NAPIT registered) to inspect, test and thereafter repair, renew or upgrade the electric appliances in the House to ensure that they are in a reasonable state of repair and in proper working order and produce to the Tribunal an unqualified electrical safety certificate (EICR).

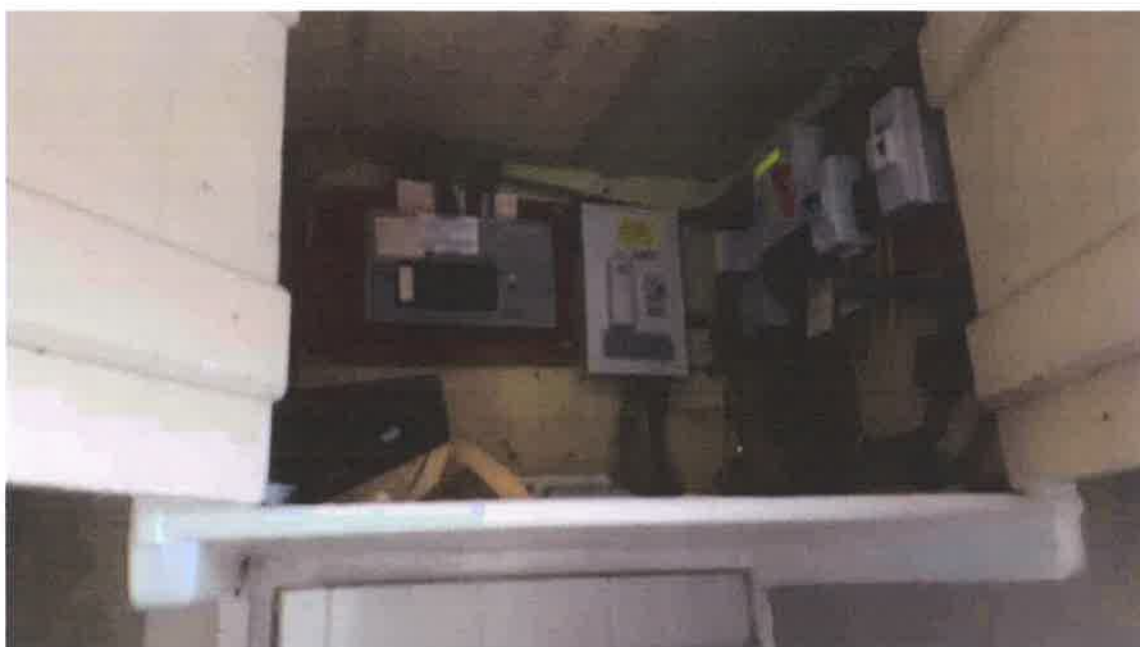
47. There was no current EICR for the House. The traditional fuse box may not meet current safety requirements. An electrical safety certificate (EICR) for the House is required. The Tribunal considered that this was an urgent ongoing safety issue relating to the health and safety of any potential occupants given that there were possible electrical issues as alluded to in the Application. In terms of section 19A of the Act the landlord must before the start of the tenancy provide the tenant with a copy of the record of the most recent electrical safety inspection carried out and to satisfy the repairing standard, section 13(1) (c) of the Act.

18 The electrical switchgear in the lounge high level cupboard

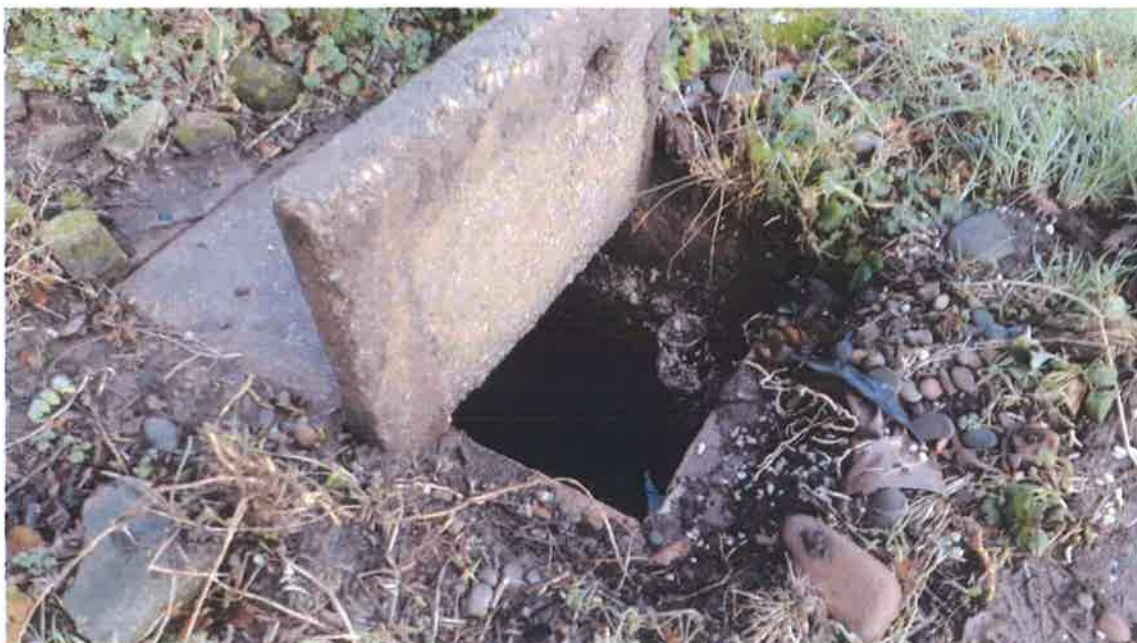
52. There was what appeared to be a Cesspit in the rear garden, as opposed to a septic tank. It was a brick built chamber and it was difficult to assess where it drained to. Accordingly, the repairing standard has not been met (section 13 (1) (a) and (c) of the Act.)

19 The cesspit in the rear garden

- (m) To install a septic tank compliant with all current SEPA requirements;
- (n) On completion of all the above works, to restore all affected finishes and decoration.
